# U20069: Pavement Analysis Study 2020 University of Illinois at Urbana-Champaign

## Final Report

Applied Pavement Technology, Inc.  
115 West Main Street, Suite 400  
Urbana, Illinois 61801  
(217) 398-3977  
[www.appliedpavement.com](http://www.appliedpavement.com)

**AUGUST 2020**

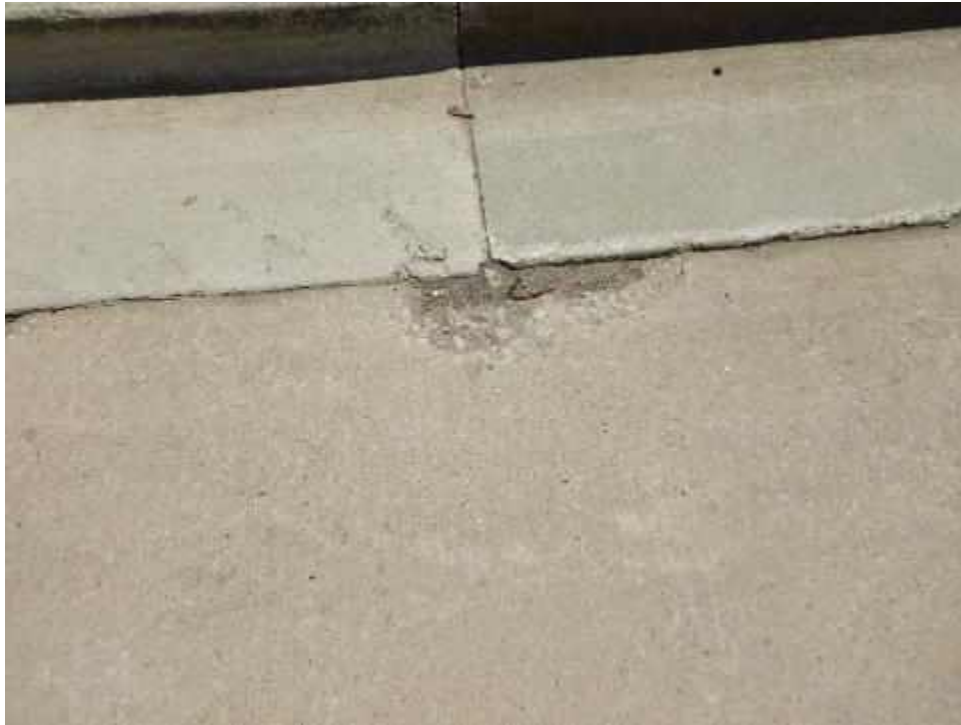
ARMRYA-E05-Joint Spalling-(Sample Unit No. 01)

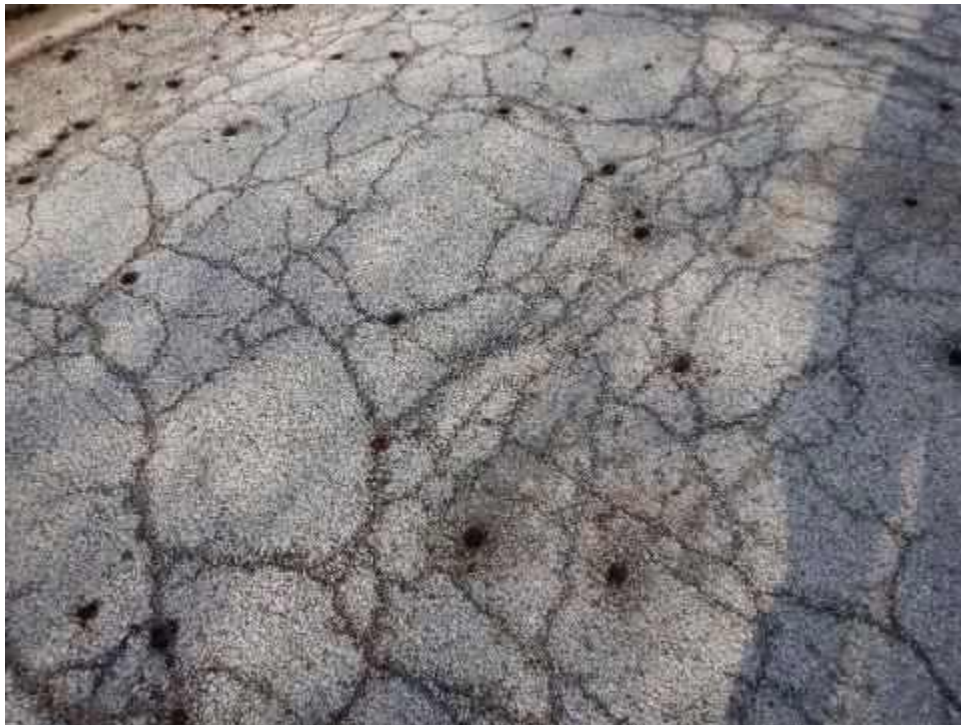
BAILEYD-E00-Alligator Cracking-(Sample Unit No. 02)

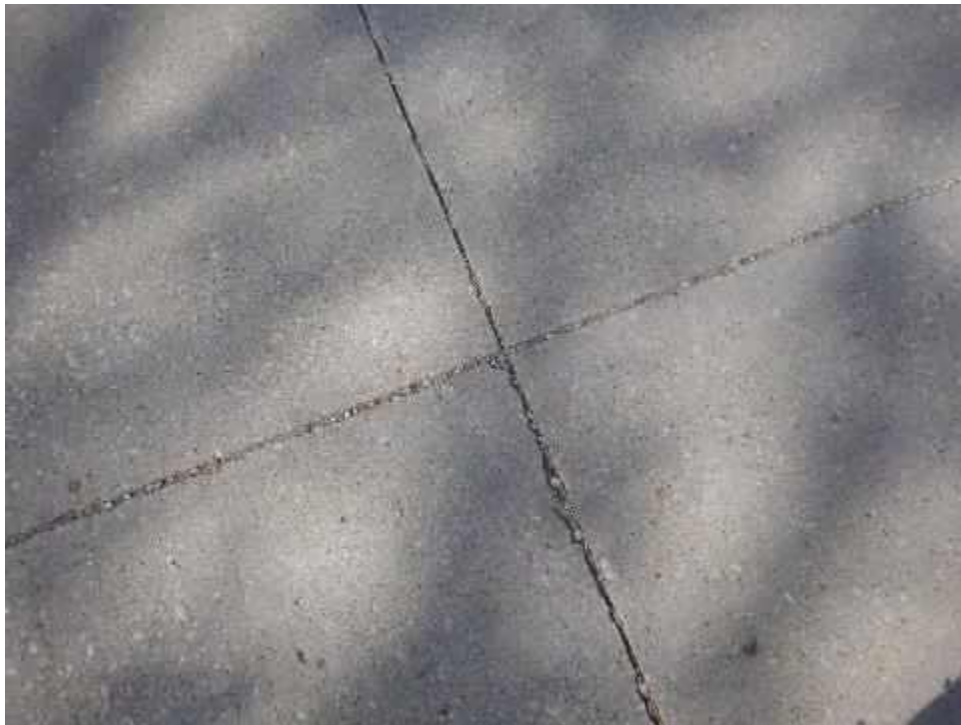
CLARKST-UW12-Joint Seal Damage-(Sample Unit No. 01)

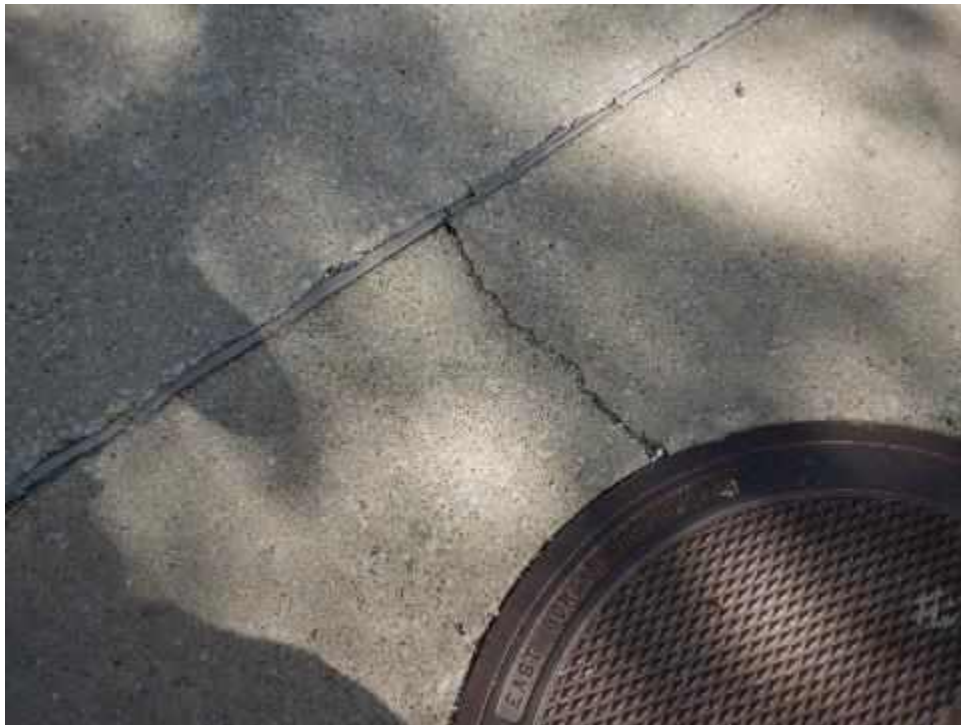
CLARKST-UW12-LTD Cracking-(Sample Unit No. 01)

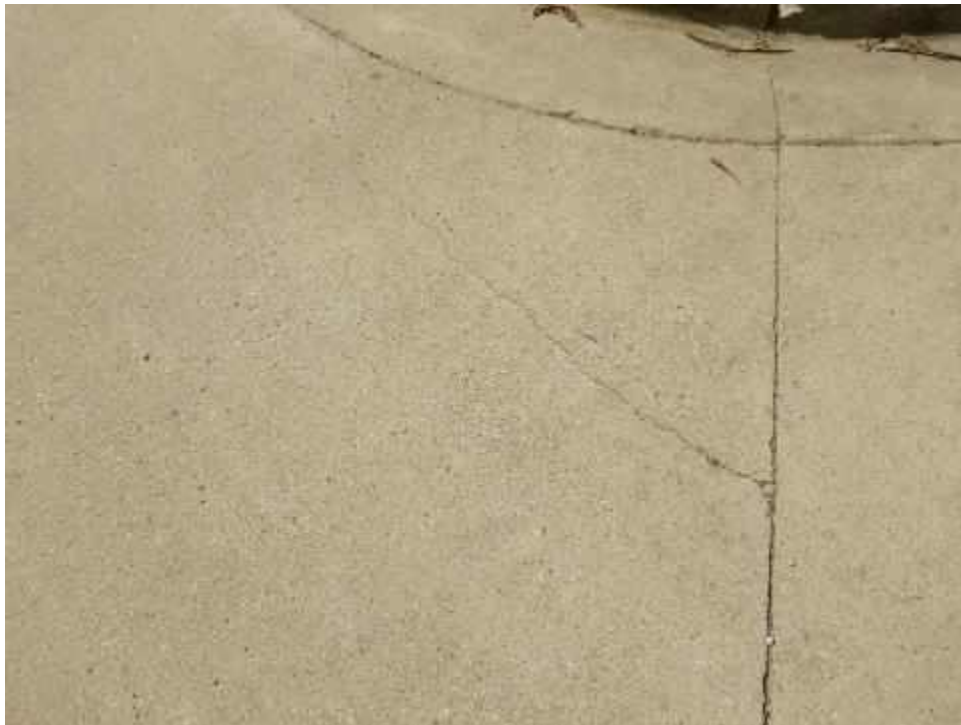
CLARKST-UW12-Shrinkage Cracking-(Sample Unit No. 01)

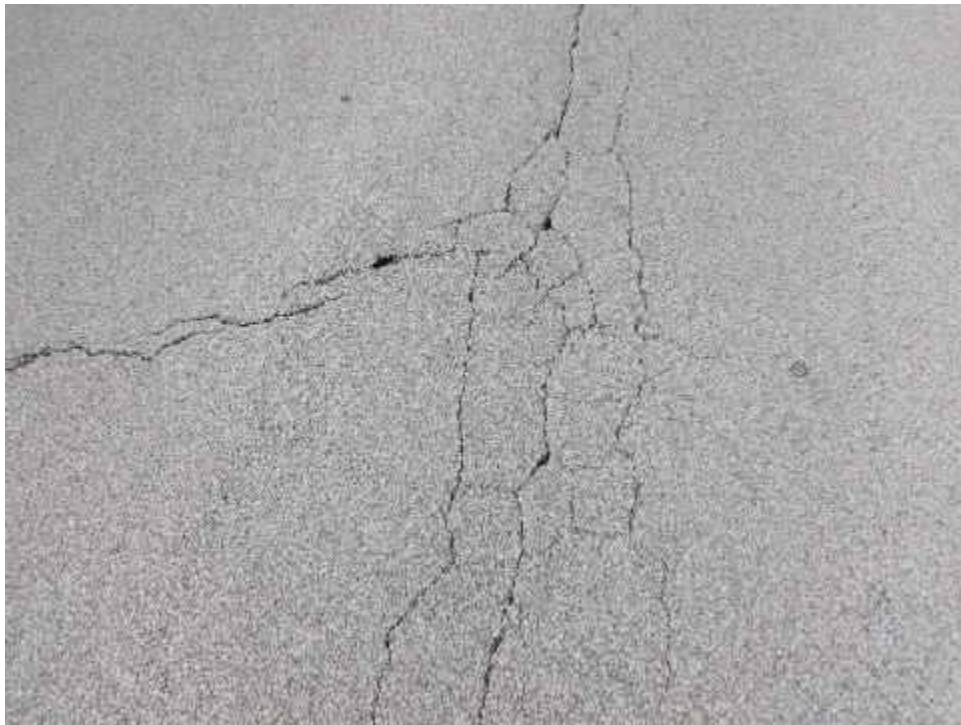
DORNRDR-US11AW-Alligator Cracking-(Sample Unit No. 01)

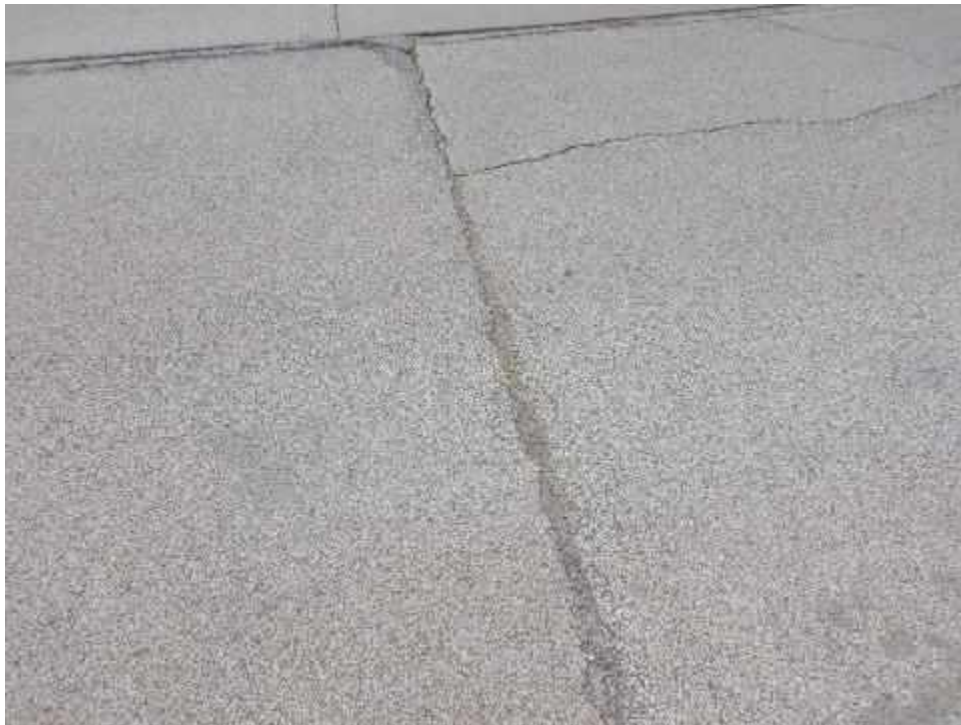
DORNRDR-US11BE-Joint Reflection Cracking-(Sample Unit No. 01)

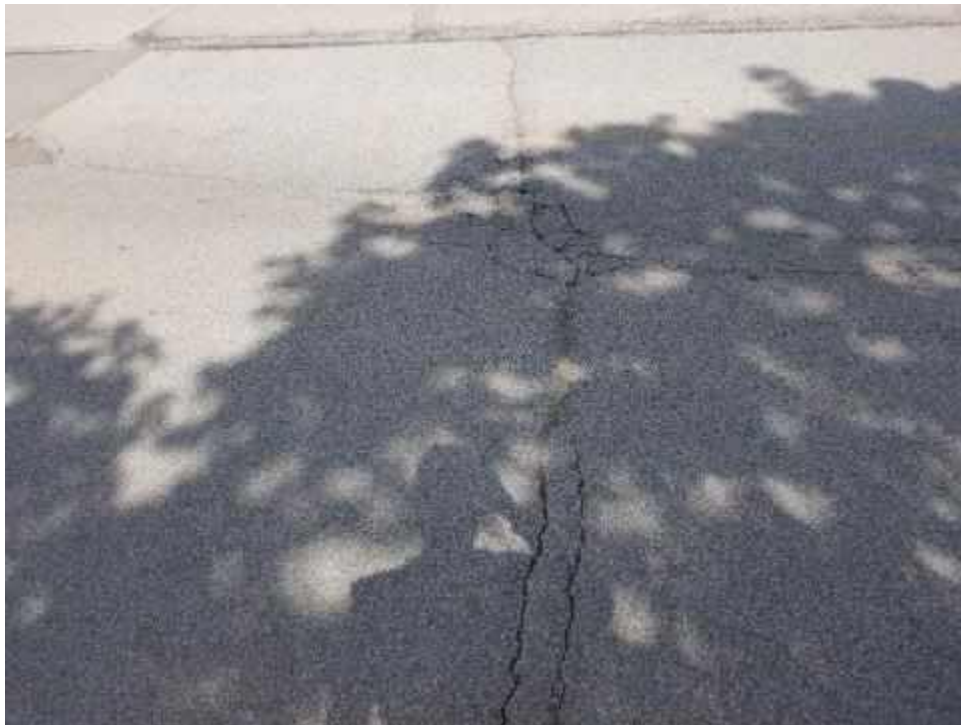
DORNRDR-US11BW-Joint Reflection Cracking-(Sample Unit No. 01)

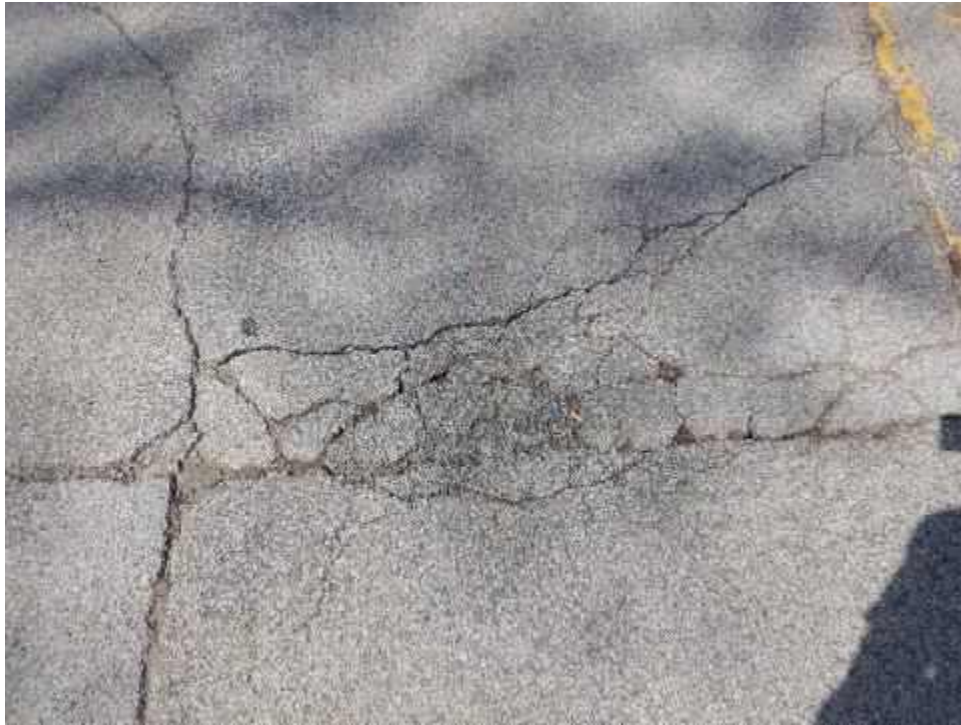
DORNRDR-US13W-Alligator Cracking-(Sample Unit No. 01)

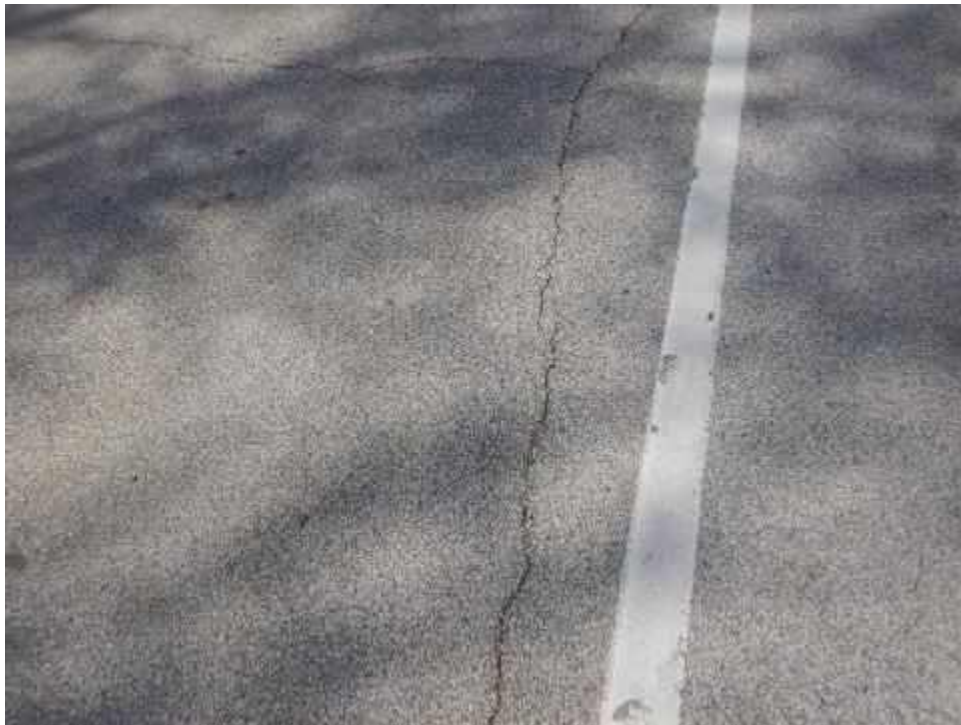
DORNRDR-US13W-L&T Cracking-(Sample Unit No. 01)

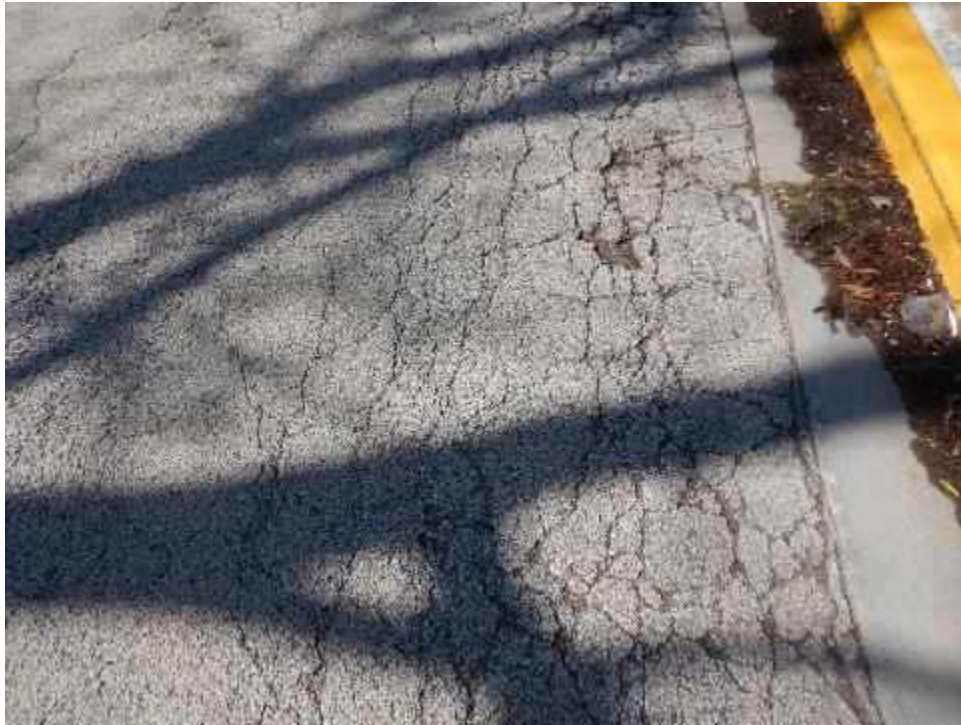
EUCLDS-S12-Alligator Cracking-(Sample Unit No. 02)

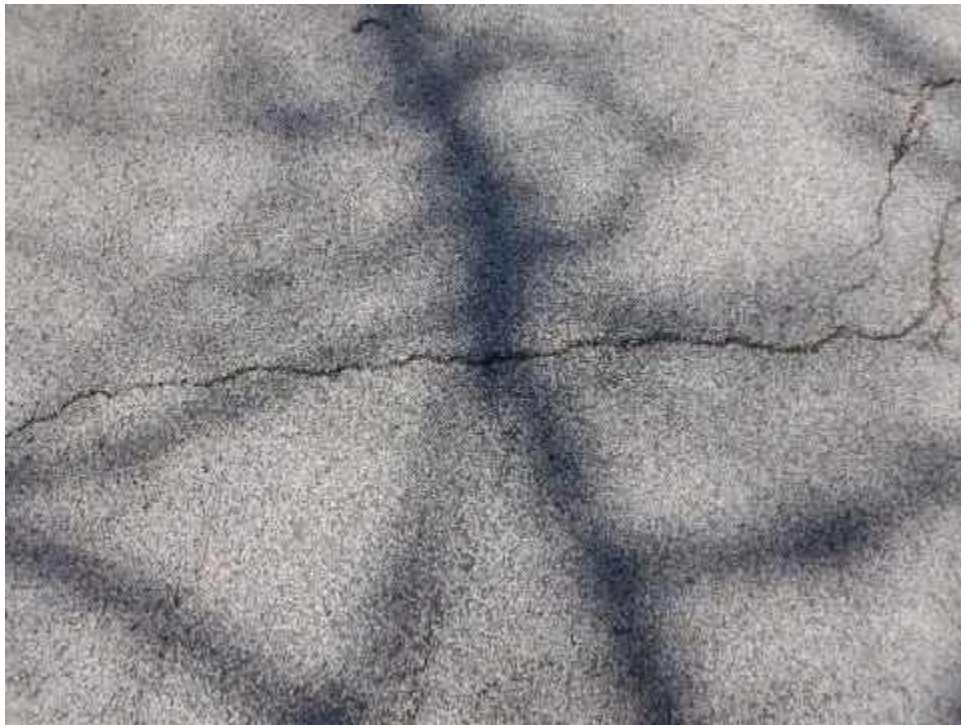
EUCLDS-S12-L&T Cracking-(Sample Unit No. 01)

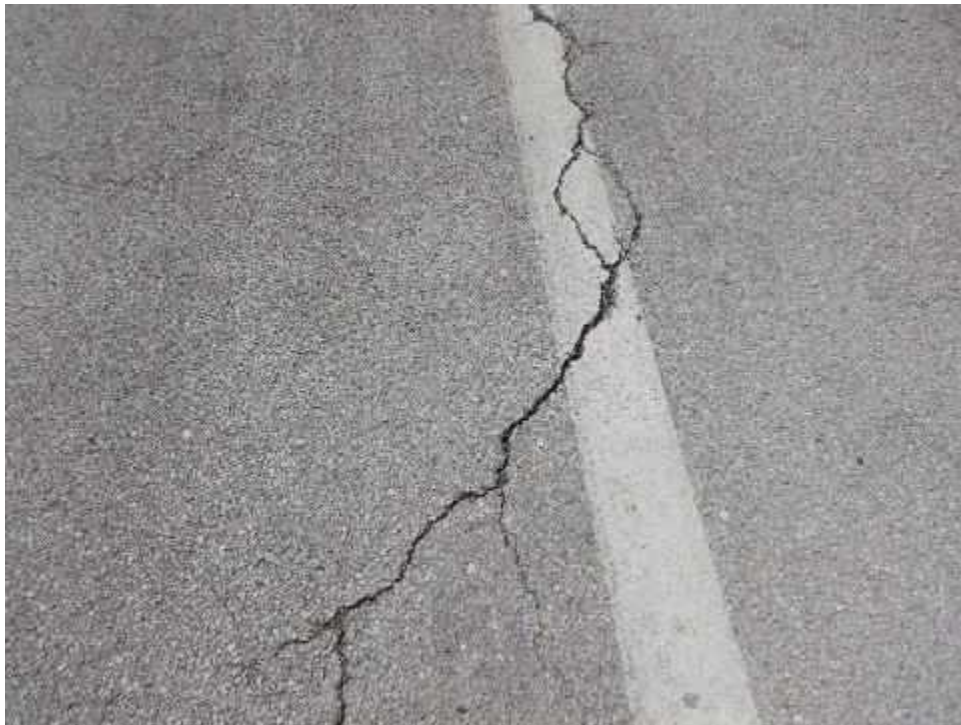
FIRSTS-S15-L&T Cracking-(Sample Unit No. 01)

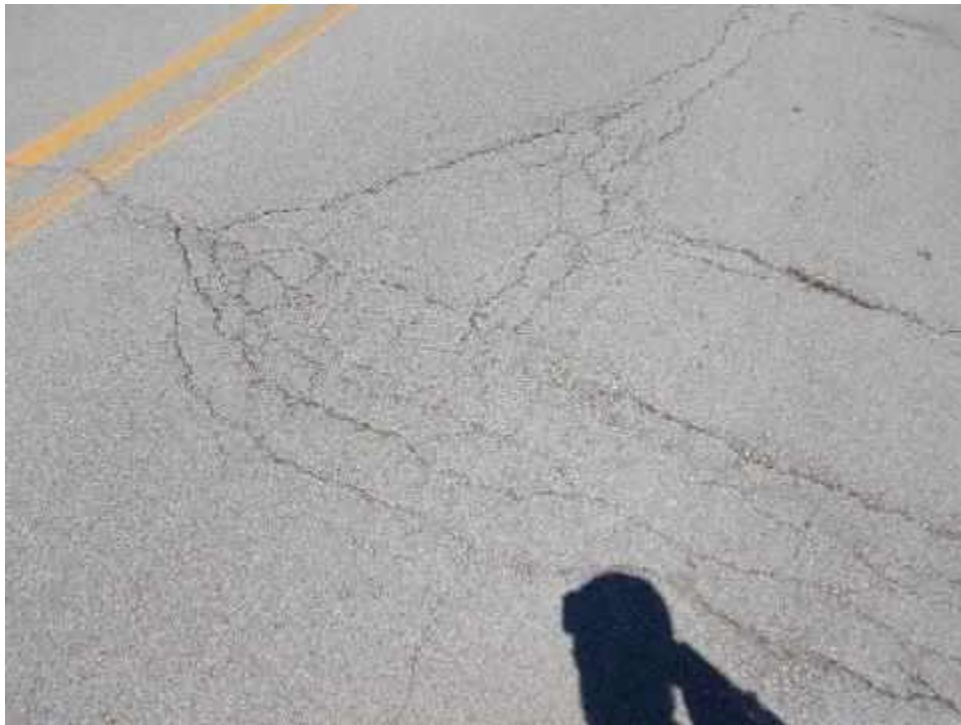
FOURTS-S12-Alligator Cracking-(Sample Unit No. 003)

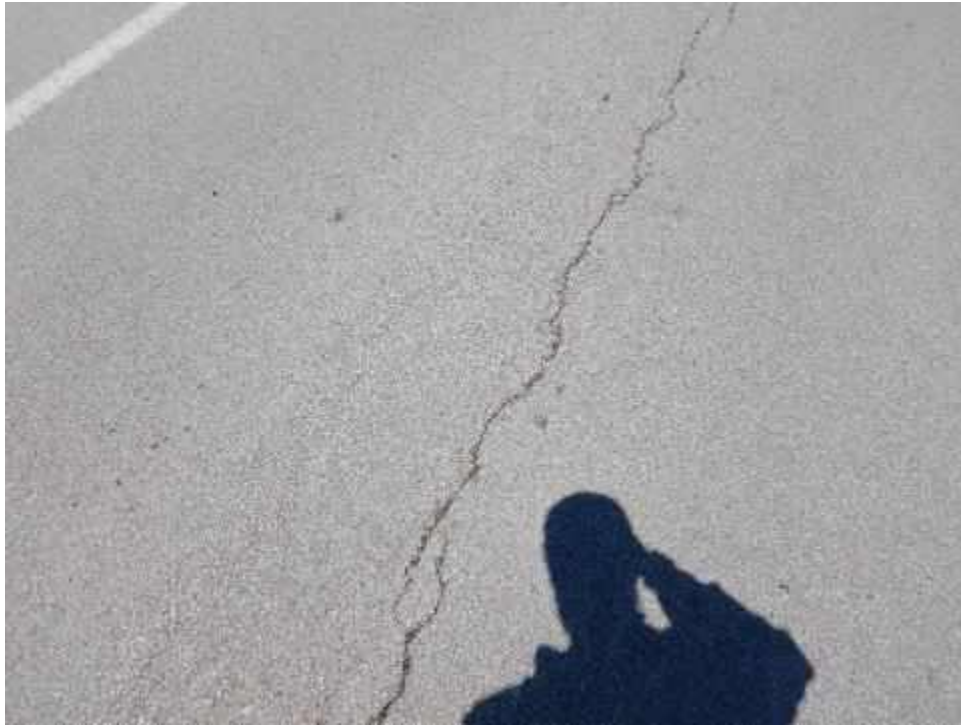
FOURTS-S14-L&T Cracking-(Sample Unit No. 01)

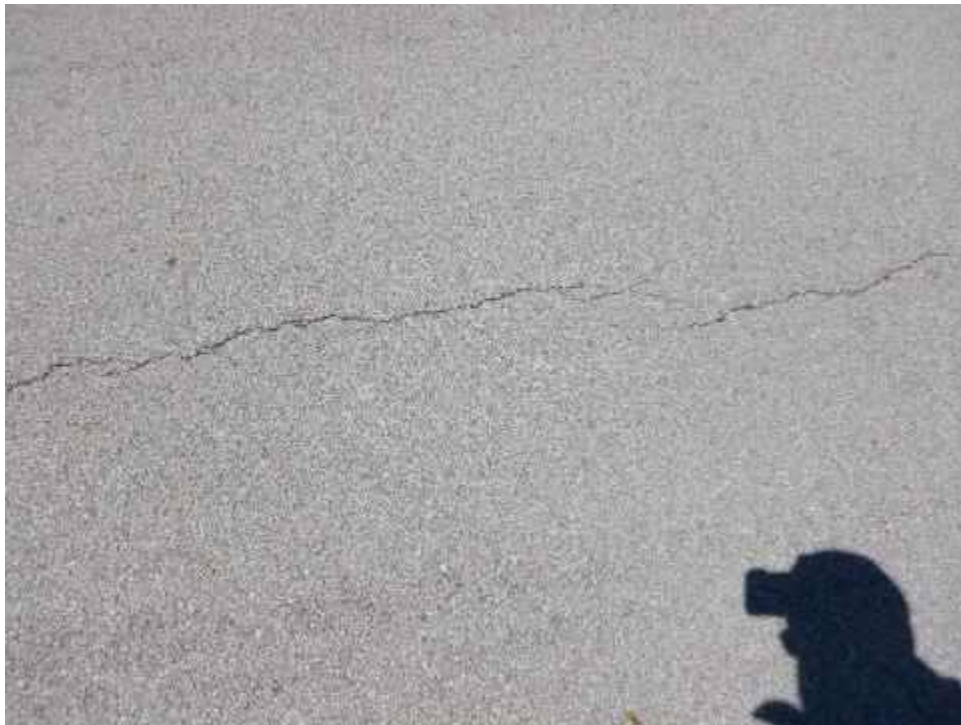
FOURTS-S15A-L&T Cracking-(Sample Unit No. 01)

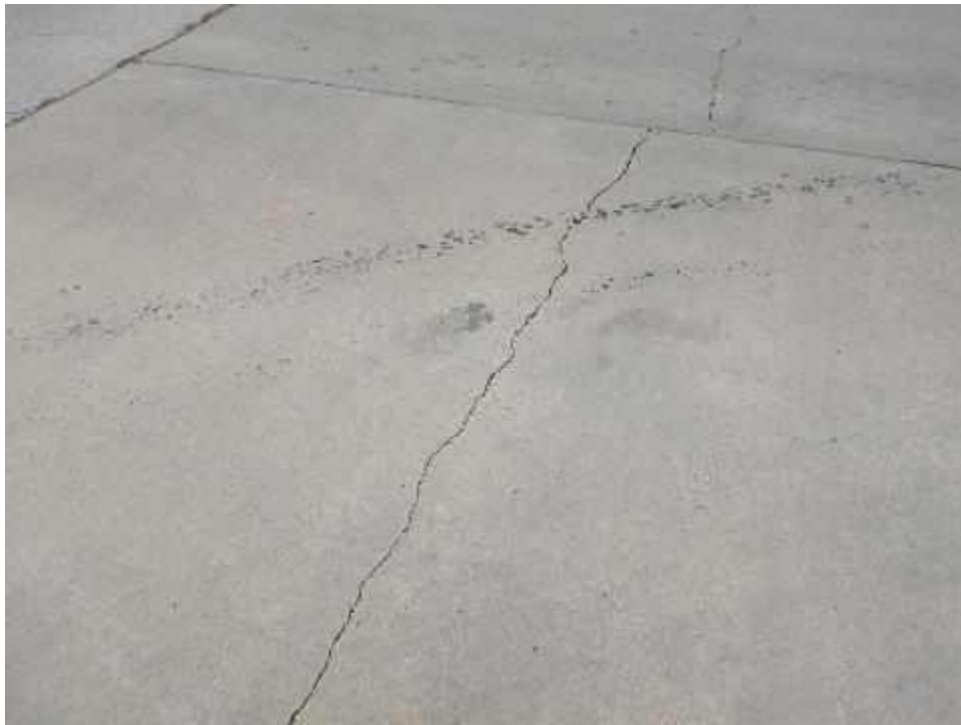
FOURTS-S15B-LTD Cracking-(Sample Unit No. 01)

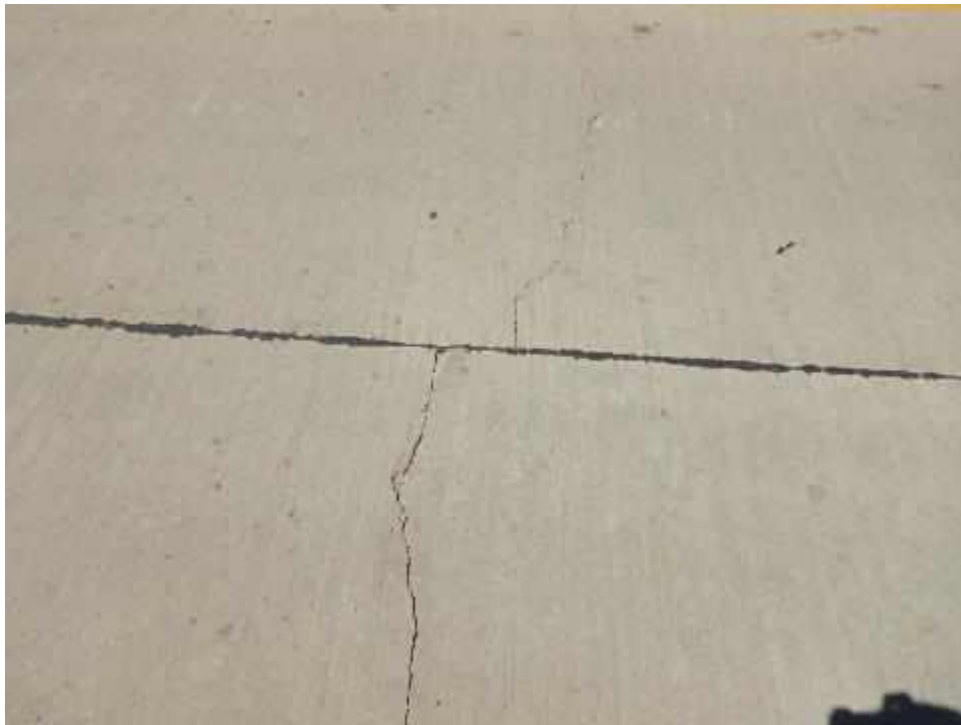
FOURTS-S16-LTD Cracking-(Sample Unit No. 01)

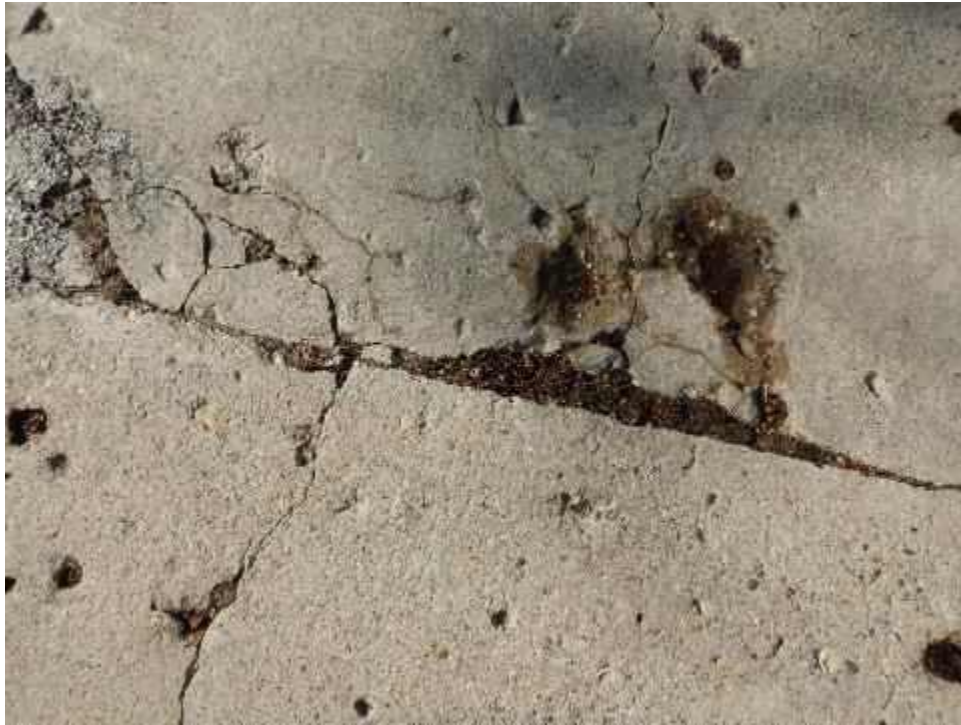
GERTYD-E00B-Joint Spalling-(Sample Unit No. 01)

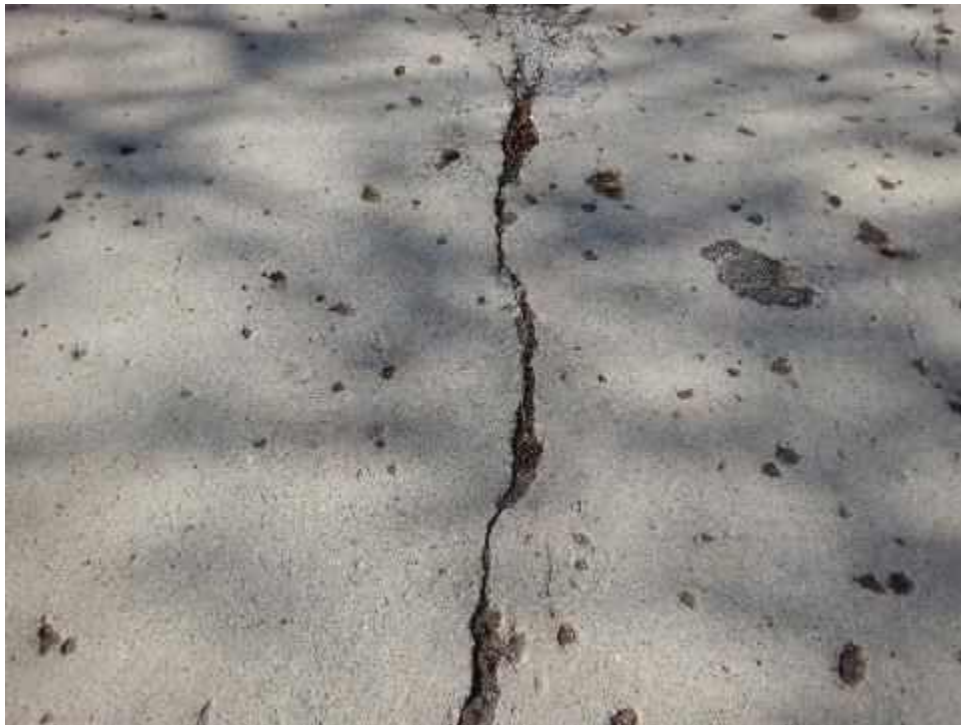
GERTYD-E00B-LTD Cracking

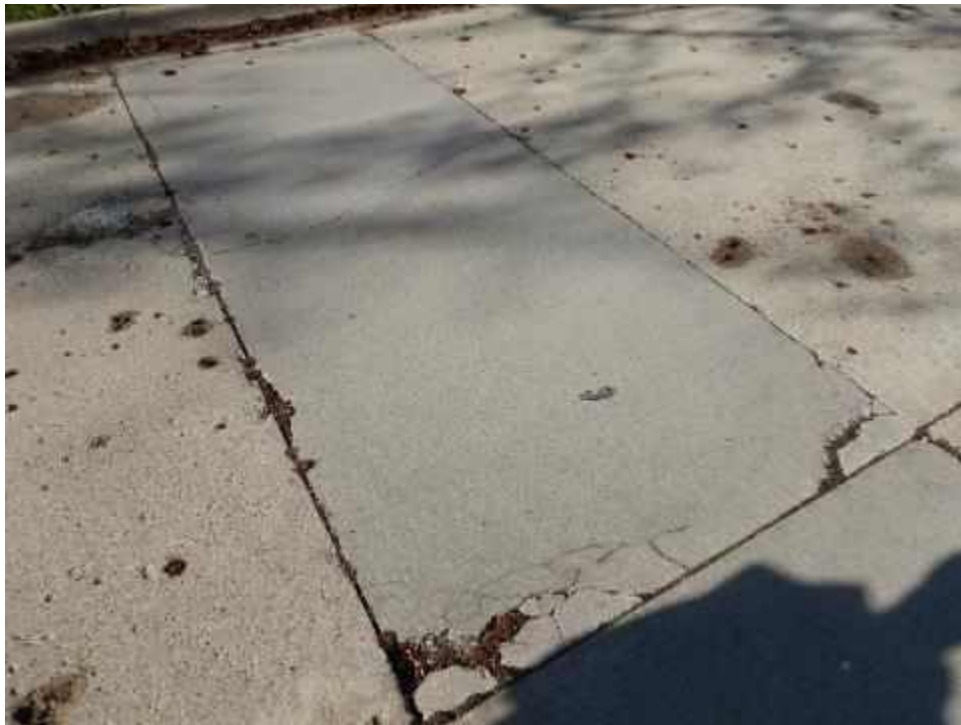
GERTYD-E00B-Large Patching-(Sample Unit No. 01)

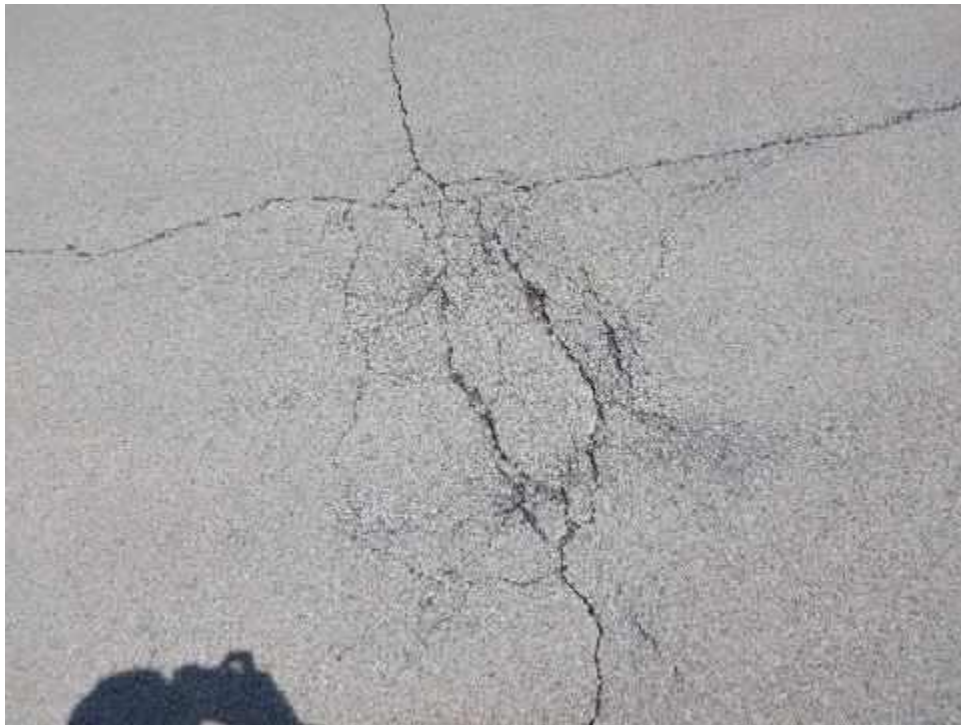
GHUFFDR-UW04BN-Alligator Cracking-(Sample Unit No. 01)

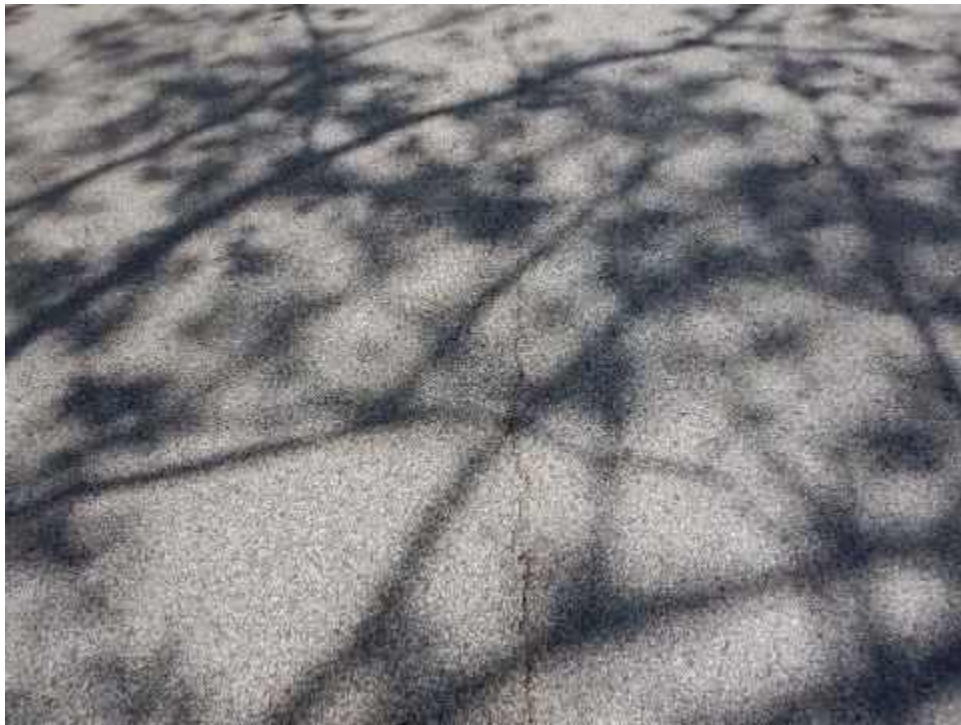
**GHUFFDR-UW04S-L&T Cracking-(Sample Unit No. 01)**

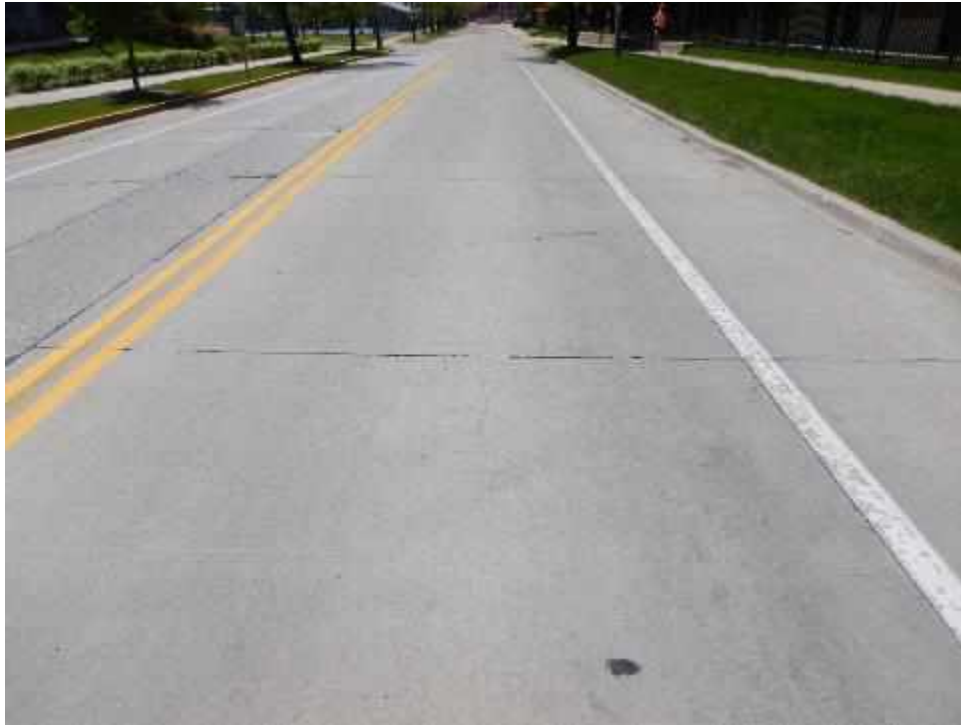
GREGYD-E01BN-Overview-(Sample Unit No. 01)

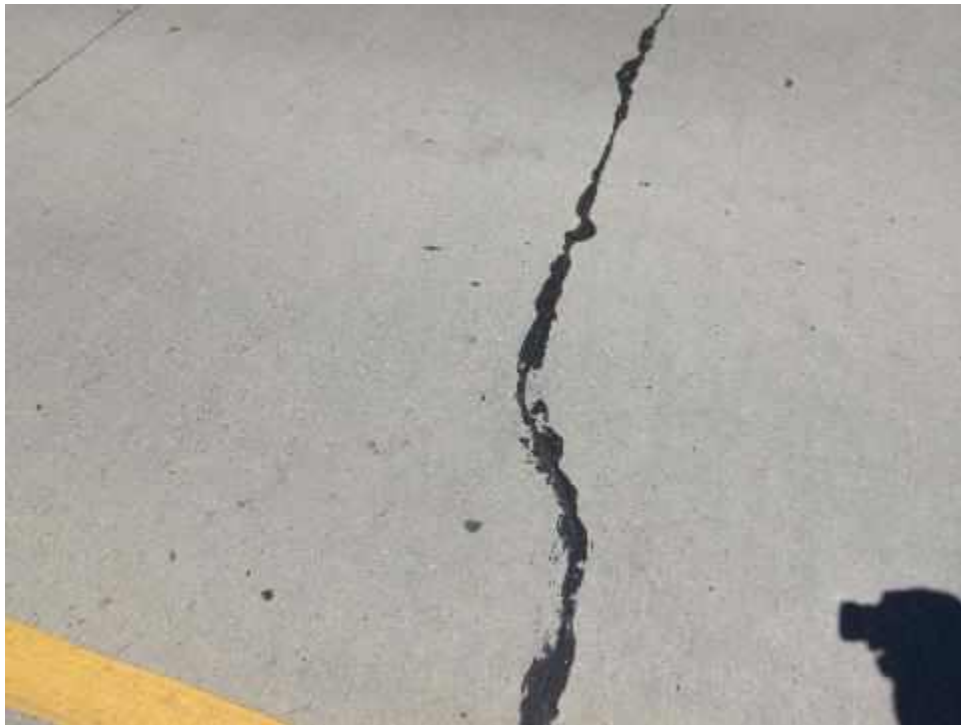
GREGYD-E02A-LTD Cracking-(Sample Unit No. 01)

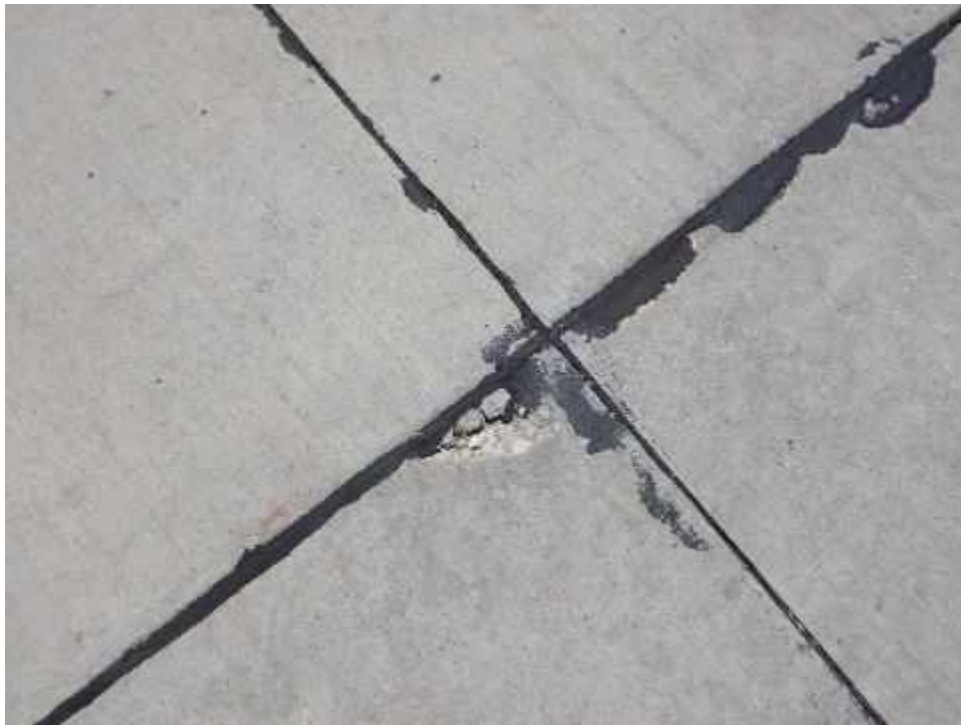
GREGYD-E03B-Corner Spalling-(Sample Unit No. 01)

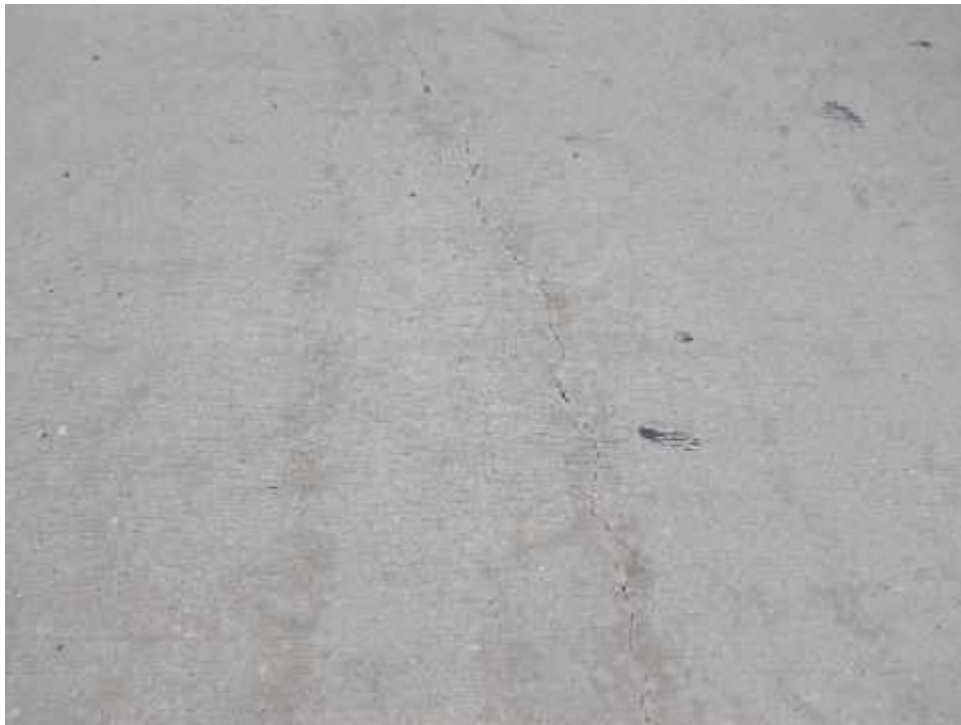
GREGYD-E03B-LTD Cracking-(Sample Unit No. 01)

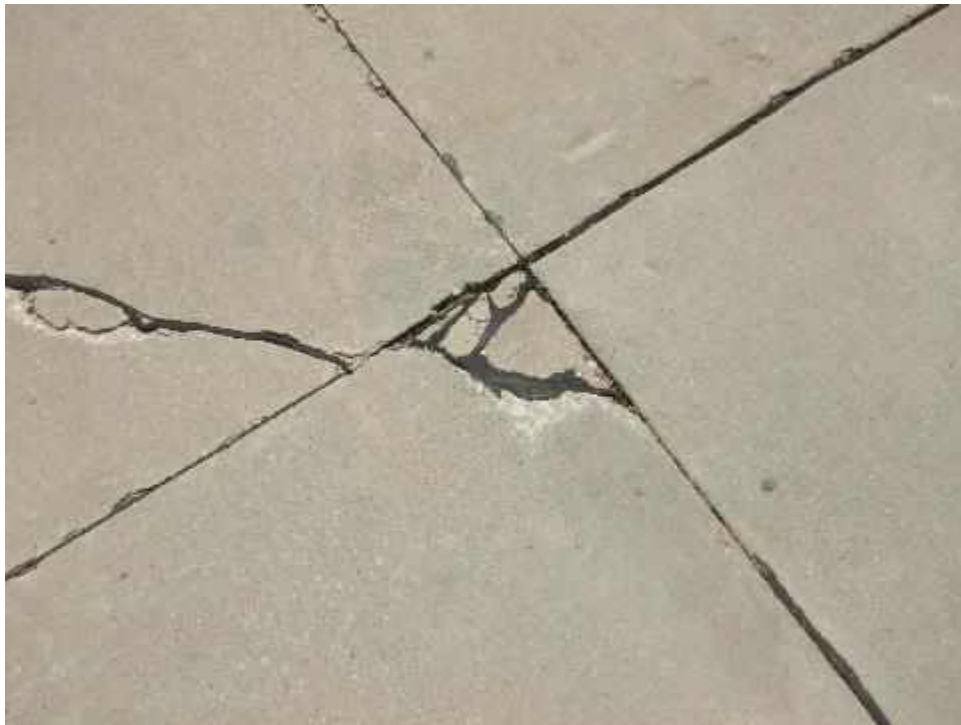
GREGYD-E04-Corner Spalling-(Sample Unit No. 01)

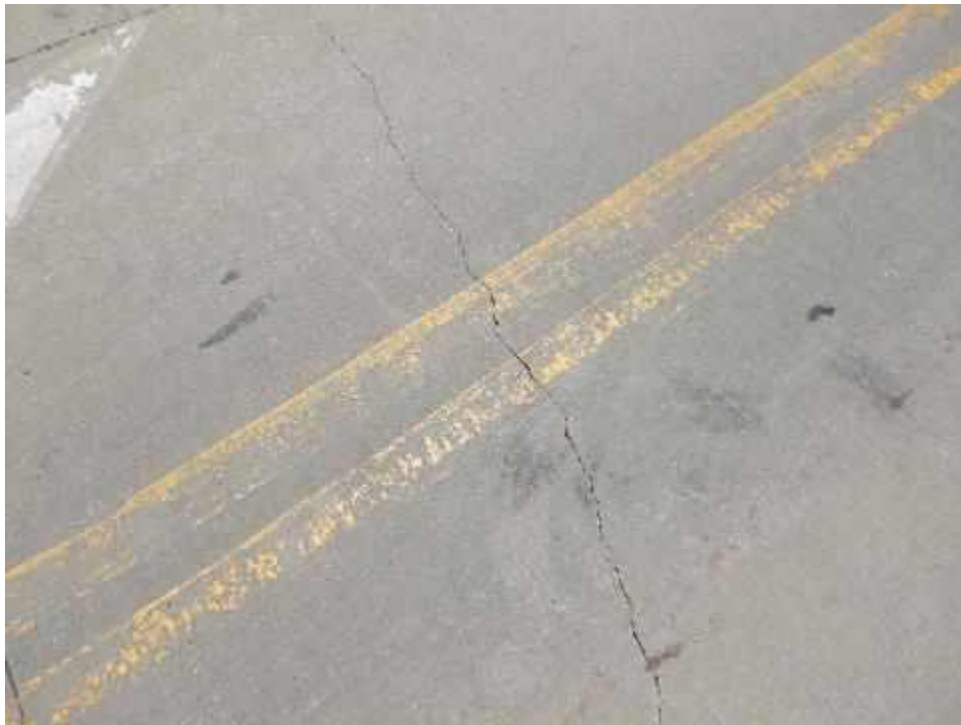
GREGYD-E04-LTD Cracking-(Sample Unit No. 01)

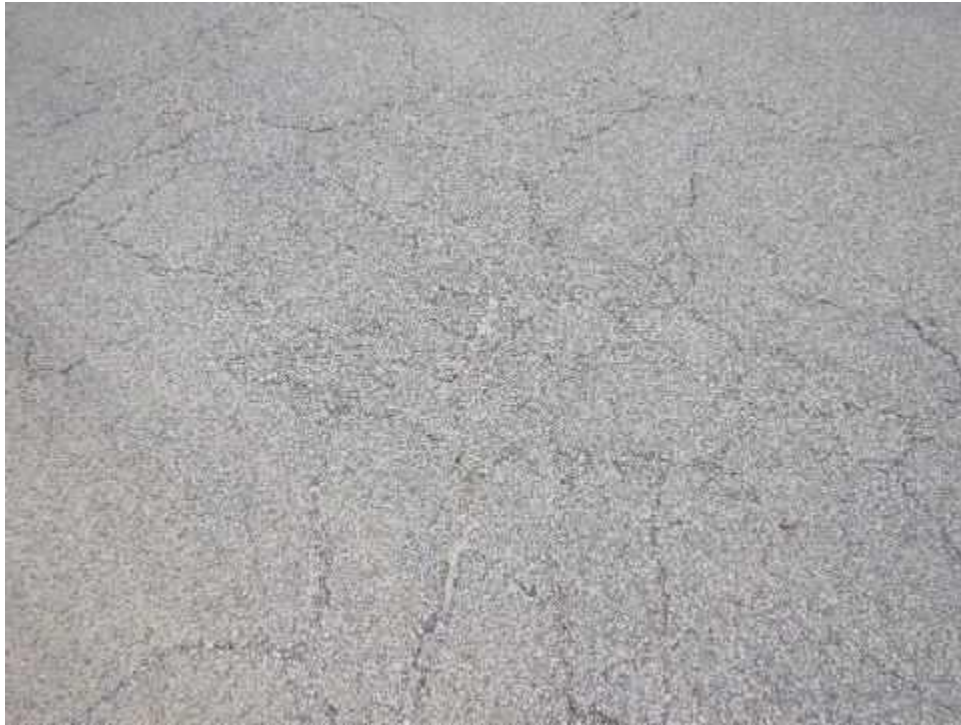
GREGYD-UW11-Alligator Cracking-(Sample Unit No. 01)

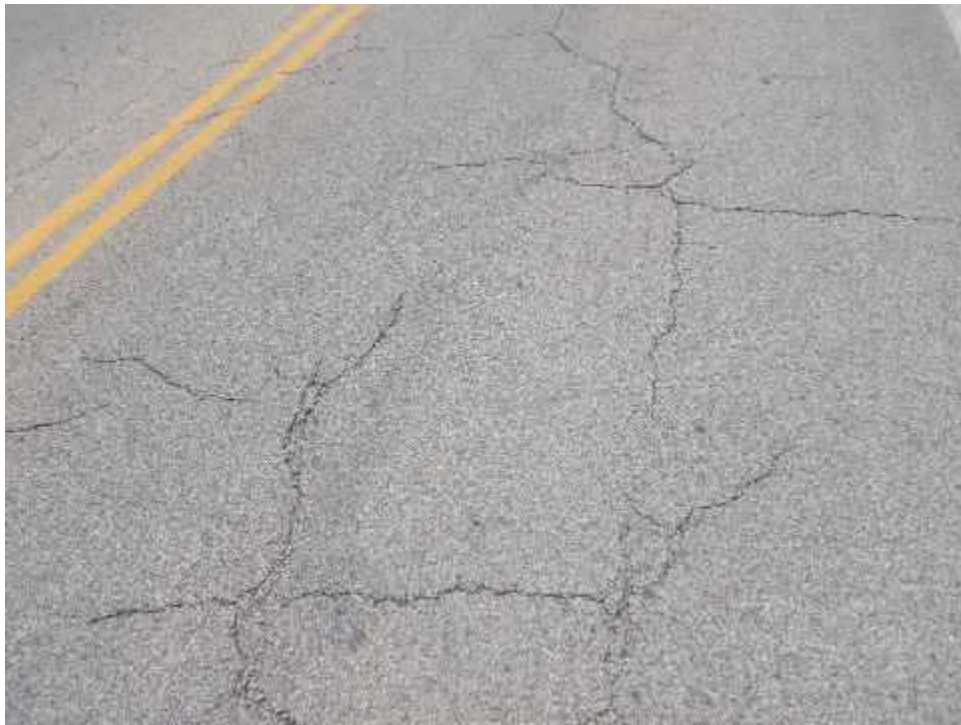
GREGYD-UW11-Block Cracking-(Sample Unit No. 01)

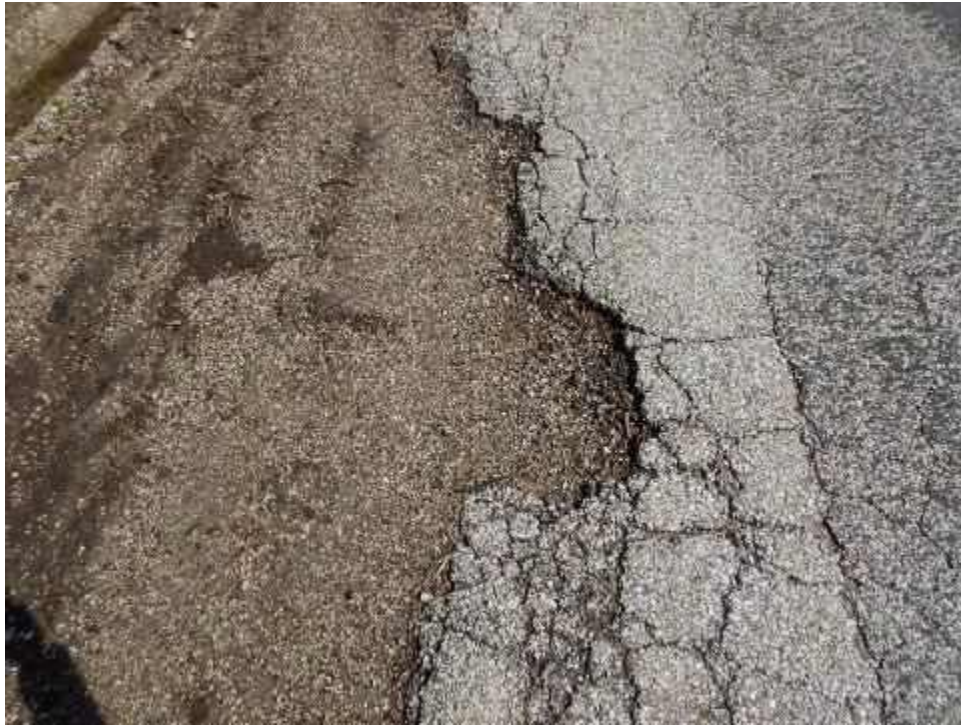
GRIFFITHD-S18-Edge Cracking-(Sample Unit No. 01)
