# U20069: Pavement Analysis Study 2020 University of Illinois at Urbana-Champaign

## Final Report

Applied Pavement Technology, Inc.  
115 West Main Street, Suite 400  
Urbana, Illinois 61801  
(217) 398-3977  
[www.appliedpavement.com](http://www.appliedpavement.com)

**AUGUST 2020**

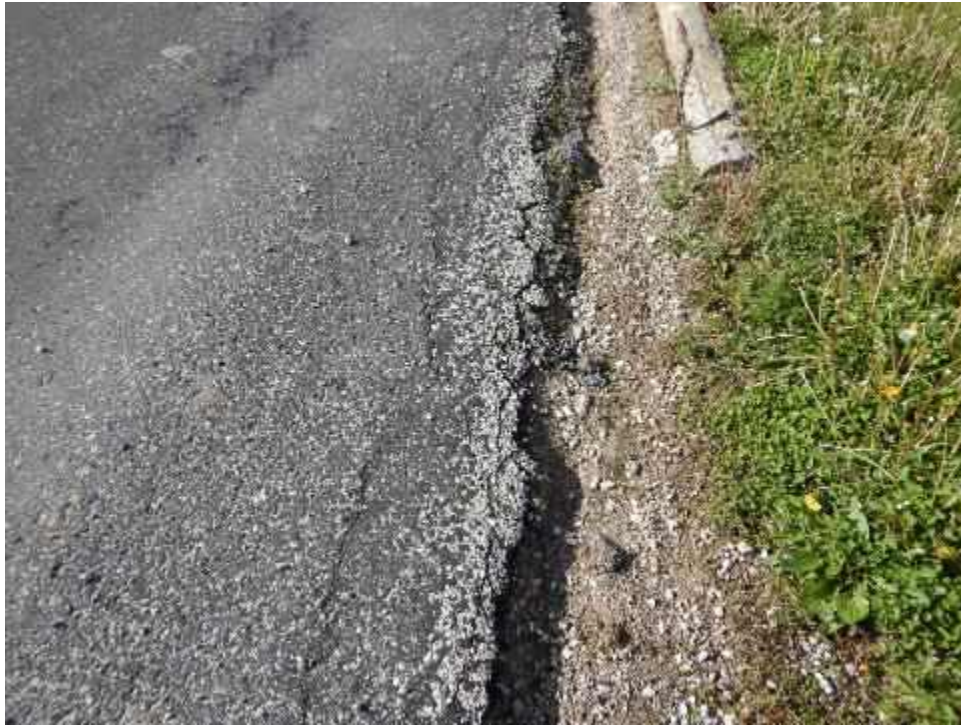
GRIFFITHD-S20-Edge Cracking-(Sample Unit No. 01)

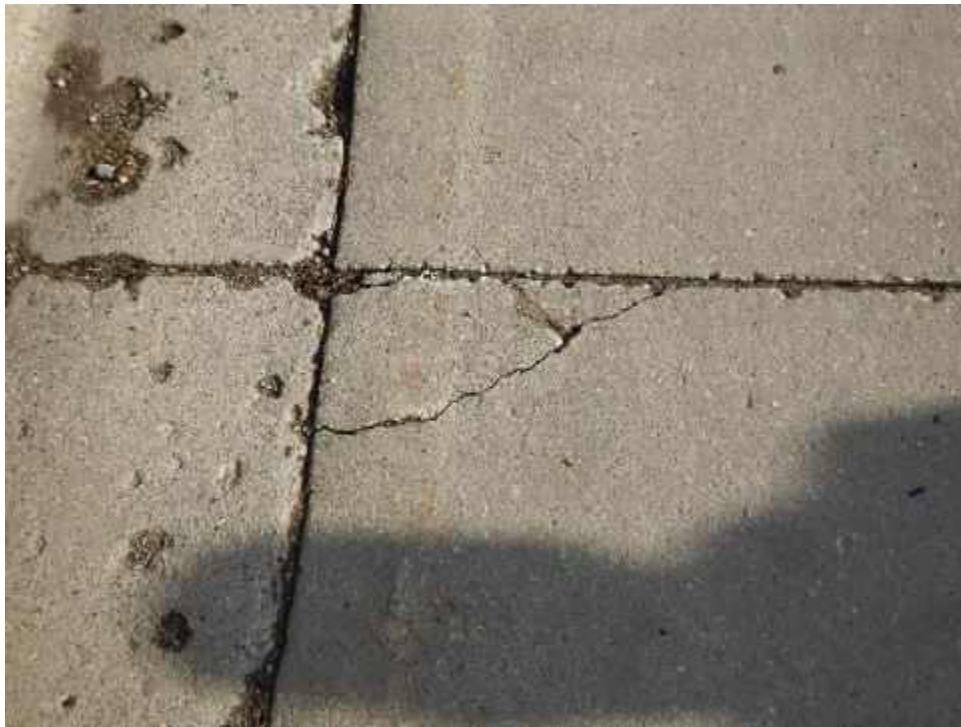
GRIFFITHD-S22B-Corner Spalling-(Sample Unit No. 01)

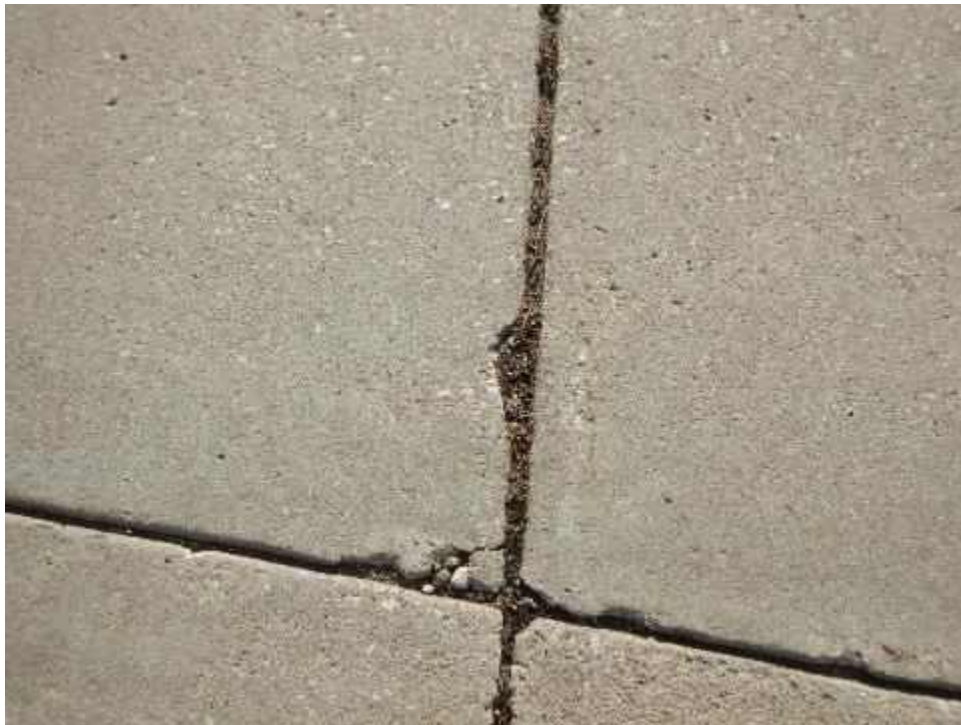
GRIFFITHD-S22B-Joint Seal Damage-(Sample Unit No. 01)

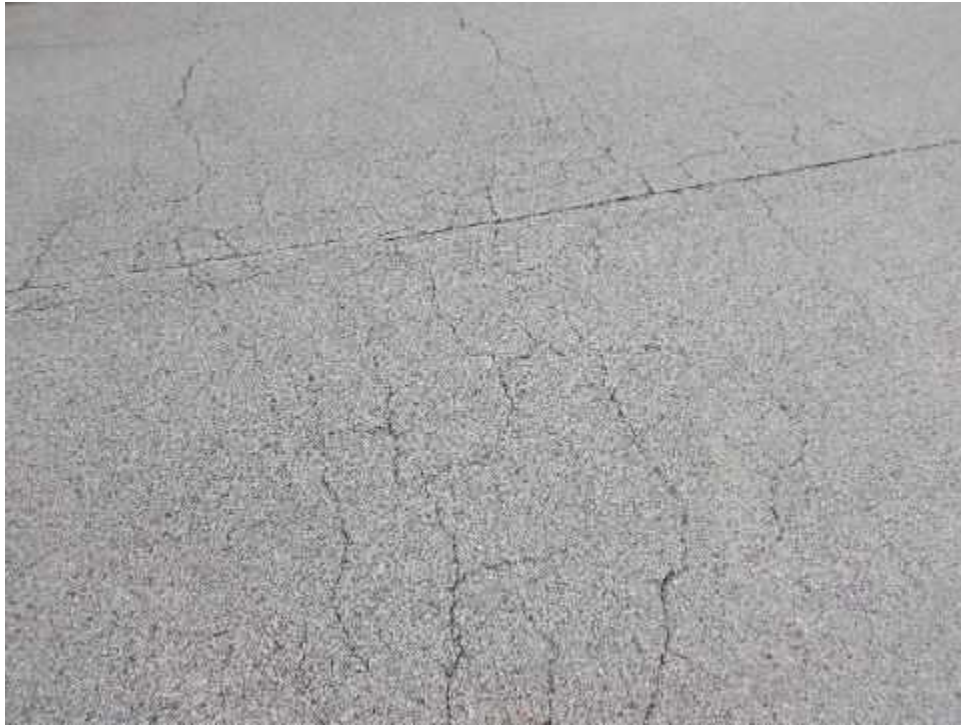
HAZELWDD-E00B-Alligator Cracking-(Sample Unit No. 01)

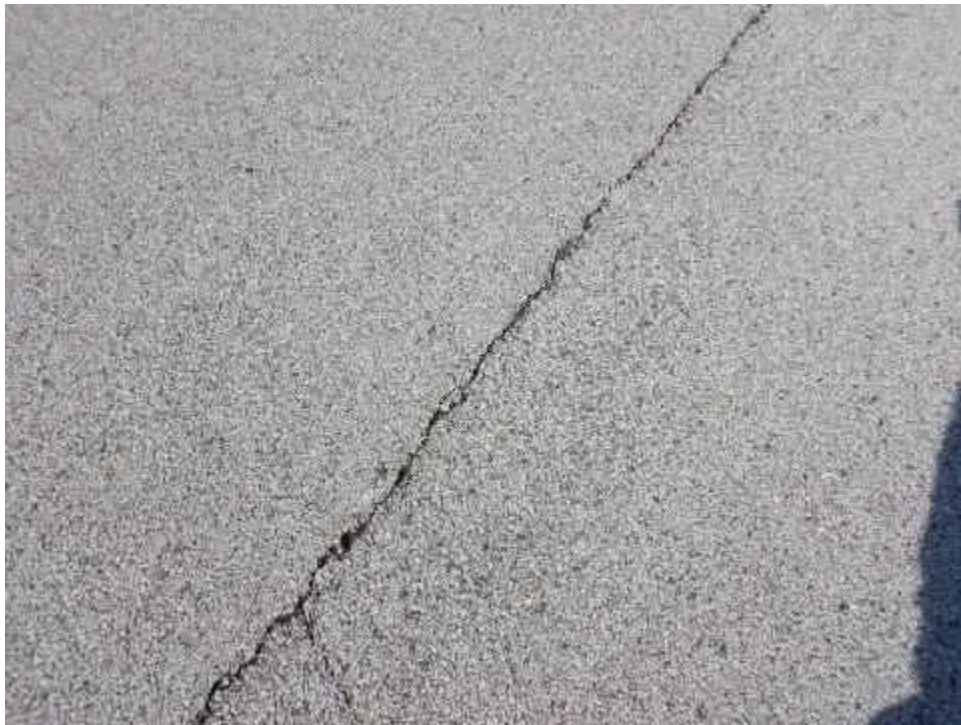
HAZELWDD-E00B-L&T Cracking-(Sample Unit No. 01)

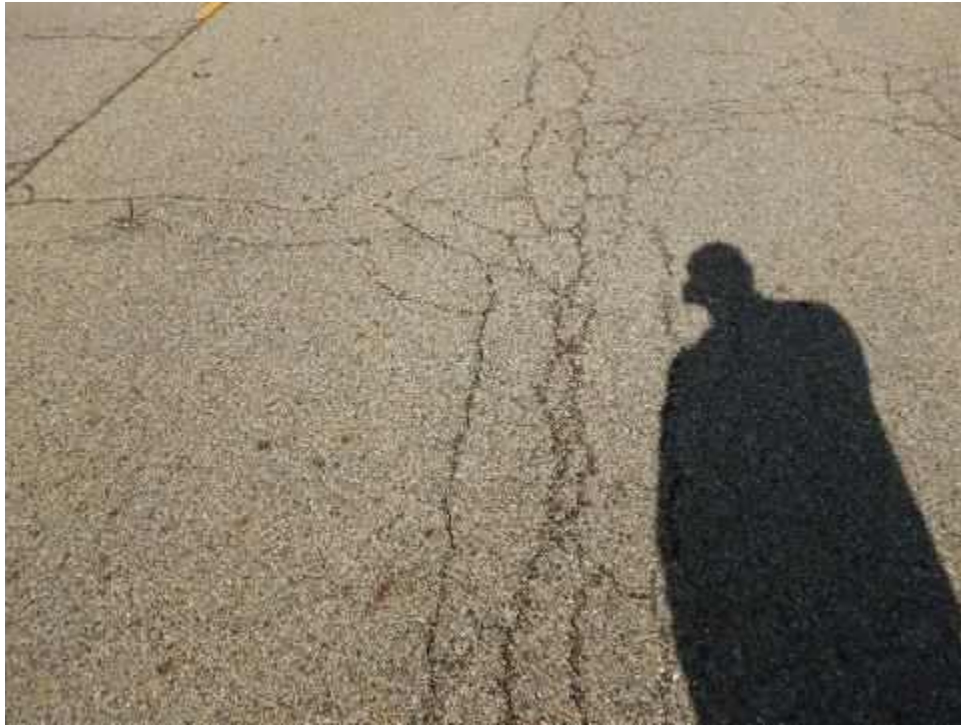
HAZELWDD-E00C-Alligator Cracking-(Sample Unit No. 01)

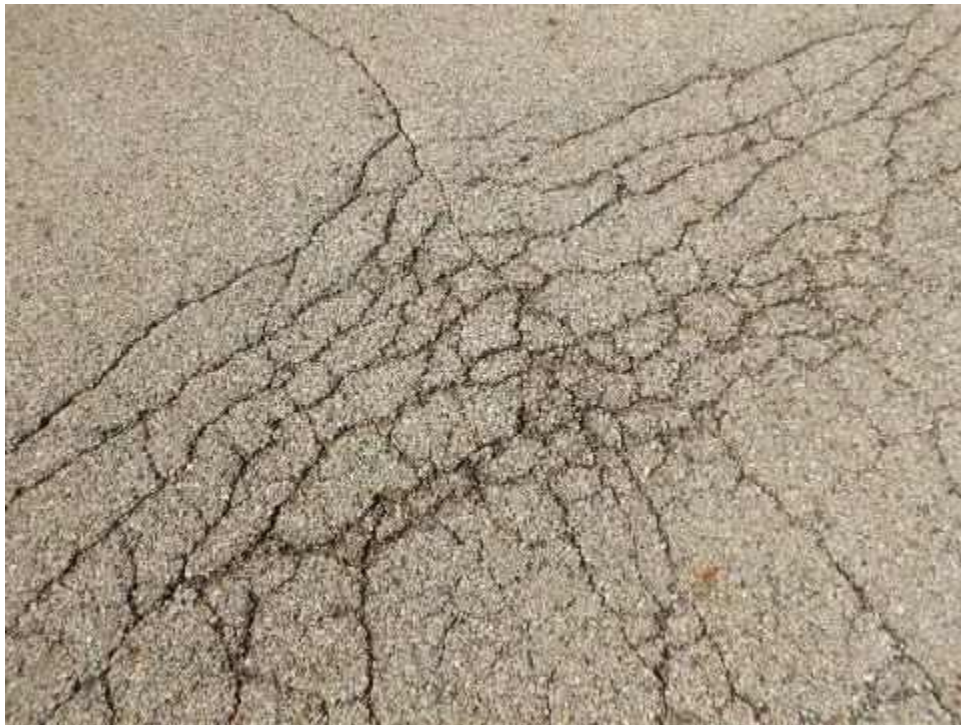
HAZELWDD-E00C-Alligator Cracking-(Sample Unit No. 02)

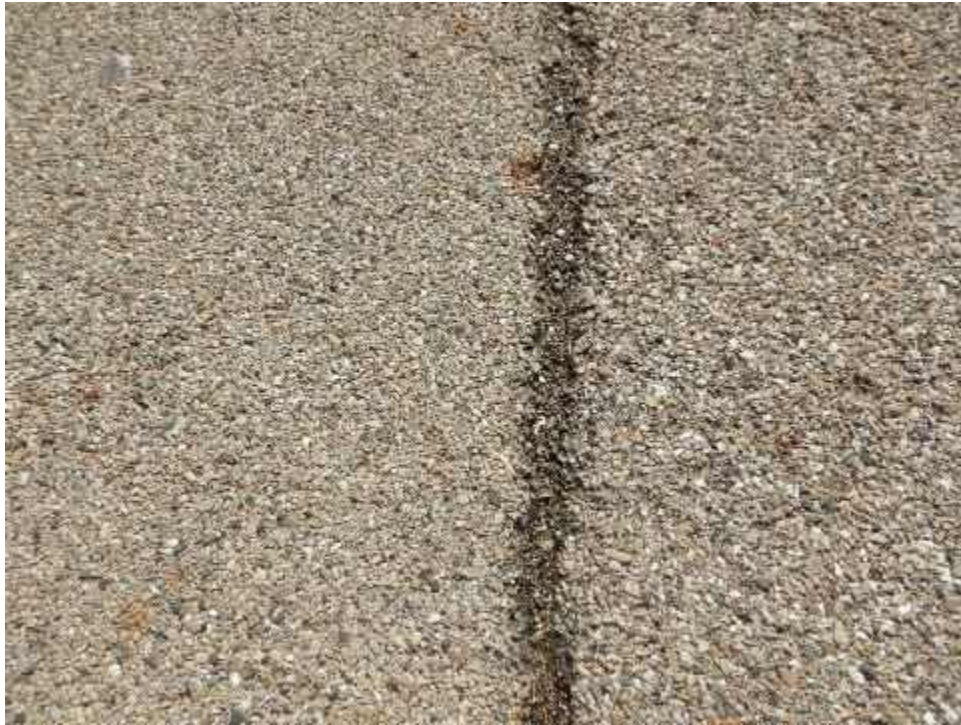
HAZELWDD-E00C-L&T Cracking-(Sample Unit No. 01)

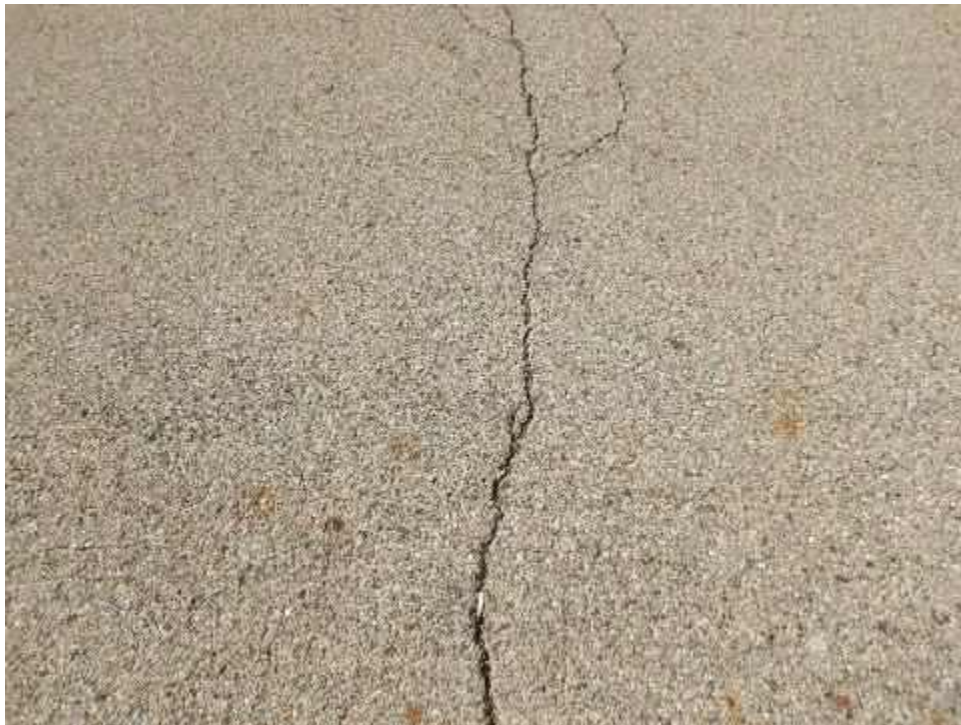
HAZELWDD-E00C-L&T Cracking-(Sample Unit No. 02)

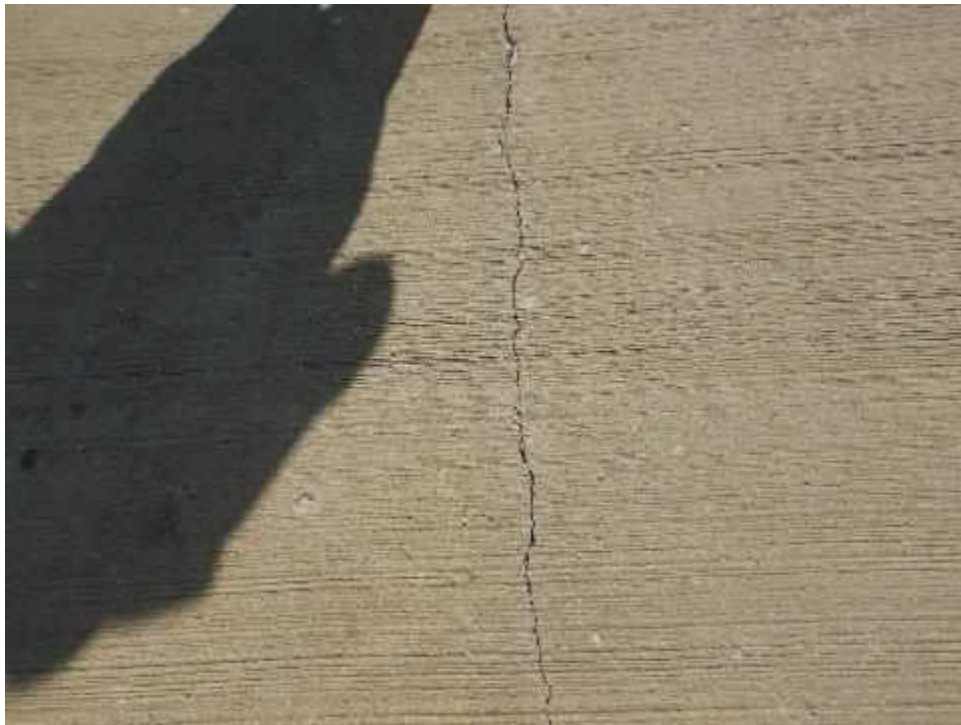
HAZELWDD-E01A-LTD Cracking-(Sample Unit No. 01)

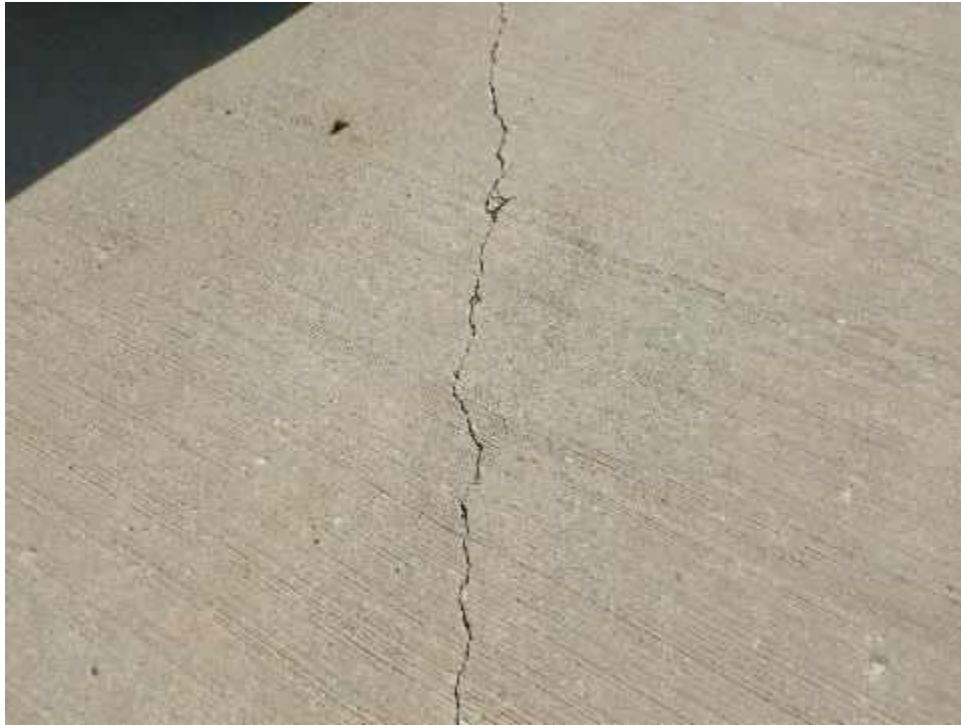
HAZELWDD-E01B-LTD Cracking-(Sample Unit No. 01)

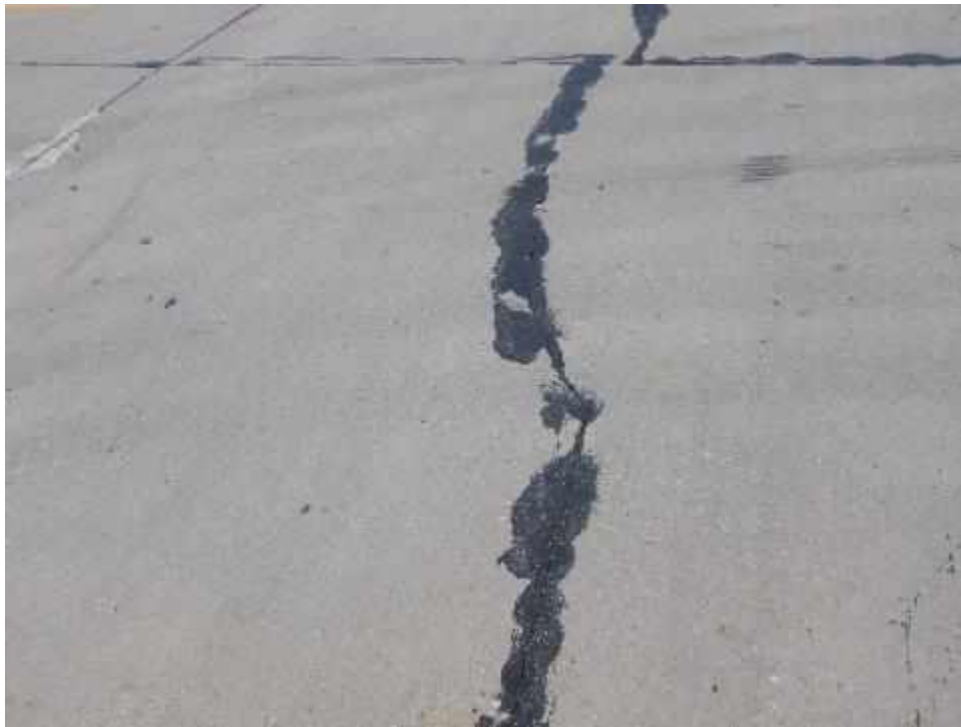
MRYLNDDR-US15-LTD Cracking-(Sample Unit No. 01)

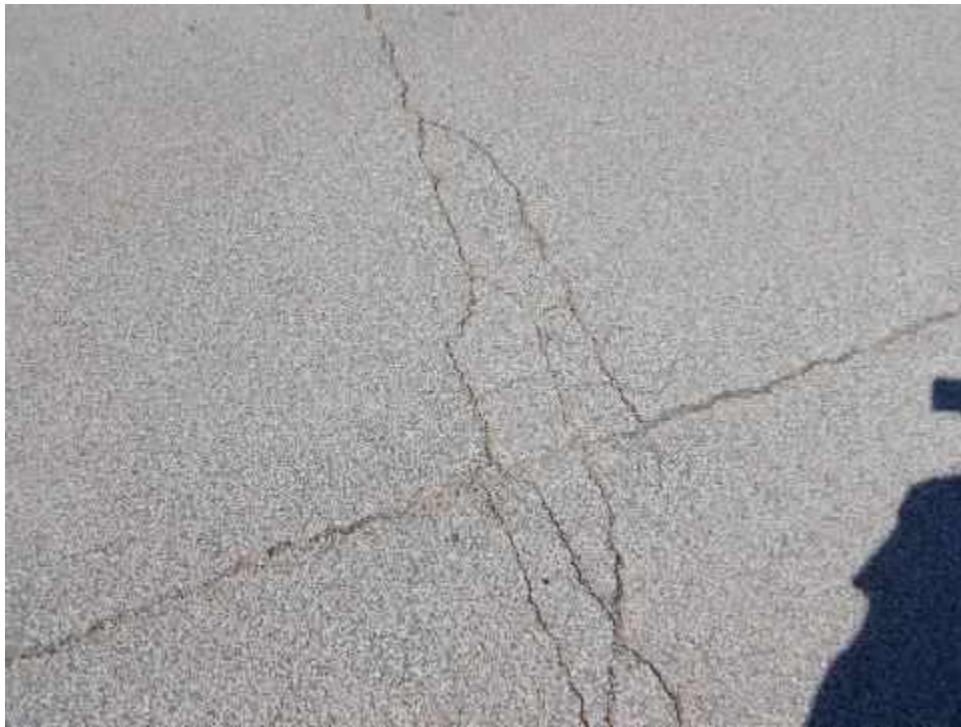
PEABYD-E03-Alligator Cracking-(Sample Unit No. 01)

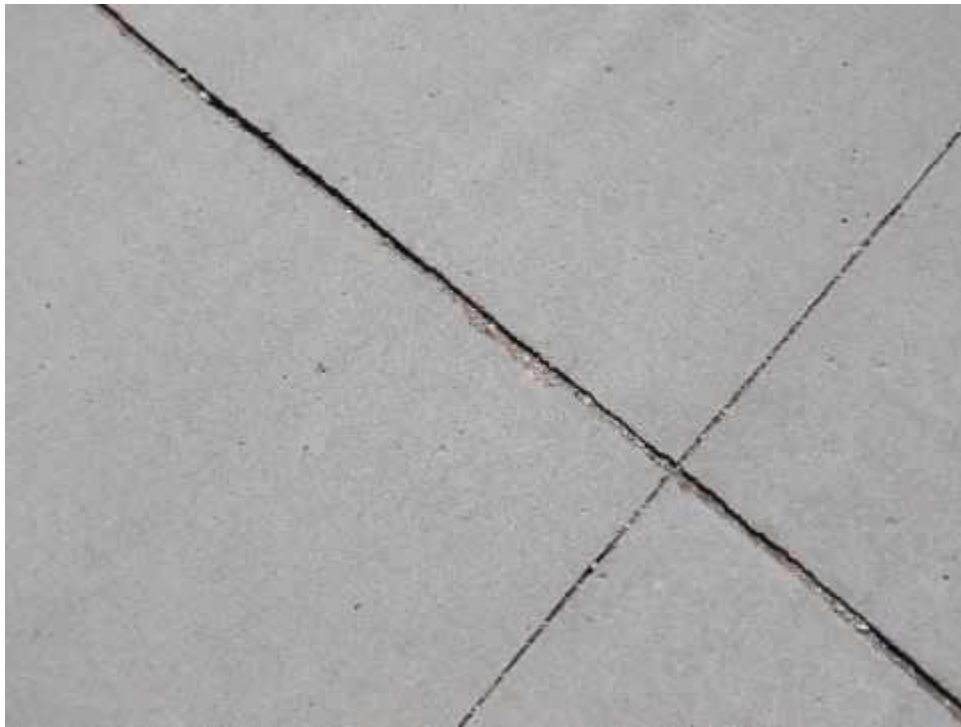
STADMD-E00C-Joint Seal Damage-(Sample Unit No. 01)

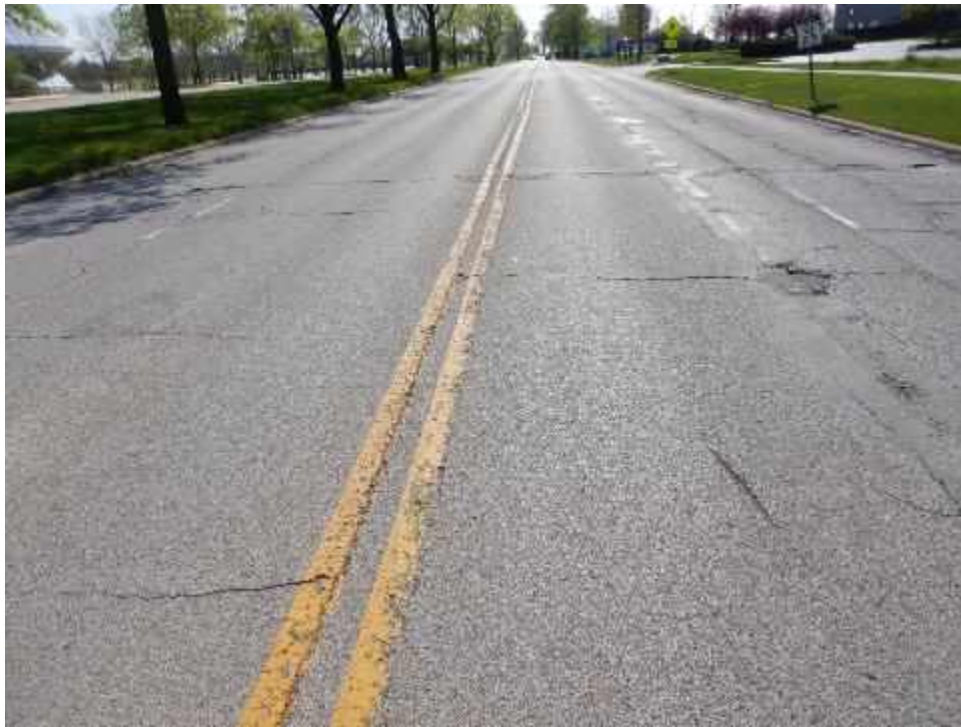
STMARR-E01-Joint Reflection Cracking-(Sample Unit No - 71)

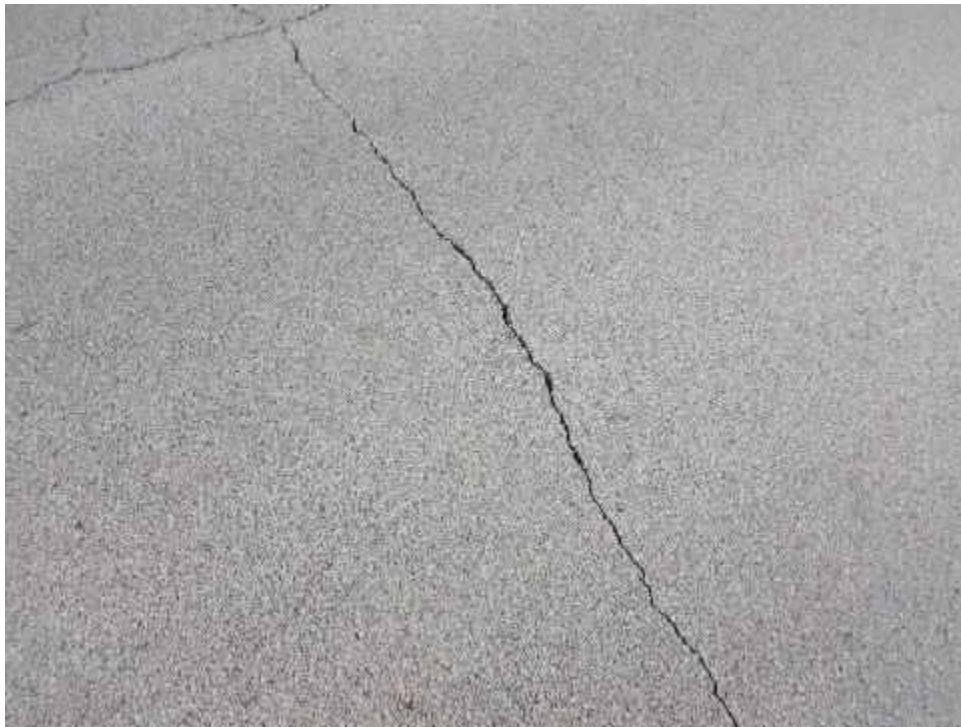
STMARR-UW12-L&T Cracking-(Sample Unit No. 01)

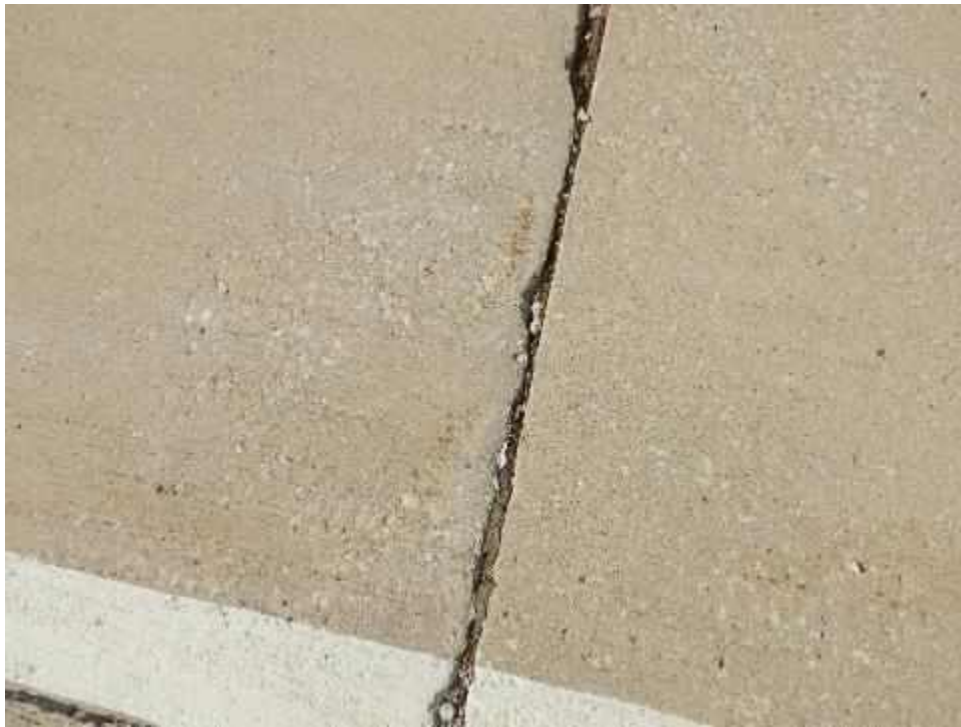
STOUGS-UW12-Joint Seal Damage-(Sample Unit No. 01)
