UNDERGRADUATE LIBRARY1402 WEST GREGORY DRIVE
URBANA, ILLINOIS 61801

SYSTEM CONDITION INDEX	BUILDING SYSTEM REPLACEMENT COST	BUILDING GROSS SQUARE FEET	NUMBER OF BUILDING STORIES	ORIGINAL YEAR OF CONSTRUCTION
.539	\$ 7,242,900	95,906	2	1969
PRIMARY BUILDING USE	CLASSROOMS / LIBRARY	BUILDING SURVEY DATE		2/7/2013
BUILDING SURVEY TEAM	CCJM: Josh Polasky (M), Stanley Panek (E)

UIUC/UIS MEP CONDITION ASSESSMENT
UIUC PROJECT NUMBER U12151
CANNON DESIGN PROJECT NUMBER 4009.01

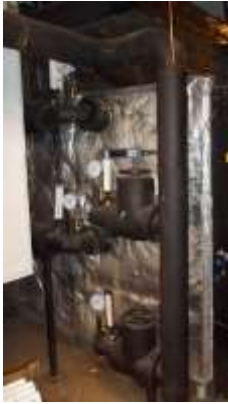
Item ID	299838	
Description	Building was connected to campus chilled water loop in 2009. Piping and coils are original from 1969.	
Overall Condition	Poor	
Date Installed	1/1/1969	
Remaining Useful Life	Exceeded	Nominal Useful Life: 30 Years
Equipment Tag	-	
Manufacturer	-	
Model Number	-	
Serial Number	-	
Size/Capacity	-	
HP/kW	-	
Voltage	-	
Material	-	
Recommendation	-	
Replacement Cost	\$153,700

Chilled water connection to AHU unit

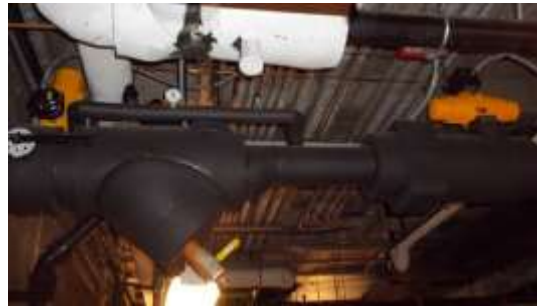
Chilled water piping

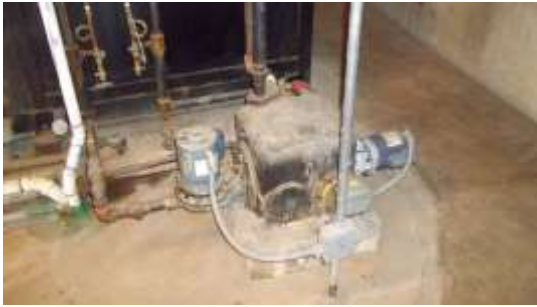
Condensate pump

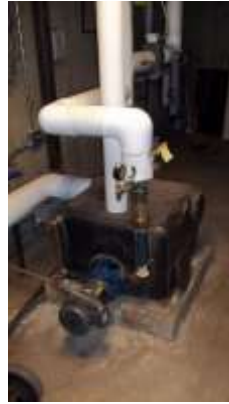
Condensate pump CP-2

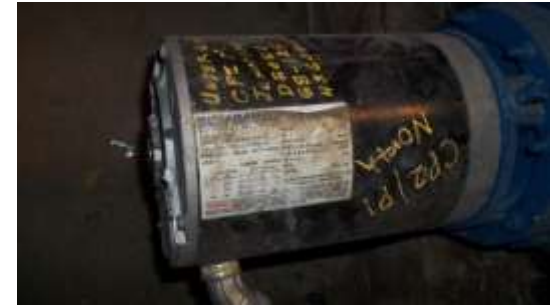
Condensate pump CP-2 motor-3HP

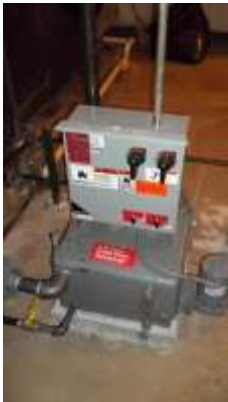
Replaced(new) condensate pump

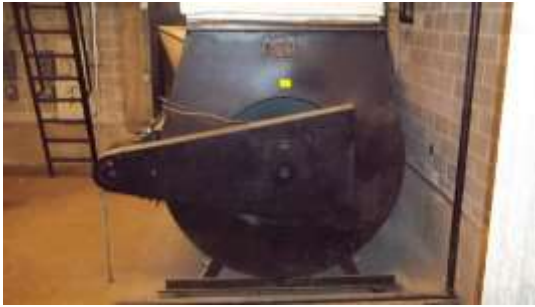
Typical supply fan

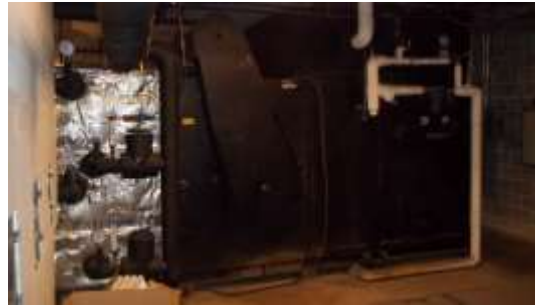
Another typical supply fan

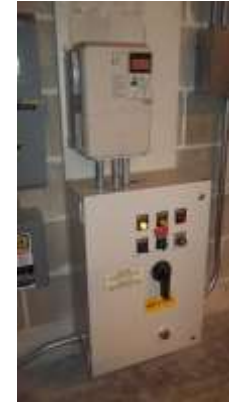
Typical VFD

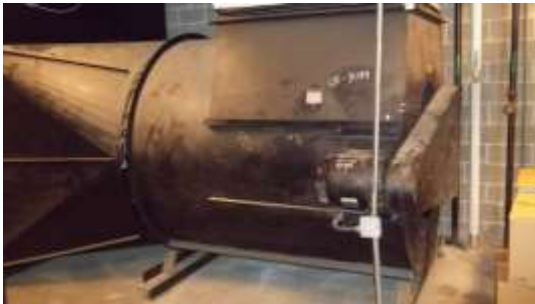
Typical return fan

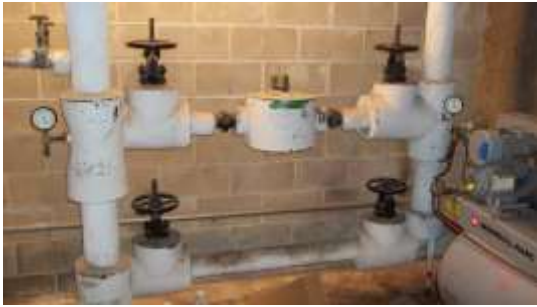
Domestic cold water piping and water meter

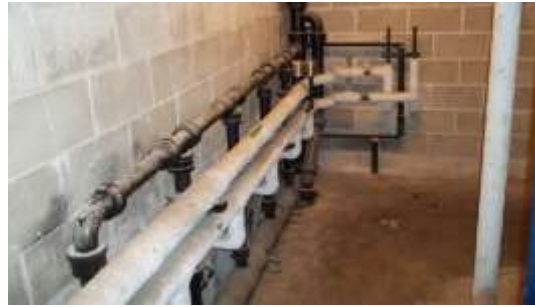
Water piping to water closets

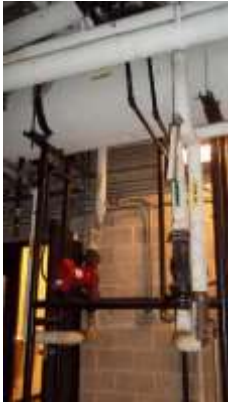
Item ID	299840	
Overall Condition	Fair	
Date Installed	1/1/1969	
Remaining Useful Life	10 Years	Nominal Useful Life: 50 Years
Manufacturer	-	
Model Number	-	
Serial Number	-	
Size/Capacity	-	
HP/kW	-	
Voltage	-	
Material	-	
Recommendation	Verify size of circulating pump.	
Replacement Cost	\$114,900	
Comments	Hot water to West side of building is frequently unavailable; staff suspects circulation pump is undersized.

Steam to hot water heat exchanger and hot water circulating pump

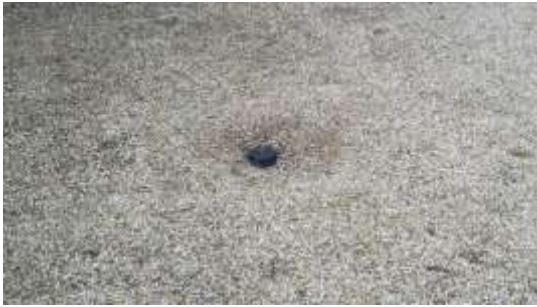
Area drain

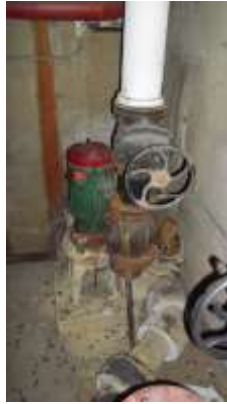
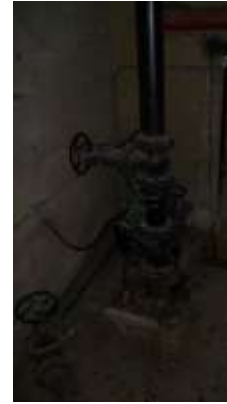
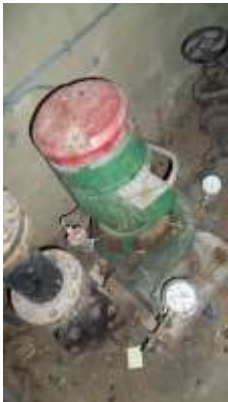
Item ID	299855	
Description	Large duplex sump pump located in basement mechanical room #100. Two 7.5 HP motors.	
Overall Condition	Poor	
Date Installed	1/1/1969	
Remaining Useful Life	5 Years	Nominal Useful Life: 50 Years
Equipment Tag	-	
Manufacturer	-	
Model Number	-	
Serial Number	-	
Size/Capacity	-	
HP/kW	7.5	
Voltage	480	
Material	Cast iron drainpipes and drains.	
Recommendation	-	
Replacement Cost	\$322,900	
Comments	Remaining useful life applicable for sump pump only. Piping has longer life. Oversized sump pump was installed in lowered area of basement mechanical room with the expectation that a below-ground building would have flooding issues, this has turned out to not be the case.

Sump pump

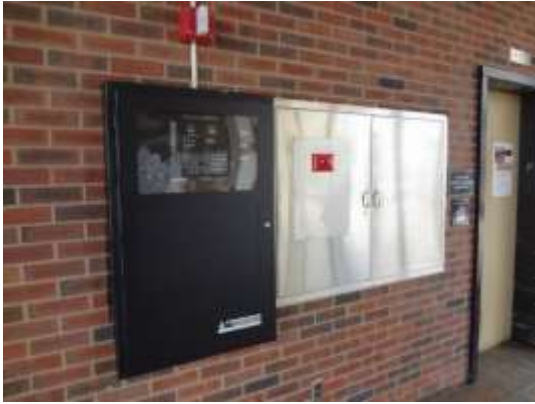
Fire alarm panel

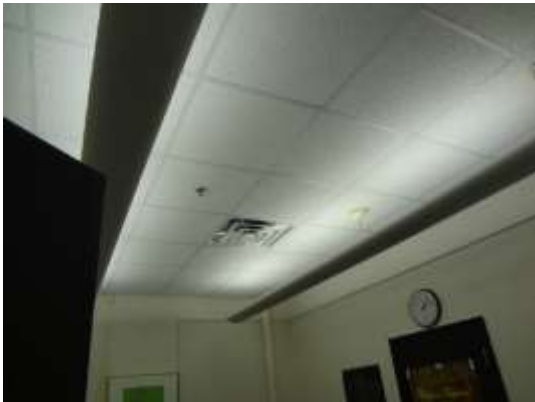
Item ID	299845	
Description	Original fire alarm system was replaced in 1996 with an addressable type fire alarm system. New devices include horns, heat detectors, pull stations, smoke detectors, and strobes. The panel is located in the upper lobby.	
Overall Condition	Poor	
Date Installed	1/1/1996	
Remaining Useful Life	3 Years	Nominal Useful Life: 20 Years
Equipment Tag	Nor applicable	
Manufacturer	Pyrotronics/Siemens	
Model Number	MXL	
Serial Number	Not Applicable	
Size/Capacity	Not Applicable	
HP/kW	Not Applicable	
Voltage	12 V	
Material	Not Applicable	
Recommendation	Migration to XLS system	
Replacement Cost	\$187,400	
Critical Issues	Smoke detectors are outdated and should be replaced or refurbished.

Smoke detector

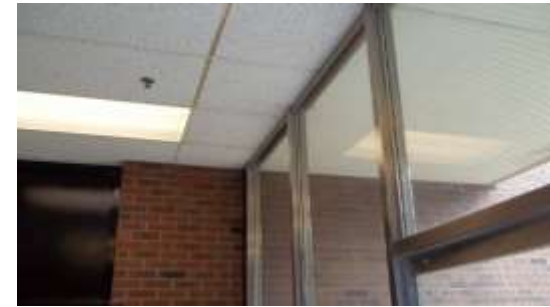
Sprinkler head near café door

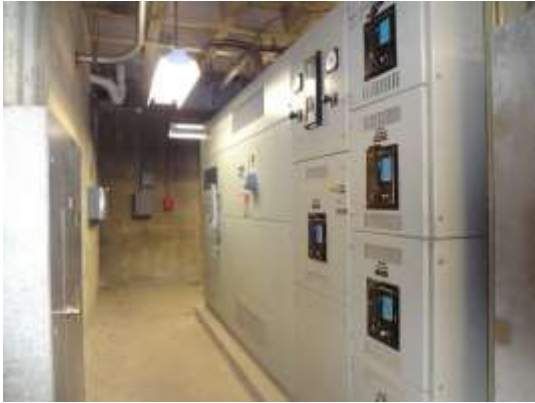
Item ID	299857	
Description	4160/277/480 V Substation with 500 KVA HAVI-DUTY Transformer, (6) 600 A air draw out breakers, Kirk interlock switches, 25,000 A short circuit, Metering Section and KWH Meter # 30-855-427.	
Overall Condition	Poor	
Date Installed	1/1/1969	
Remaining Useful Life	Exceeded	Nominal Useful Life: 40 Years
Equipment Tag	No tag	
Manufacturer	ITE	
Model Number	Not Available	
Serial Number	Custom Unit	
Size/Capacity	600/85 A switch/fuse	
HP/kW	Not Applicable	
Voltage	4160V	
Material	Copper bus	
Recommendation	Maintain and test of breakers per manufacturer recommendation.	
Replacement Cost	\$8,100

Main substation

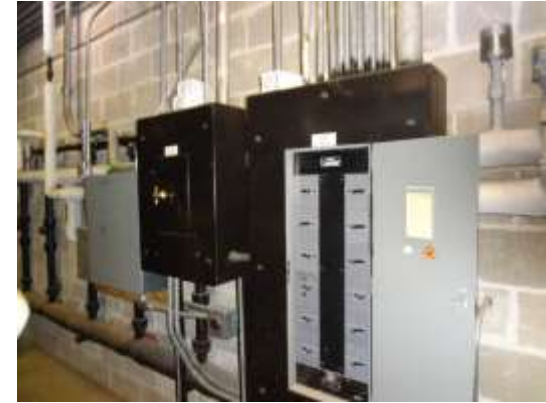
Item ID	299851	
Description	Load side of the substation consists of breakers serving 277/480 V distribution panelboards . 150 KVA transformer serves 120/208 Volt load. In 1989 an additional 225 KVA transformer and panelboards were installed to provide power to new receptacles located in reading area.	
Overall Condition	Poor	
Date Installed	1969 and 1989	
Remaining Useful Life	Exceeded for 1969 equipment. 15 Years left for 1989 equipment.	Nominal Useful Life: 40 Years
Equipment Tag	Not Applicable	
Manufacturer	Kinney	
Model Number	AJ,PRL1A,45	
Serial Number	Not Applicable	
Size/Capacity	Varies	
HP/kW	Not Applicable	
Voltage	120/208 V and 277/480 V	
Material	Cooper Bus	
Recommendation	-	
Replacement Cost	\$548,200	
Comments	Condition poor due to age of equipment.

Original paneboards

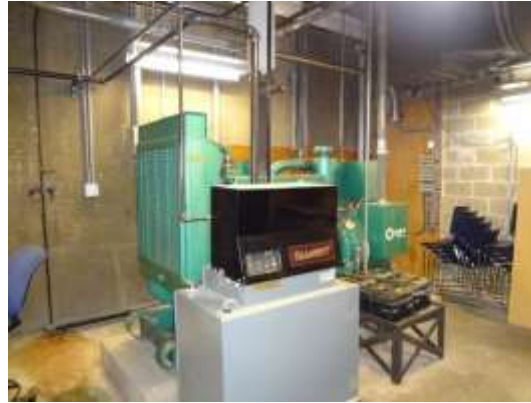
Item ID	299847	
Description	Diesel generator and day tank (50 Gal) - located in Rm #144.	
Overall Condition	Poor	
Date Installed	1/1/1971	
Remaining Useful Life	Exceeded	Nominal Useful Life: 25 Years
Equipment Tag	Not Applicable	
Manufacturer	Onan	
Model Number	115DFC-4xR8/26971	
Serial Number	9709890970	
Size/Capacity	100 KW	
HP/kW	300	
Voltage	277/480 V	
Material	Not Applicable	
Recommendation	Replacement or reconditioning.	
Replacement Cost	\$45,400	
Comments	Poor condition is due to age only.

Generator and day Tank

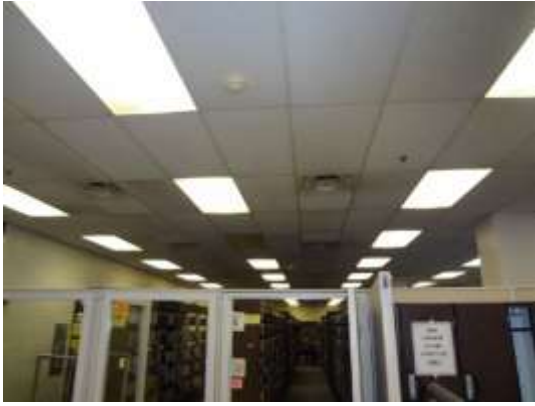
Approx. 10% of general lighting is connected to
Emergency circuit

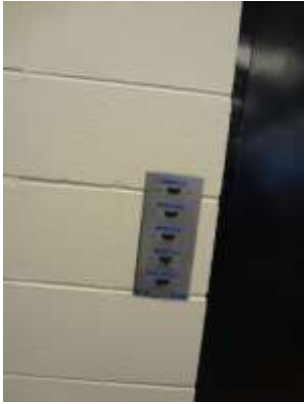
Item ID	299850	
Description	Two switches per floor control library area lighting. Control contactors are located within lighting panels. Exterior lighting is controlled by photocell and timers.	
Overall Condition	Poor	
Date Installed	1/1/1969	
Remaining Useful Life	Exceeded	Nominal Useful Life: 20 Years
Equipment Tag	Not Applicable	
Manufacturer	ASCO	
Model Number	Not Applicable	
Serial Number	Not Applicable	
Size/Capacity	100 A	
HP/kW	Not Applicable	
Voltage	277 V	
Material	Not applicable	
Recommendation	-	
Replacement Cost	\$207,000	
Comments	Condition poor due to age of equipment.

Switches for reading areas and circulation area 81

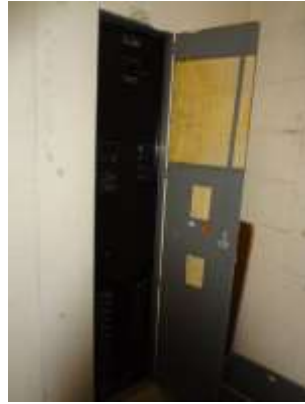
Lighting panelboard with contactor
