Walkability Audit **Report**

University of Illinois Wellness Center

Capstone Project

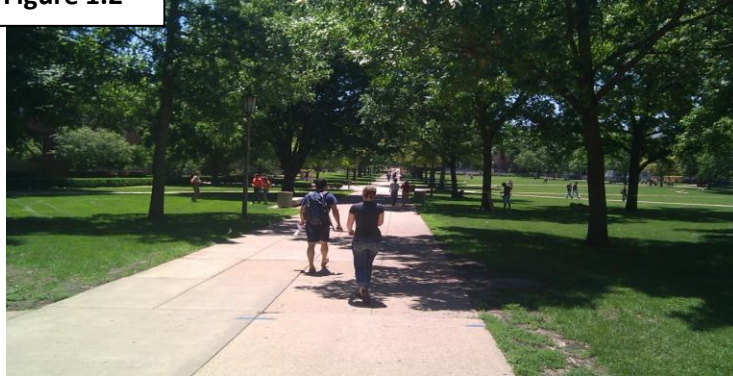
Overall, the University of Illinois Urbana Campus was found to be moderately walkable. The overall score of the entire campus was 72.3/100. See Figure 1.2 for a visual representation of the moderately walkable UIUC campus.

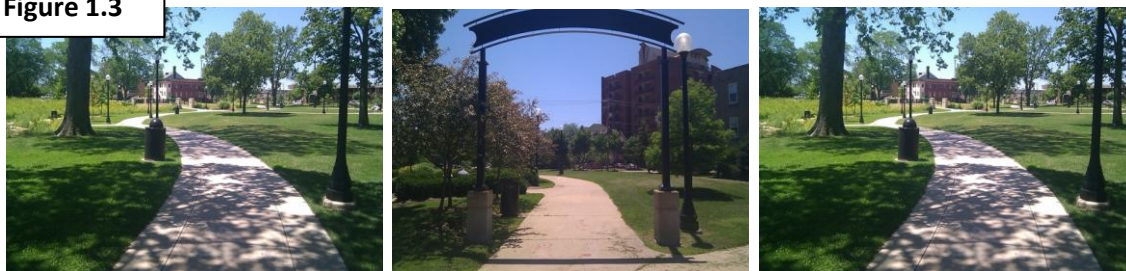
Although the campus was found to be moderately walkable, the scores varied by quadrants. Quadrant 2 had the highest average score of 83/100 and scored high in a majority of the nine categories observed through the audit. This score found that quadrant 2 had good walking conditions. Quadrant 2 scored high in walking surface (4.3/5), crosswalks (4/5), maintenance (4/5), path size (5/5), accessibility (4.7/5), and aesthetics (4.3/5). The City of Champaign spent a great deal of time redeveloping multiple areas throughout quadrant between 2005 and 2010. This redevelopment could be directly related to the high scores found in quadrant 2. The City of Champaign took into consideration redevelopment ideas to make the area more visually appealing and more walkable for pedestrians. Landscaping was improved, paths were widened, sidewalks are now in great condition, and the overall visual appeal of the area is very inviting. The redevelopment by the City of Champaign in quadrant 2 created an optimal environment to walk in. Figure 1.3 shows a visual representation of the good walking conditions located in Quadrant 2 on the UIUC campus.

**Quadrant 2:**

Springfield Ave-Lincoln Ave-Green St.-First St.

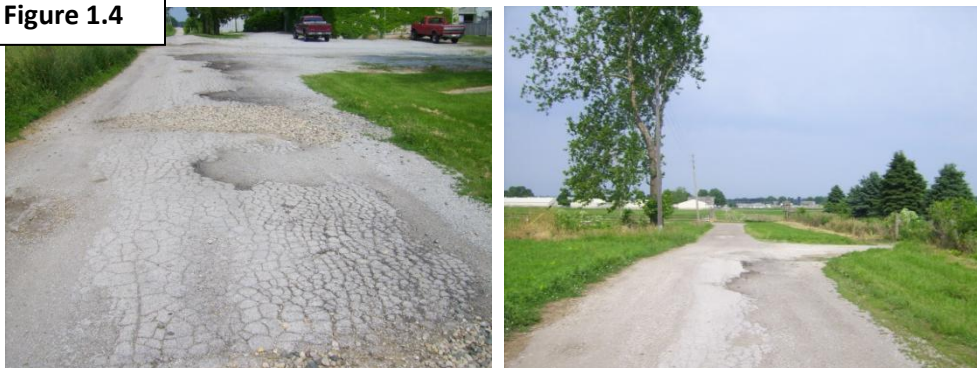
Quadrant 9 had low category scores in walking surface (1/5), crosswalks (2.5/5), path size (2.5/5), buffers (1.5/5), accessibility (1.5/5) and shade (2/5). Figure 1.4 shows visual representation of the poor walking conditions of quadrant 9. As shown in Figure 1.4, the walking surface in quadrant 9 is extremely poor and there are limited buffers present.

**Quadrant 9:**

St. Mary's Rd.-Fourth St.-Hazelwood Dr.-Neil St.

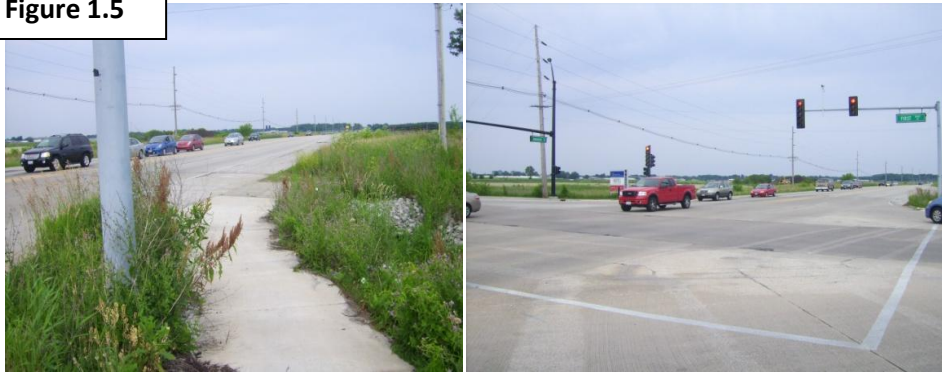
Quadrant 10 had low scores in walking surface (2.5/5), crosswalks (2.25/5), path size (2.25/5), buffers (2/5), accessibility (2.5/5), and shade (2.25/5). Figure 1.5 shows visual representation of the poor walking conditions found in quadrant 10. As shown in Figure 1.5, some of the walking paths end abruptly and the walking surface is lacking safe crosswalks throughout the entire quadrant.

Quadrant 10:

Hazelwood Dr.-Fourth St.-Windsor Rd.-Neil St.

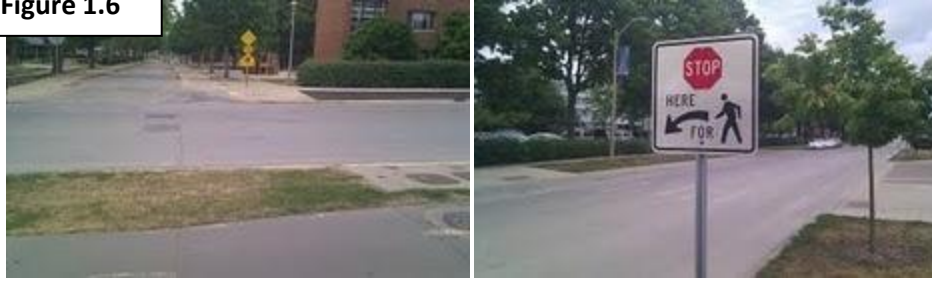
Quadrant 4 had low category scores in pedestrian conflict (2.5/5), crosswalk (2.5/5), shade (3/5), and buffers (3.5/5). All of these quadrants would have less than favorable conditions for walking. Figure 1.6 is a visual representation of the poor walking conditions present in quadrant 4. Based on Figure 1.6, the buffers in quadrant 4 are limited and there is a high amount of pedestrian conflict.

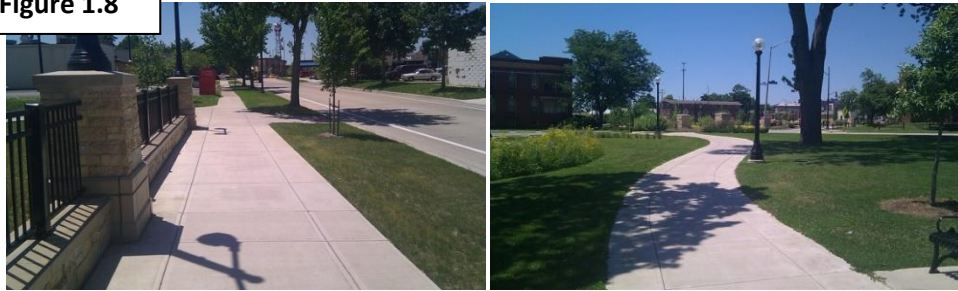
The walkability audit scores showed that the University of Illinois is doing a good job with accessibility, aesthetics, maintenance, and path size. These were the three highest scoring categories in the walkability audit. Although these categories scored the highest for the campus as a whole, there is still room to improve each of these individual categories. The walkability audits showed that maintenance and path size could both be improved in specific areas on campus. Topics such as small path size, or cracked sidewalks were mentioned as areas to improve the walkability of the campus. Figure 1.8 shows visual

representation of good walking conditions on UIUC campus. As shown in Figure 8, the walking surface is in great shape and the overall environment is appealing to walkers. These are great examples of excellent walking conditions on UIUC campus.

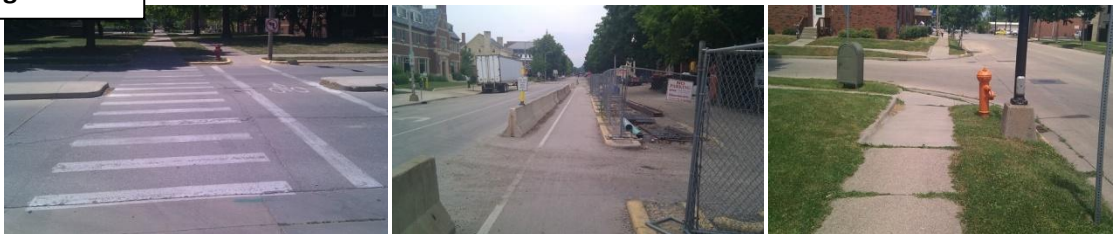
The walkability audit scores showed that the University of Illinois needs to improve in the areas of walking surface, pedestrian conflict, crosswalks, buffers, and shade. These were the lowest scoring categories in the walkability audit. Although these were the lowest scoring categories, none of them scored under a 3.2, which is a satisfactory score. Figure 1.9 shows a visual representation of poor walking conditions on UIUC campus. Based on Figure 1.9, UIUC can improve on crosswalks, buffers, and walking surface.

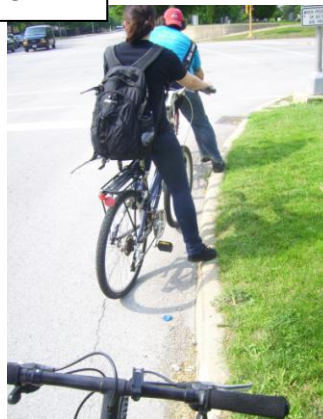
The most prevalent themes that emerged from the observations of the auditors were lack of buffers, lack of sidewalks/curbs, and lack of crosswalks. Buffers, sidewalks/curbs, and crosswalks were the top three themes mentioned from observations of the walkability audits. Bike and pedestrian conflict were other major themes that were mentioned throughout the audits. These themes are important to mention because walking surface, crosswalks, and pedestrian conflict are all items high importance categories that greatly affect the overall scores of the audits because they are the most heavily weighted in terms of scoring. Figure 2.2 shows a visual representation of bike and pedestrian conflict, which was a major theme identified by observers.

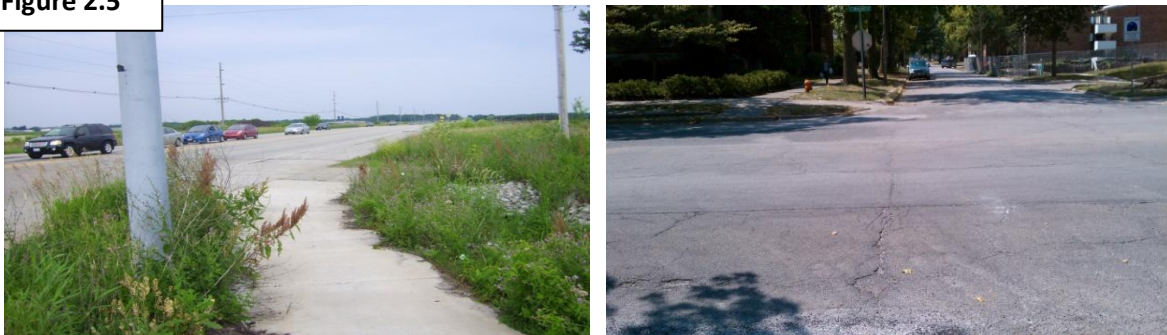
One major item that needs to be addressed is that there are very dangerous curbs on Springfield and Mathews. Another major immediate action should be to redevelop the area of Second and Springfield. This is a very busy area in terms of motor vehicle traffic and there is barely a crosswalk for pedestrians to cross Springfield Ave. Also, there is no signage in this area, which creates a very unsafe environment for walkers. Also, at the intersection of Sixth and John the motor vehicle drivers need more time to cross the intersection. As it is currently set, the motor vehicle drivers run out of time to turn and as a result run a red light. This creates a very unsafe environment for both motor vehicle drivers and pedestrians who are trying to cross the street.

Other areas that need immediate action are areas on campus that do not have a sidewalk or crosswalk. It is important to fix this immediately because a lack of sidewalk or crosswalk creates a very hazardous and unsafe environment for motor vehicles and pedestrians trying to walk or cross the street. Areas on campus that do not have a sidewalk include: east side of First, south side of Pennsylvania, Fourth to iHotel, Oak to Neil, Gerty to Oak, and Oak to Littlefuse. There is also one main area on the UIUC campus that does not have a crosswalk. The intersection of Gerty and First Street needs to have a crosswalk painted so that pedestrians can cross the street safely. Figure 2.5 shows examples of walking routes on the UIUC campus that need to be improved immediately. Lack of a sidewalk and lack of a crosswalk create a very dangerous walking environment.

There are multiple immediate action recommendations for the University of Illinois at Urbana-Champaign campus. These are items that are creating an extremely hazardous and unsafe environment for walkers on the UIUC campus. These changes are recommended to be made immediately in order to avoid serious complications and to improve overall safety and walkability of the campus.
