WALKABILITY AUDIT 2021-22
University of Illinois Urbana-Champaign

SUTAPA BANERJEE
2ND YEAR MUP GRADUATE STUDENT, UIUC

GOAL: Develop a Walkability Index for the campus of University of Illinois Urbana Champaign

The Facilities & Services Transportation Demand Management (F&S TDM) Dept. of UIUC is conducting a thorough walkability audit of the University District using two surveys:

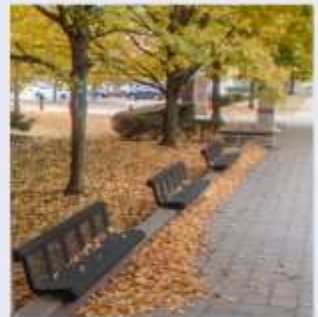
Shaded, visually appealing landscaped areas

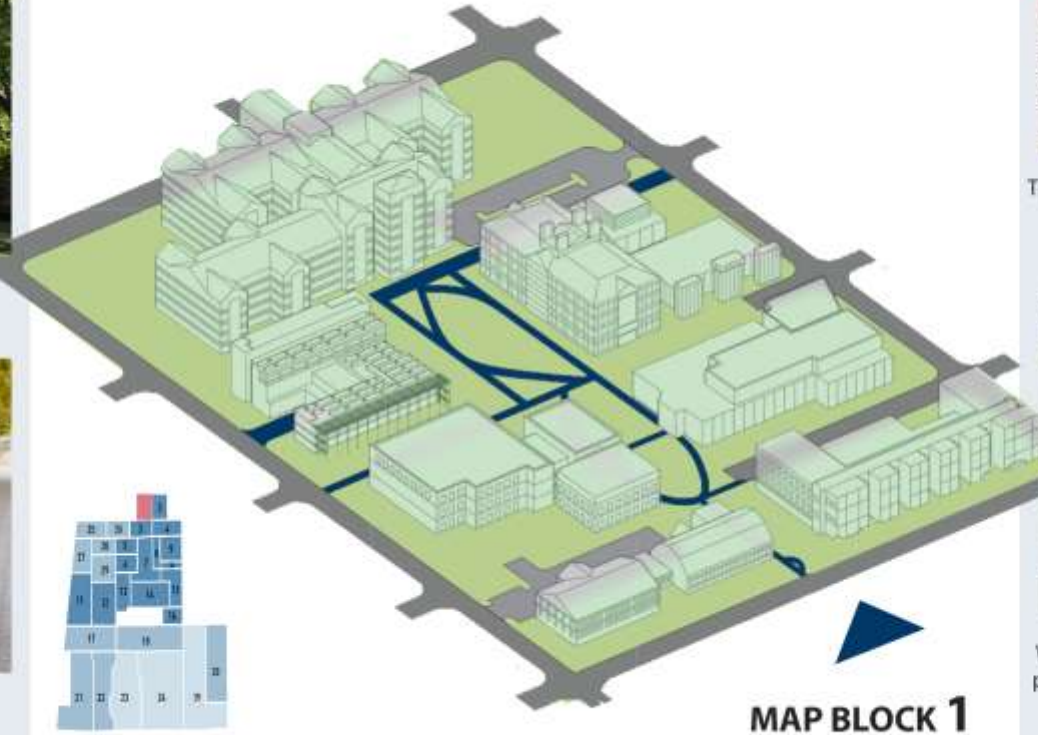
MAP
BLOCK
1

After averaging the scores of each map block, it was found that map block 1 had one of the best walking conditions with a score of 87.6/100. Map block 1 scored high Sidewalk Presence (5/5), Sidewalk connectivity (5/5), Parking connectivity to walkways (5/5), Pedestrian Visibility along sidewalks (5/5), Walk Appeal (4.9/5). All average scores of the parameters of Map Block 1 were above (4.0/5).

Map block 1 is relatively smaller in size as compared to the rest of the map-blocks and houses the North quadrangle. It has multiple landscaped spaces with presence of shade and its streets have safe crosswalks with multiple traffic calming measures. It also has several transit stops that make it accessible and pedestrian friendly.

Well maintained walkways in the North Quad along with landscaping elements

Transit stops with several amenities to support pedestrians

Well connected sidewalk network present on both sides of the street

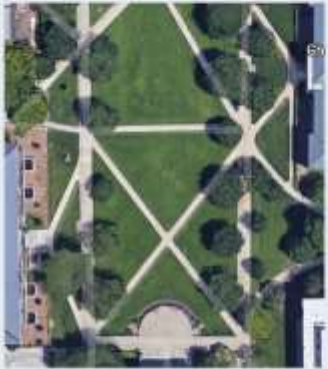
The sidewalk network in the main quad is a design feature and also increases accessibility

Although the campus was found to be moderately walkable, the scores varied greatly amongst map blocks. **The average weighted score of map block 7 scored 84/100 and had one of the best walking conditions.** Map block 7 scored high in Sidewalk Presence (5/5), Pedestrian Visibility along crosswalks (5/5), Sidewalk Connectivity (5/5), and scores above 4.0/5 in almost all the parameters of assessment.

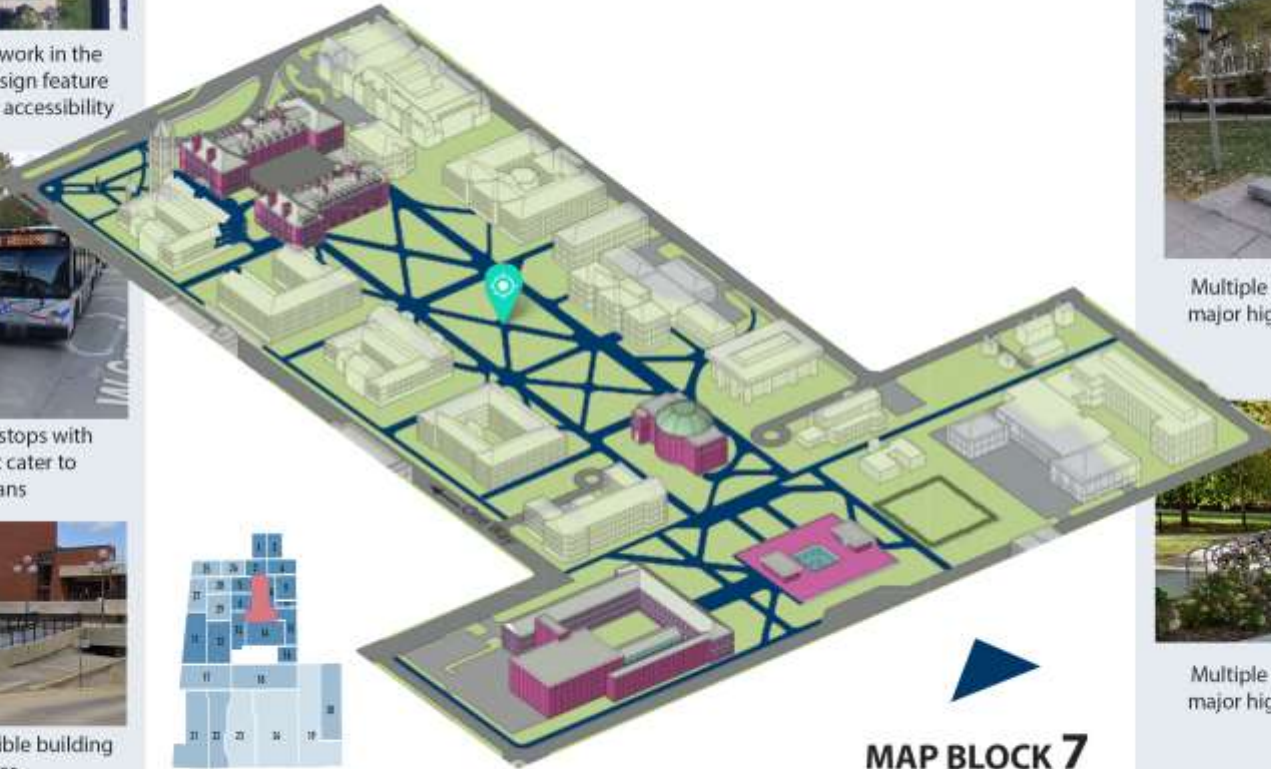
MAP BLOCK 7

This map block represents the core of the campus with green open spaces for congregation at its center and has great accessibility of the sidewalk network. Since this area represents the face of the campus, it is maintained regularly. This area also witnesses peak pedestrian traffic between class changes and major events open to the all the university students.

Well maintained, wide sidewalk network in the Main Quad.

Multiple bike stands along major high traffic buildings

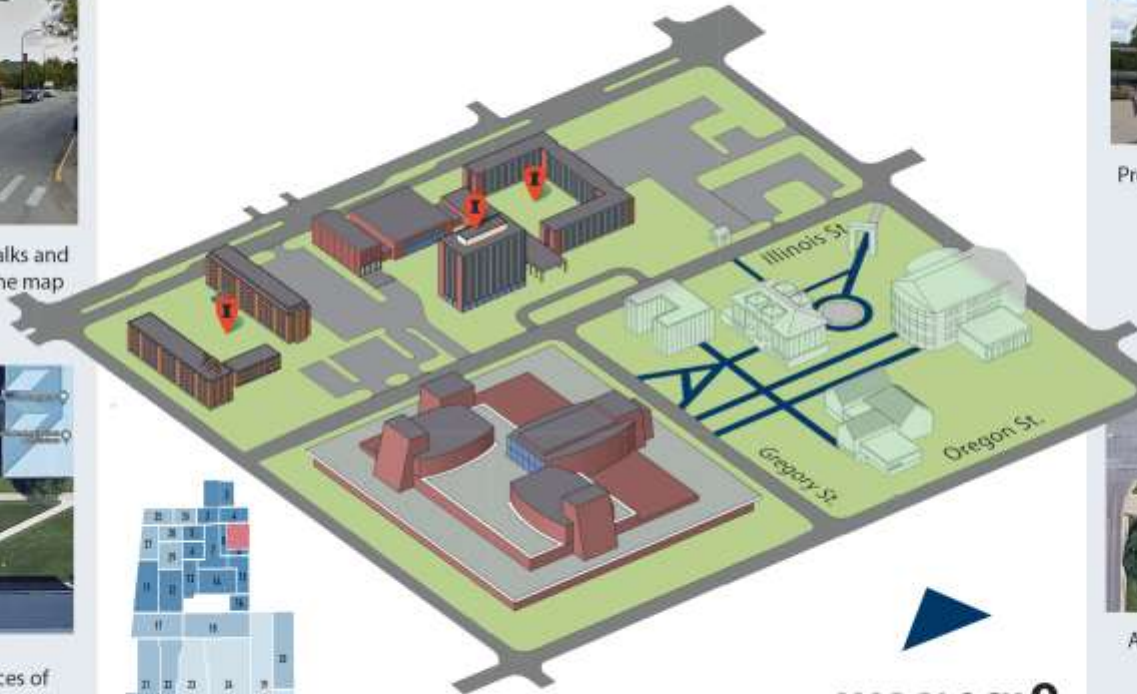
MAP BLOCK 9

Map block 9 had one of the best walking conditions with a score of 83.7/100. Map block 9 scored high Sidewalk Presence (5/5), Building entrances (4.89/5), Parking connectivity to walkways (5/5), Transit stop distance (5/5), Pedestrian Visibility along sidewalks (5/5).

Map block 9 houses the Krannert center and has well maintained sidewalks with shaded seating spaces, ADA ramps and curb extensions to ensure smooth transition for pedestrians. i

Presence of ADA ramps for wheelchair access

Presence of curb extensions at high traffic locations

Adequate buffer widths from street (Pedestrian and vehicular separation)

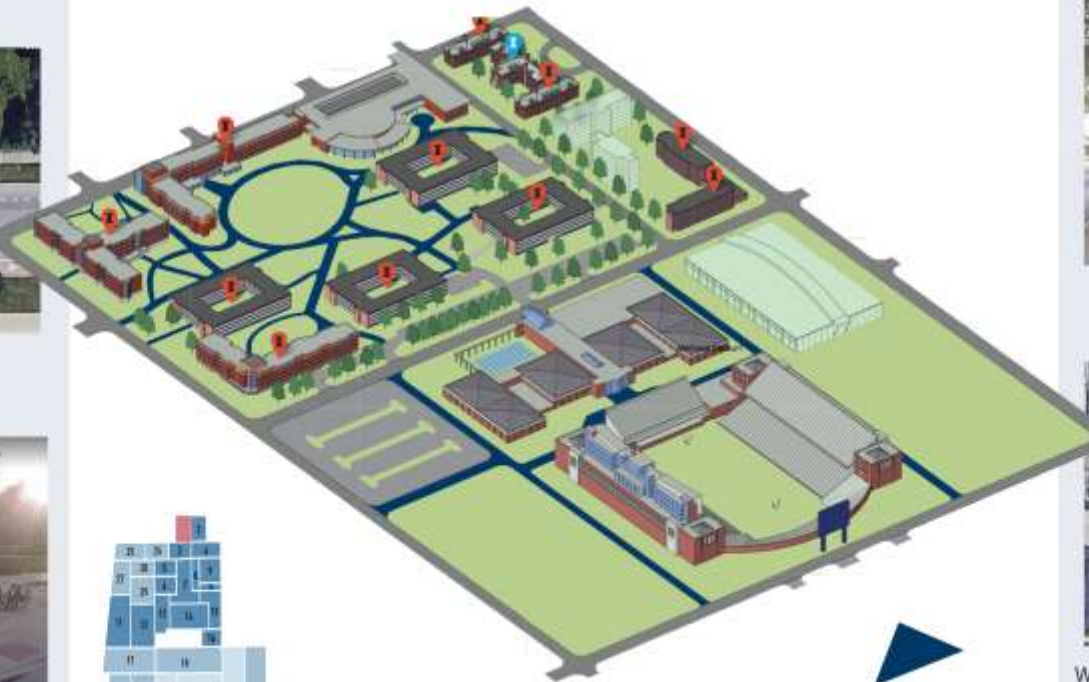
MAP BLOCK 12

Map block 12 scored high Absence of obstructions (4.9/5), Sidewalk connectivity (5/5), Parking connectivity to walkways (4.6/5), Pedestrian Visibility along sidewalks (5/5), Walk Appeal (4.3/5). All average scores of most of the parameters of Map Block 12 were above (4.0/5).

Well maintained walkways in the North Quad along with landscaping elements

Well shaded sidewalks

Well connected sidewalk network that increases accessibility

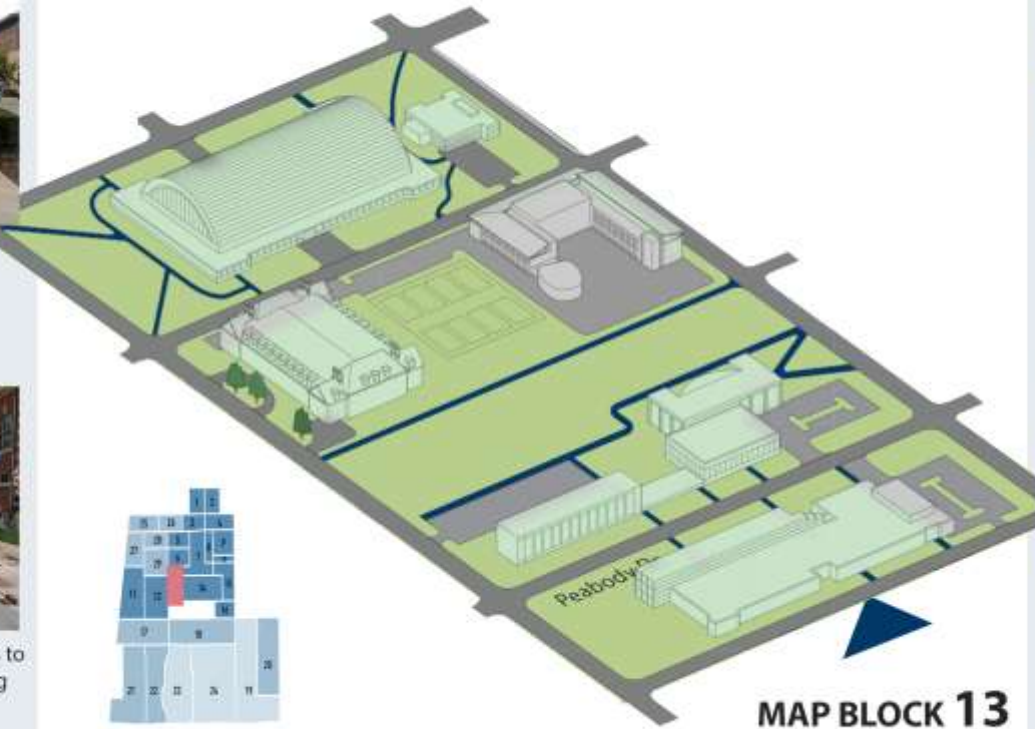
MAP BLOCK 13

Although the campus was found to be moderately walkable, the scores varied greatly amongst map blocks. **This score found that map block 13 had the best walking conditions.** Map block 13 scored high in Pedestrian facilities and design(5/5), crosswalks (4/5), transit areas(5/5), universal accessibility (4.7/5), safety (4.5/5) and walk appeal(4.3/5).

Traffic calming measures like signalization, audio signals and push buttons

Shaded sidewalks with several landscaped elements

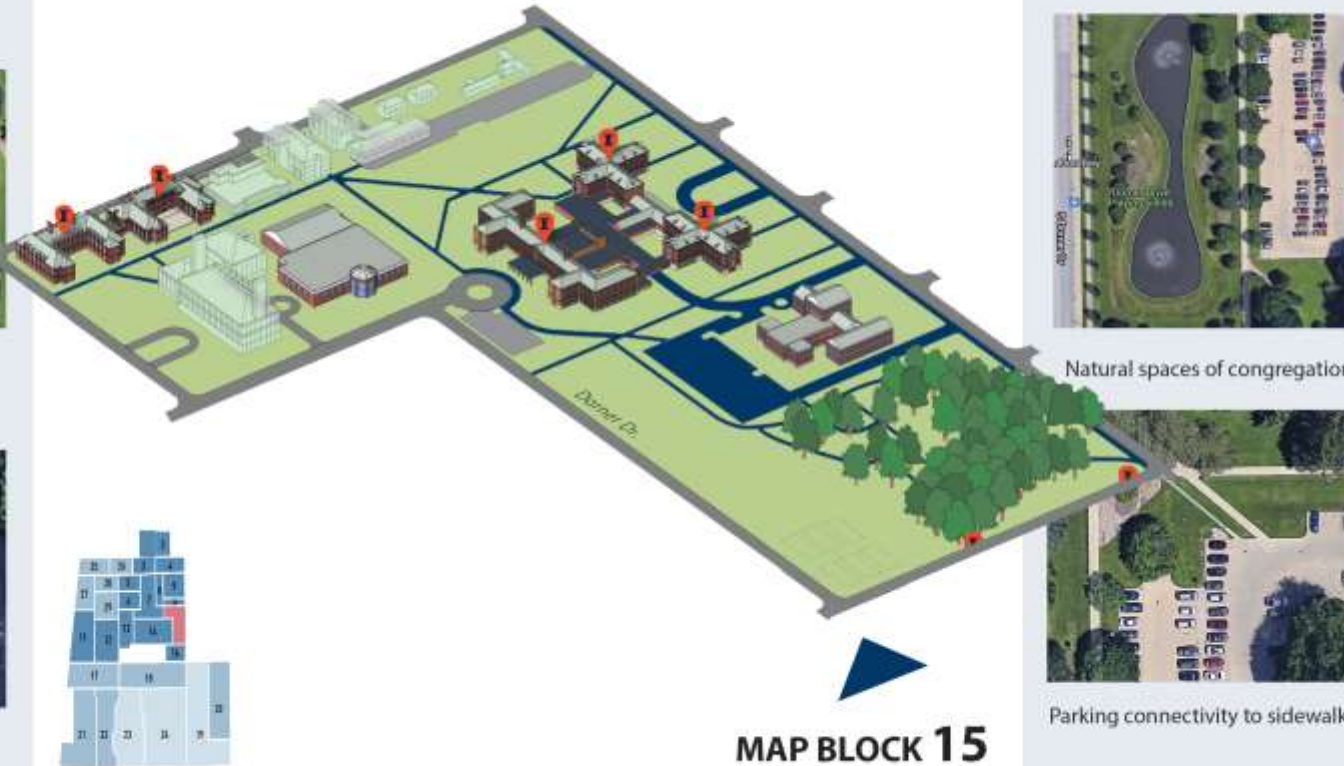
MAP
BLOCK
15

Map block 15 had one of the best walking conditions with a score of 86.8/100. Map block 15 scored high on Sidewalk Presence (5/5), Curb cut alignment (5/5), Sidewalk connectivity (5/5), Parking connectivity to walkways (5/5), Pedestrian Visibility along sidewalks (5/5), Walk Appeal (4.7/5). All average scores of the parameters of Map Block 1 were above (4.0/5).

Presence of Traffic calming measures like Stop signs. Availability of Emergency phone booths

Natural spaces of congregation

Parking connectivity to sidewalks

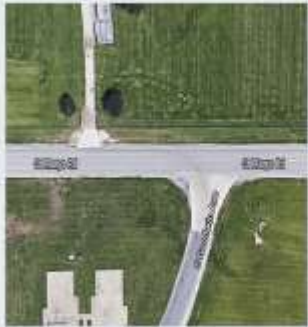
Lack of sidewalks and crosswalks

Scattered and undefined landscape

Map blocks 19, 23 and 24 had extremely low average scores, which were an exception to the overall walkability score of campus. Map block 19 an average of 33.3/100, Map block 23 had an average score of 53.3/100 and Map block 24 scored an average of 44.6/100. These map blocks were generally the parts of the campus that did not have important campus buildings but have a majority of vacant and green space expanses. Therefore, the sidewalks are often unpaved with walkways only on one side. This might have greatly affected the scoring since our surveys have questions that are perception based.

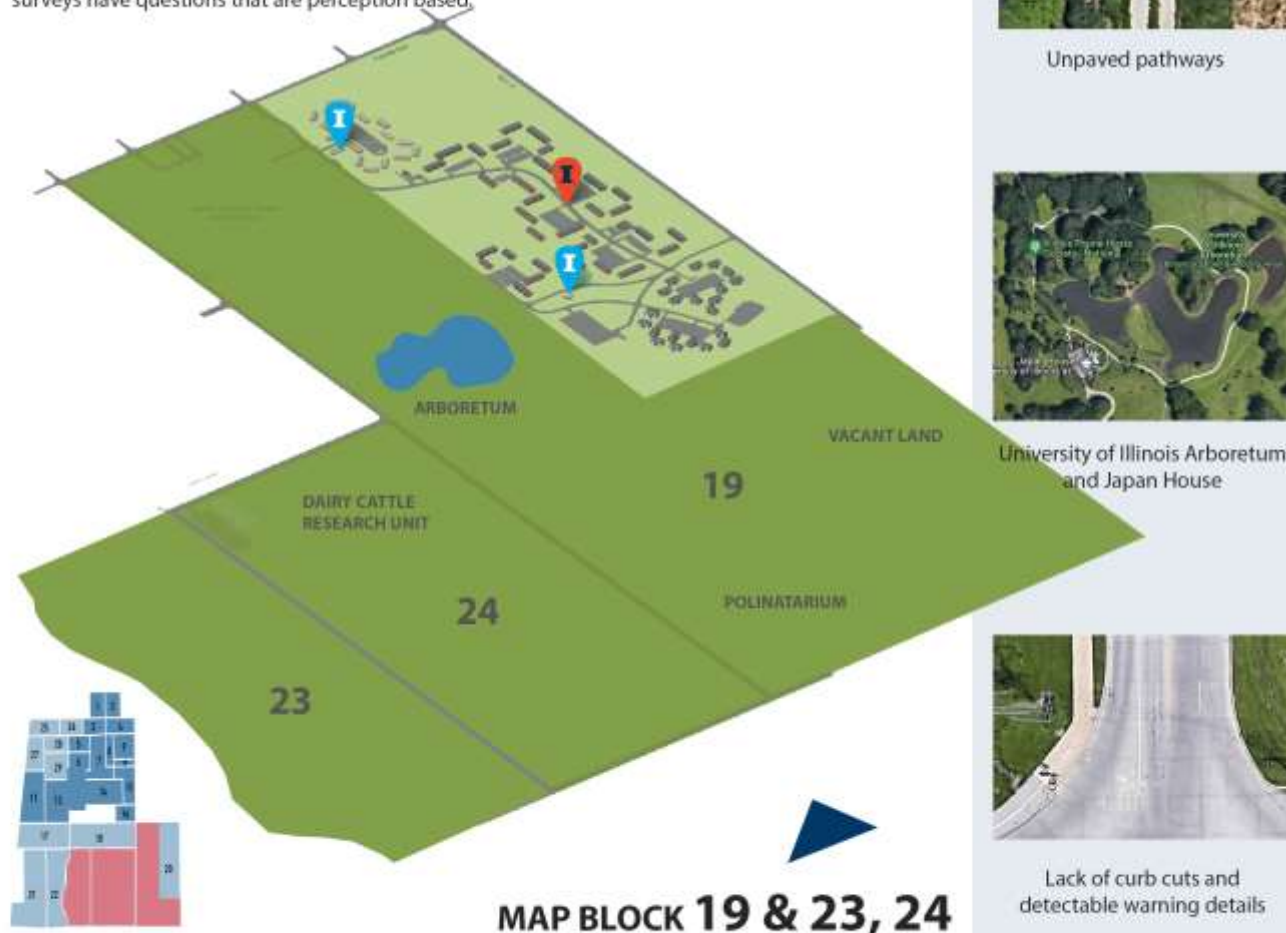
MAP BLOCK	SCORE
19	33.3/100
23	53.3/100
24	44.6/100

Unpaved pathways

University of Illinois Arboretum and Japan House

Lack of curb cuts and detectable warning details

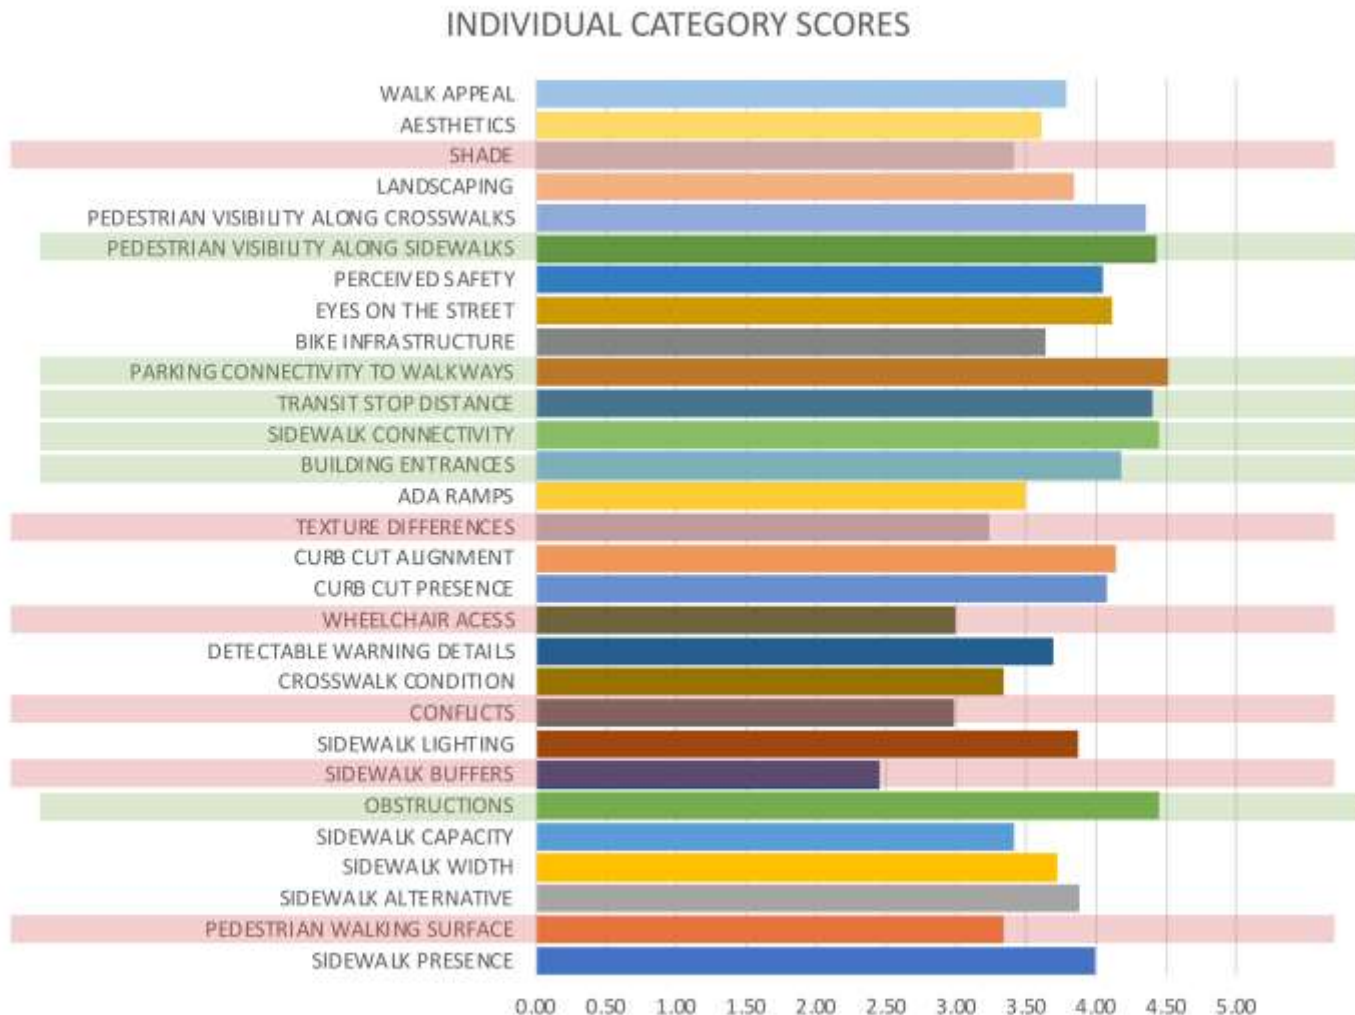
High (Above 3.8/5)

Sidewalk Presence, Temporary and Permanent obstructions, Sidewalk Lighting, Curb Cut Presence, Curb Cut alignment, Building entrances, Sidewalk Connectivity, Transit stop distance, Parking connectivity, Perceived Safety, Pedestrian Visibility along sidewalks and crosswalks, Landscaping, Walk Appeal

Sidewalk Maintenance, Sidewalk Alternate, Sidewalk Width, Sidewalk Capacity, Crosswalk condition, Detectable warning details, Texture differences, ADA ramps, Bike Infrastructure, Shade, Aesthetics

Sidewalk buffers, Wheelchair Access, Pedestrian and Vehicular Conflicts

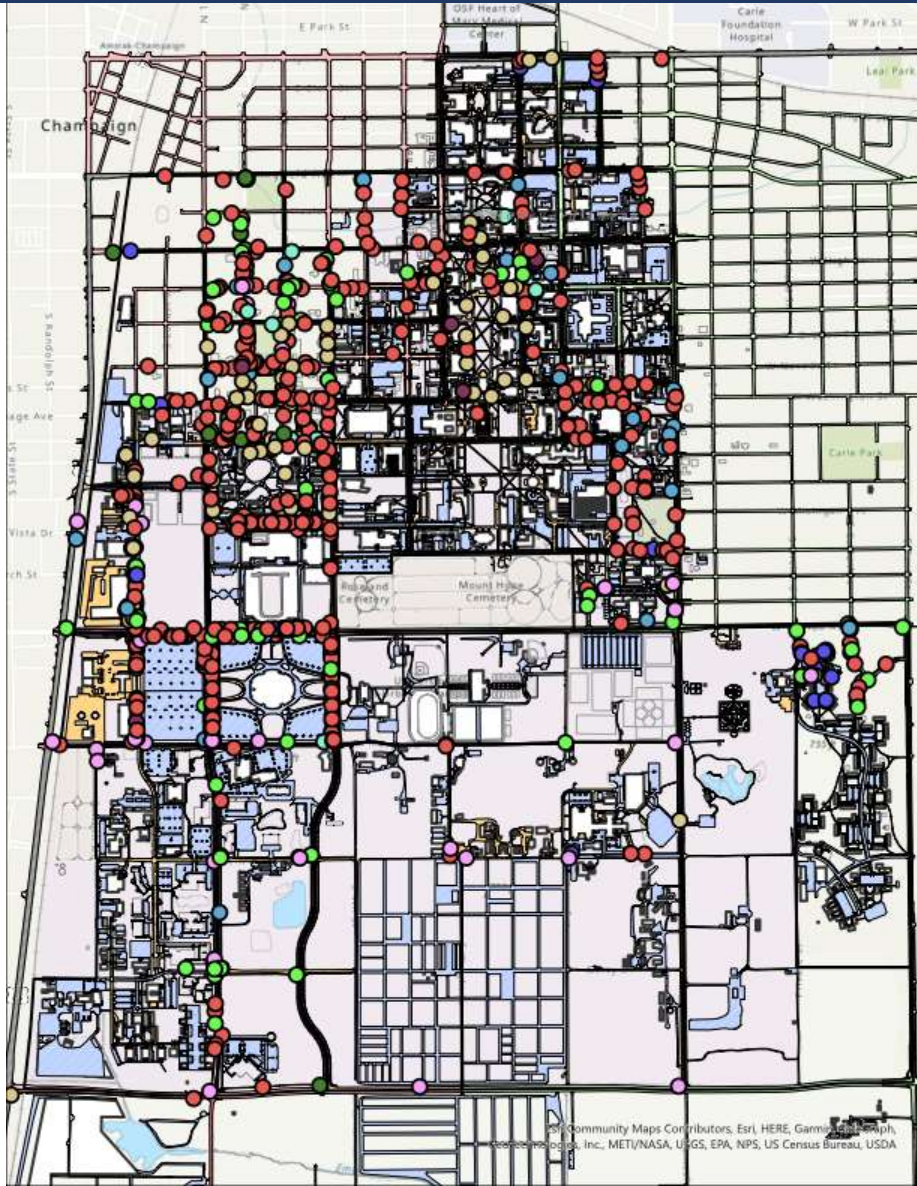
Deficiency points superimposed over Division of Responsibility map

Highest Deficiency categories:

1. Sidewalk Maintenance
2. Crosswalk Maintenance
3. Accessibility Issues

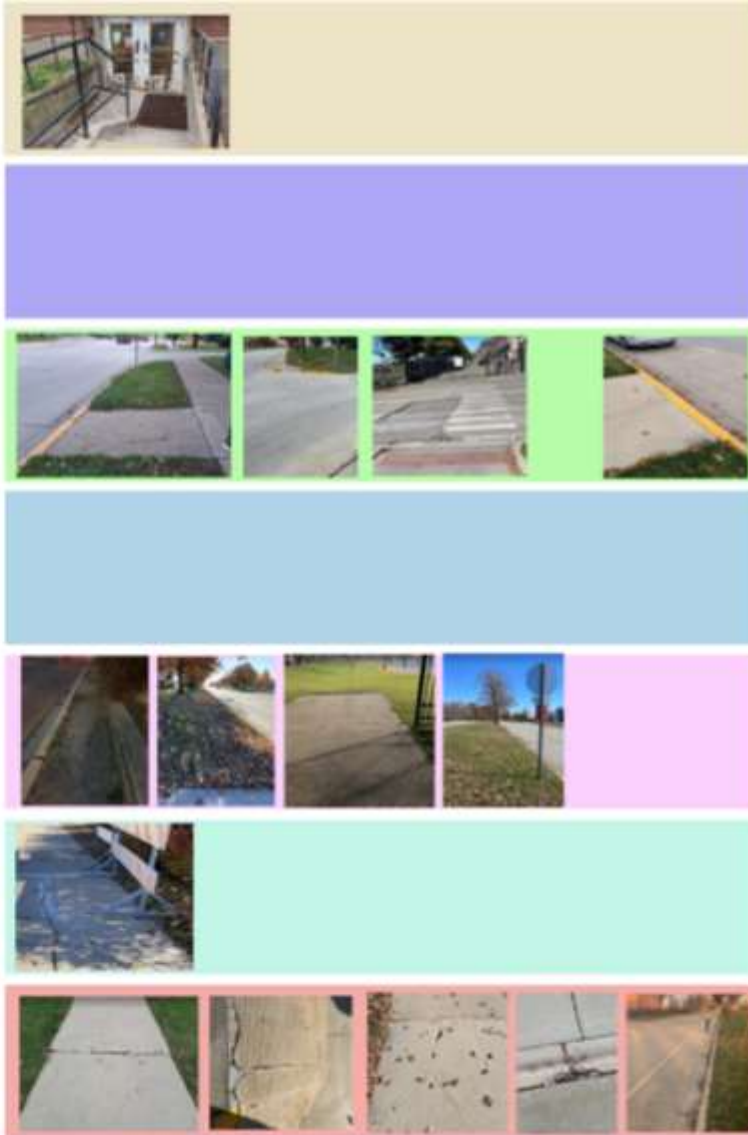
MAP BLOCK 11

DIVISION OF RESPONSIBILITY

- Facilities and Services
- Auxiliary
- City of Champaign
- City of Urbana
- Village of Savoy
- Champaign County

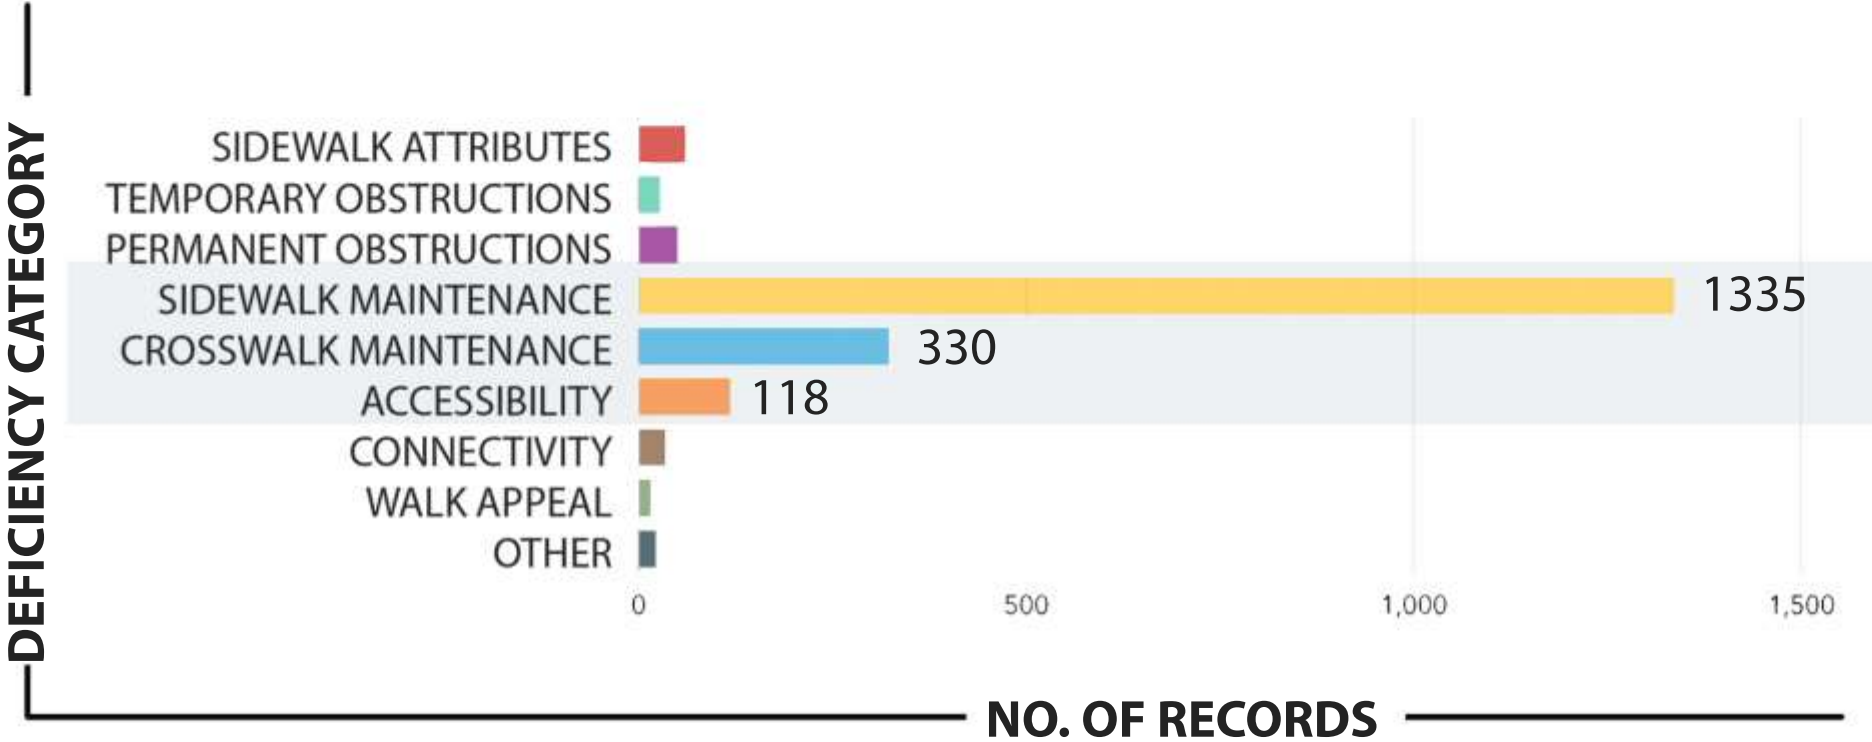
The most dominant form of deficiency identified fell under **'Sidewalk Maintenance'** with over 1330/2000 points recorded. **'Crosswalk Maintenance'** stands second with over 330 data points followed by **'Accessibility issues'** with 118 points recorded.

Bar graph showing Deficiency category count

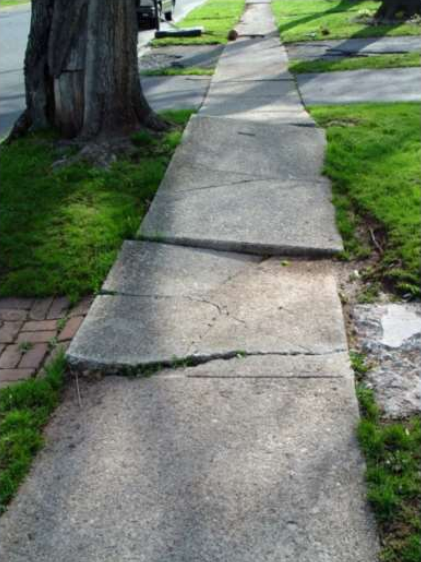
Vertical Faults (Count: 518)

- Ensure sidewalk presence on both sides of the street
- Conduct periodical maintenance of sidewalk surfaces
- Provide amenities along sidewalks at regular intervals to support pedestrian walking trips
- Determine sidewalk widths proportionate to peak hour traffic
- Remove temporary and permanent obstructions

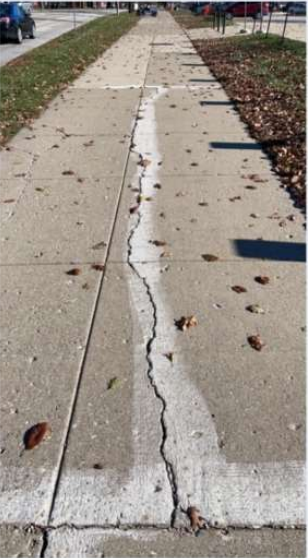
Cracks- more than 4 feet of accessible sidewalk (Count: 311)

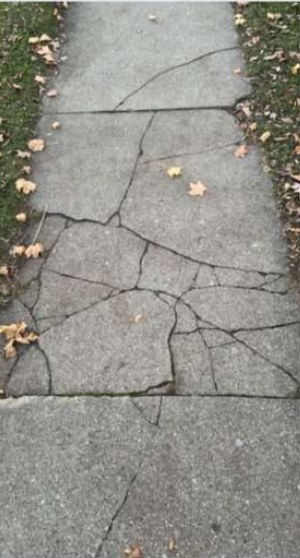
Cracks- more than 4 feet of accessible sidewalk (Count: 350)

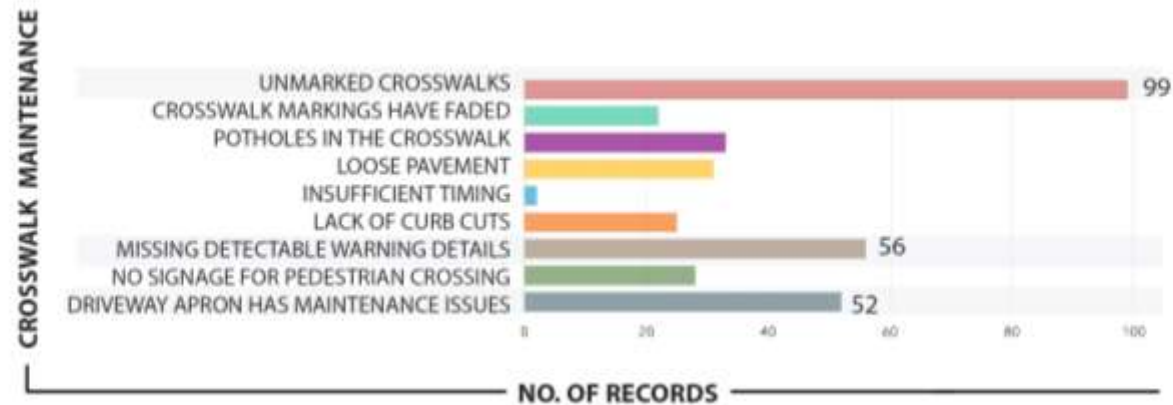
Crosswalk maintenance was the 2nd highest Deficiency category identified. Within the category, the highest reported issues were: Unmarked crosswalks, Lack of Detectable warning details and Maintenance issues in the Driveway apron.

Bar graph showing Crosswalk maintenance Deficiency category count

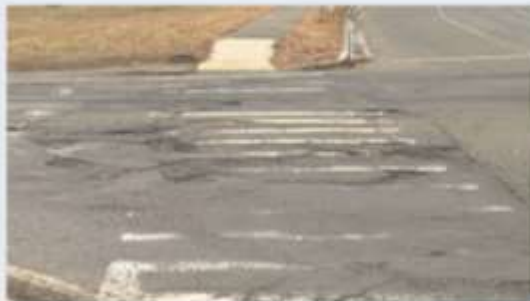
Faded crosswalk markings

- Paint unmarked crosswalks
- Repaint faded crosswalk markings
- Start maintenance measures to tackle top-layer deterioration of crosswalks

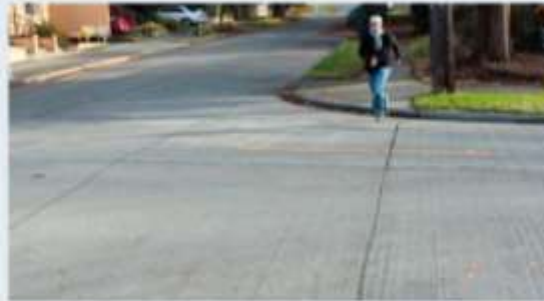
Unmarked crosswalks

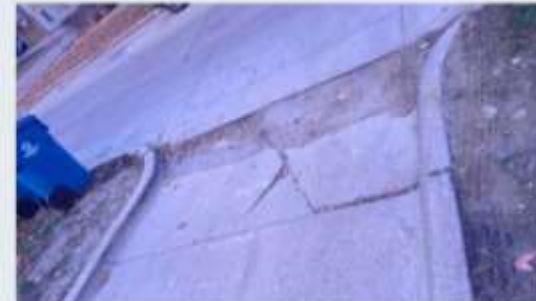
Driveway apron has maintenance issues
