# U20069: Pavement Analysis Study 2020 University of Illinois at Urbana-Champaign

## Final Report

Applied Pavement Technology, Inc.  
115 West Main Street, Suite 400  
Urbana, Illinois 61801  
(217) 398-3977  
[www.appliedpavement.com](http://www.appliedpavement.com)

**AUGUST 2020**

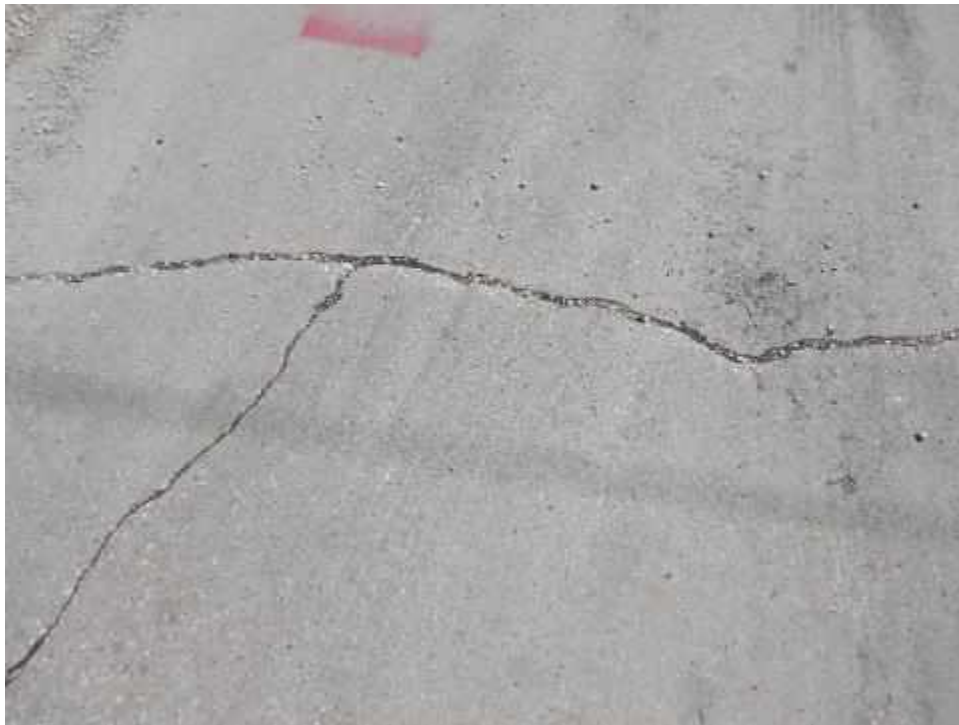
ARMRYA-E00-LTD Cracking-(Sample Unit No. 01)

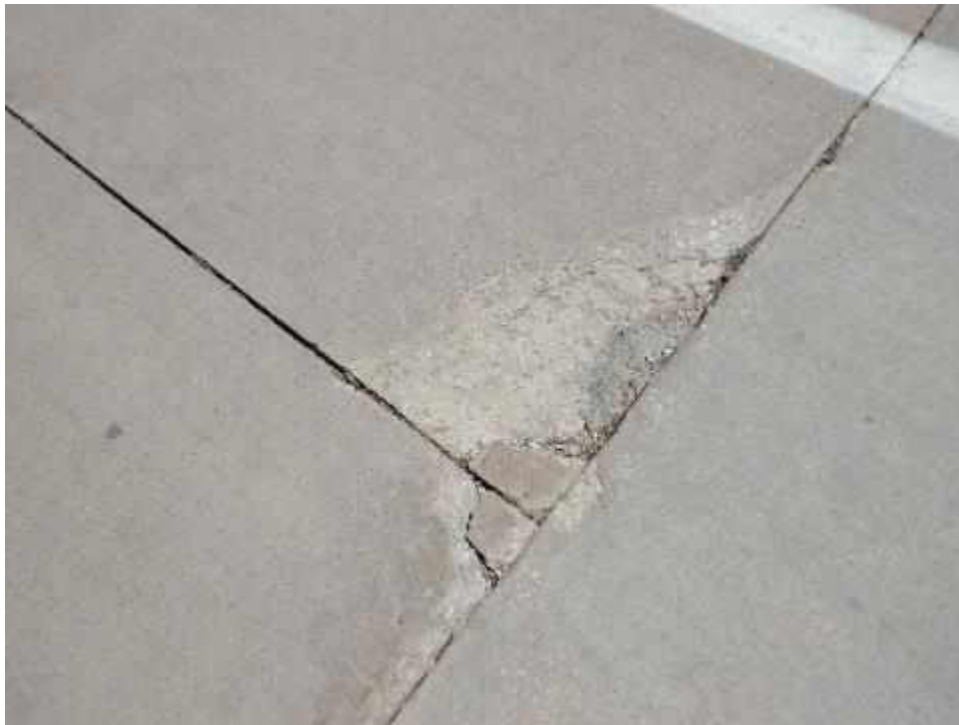
ARMRYA-E04-Corner Spalling-(Sample Unit No. 01)

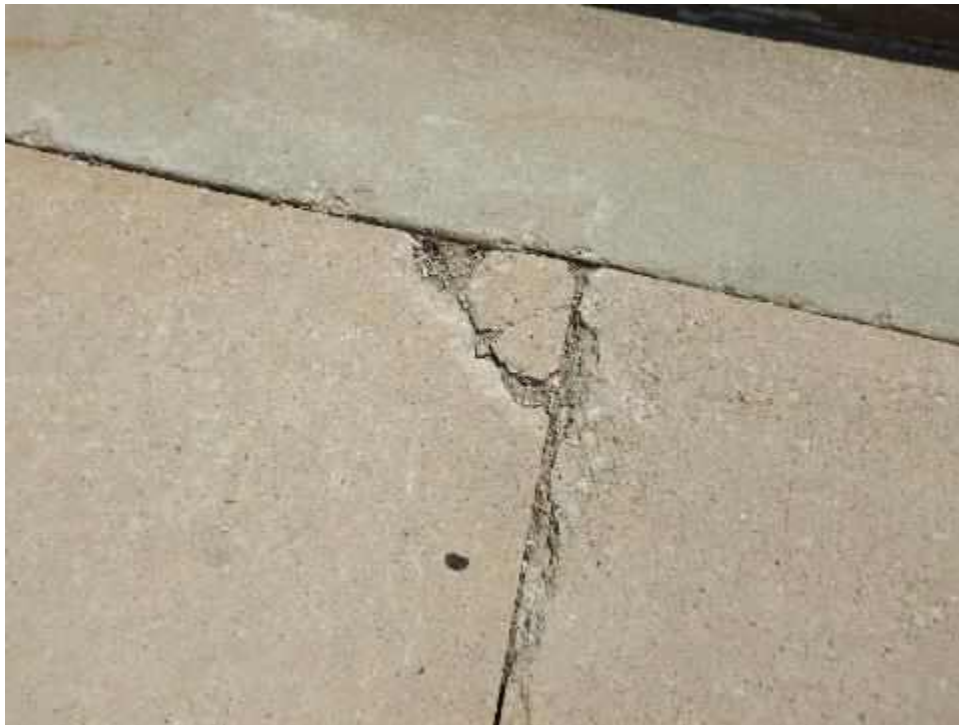
ARMRYA-E05-Corner Spalling-(Sample Unit No. 01)

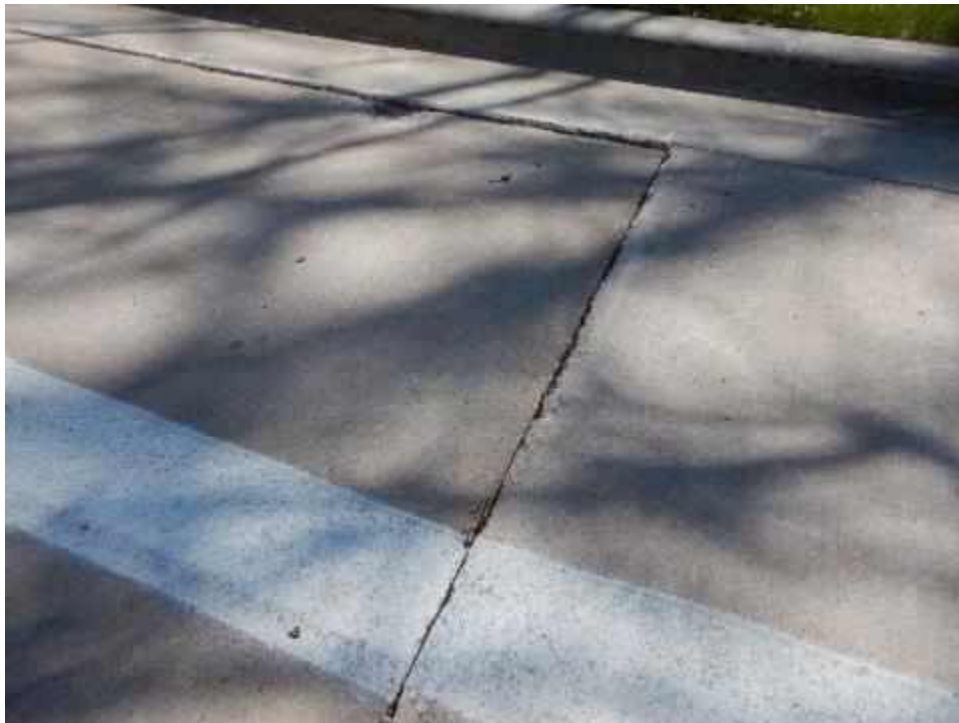
ARMRYA-E05-Faulting-(Sample Unit No. 01)

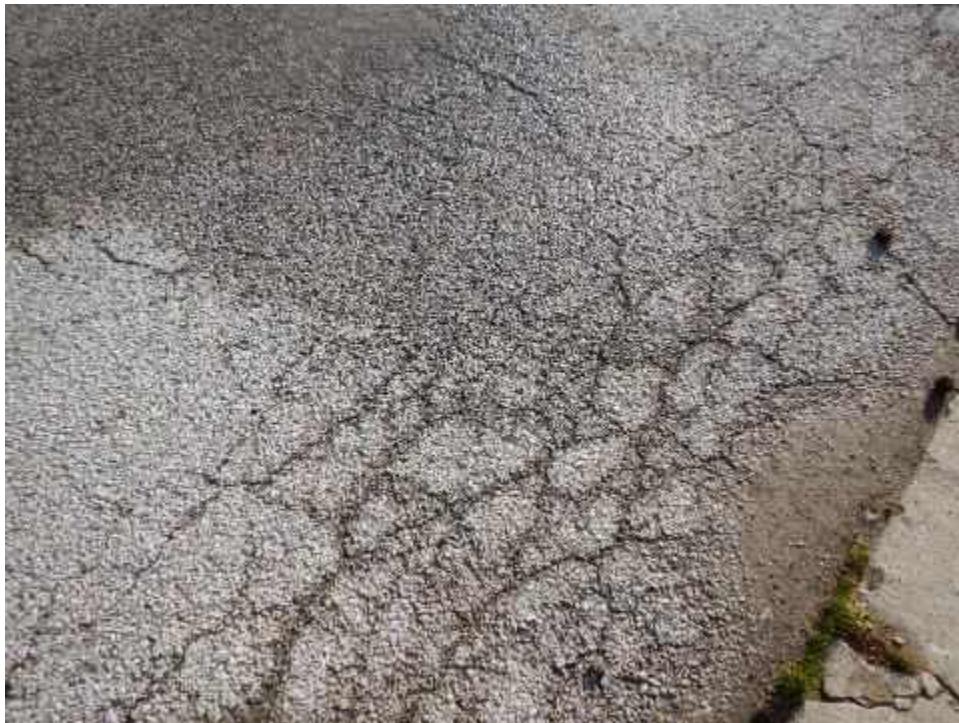
BAILEYD-E00-Alligator Cracking-(Sample Unit No. 01)

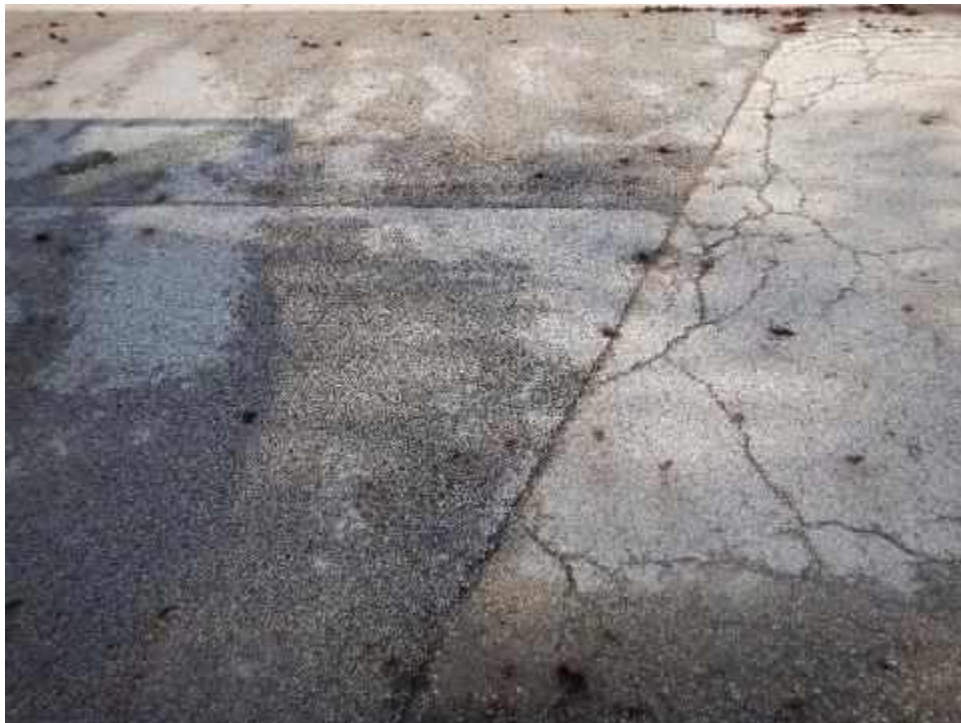
BAILEYD-E00-Patching-(Sample Unit No. 02)

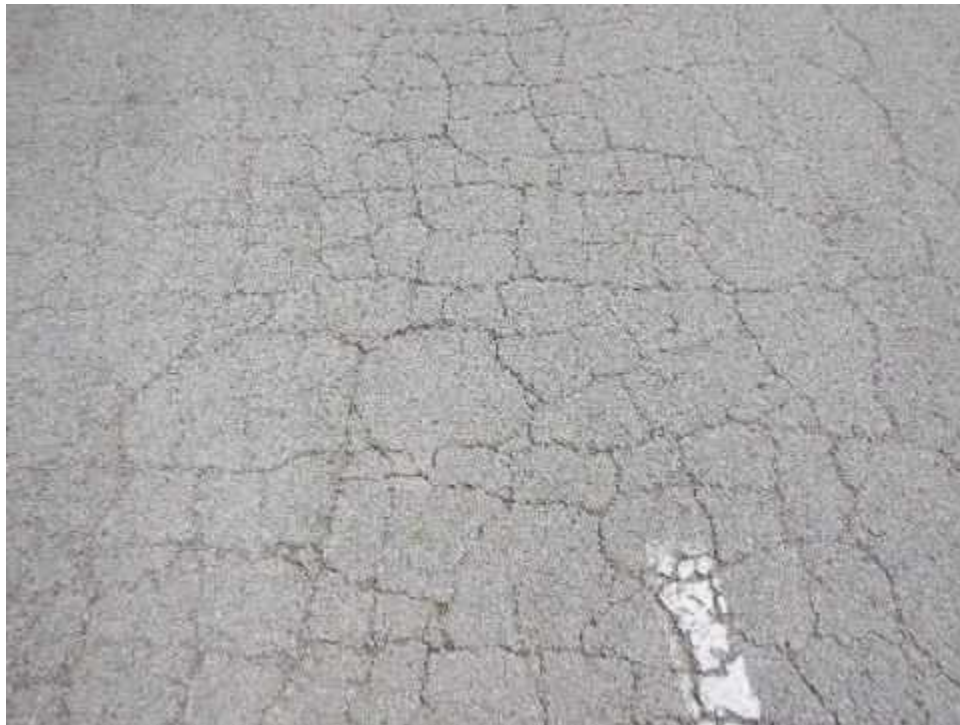
COLAGCT-UW09AN-Alligator Cracking-(Sample Unit No. 01)

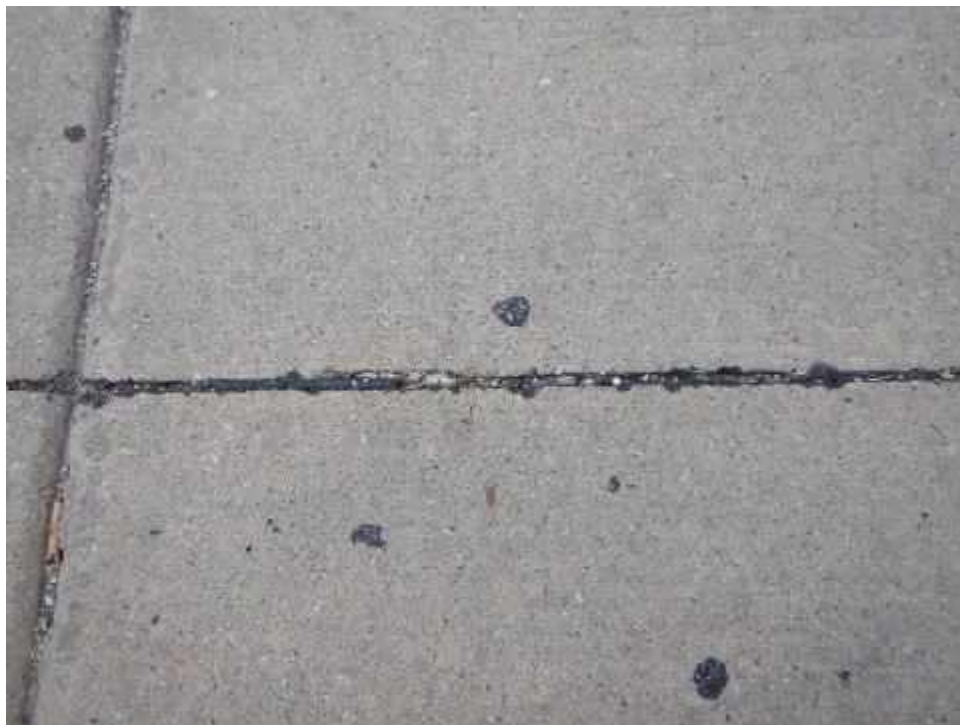
COLAGCT-UW09AN-Joint Seal Damage-(Sample Unit No. 01)

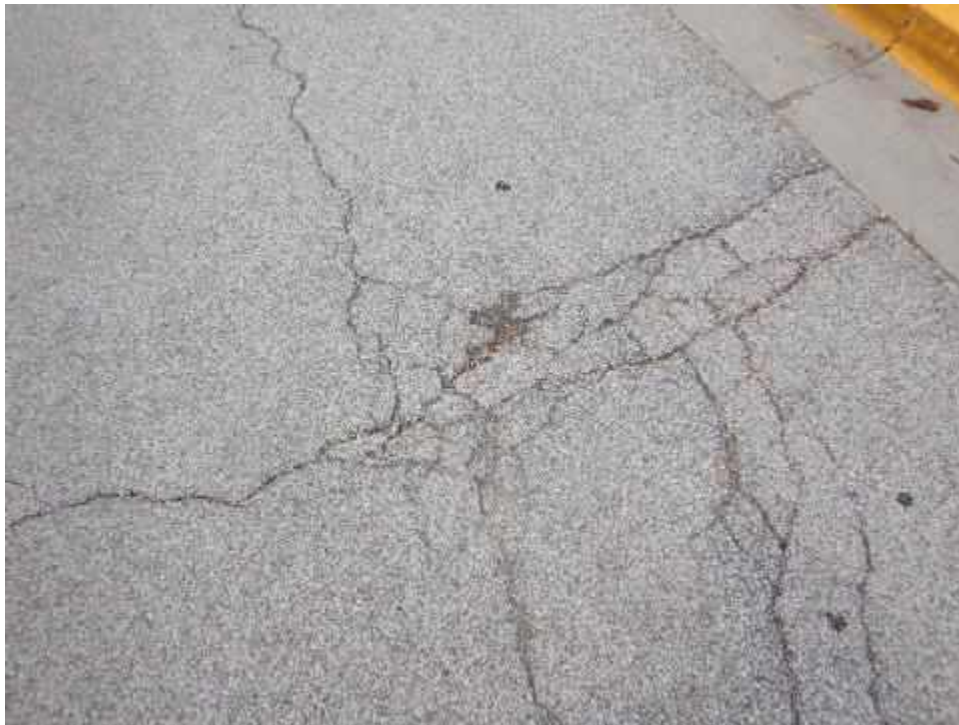
COLAGCT-UW09BN-Alligator Cracking-(Sample Unit No. 01)

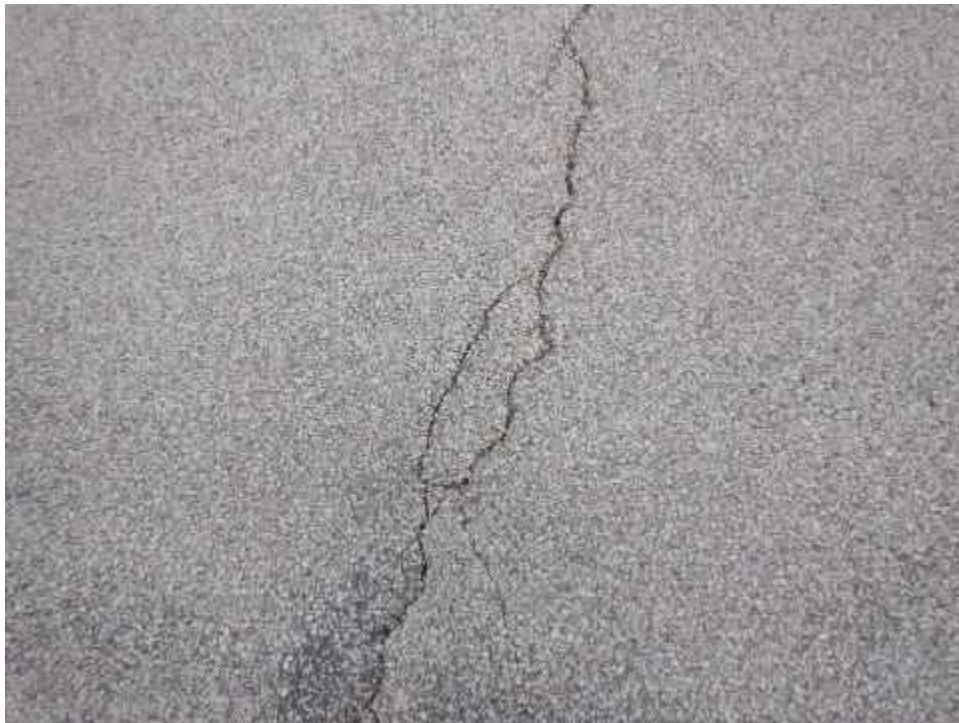
COLAGCT-UW09BN-L&T Cracking-(Sample Unit No. 01)

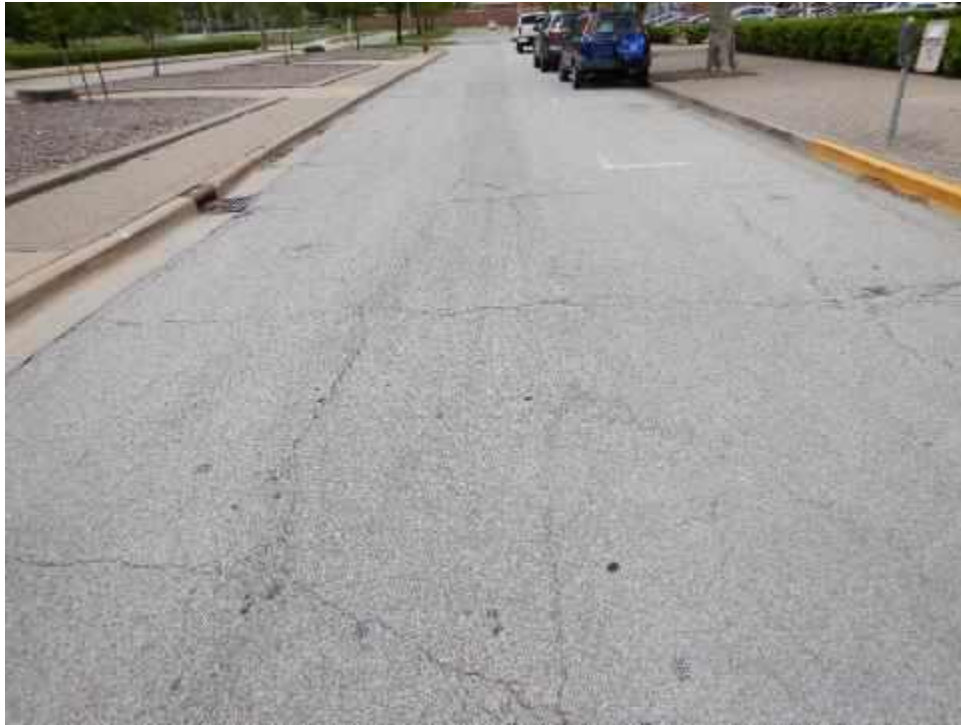
COLAGCT-UW09BN-Overview-(Sample Unit No. 01)

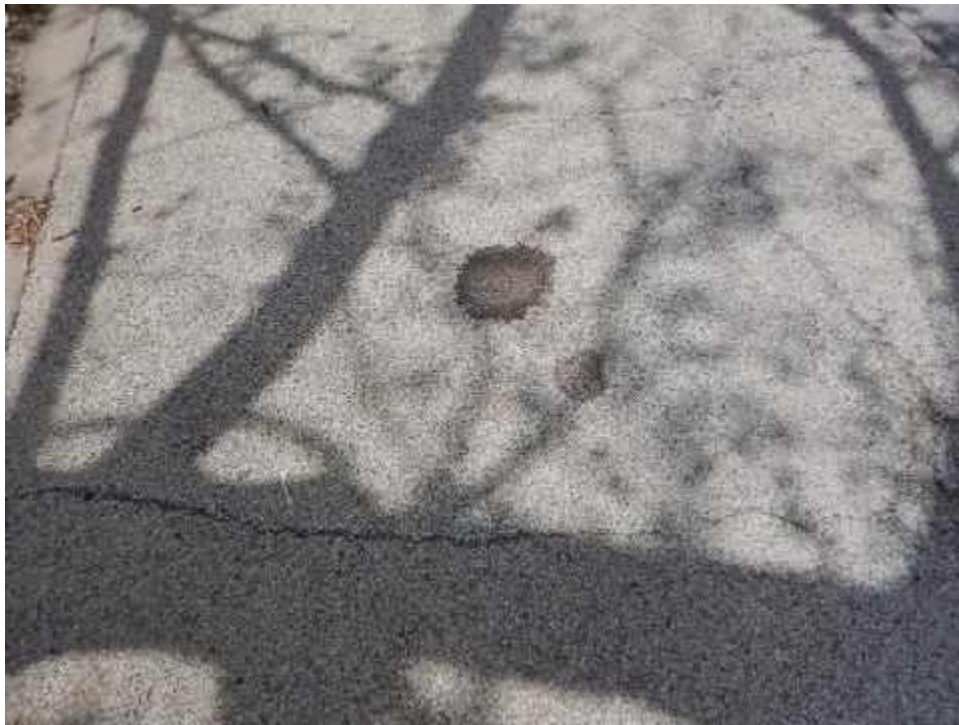
COLAGCT-UW09BS-Block Cracking-(Sample Unit No. 01)

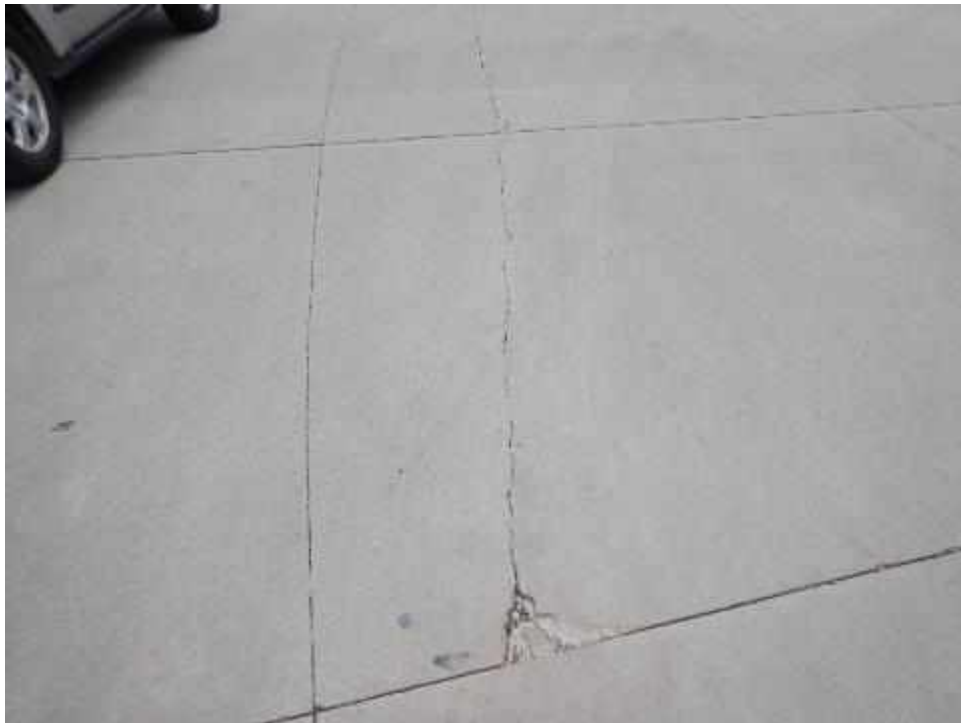
COLAGCT-UW09CN-LTD Cracking-(Sample Unit No. 01)

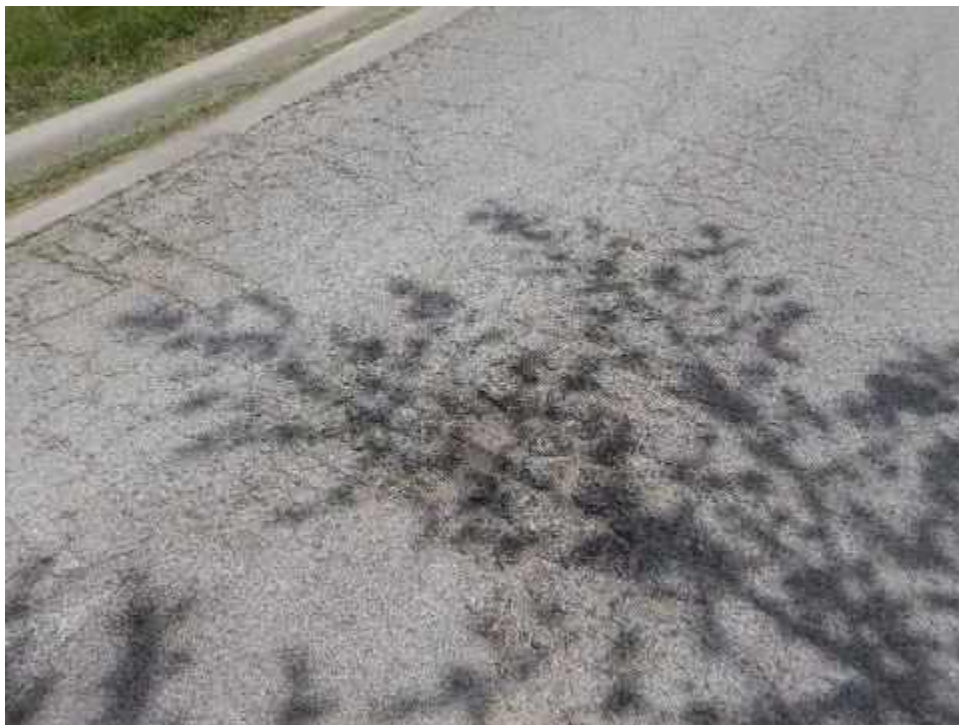
COLAGCT-UW09CS-Alligator Cracking-(Sample Unit No. 01)

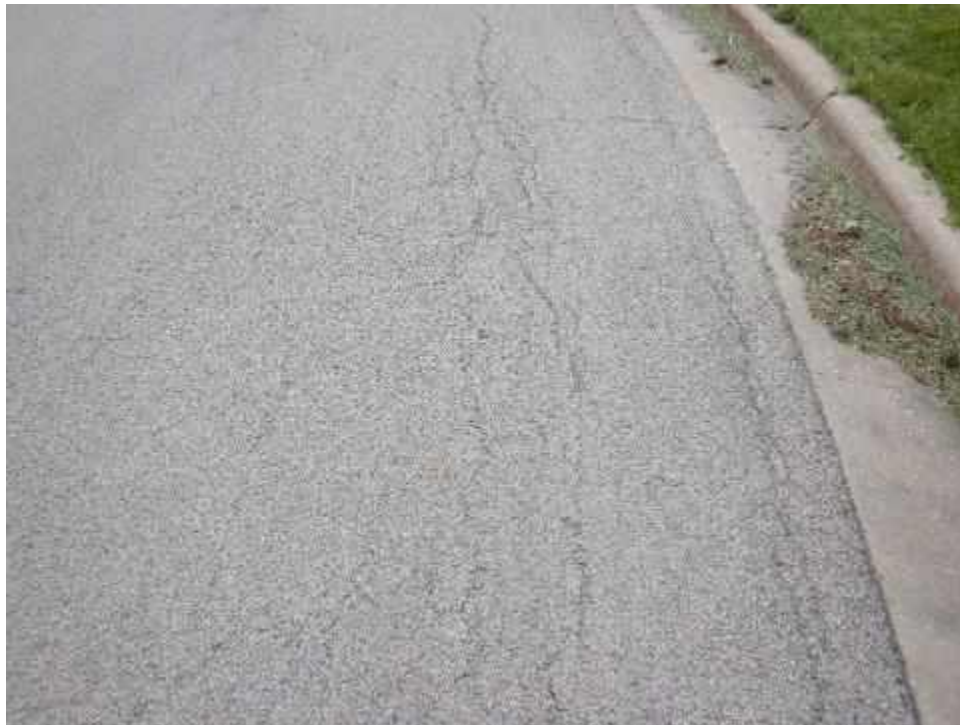
COLAGCT-UW09DN-Alligator Cracking-(Sample Unit No. 01)

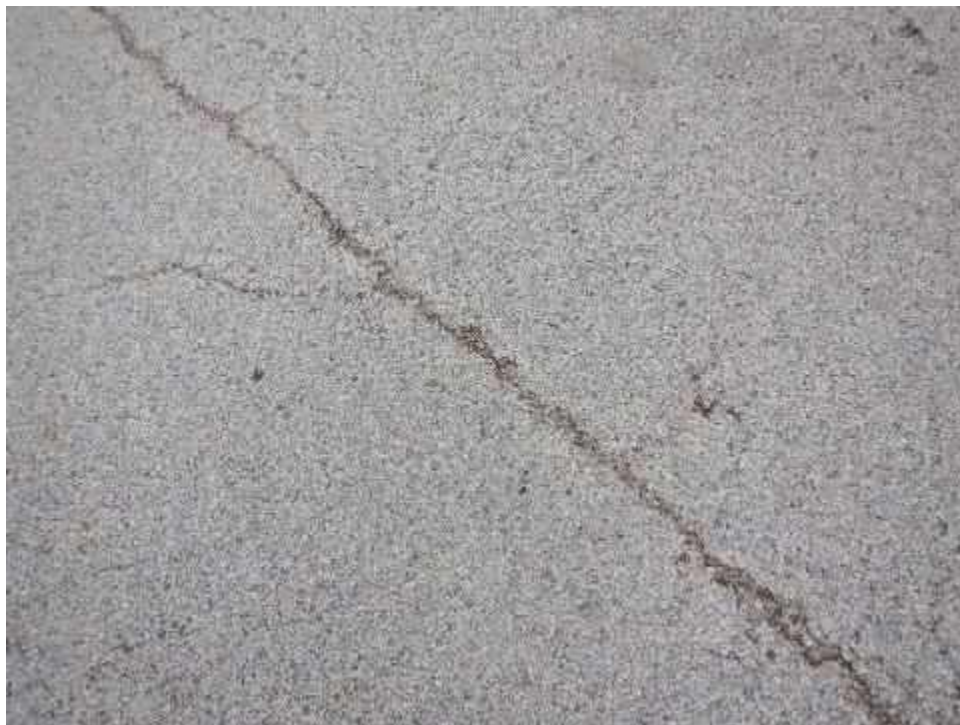
COLAGCT-UW09DN-L&T Cracking-(Sample Unit No. 01)

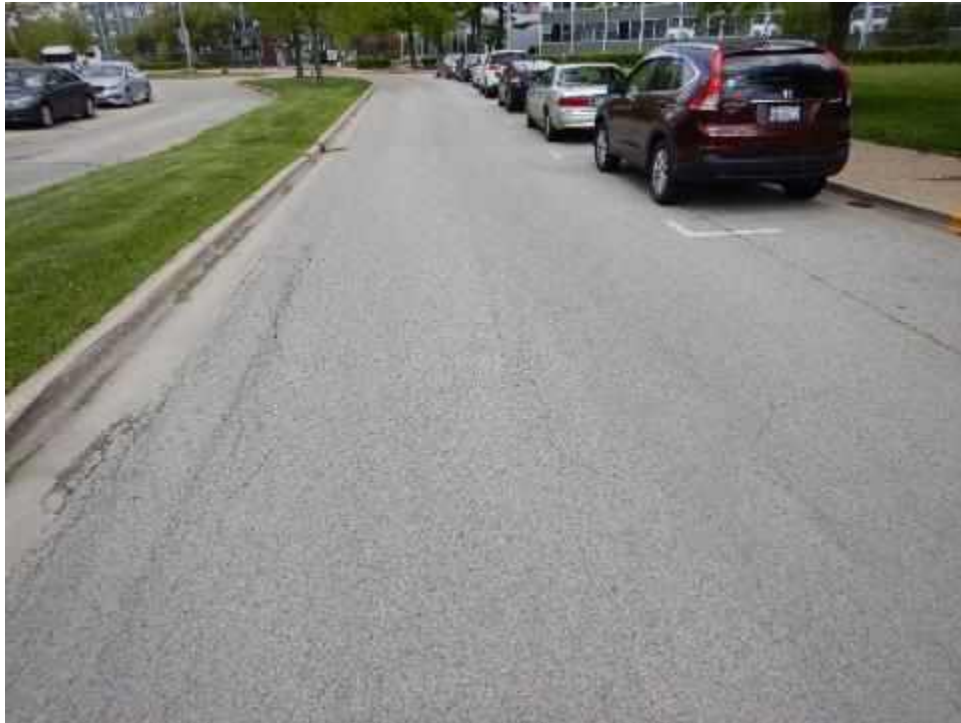
COLAGCT-UW09DN-Overview-(Sample Unit No. 01)

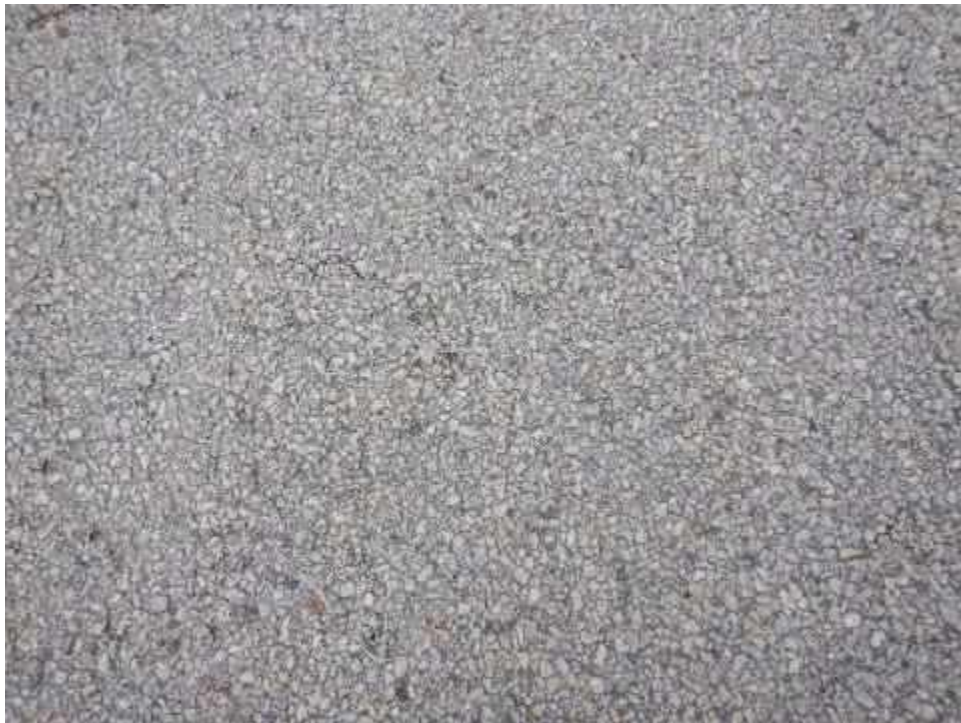
COLAGCT-UW09DN-Weathering-(Sample Unit No. 01)

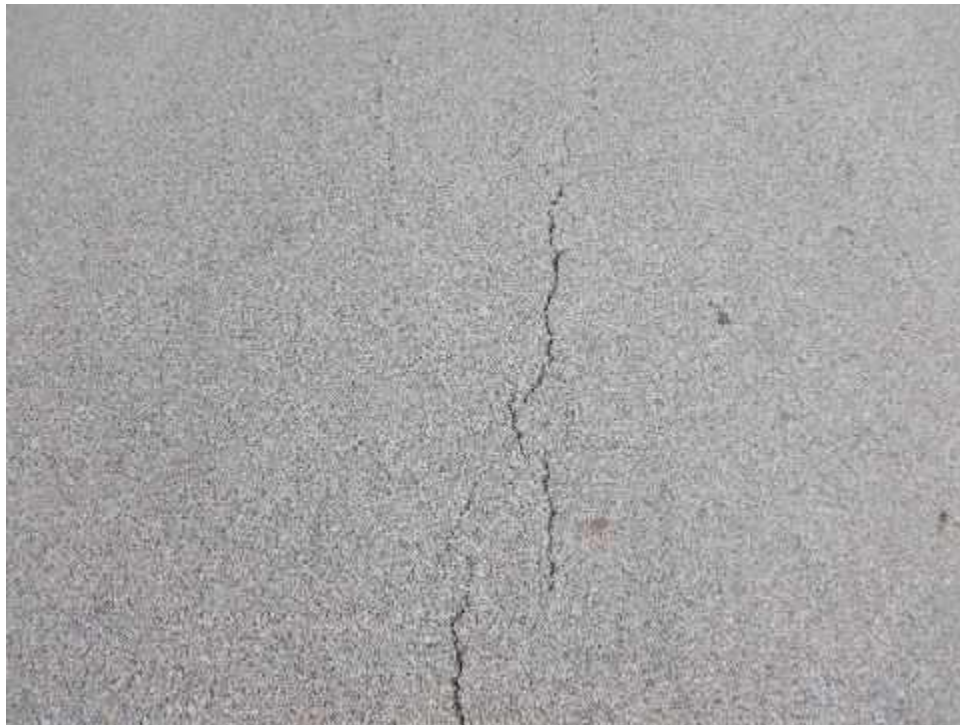
DORNRDR-US11AE-L&T Cracking-(Sample Unit No. 01)

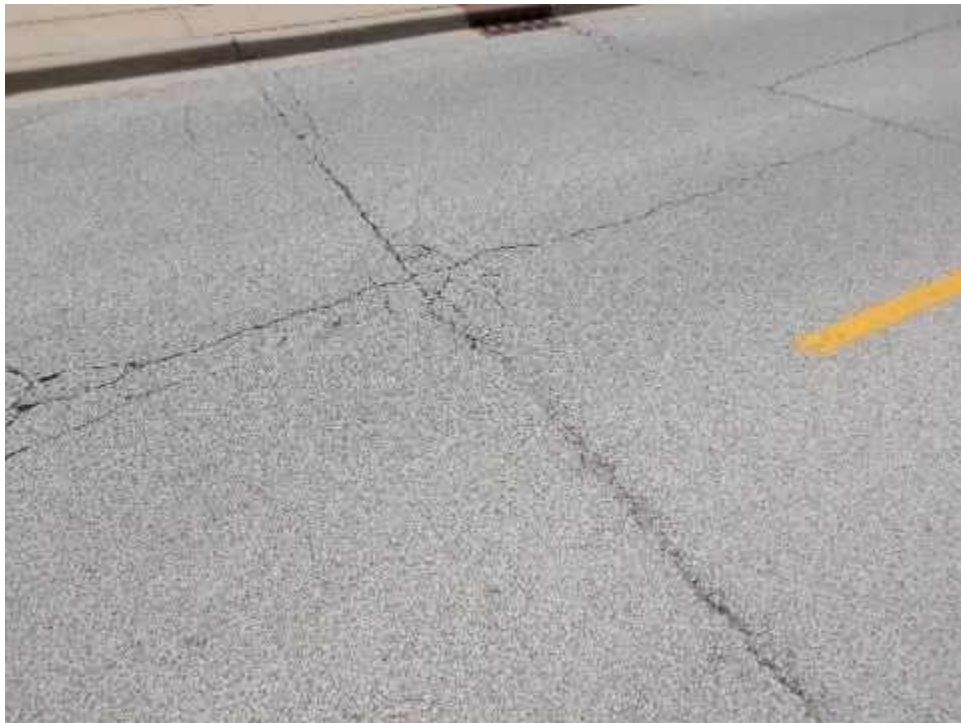
DORNRDR-US11AW-Joint Reflection Cracking-(Sample Unit No. 01)

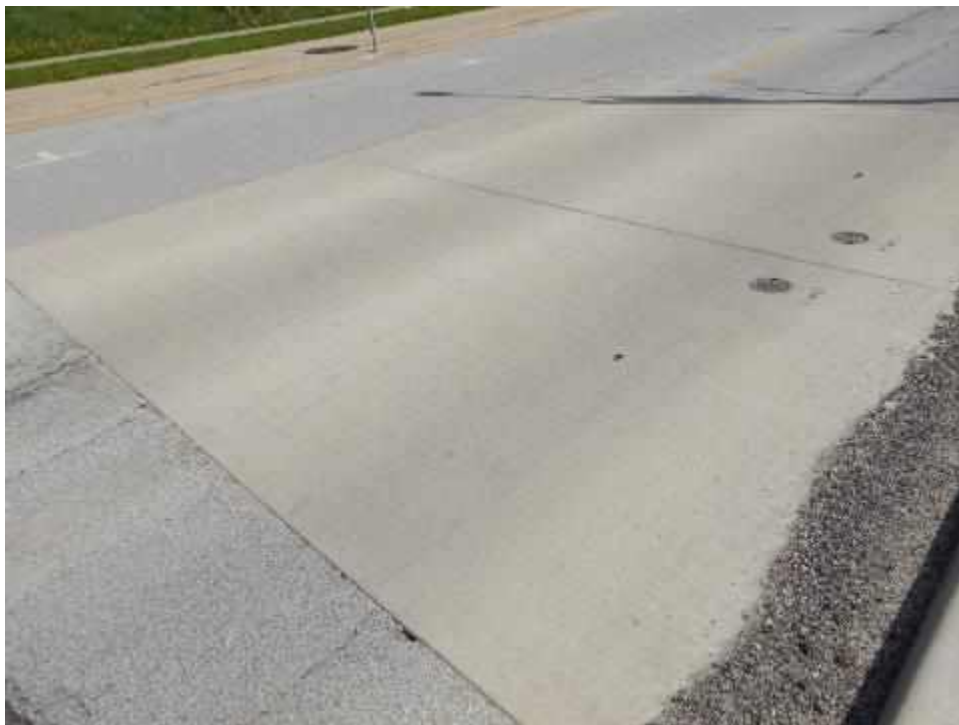
DORNRDR-US11AW-Patching-(Sample Unit No. 01)

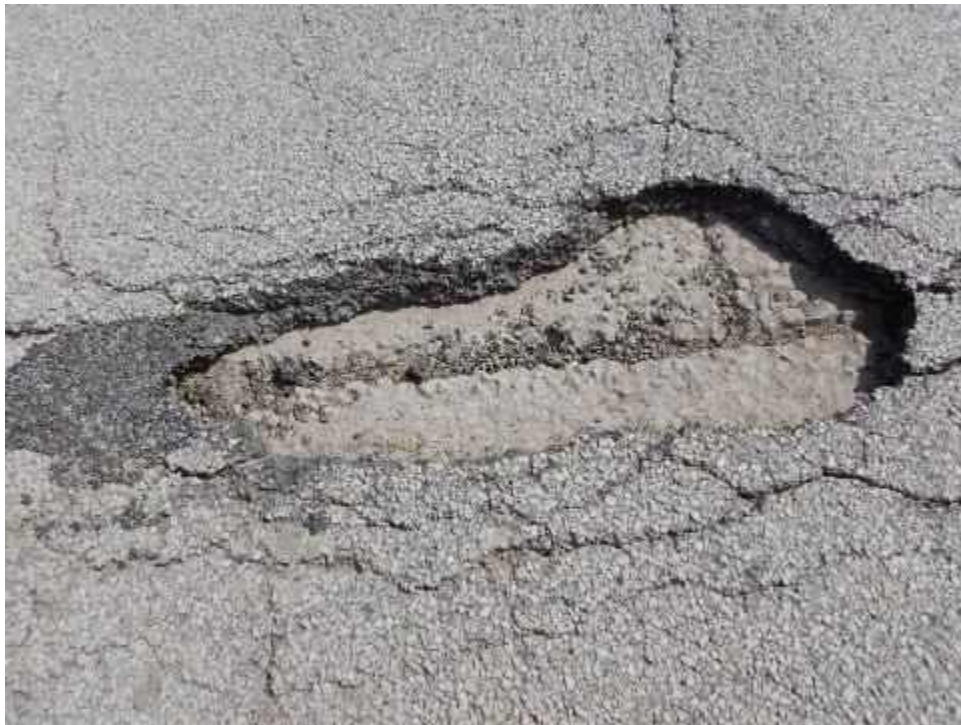
DORNRDR-US11AW-Pothole-(Sample Unit No. 01)

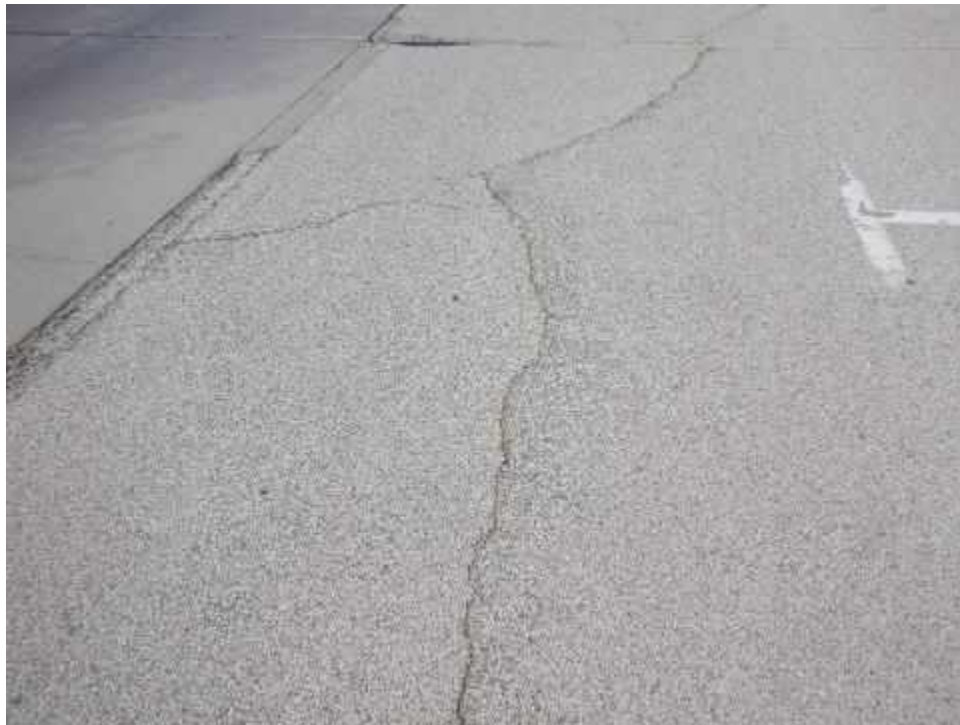
DORNRDR-US11BE-L&T Cracking-(Sample Unit No. 01)

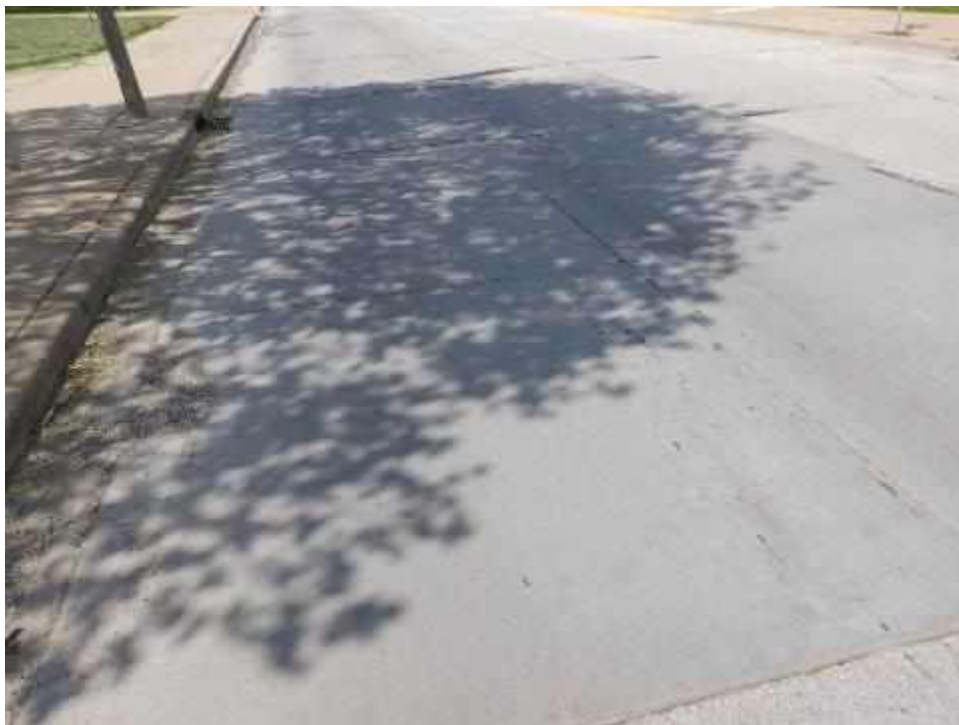
DORNRDR-US11BW-Patching-(Sample Unit No. 01)

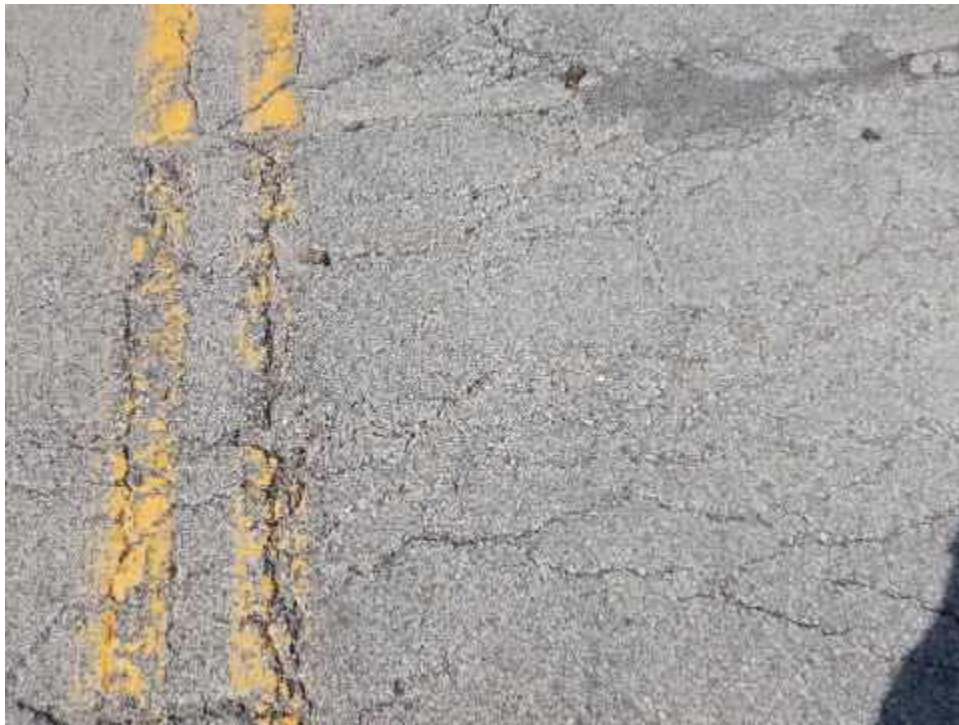
DORNRDR-US13E-Alligator Cracking-(Sample Unit No. 01)

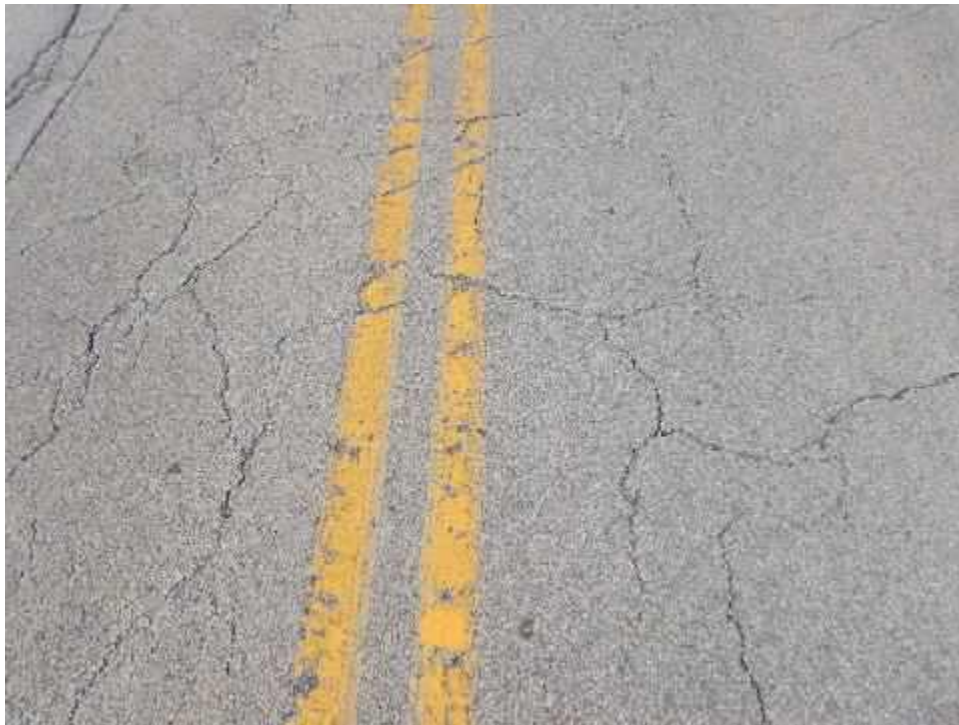
DORNRDR-US13E-Block Cracking-(Sample Unit No. 01)

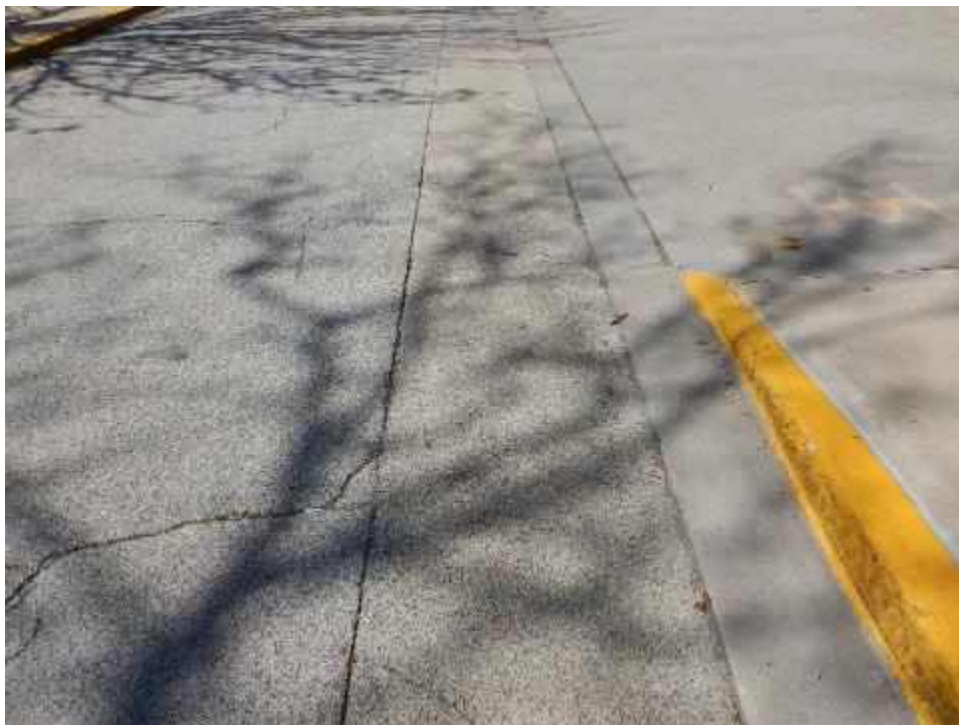
EUCLDS-S12-Patching-(Sample Unit No. 01)

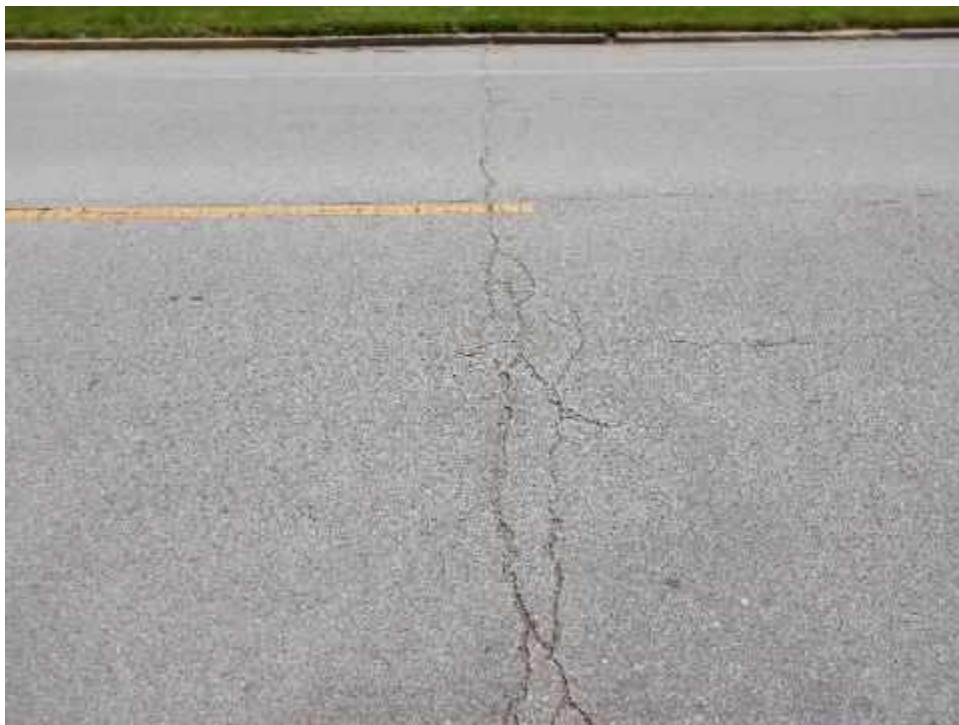
FIRSTS-S15-Joint Reflection Cracking-(Sample Unit No. 01)

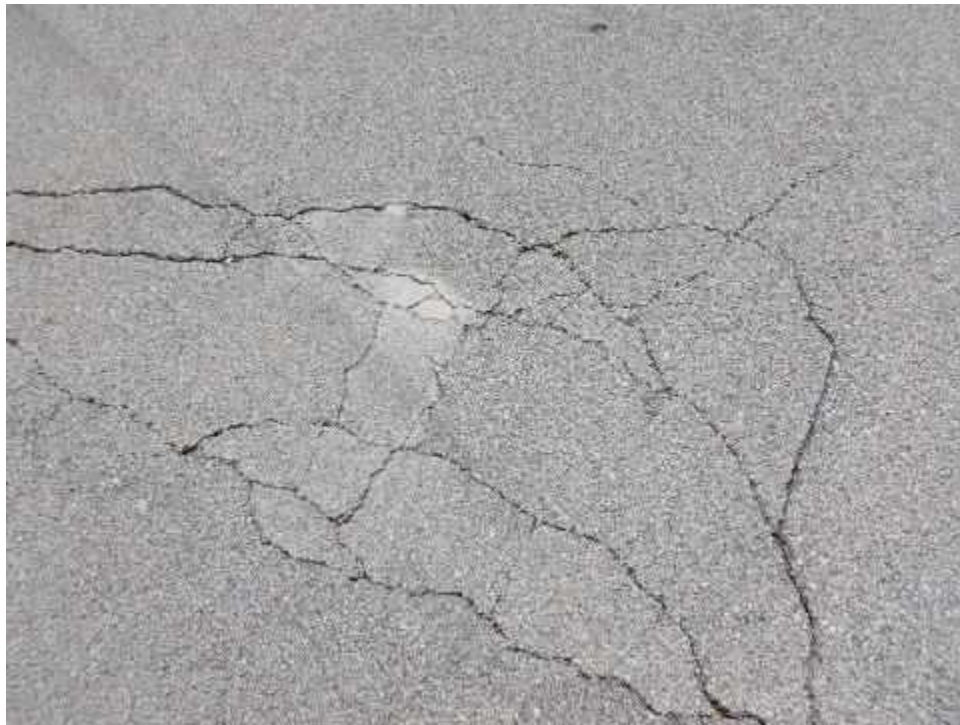
FIRSTS15-Alligator-Cracking-(Sample Unit No.01)

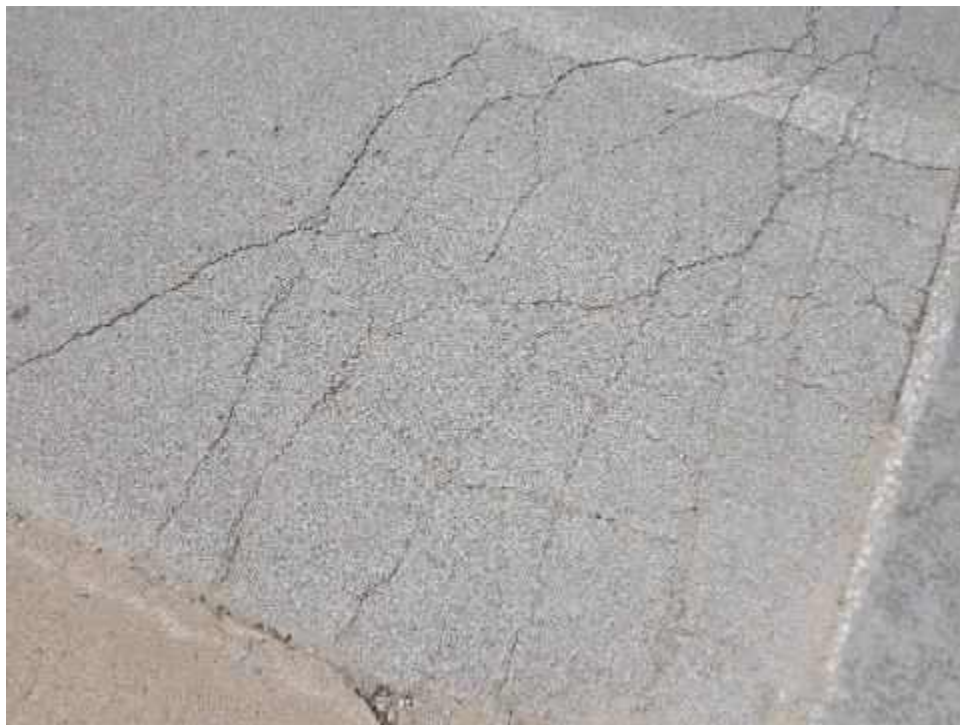
FOURTS-S11-Alligator Cracking-(Sample Unit No. 01)

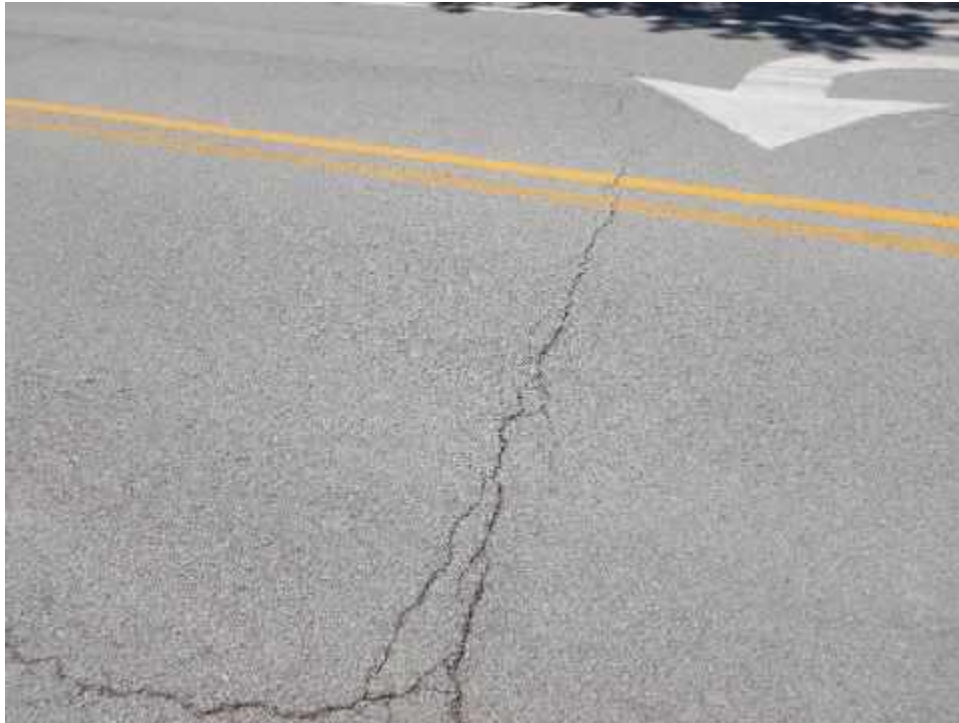
FOURTS-S11-Joint Reflection Cracking-(Sample Unit No. 01)

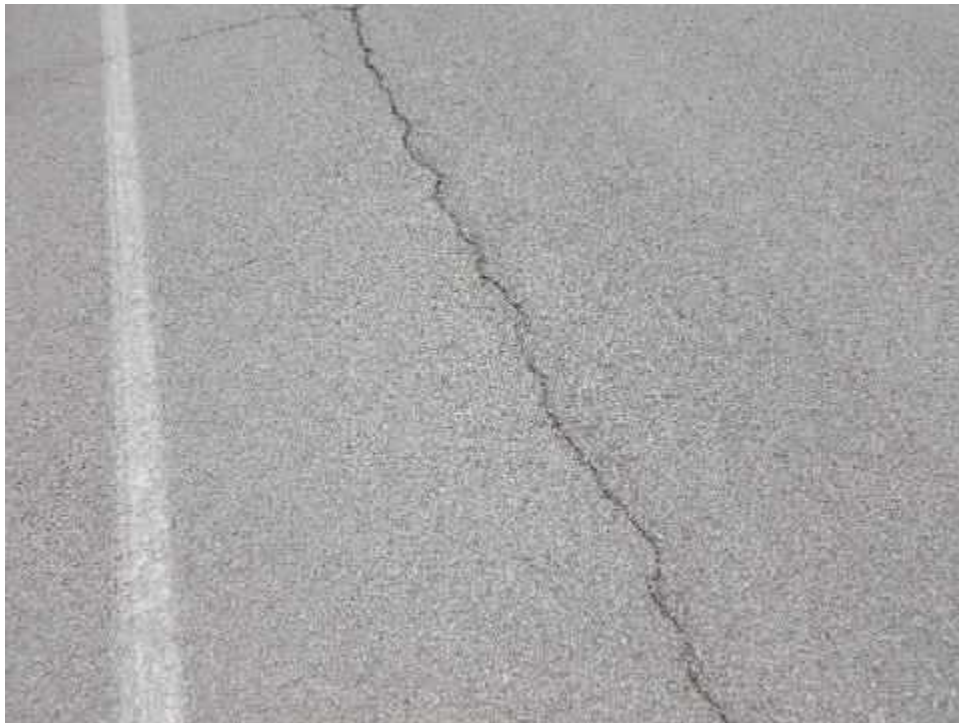
FOURTS-S11-L&T Cracking-(Sample Unit No. 01)
