# U20069: Pavement Analysis Study 2020 University of Illinois at Urbana-Champaign

## Final Report

Applied Pavement Technology, Inc.  
115 West Main Street, Suite 400  
Urbana, Illinois 61801  
(217) 398-3977  
[www.appliedpavement.com](http://www.appliedpavement.com)

**AUGUST 2020**

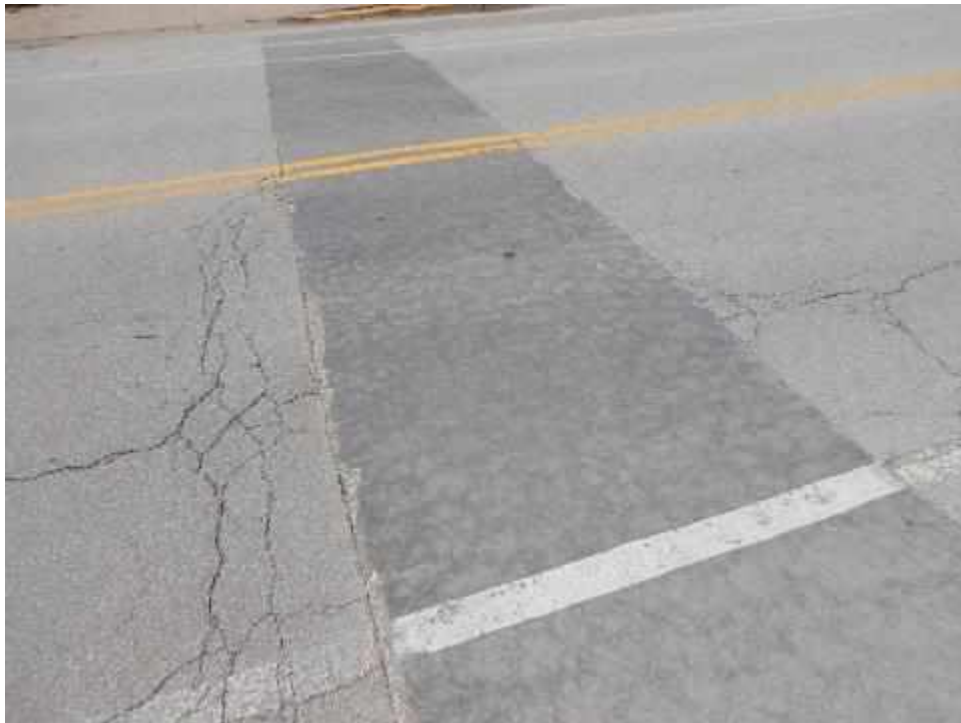
FOURTS-S11-Patching-(Sample Unit No. 02)

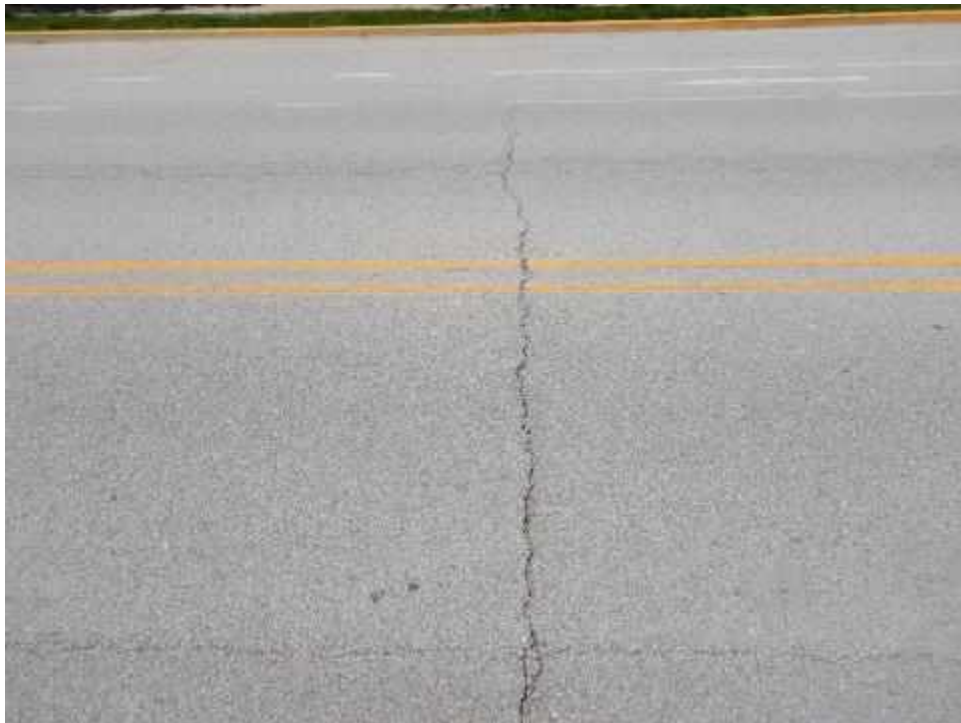
FOURTS-S12-Joint Reflection Cracking-(Sample Unit No. 01)

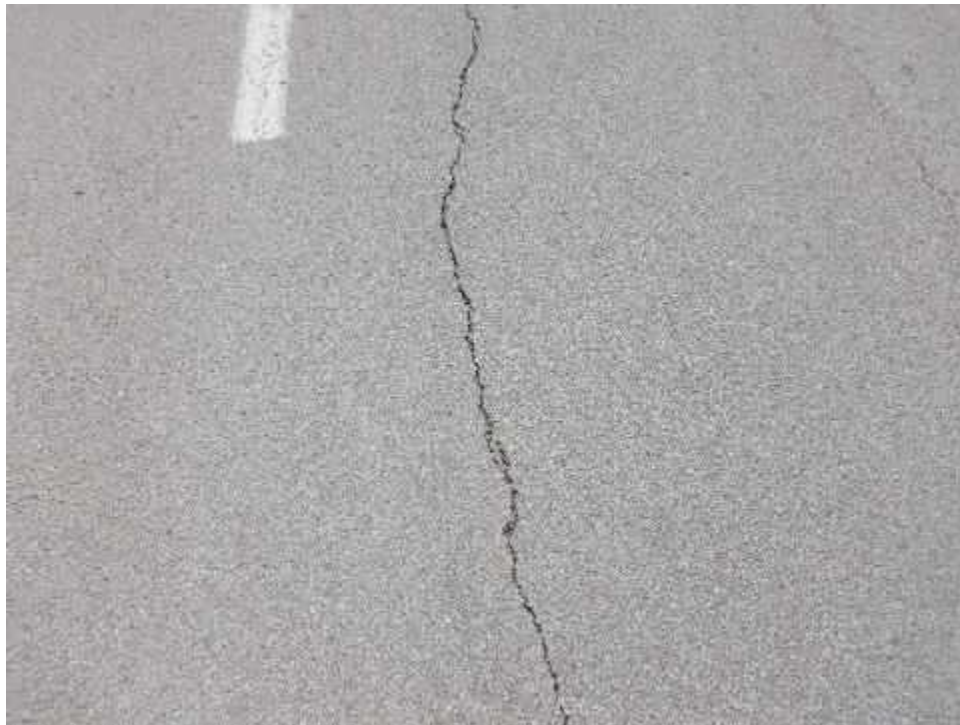
FOURTS-S12-L&T Cracking-(Sample Unit No. 01)

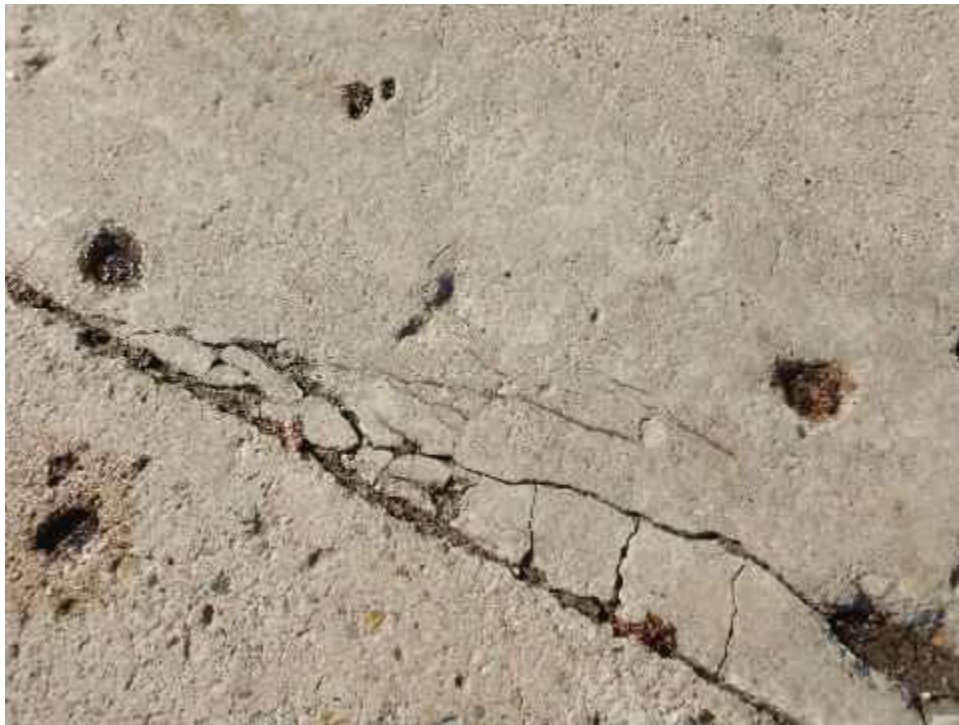
GERTYD-E00B-Durability Cracking-(Sample Unit No. 01)

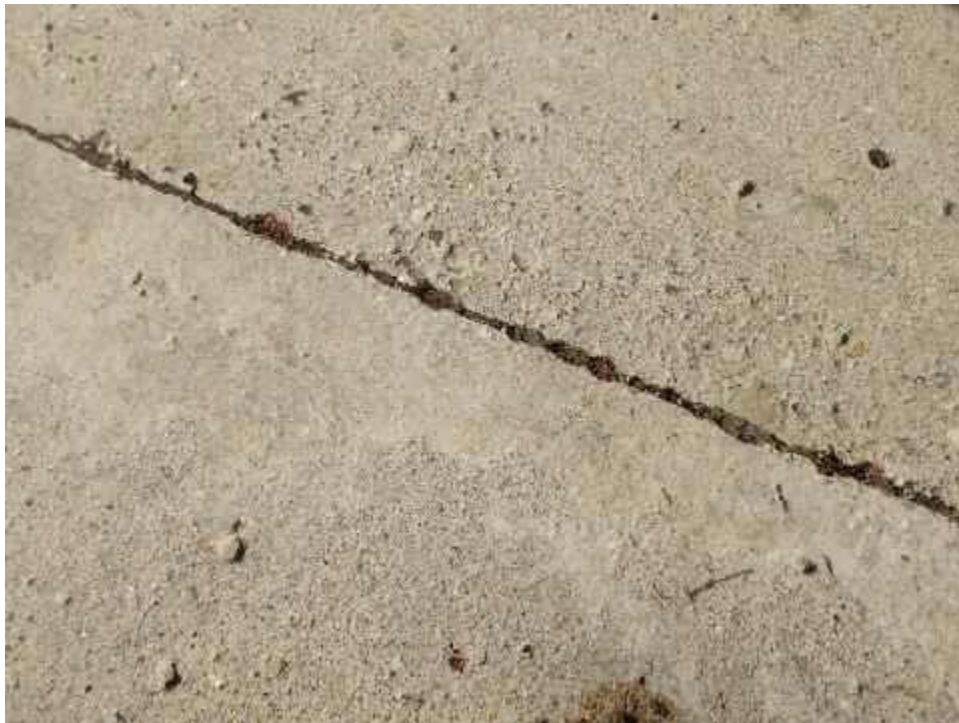
GERTYD-E00B-Joint Seal Damage

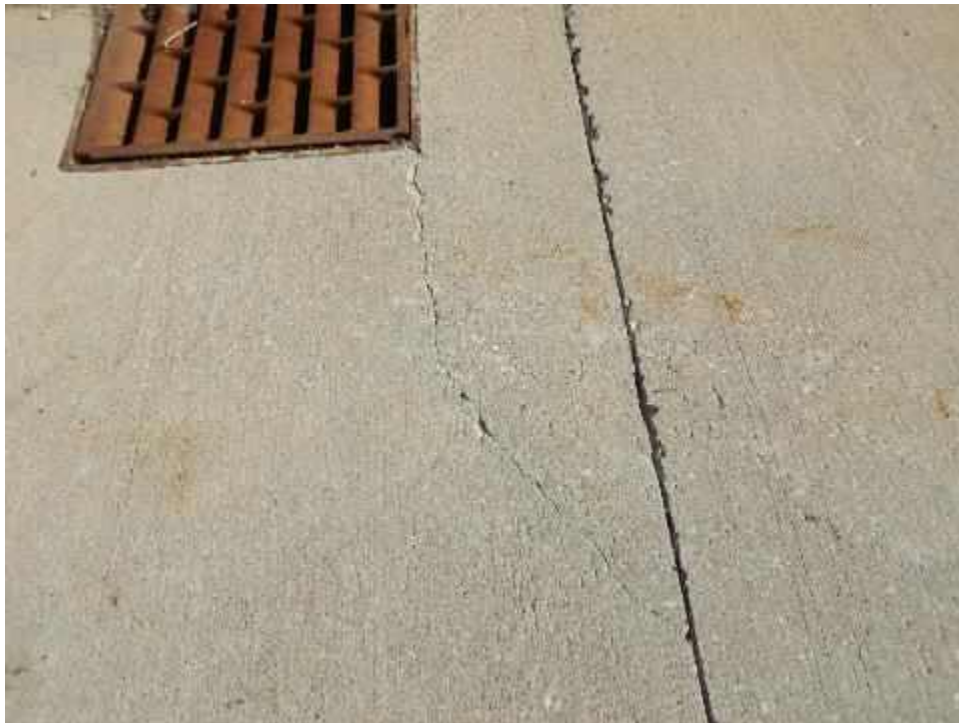
GERTYD-E00C-LTD Cracking-(Sample Unit No. 01)

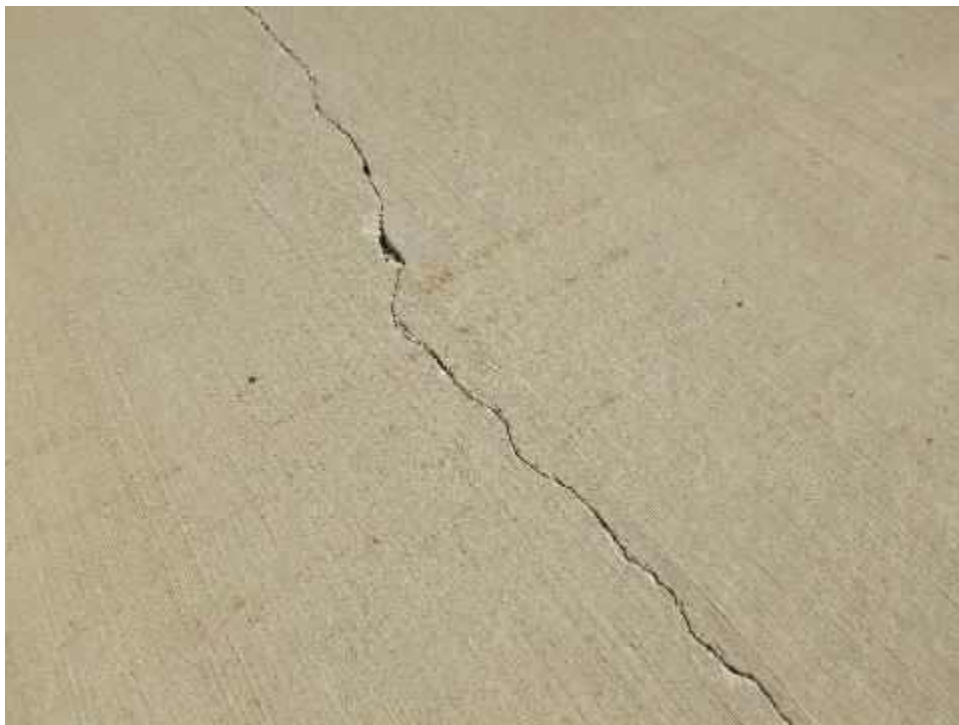
GERTYD-E00D-LTD Cracking-(Sample Unit No. 01)

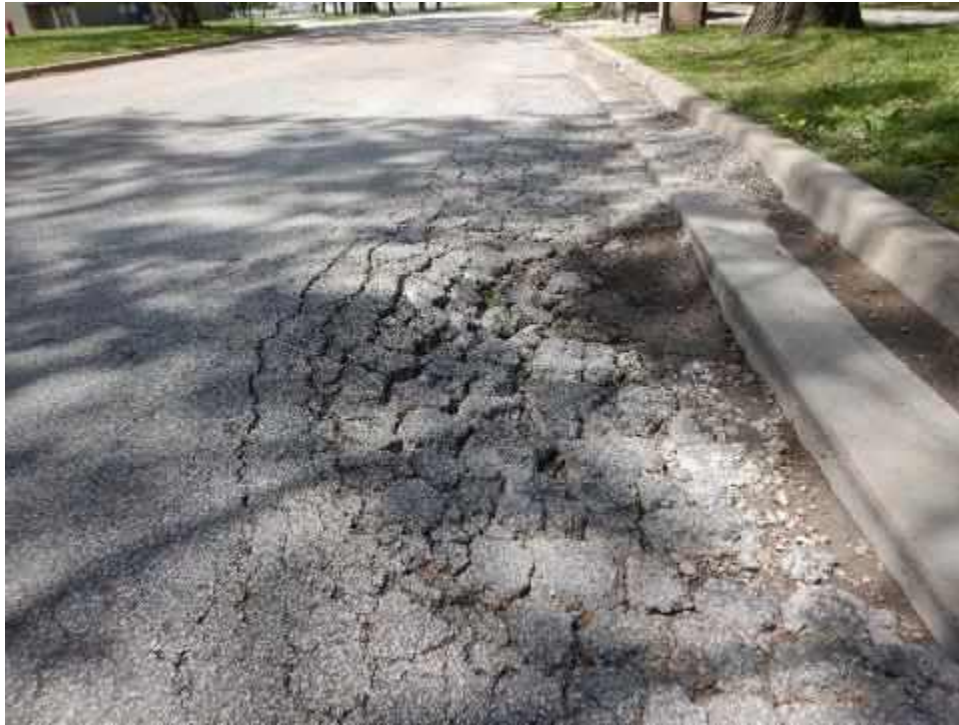
GHUFFDR-UW03-Alligator Cracking-(Sample Unit No. 01)

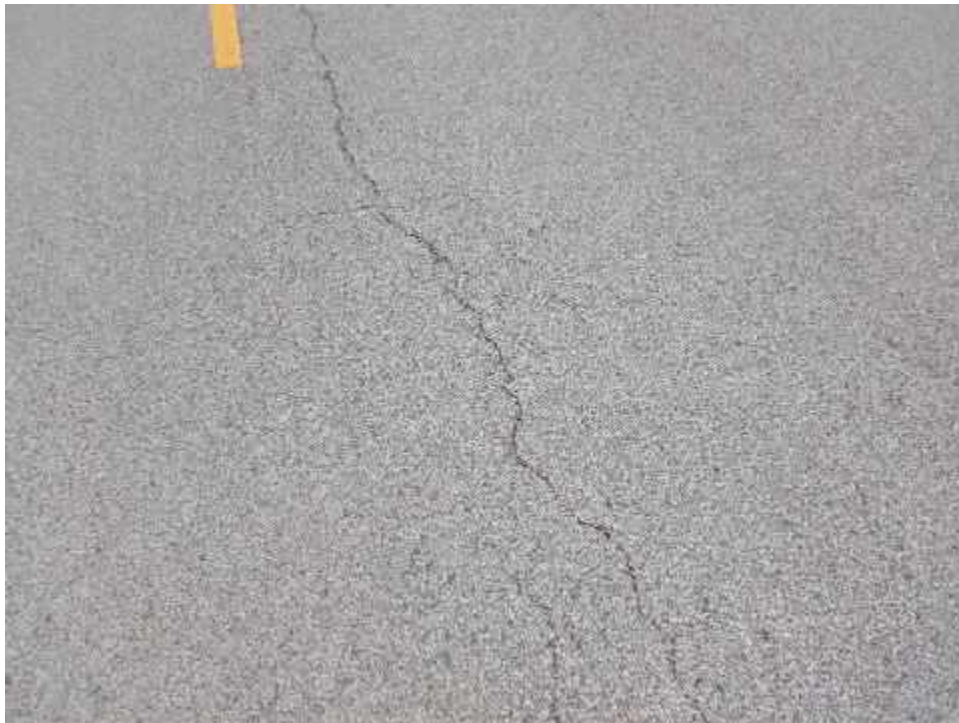
GHUFFDR-UW03-L&T Cracking-(Sample Unit No. 01)

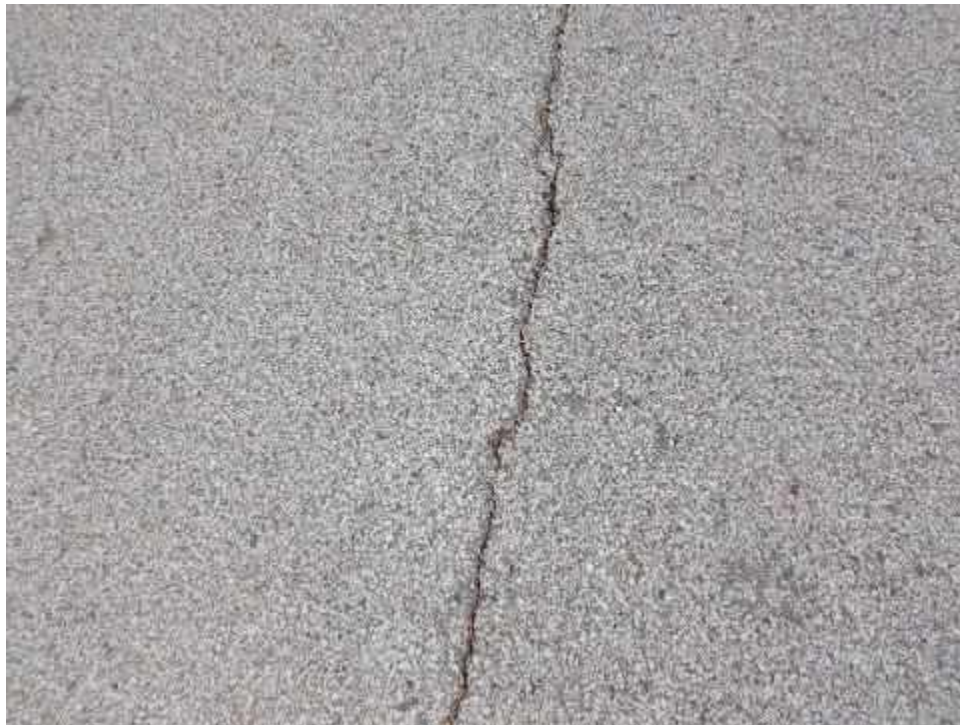
GHUFFDR-UW04AN-L&T Cracking-(Sample Unit No. 01)

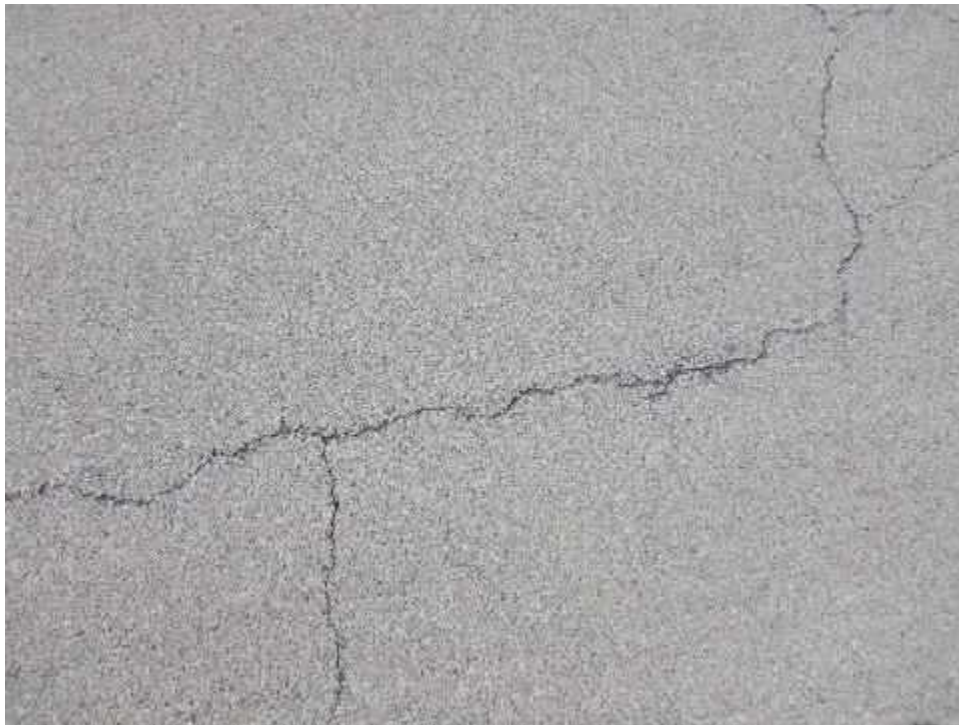
**GHUFFDR-UW04BN-L&T Cracking-(Sample Unit No. 01)**

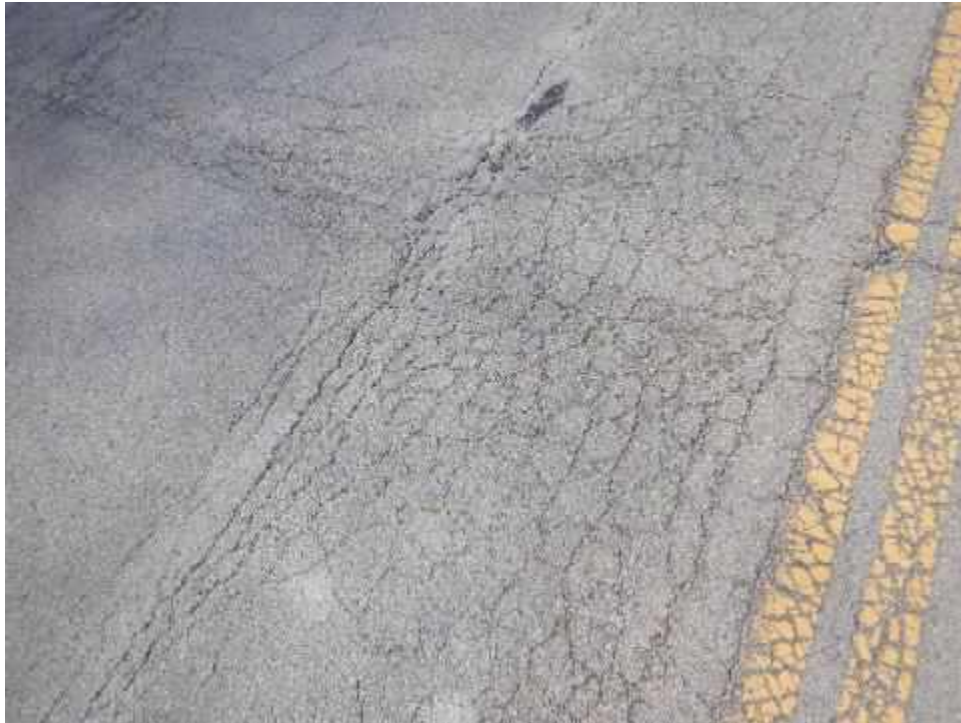
GOODWINA-US08-Alligator Cracking-(Sample Unit No. 01)

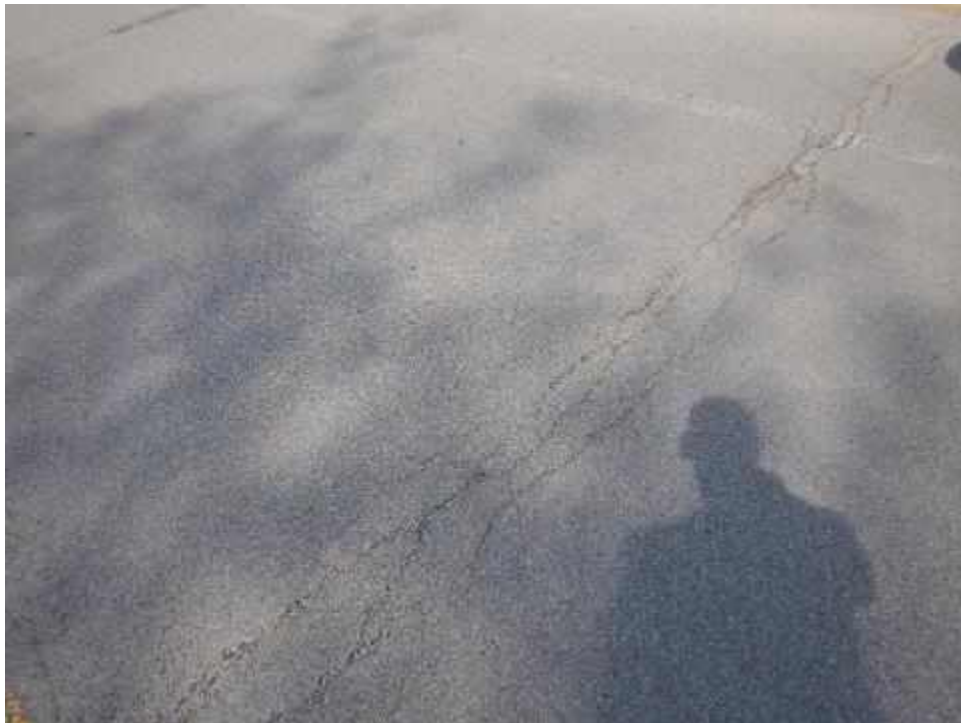
GOODWINA-US08-Joint Reflection Cracking-(Sample Unit No. 01)

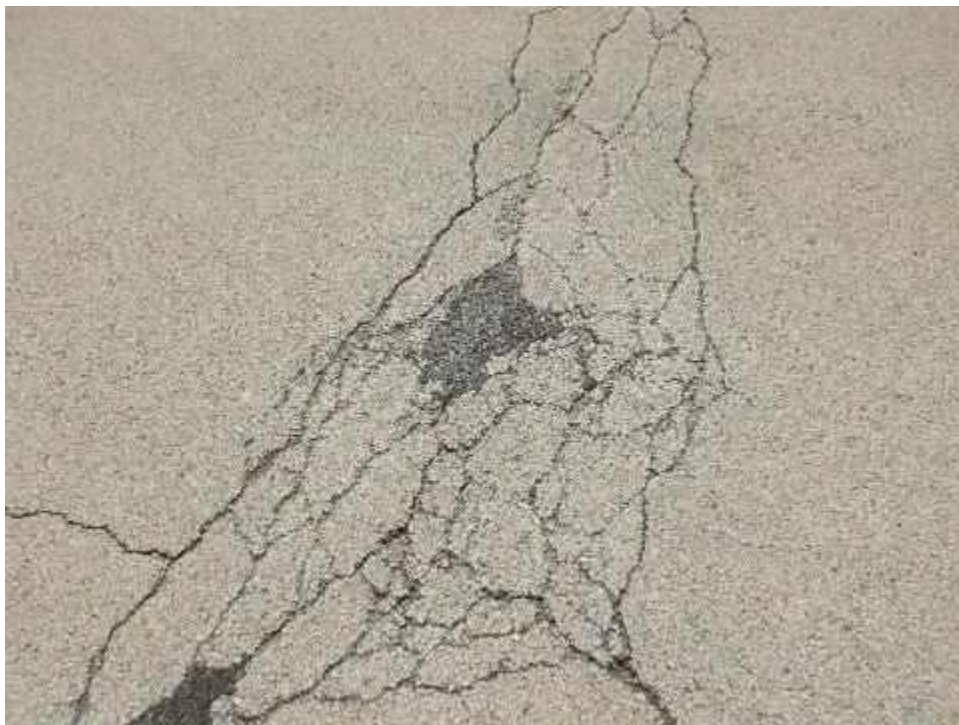
GOODWINA-US12-Alligator Cracking-(Sample Unit No. 01)

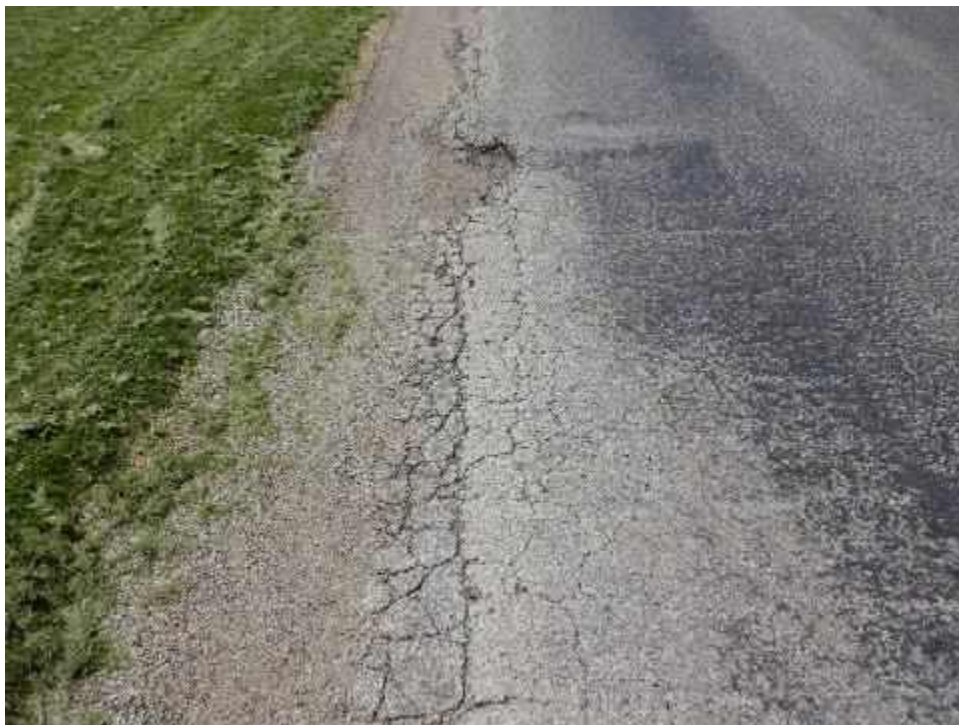
GOODWINA-US17-Edge Cracking-(Sample Unit No. 01)

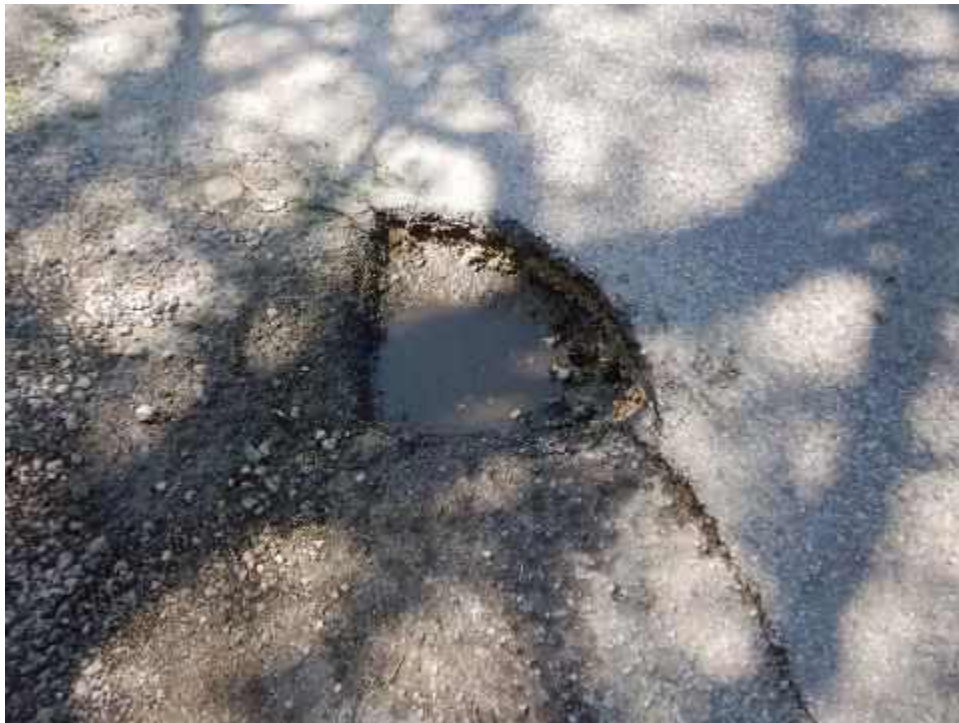
GOODWINA-US17-Pothole-(Sample Unit No. 01)

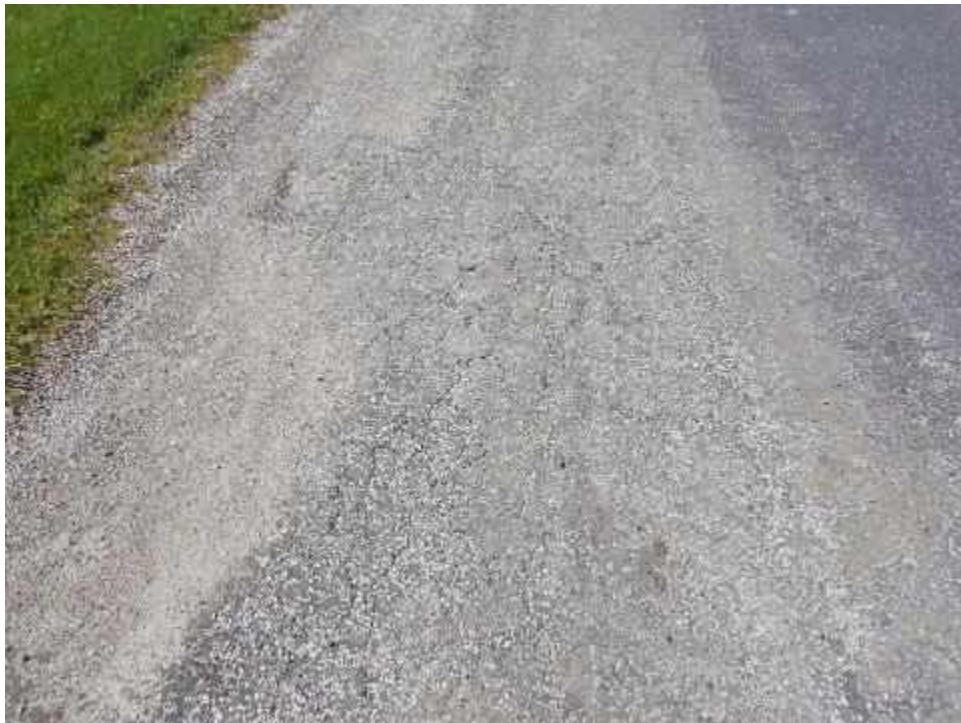
GOODWINA-US19-Alligator Cracking-(Sample Unit No. 01)

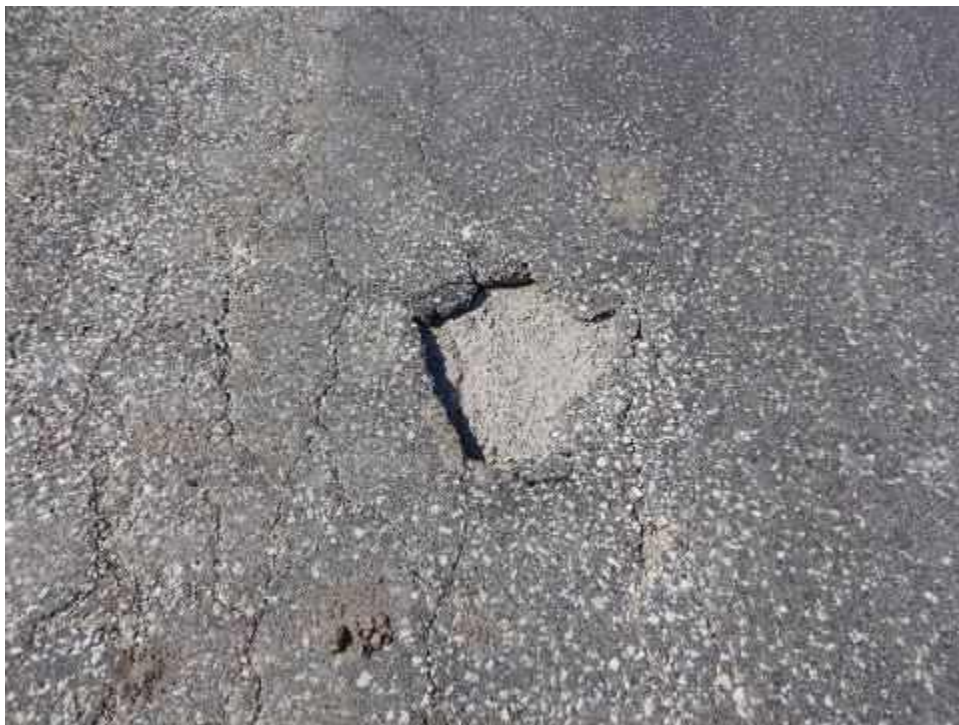
GOODWINA-US19-Pothole-(Sample Unit No. 01)

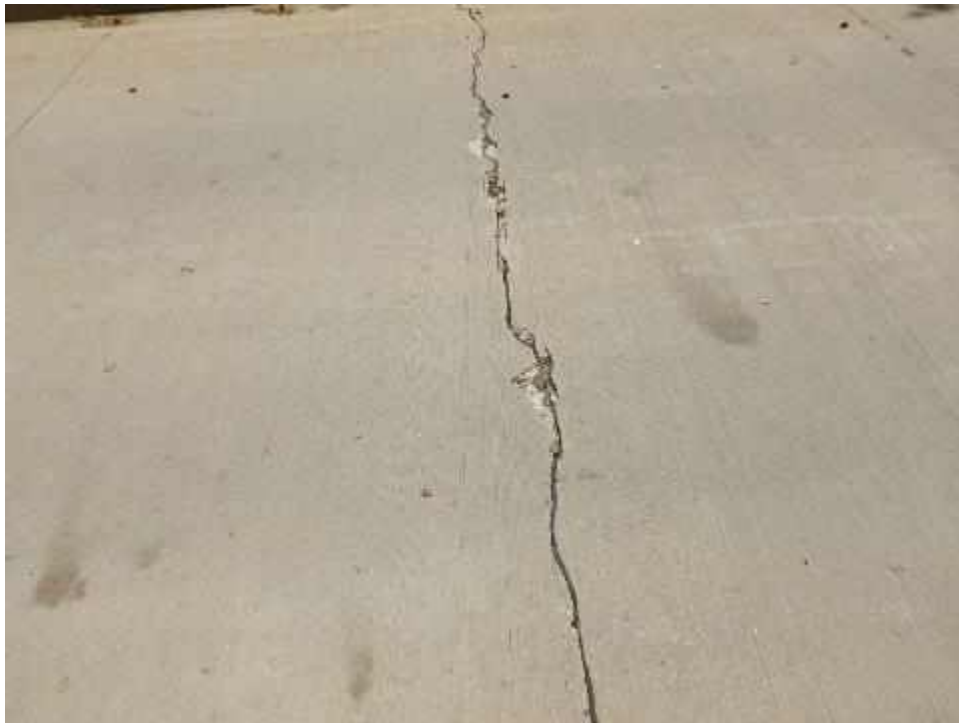
GREGYD-E00-LTD Cracking-(Sample Unit No. 01)

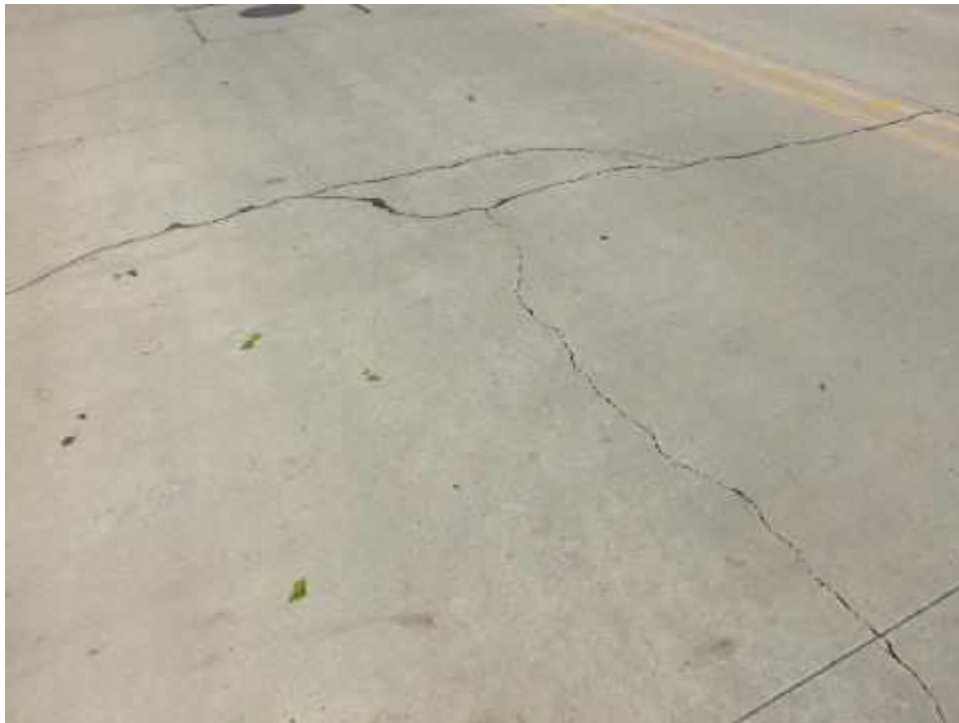
GREGYD-E00-Shattered Slab-(Sample Unit No. 01)

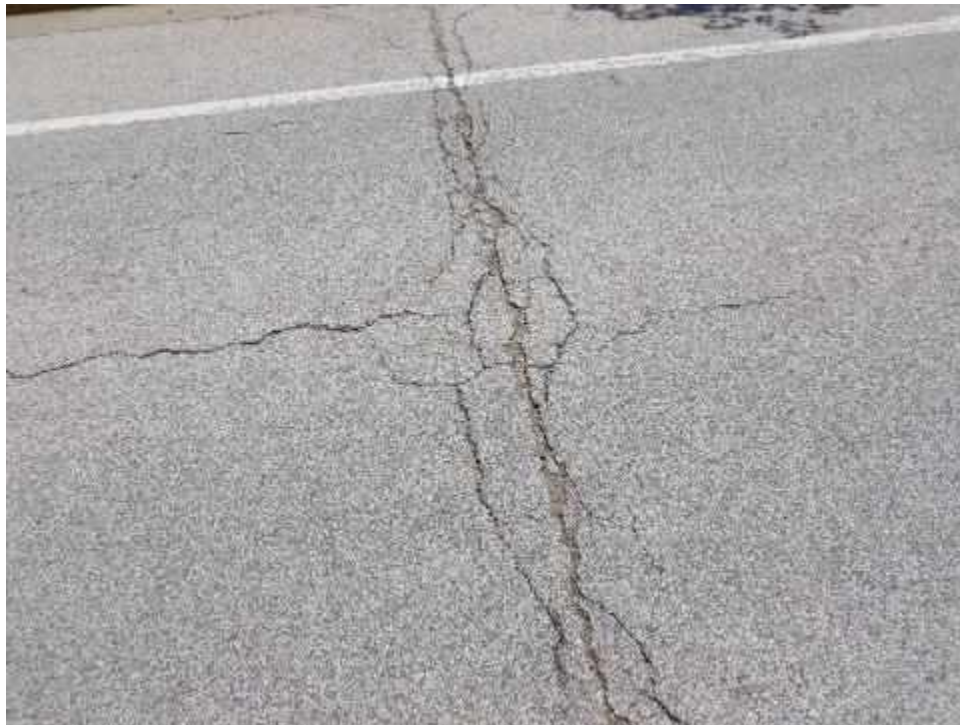
GREGYD-E01AS-Joint Reflection Cracking-(Sample Unit No. 01)

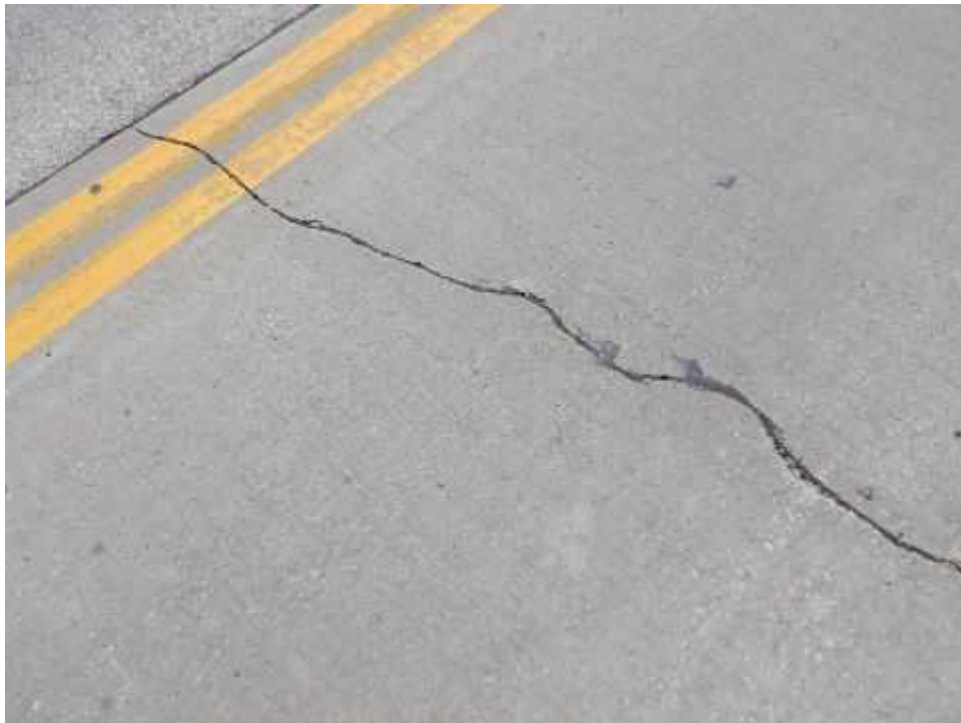
GREGYD-E01BN-LTD Cracking-(Sample Unit No. 01)

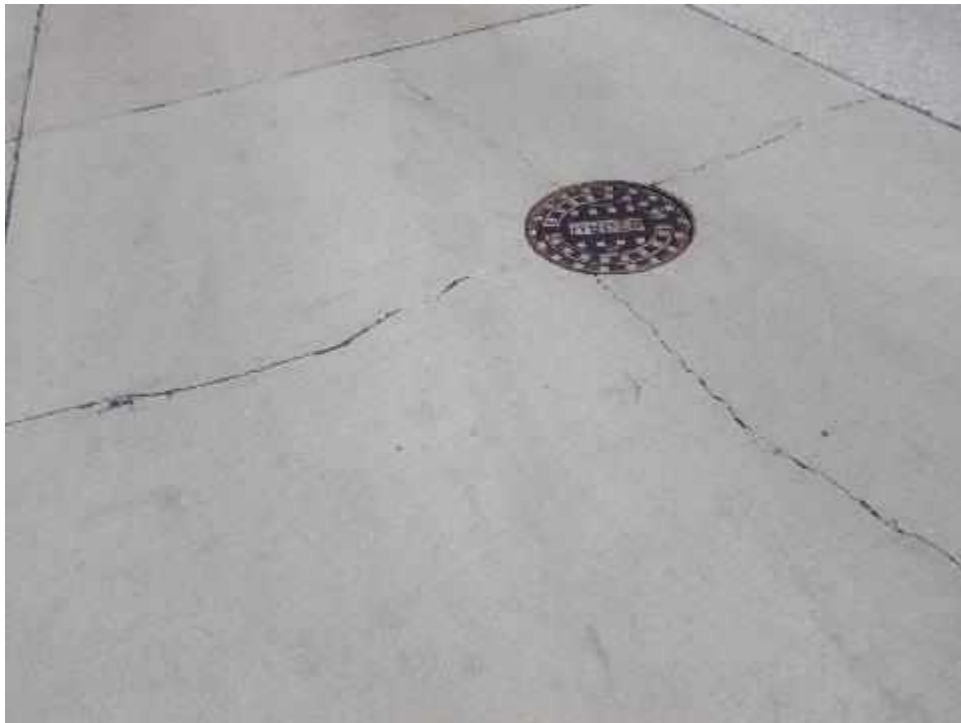
GREGYD-E02A-LTD Cracking-(Sample Unit No. 01) (2)

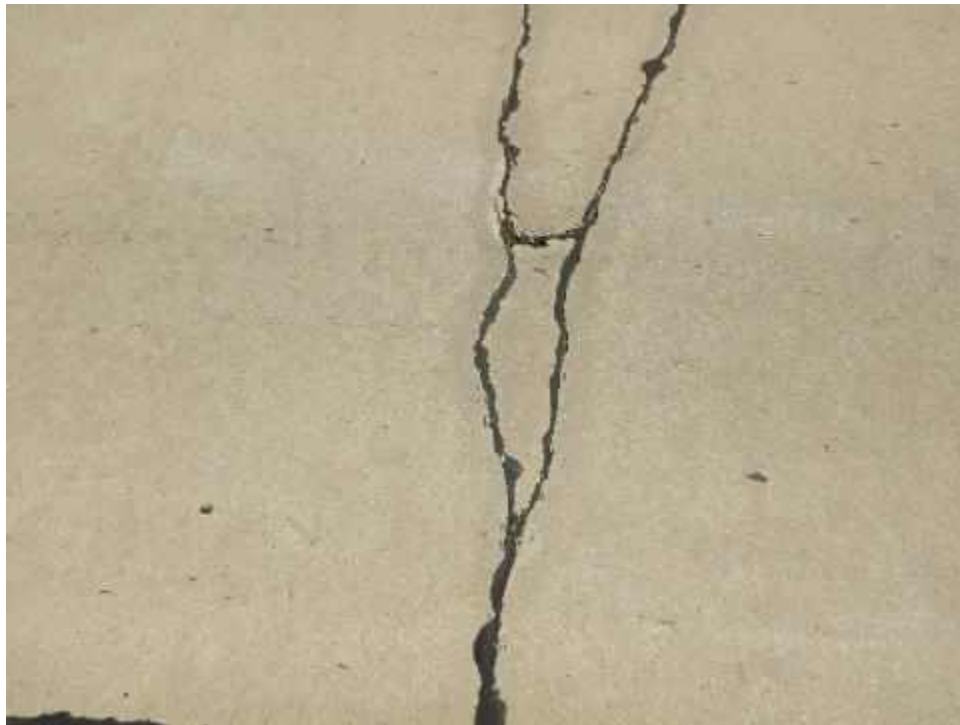
GREGYD-E02A-Shattered Slab-(Sample Unit No. 01)

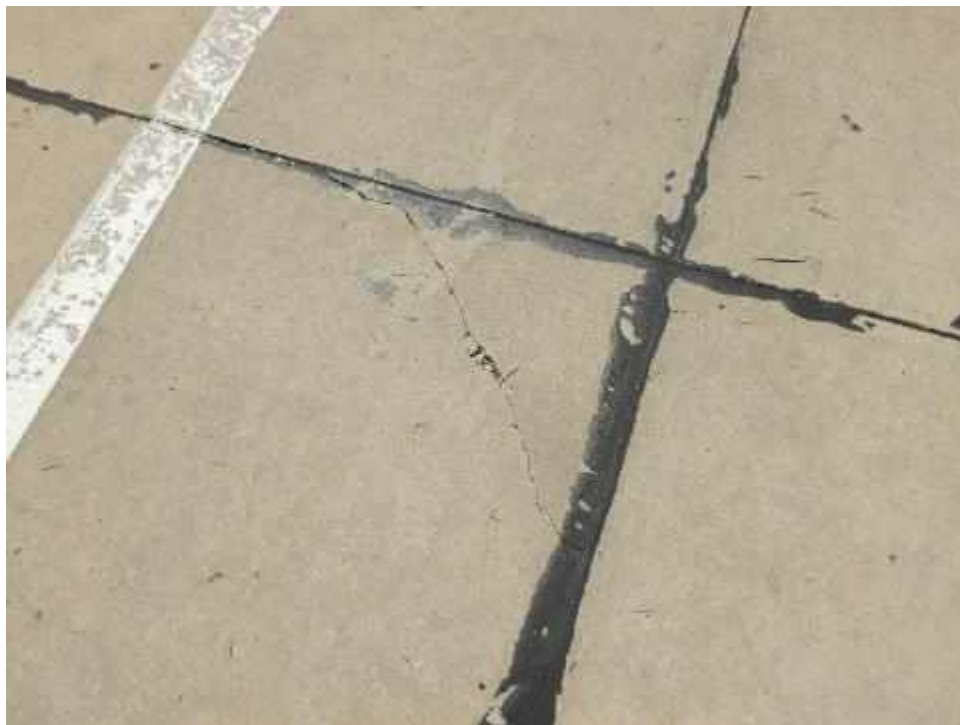
GREGYD-E02B-Corner Spalling-(Sample Unit No. 01)

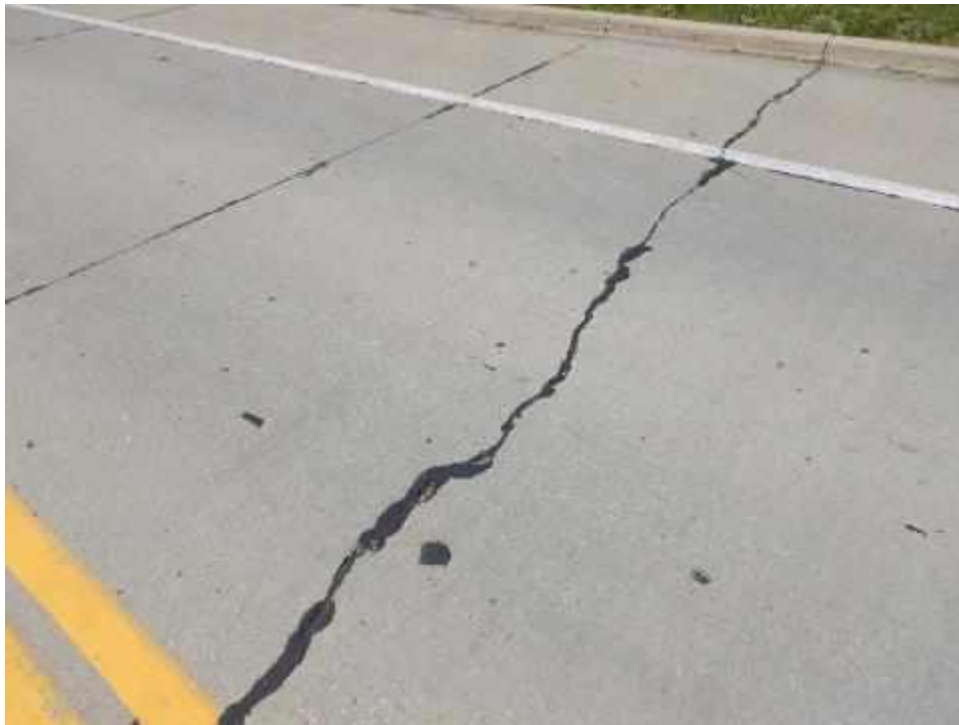
GREGYD-E02B-LTD Cracking-(Sample Unit No. 01)

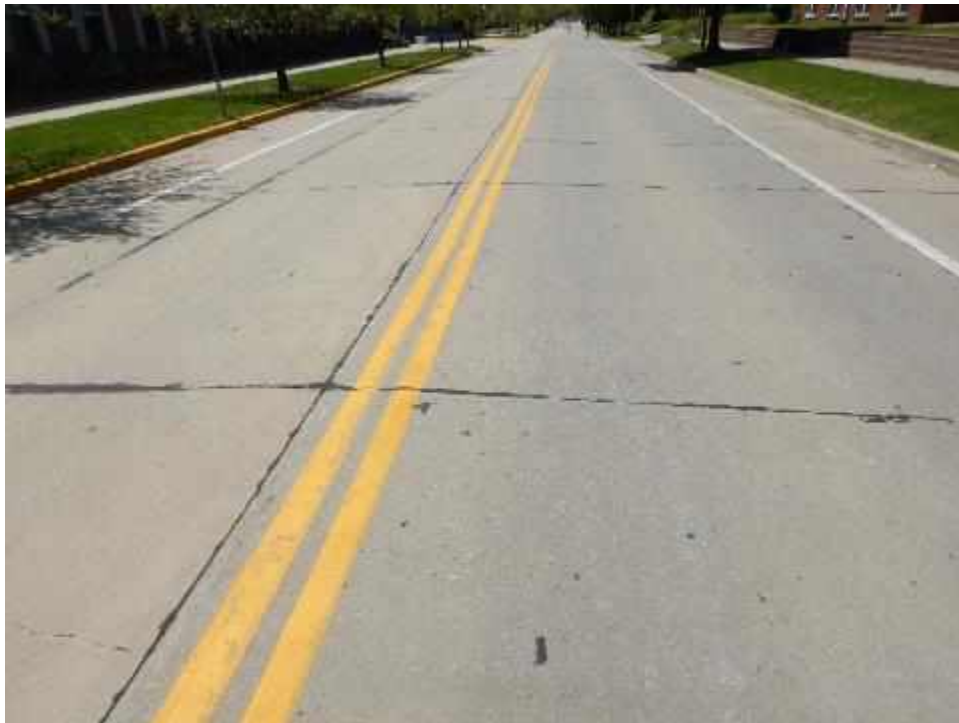
GREGYD-E03A-LTD Cracking-(Sample Unit No. 01)

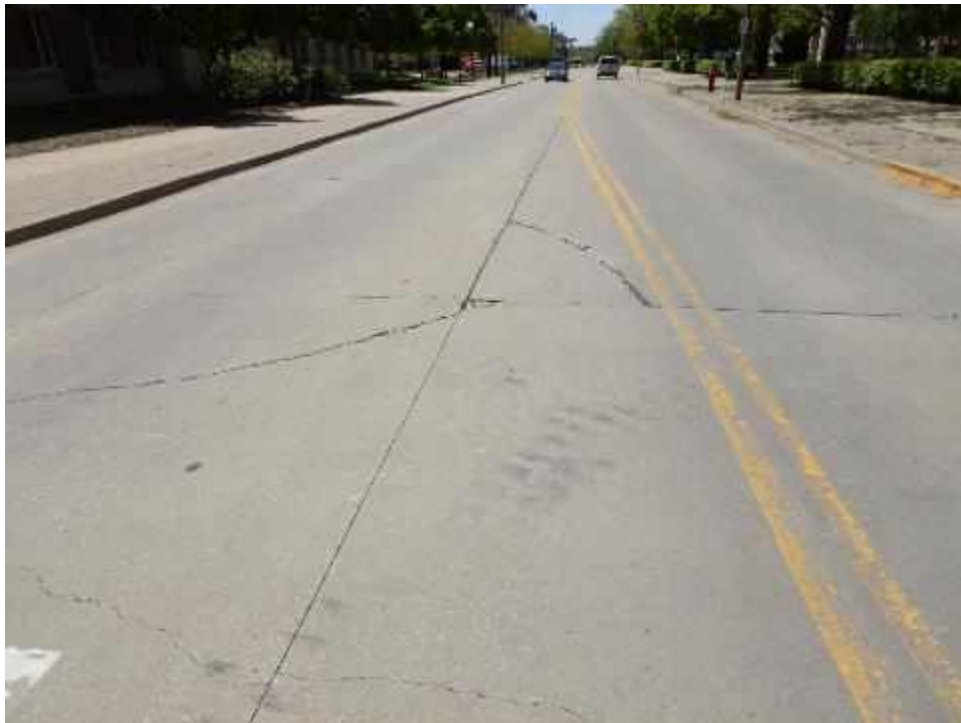
GREGYD-E04-LTD Cracking-(Sample Unit No. 01)

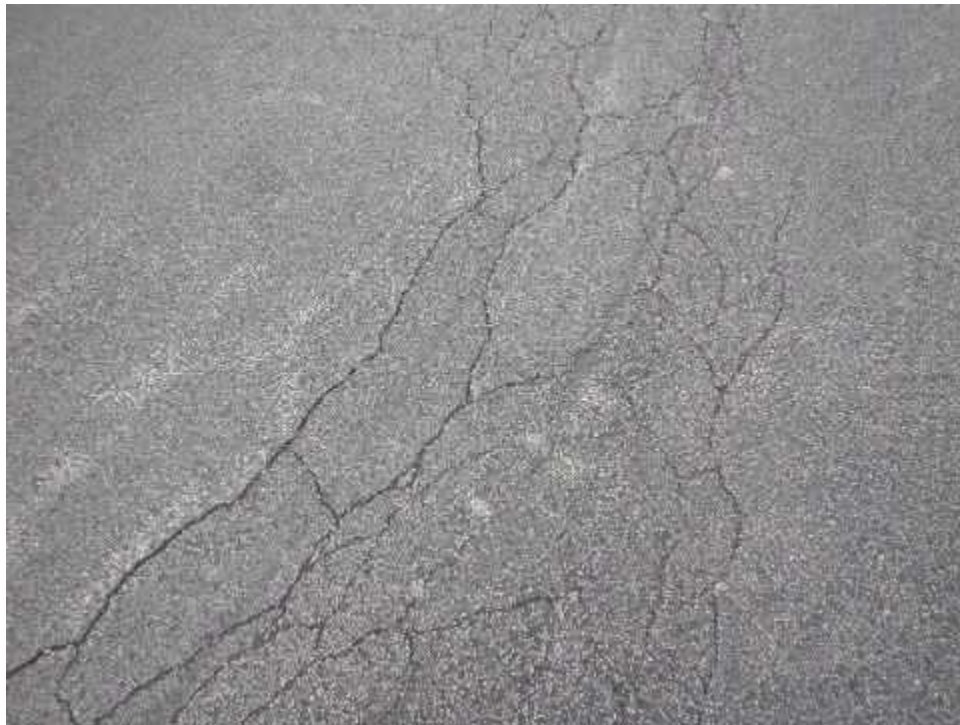
GREGYD-UW10-Alligator Cracking-(Sample Unit No. 01)

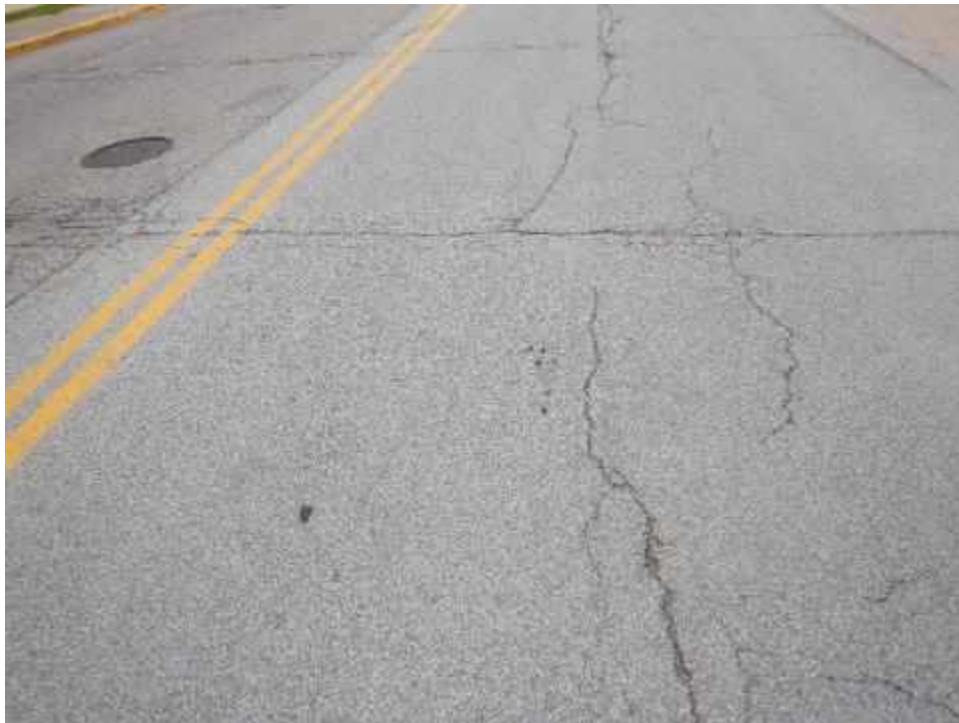
GREGYD-UW12A-Joint Reflection Cracking-(Sample Unit No. 01)

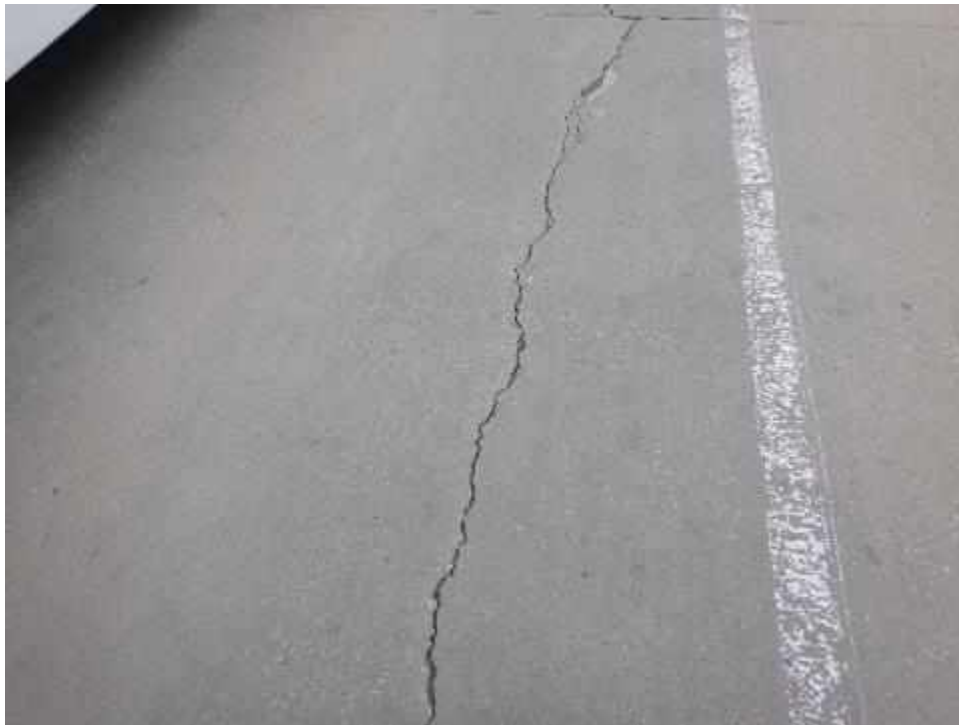
GREGYD-UW12B-Corner Spalling-(Sample Unit No. 01)

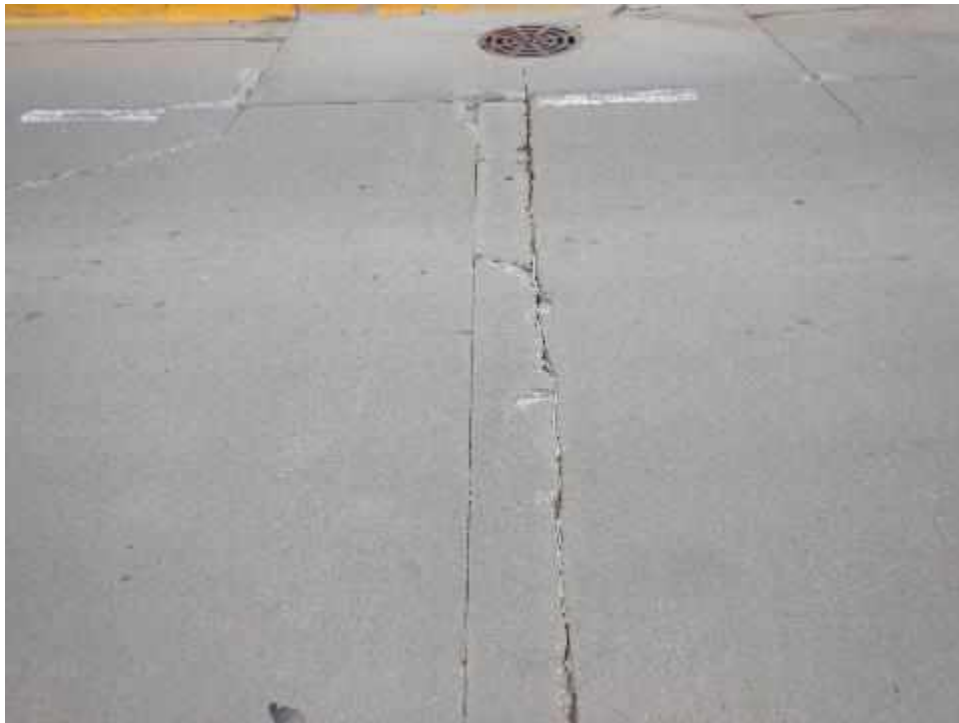
GREGYD-UW12B-LTD Cracking-(Sample Unit No. 01)
