# U20069: Pavement Analysis Study 2020 University of Illinois at Urbana-Champaign

## Final Report

Applied Pavement Technology, Inc.  
115 West Main Street, Suite 400  
Urbana, Illinois 61801  
(217) 398-3977  
[www.appliedpavement.com](http://www.appliedpavement.com)

**AUGUST 2020**

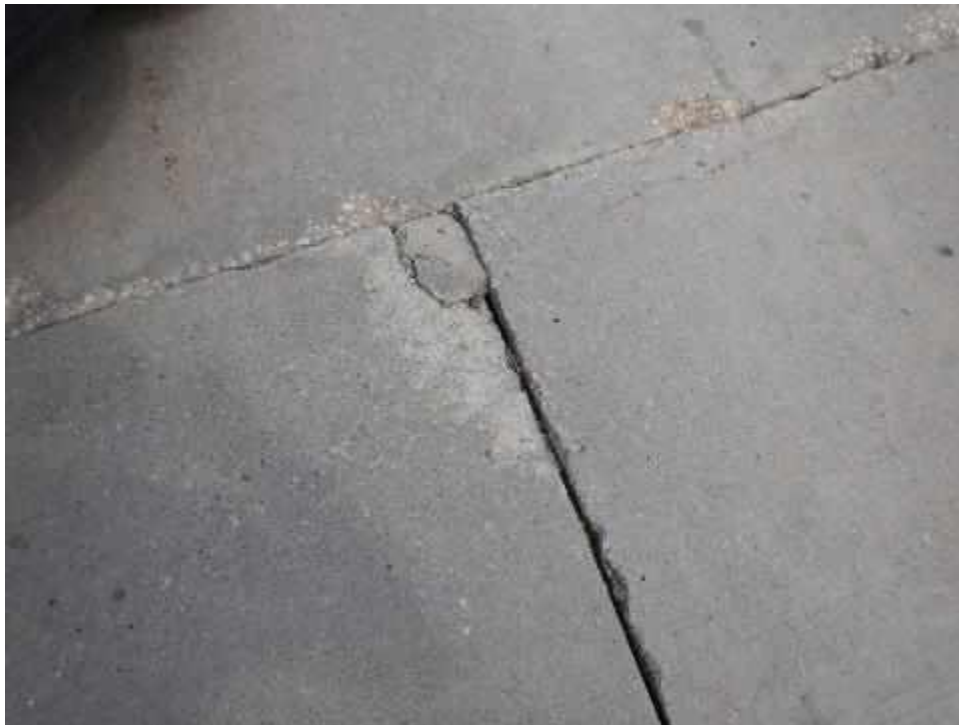
GREGYD-UW12B-Shattered Slab-(Sample Unit No. 01)

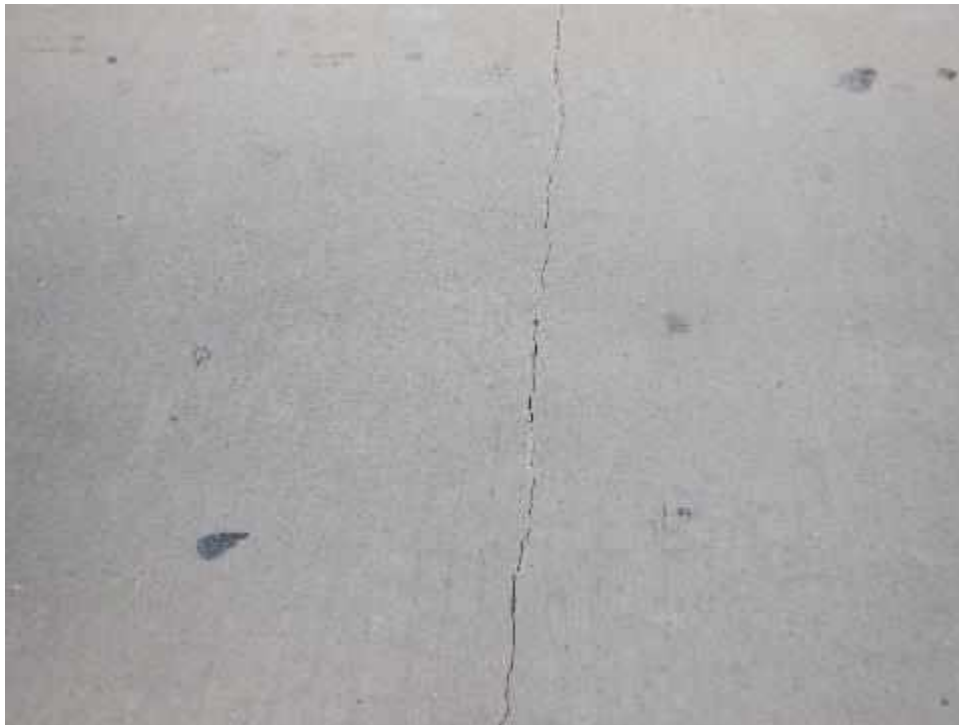
GREGYD-UW12C-Faulting-(Sample Unit No. 01)

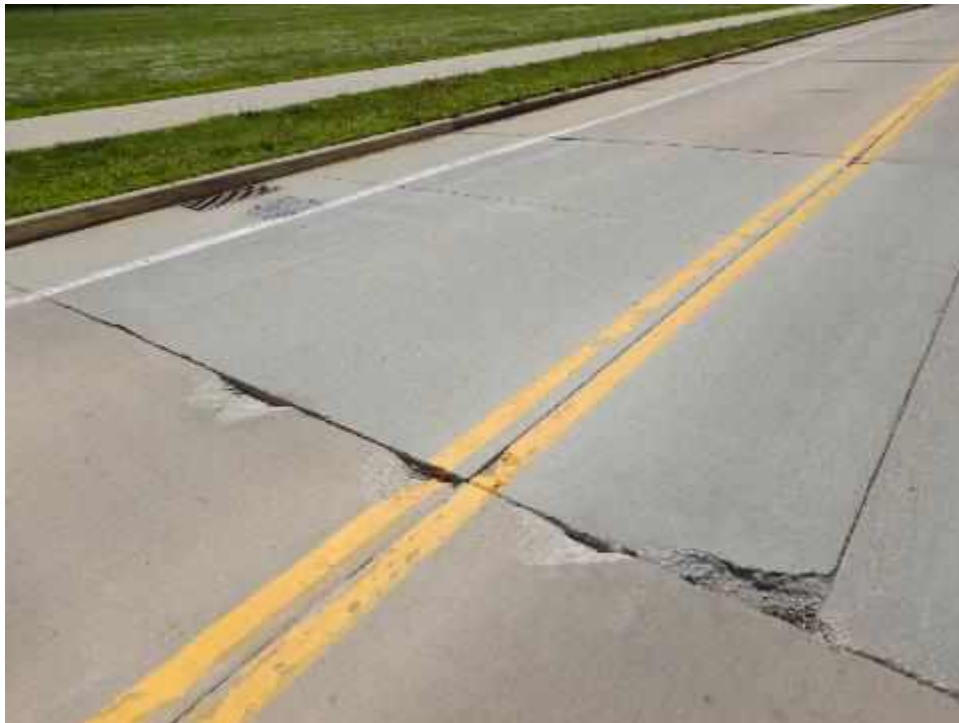
GREGYD-UW12C-LTD Cracking-(Sample Unit No. 01)

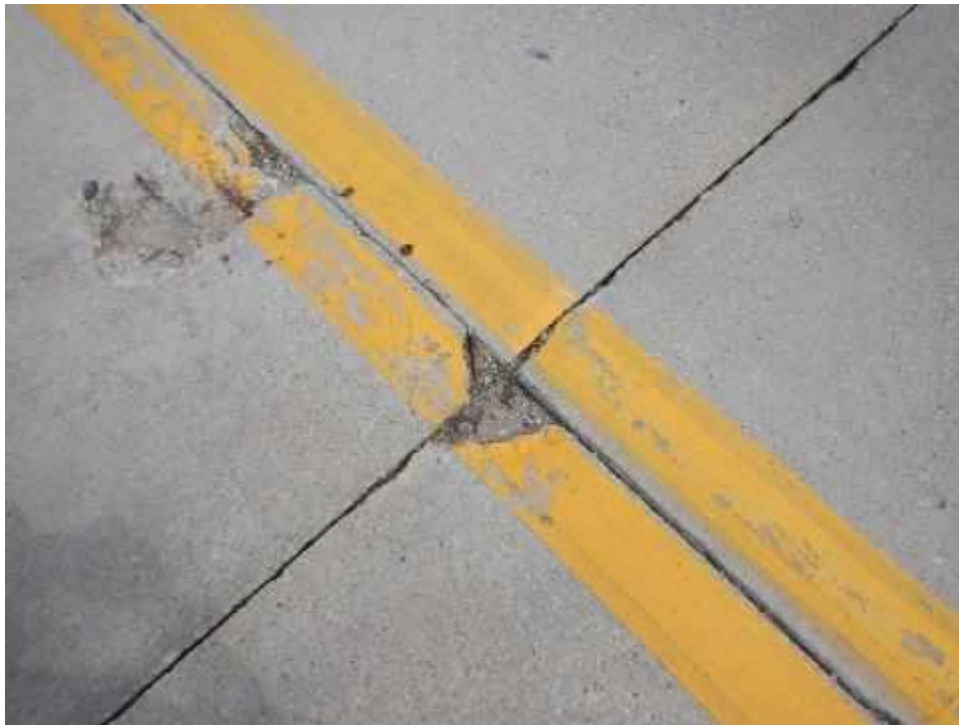
GREGYD-UW12D-Corner Break-(Sample Unit No. 01)

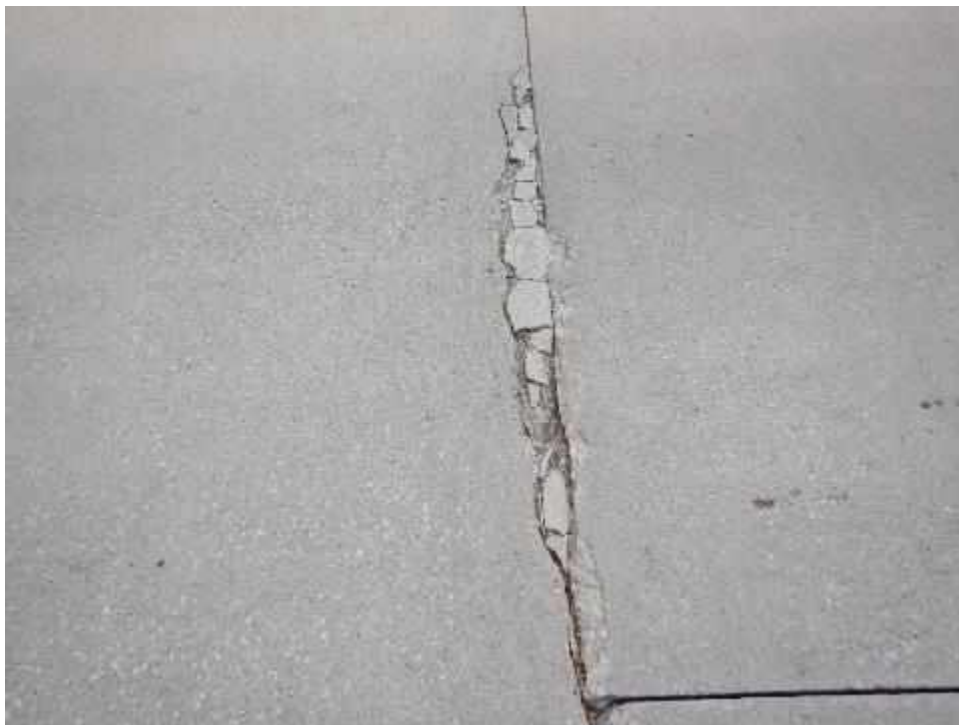
GREGYD-UW12D-Corner Spalling-(Sample Unit No. 01)

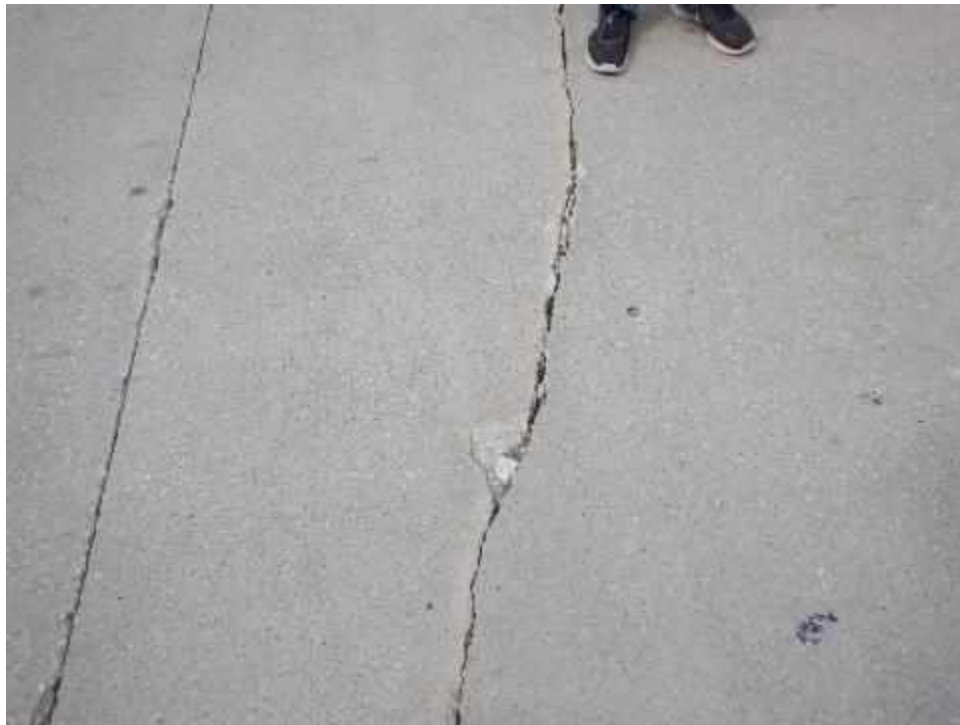
GREGYD-UW12D-Joint Spalling-(Sample Unit No. 01)

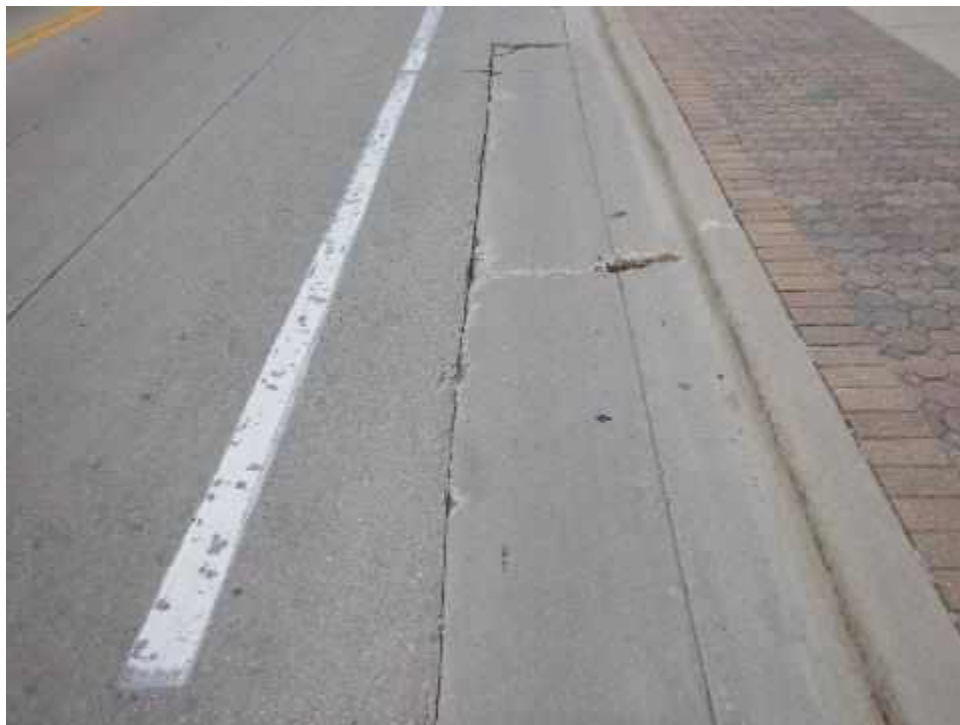
GREGYD-UW12D-LTD Cracking-(Sample Unit No. 01)

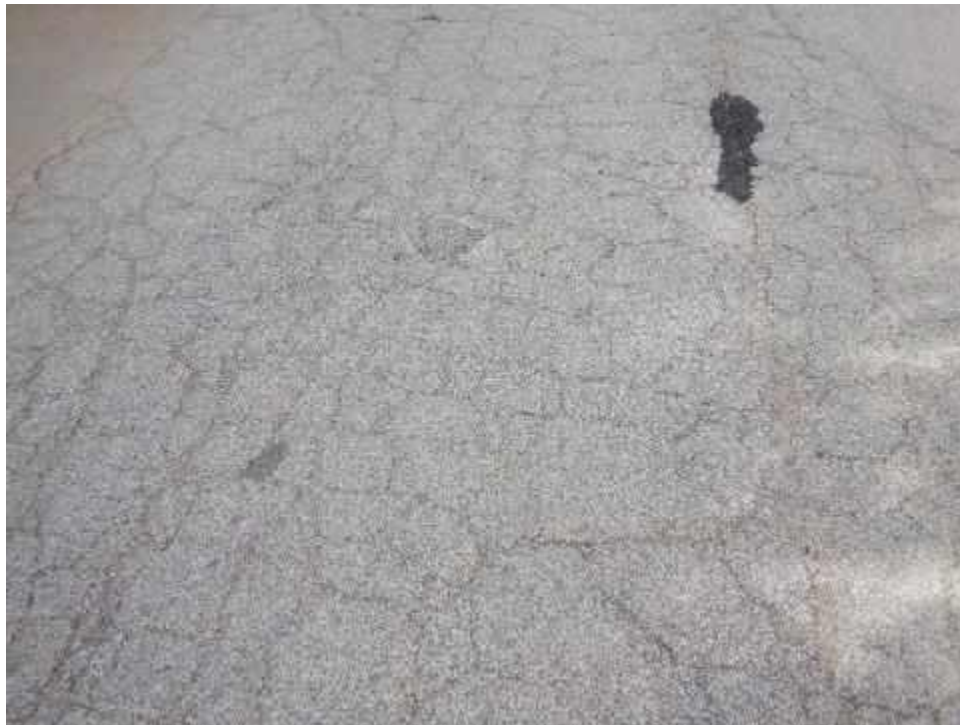
GREGYD-UW12D-Scaling-(Sample Unit No. 02)

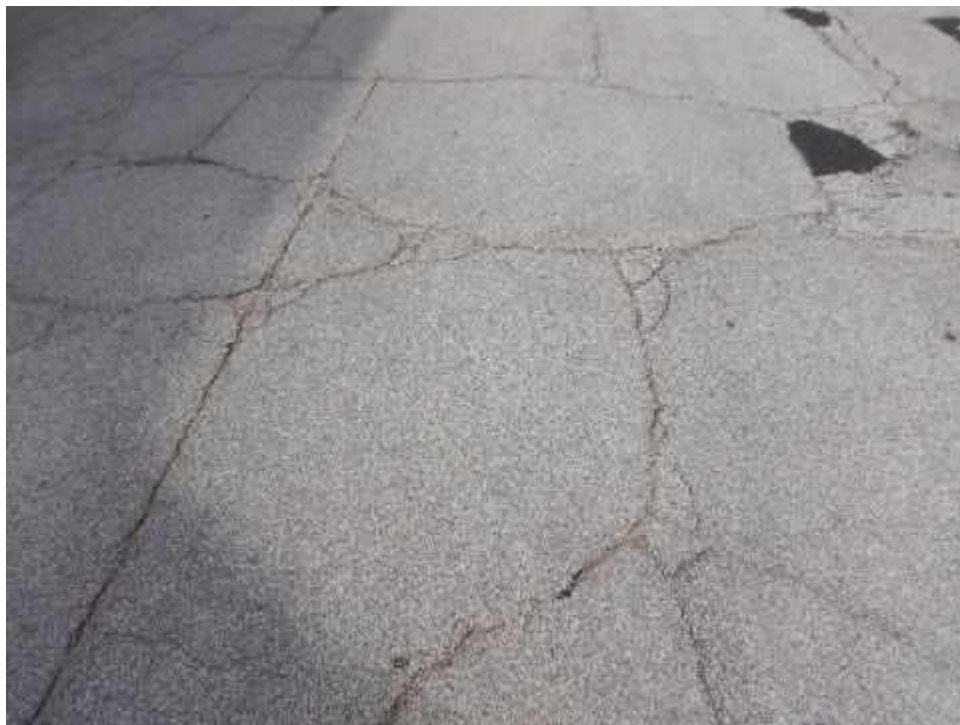
GRGRYST-US05-Alligator Cracking-(Sample Unit No. 01)

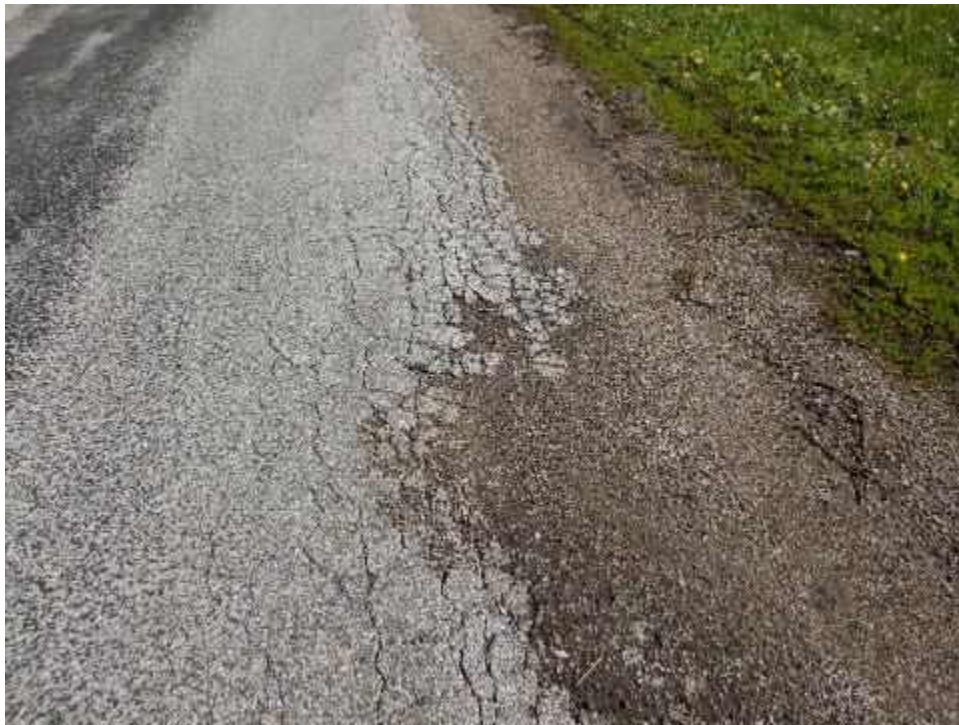
GRGRYST-US05-Patching-(Sample Unit No. 01)

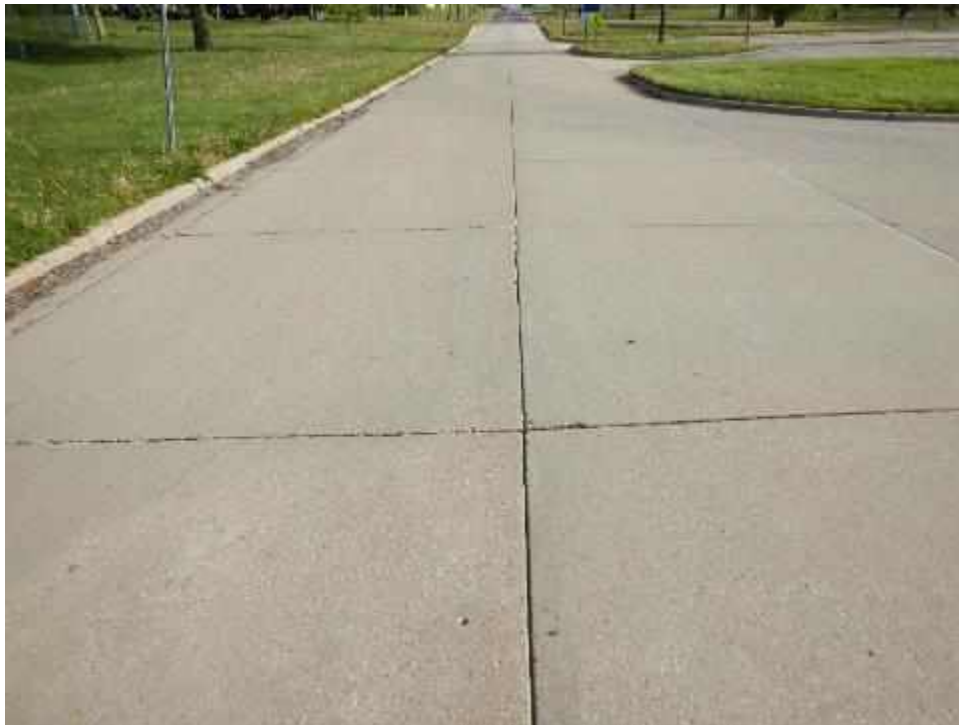
GRIFFITHD-S22B-Joint Seal Damage-(Sample Unit No. 01)

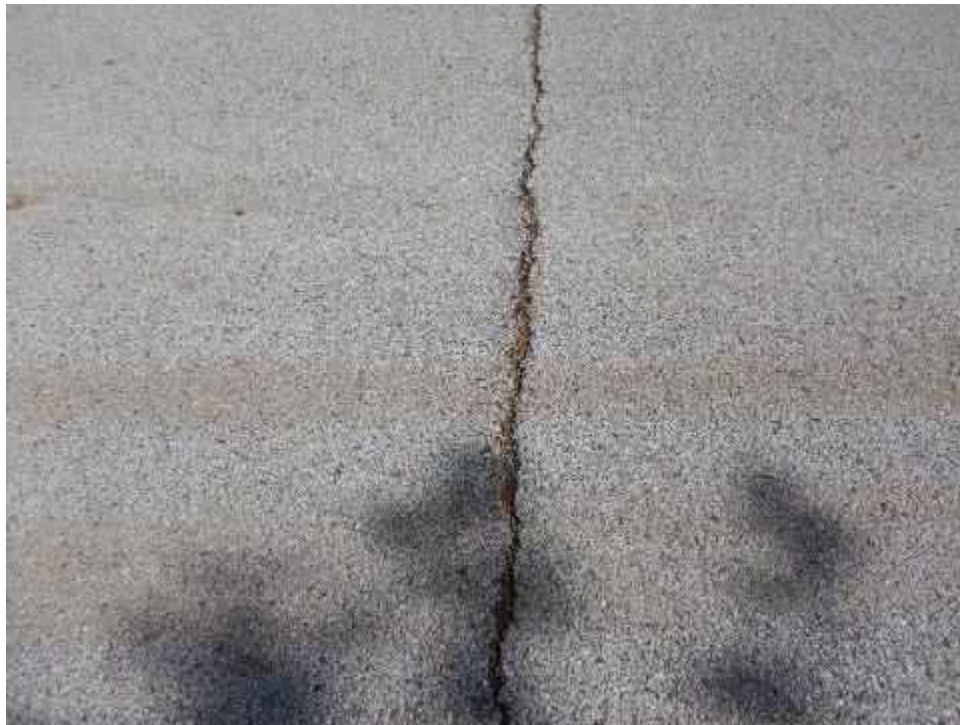
HAZELWDD-E00A-Alligator Cracking-(Sample Unit No. 01)

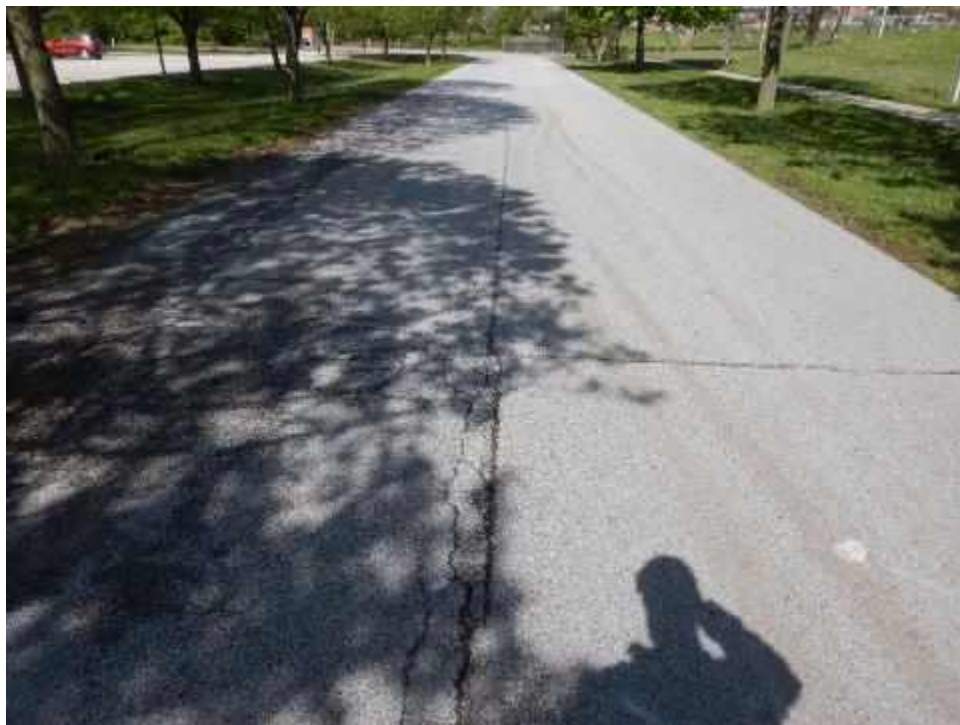
HAZELWDD-E00A-L&T Cracking-(Sample Unit No. 01)

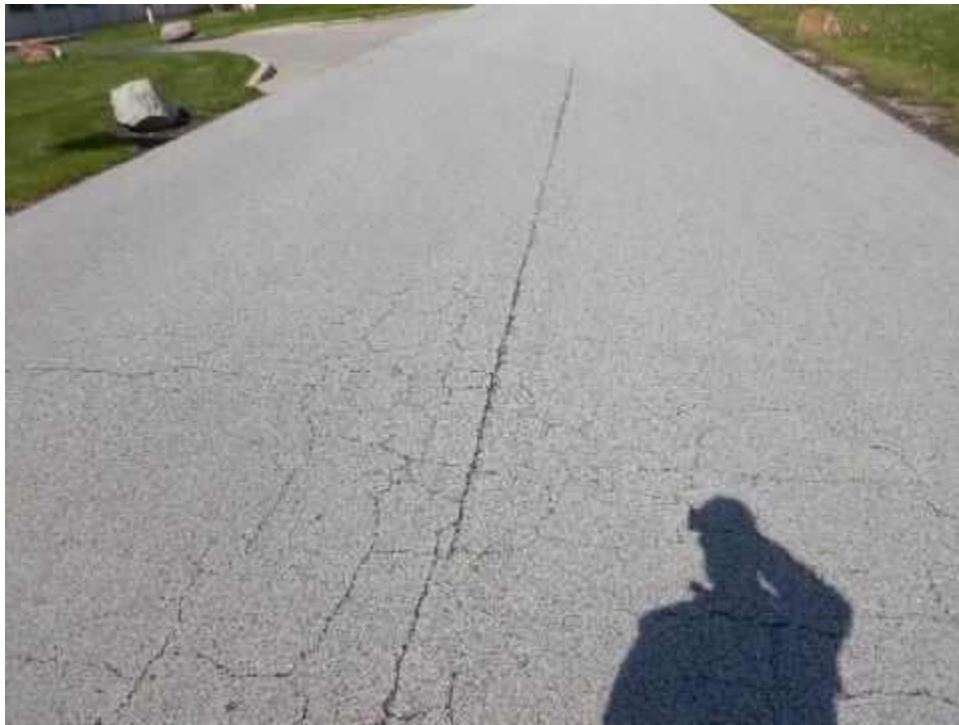
HAZELWDD-E00B-L&T Cracking-(Sample Unit No. 01)

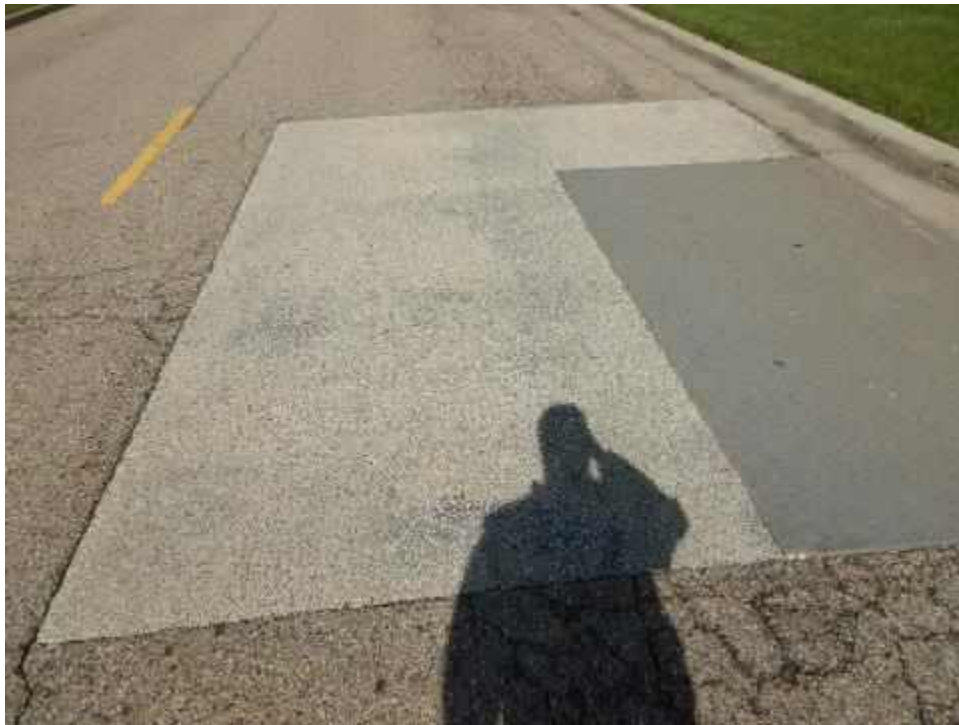
HAZELWDD-E00C-Patching-(Sample Unit No. 02)

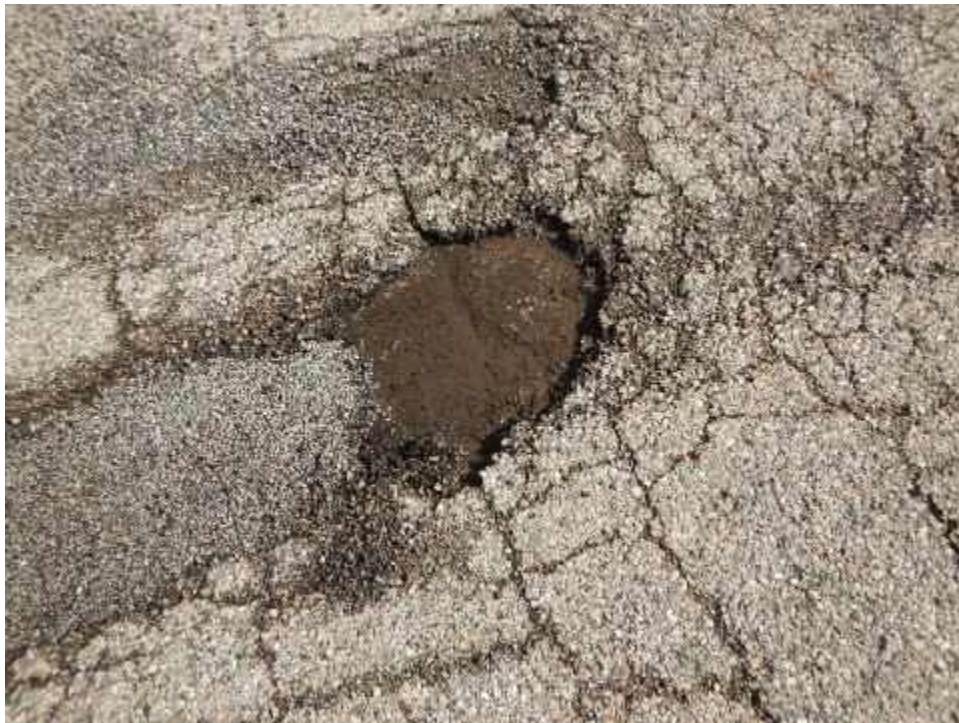
HAZELWDD-E00C-Pothole-(Sample Unit No. 02)

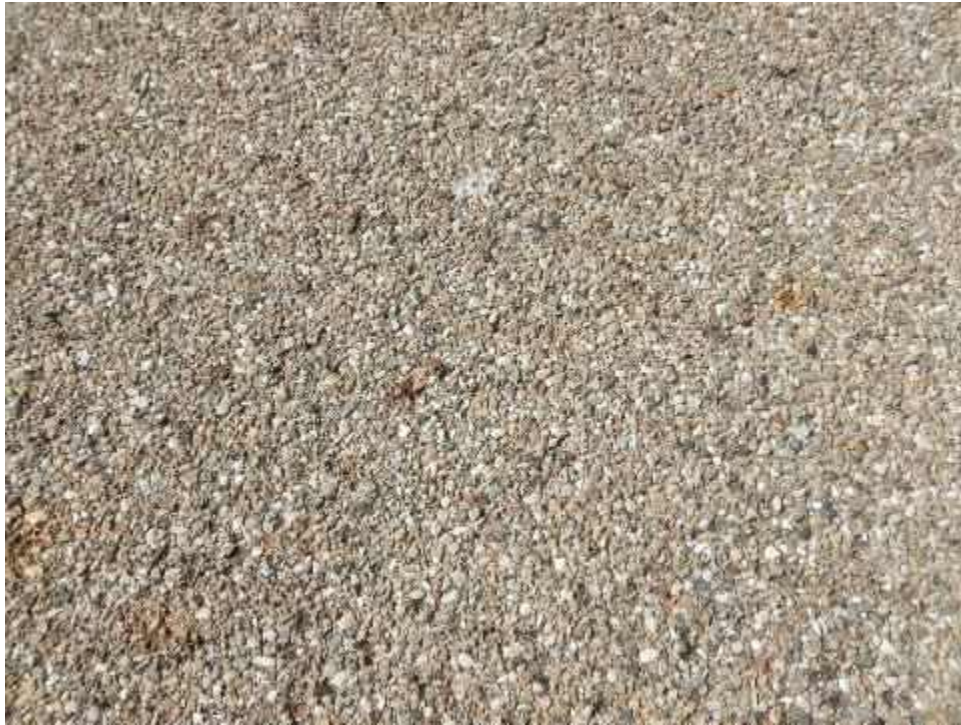
HAZELWDD-E00C-Weathering-(Sample Unit No. 01)

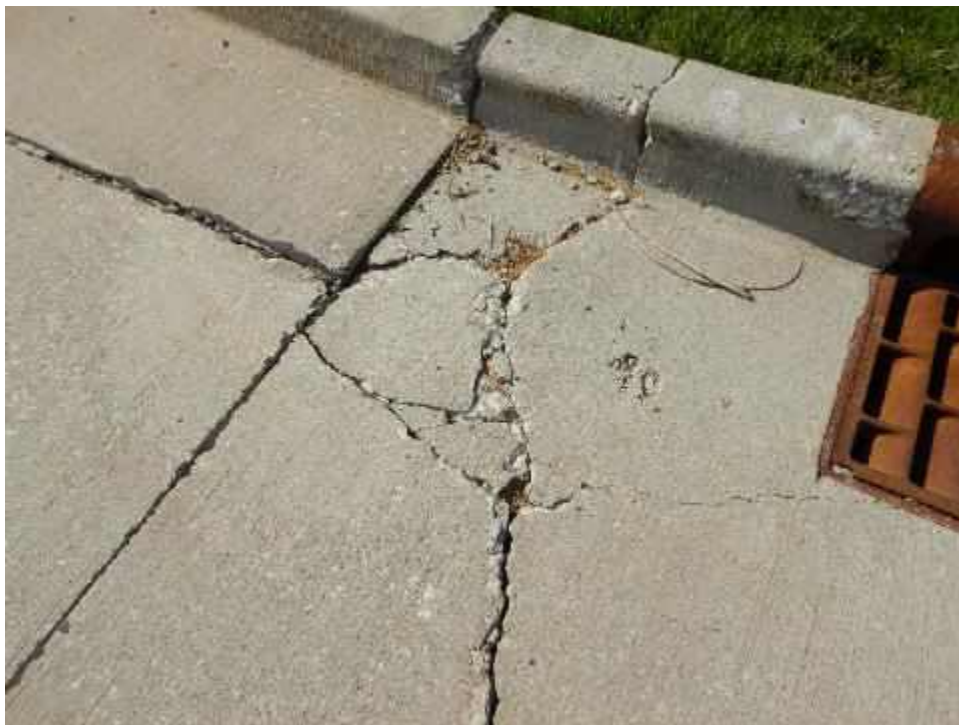
HAZELWDD-E01B-Corner Spalling-(Sample Unit No. 01)

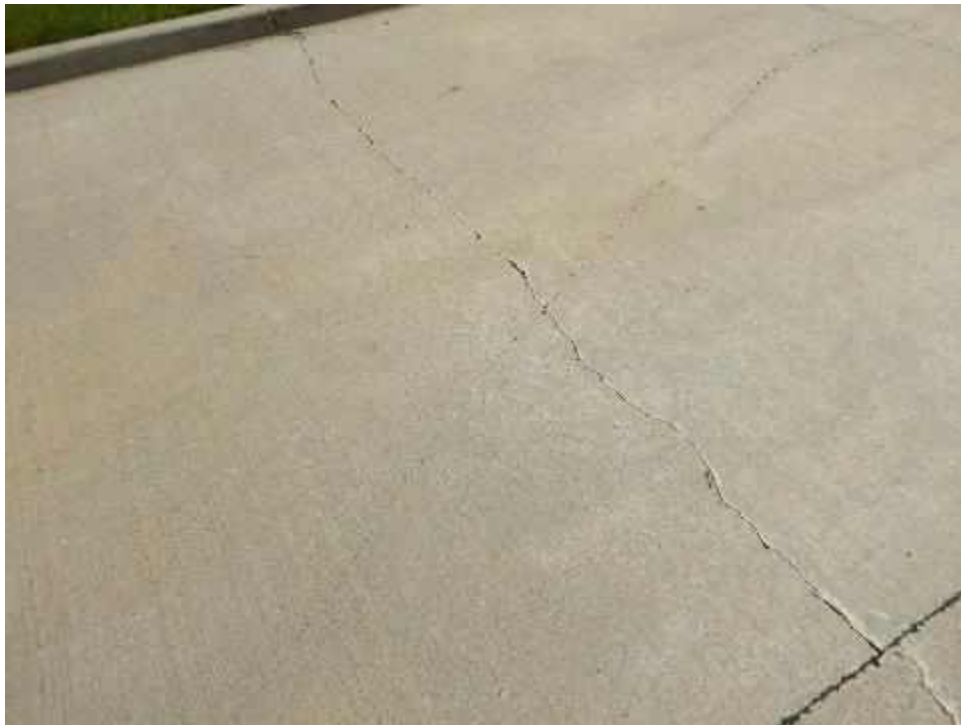
HAZELWDD-E01B-LTD Cracking-(Sample Unit No. 02)

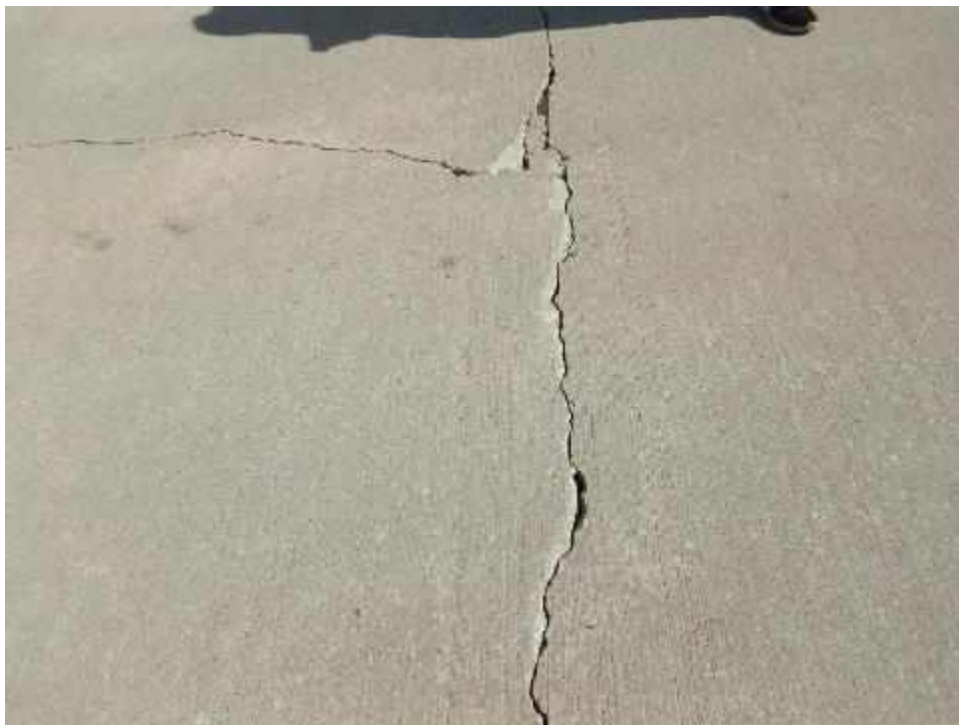
HAZELWDD-E01B-Shattered Slab-(Sample Unit No. 02)

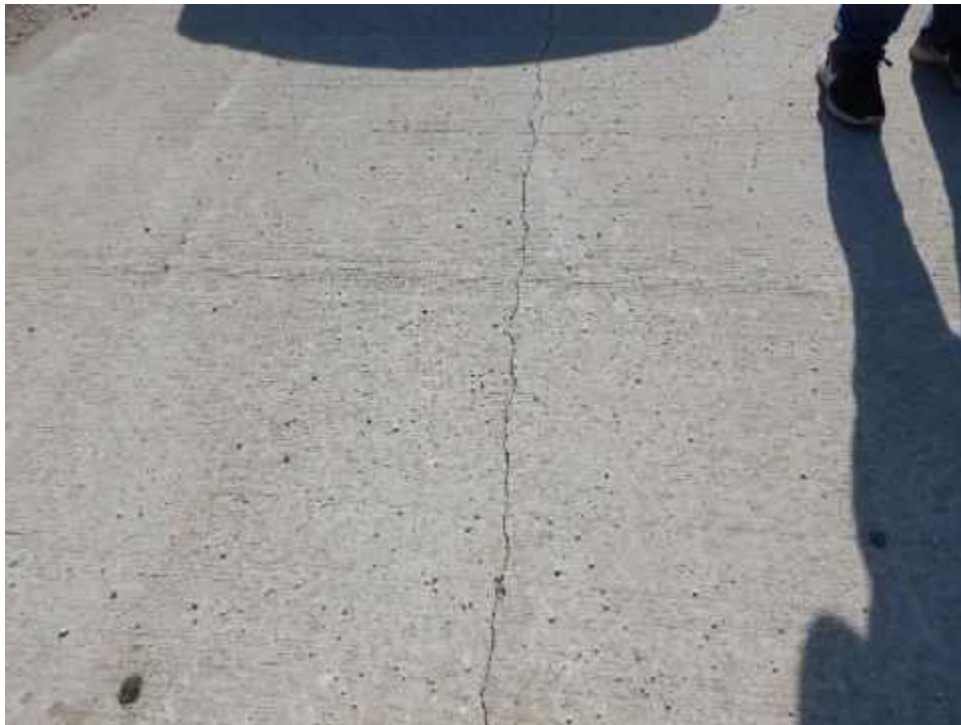
HAZELWDD-E01C-LTD Cracking-(Sample Unit No. 01)

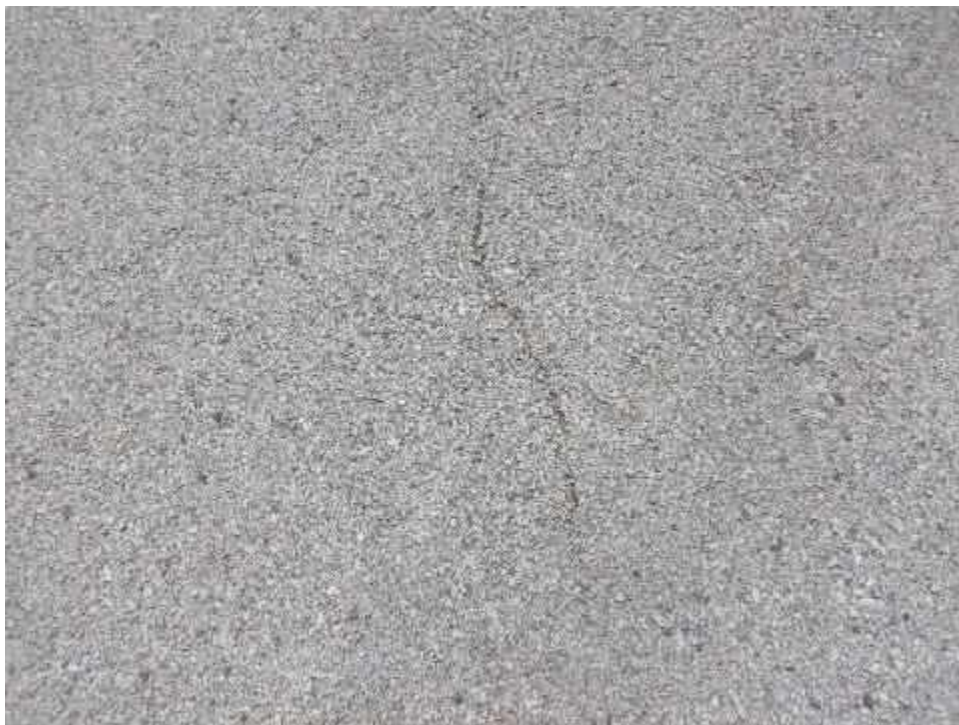
HAZELWDD-UW04-L&T Cracking-(Sample Unit No. 01)

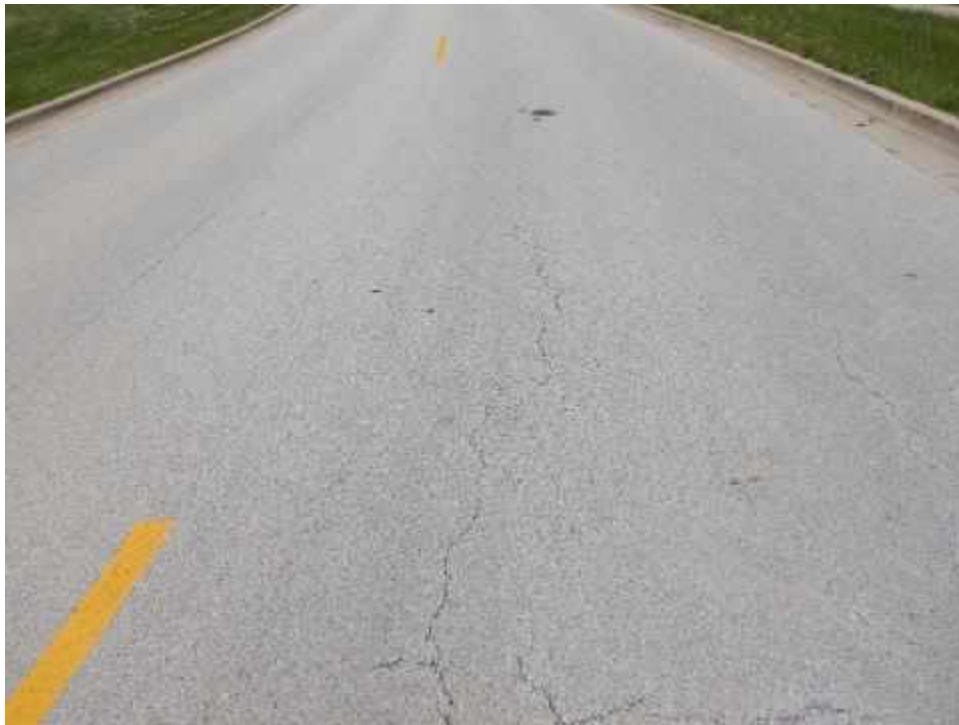
HAZELWDD-UW05-Alligator Cracking-(Sample Unit No. 01)

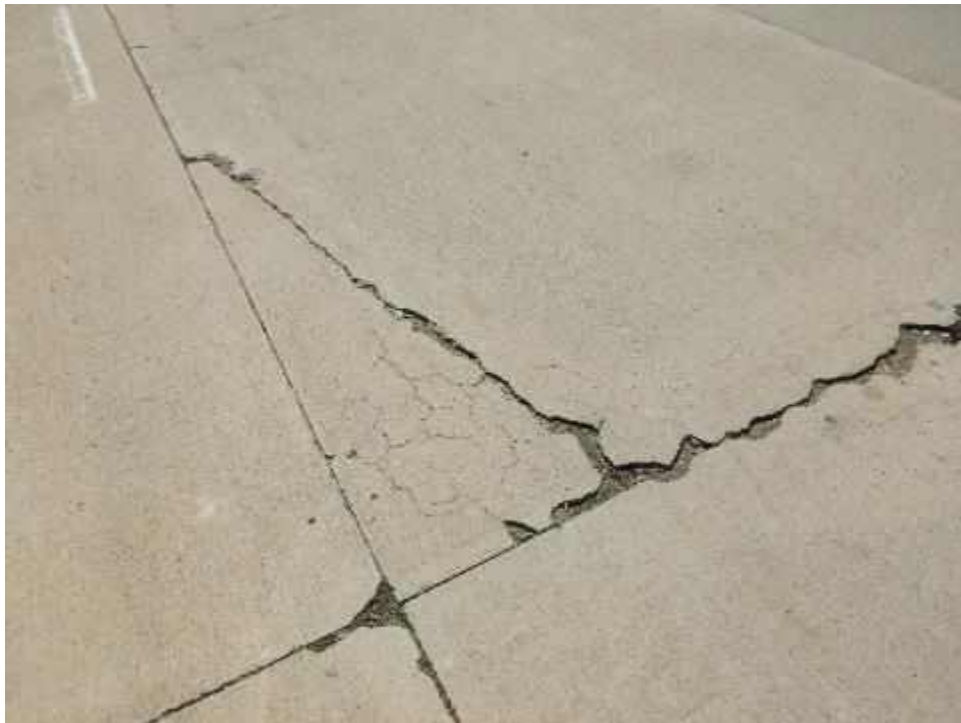
HAZELWDD-UW09-Durability Cracking-(Sample Unit No - 03)

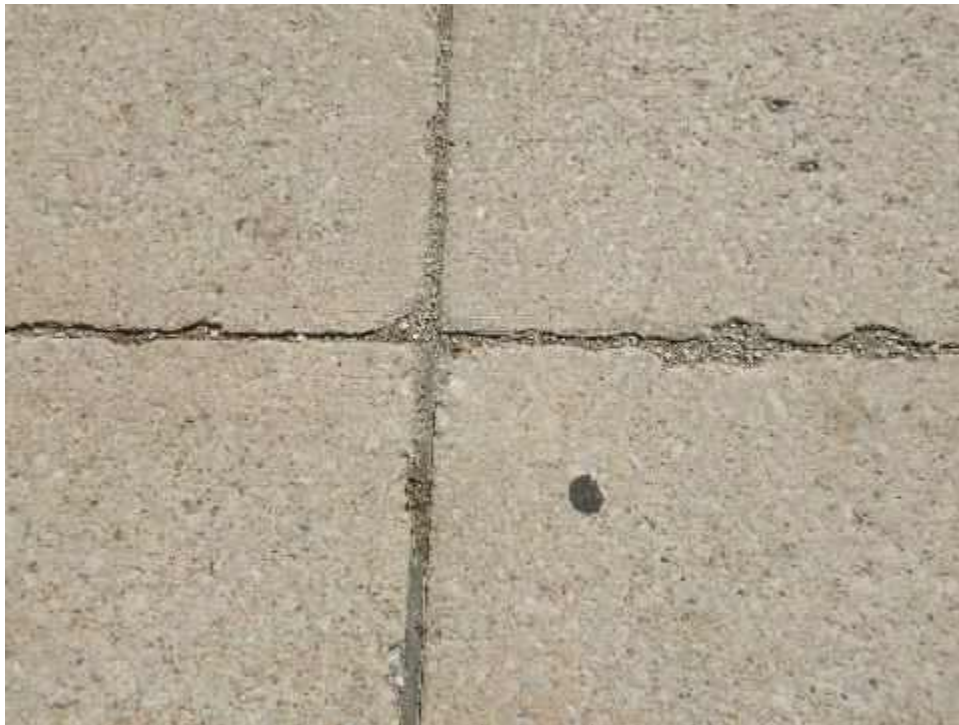
HAZELWDD-UW09-Joint Seal Damage-(Sample Unit No. 01)

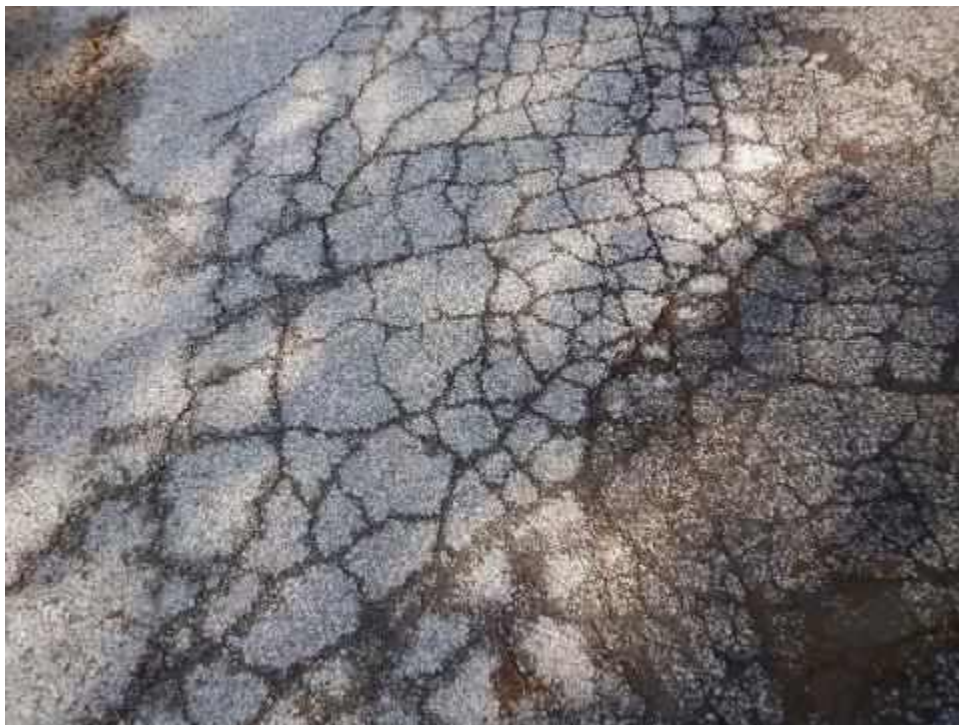
KIRKD-S20B-Alligator Cracking-(Sample Unit No. 01)

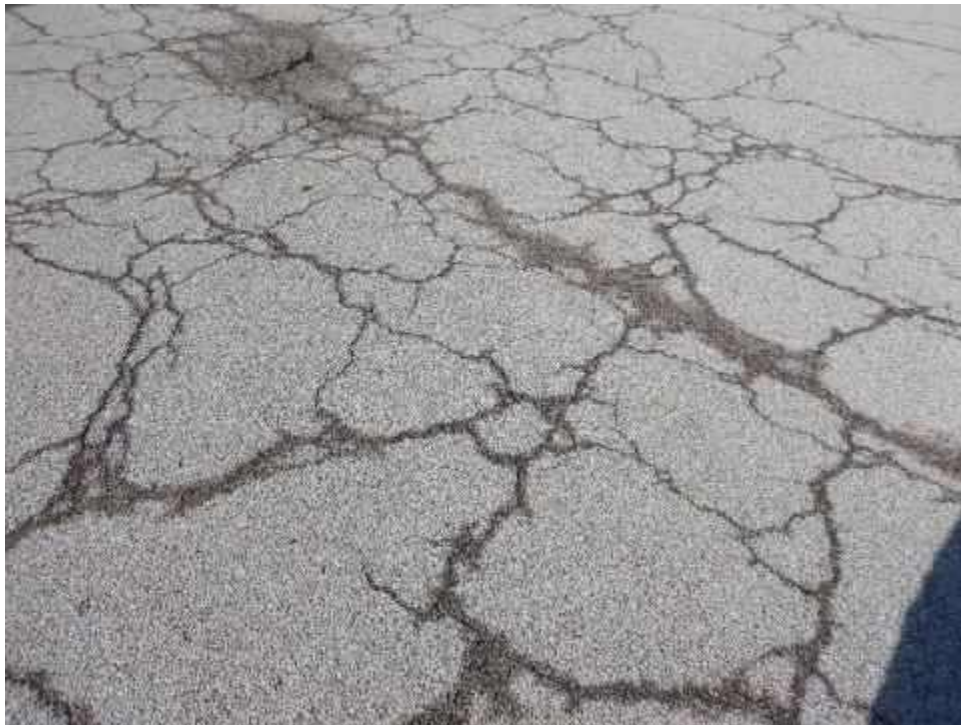
KIRKD-S20B-Block Cracking-(Sample Unit No. 01)

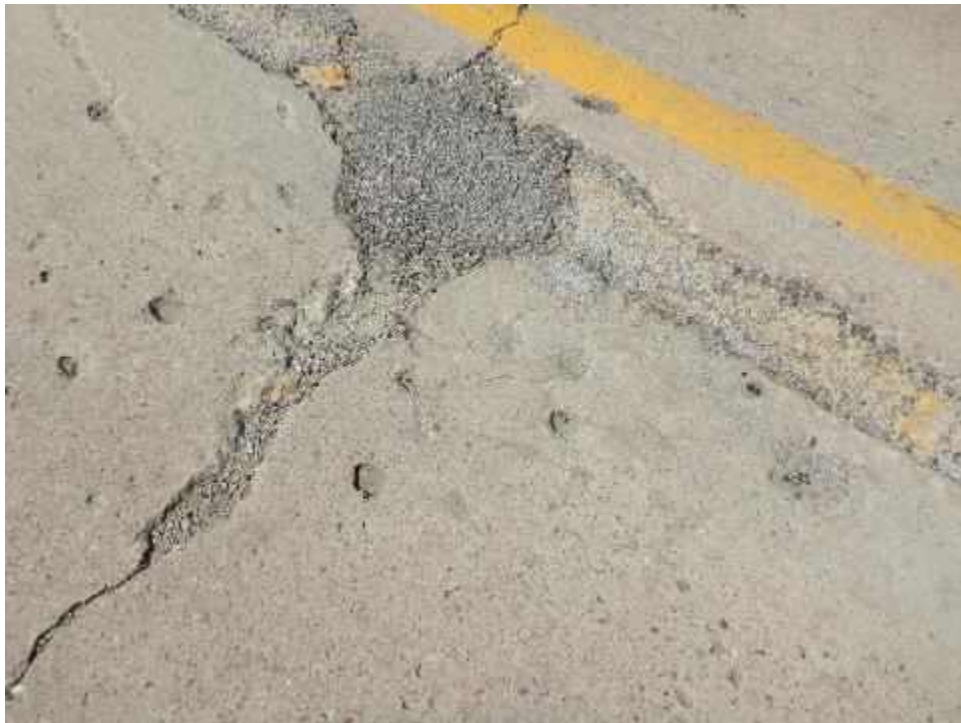
LNCLNAV-US17A-Durability Cracking-(Sample Unit No. 01)

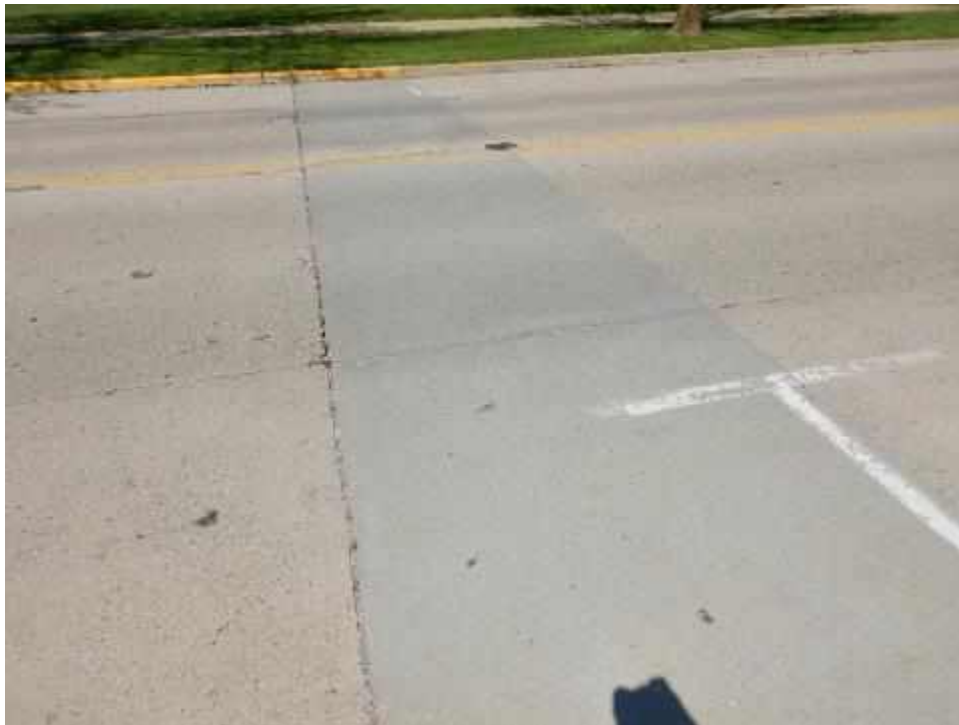
LNCLNAV-US17A-Large Patching-(Sample Unit No. 01)

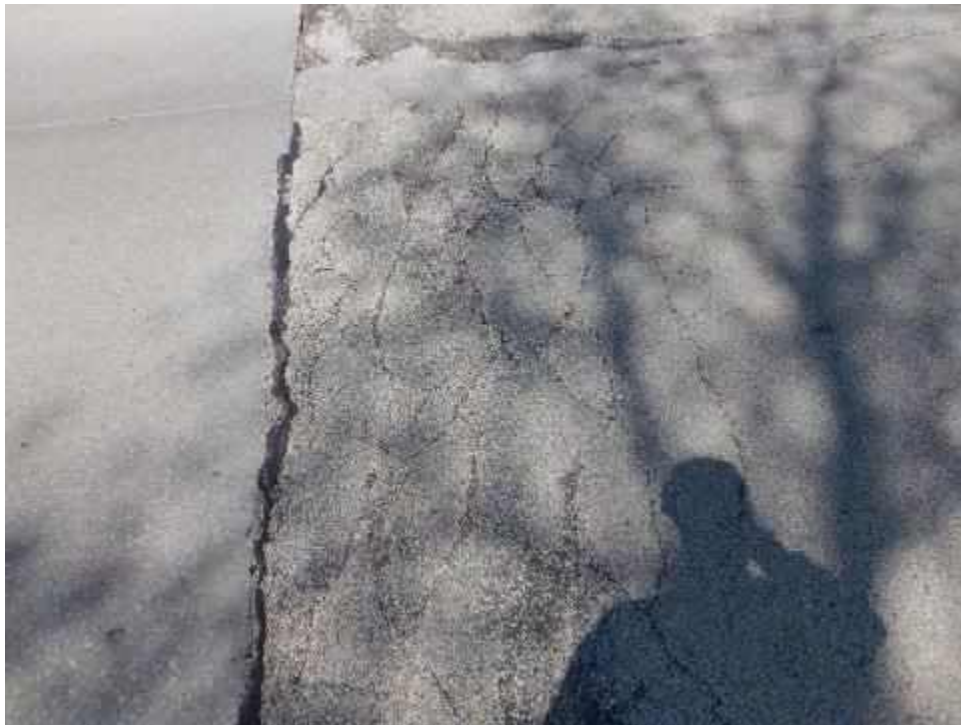
LNCLNAV-US17B-Alligator Cracking-(Sample Unit No. 01)

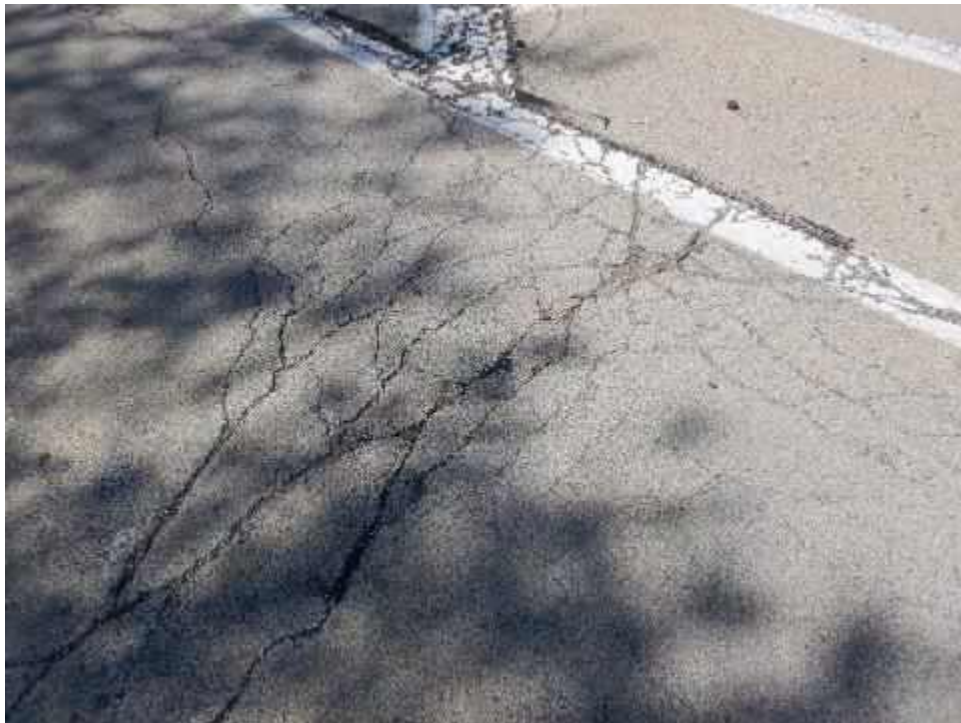
LNCLNAV-US17B-Alligator Cracking-(Sample Unit No. 02)

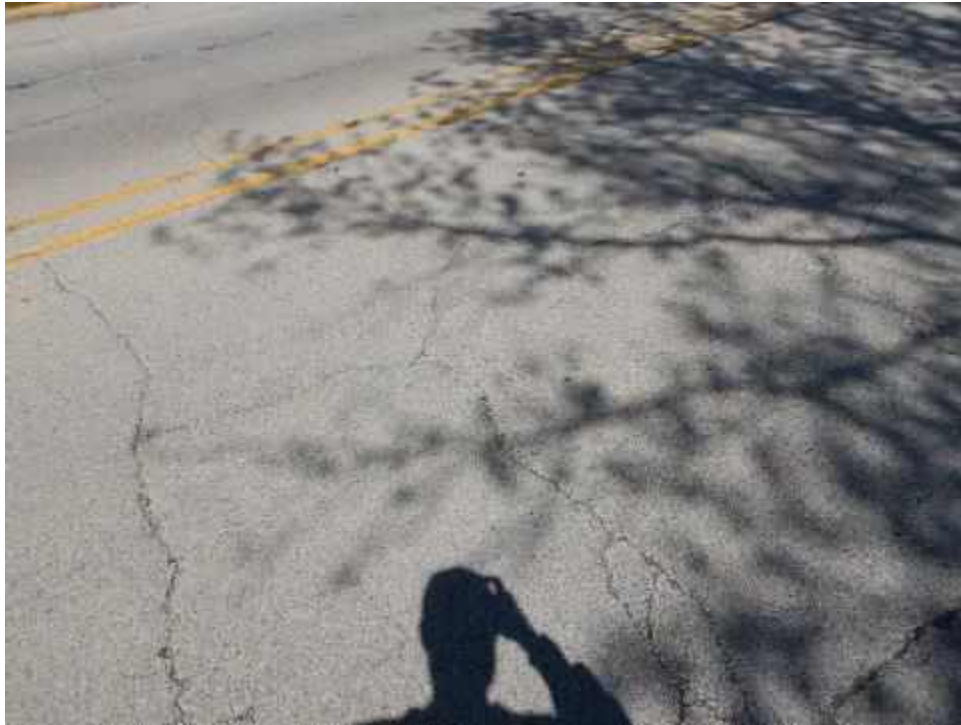
LNCLNAV-US17B-Block Cracking-(Sample Unit No. 01)
