# U20069: Pavement Analysis Study 2020 University of Illinois at Urbana-Champaign

## Final Report

Applied Pavement Technology, Inc.  
115 West Main Street, Suite 400  
Urbana, Illinois 61801  
(217) 398-3977  
[www.appliedpavement.com](http://www.appliedpavement.com)

**AUGUST 2020**

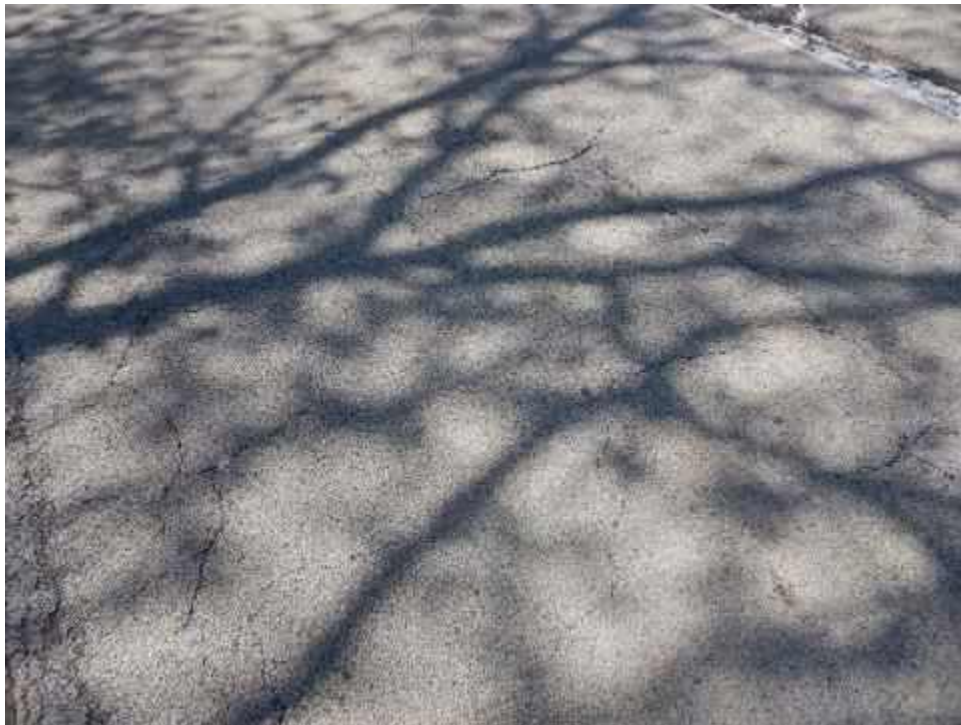
LNCLNAV-US17B-Block Cracking-(Sample Unit No. 02)

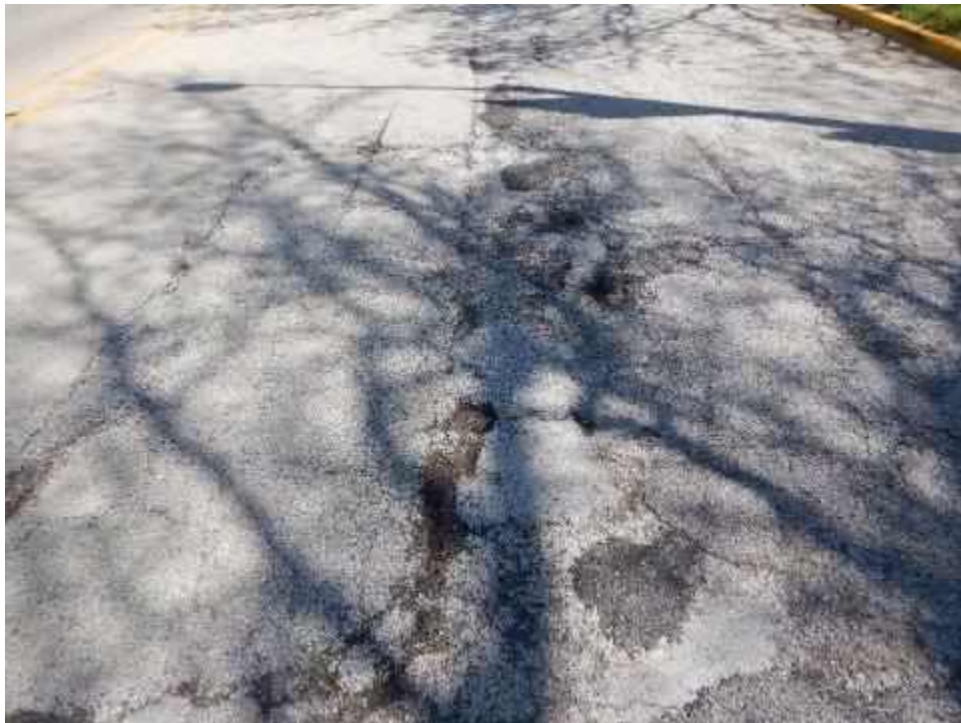
LNCLNAV-US17B-Joint Reflection Cracking-(Sample Unit No - 72)

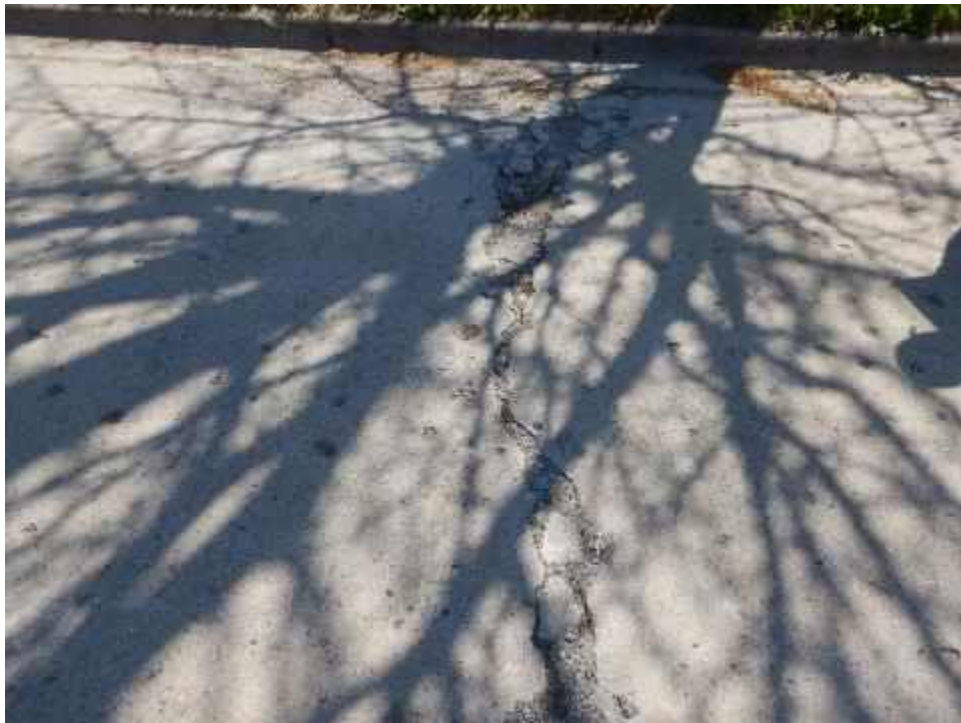
LNCLNAV-US17B-Raveling-(Sample Unit No. 01)

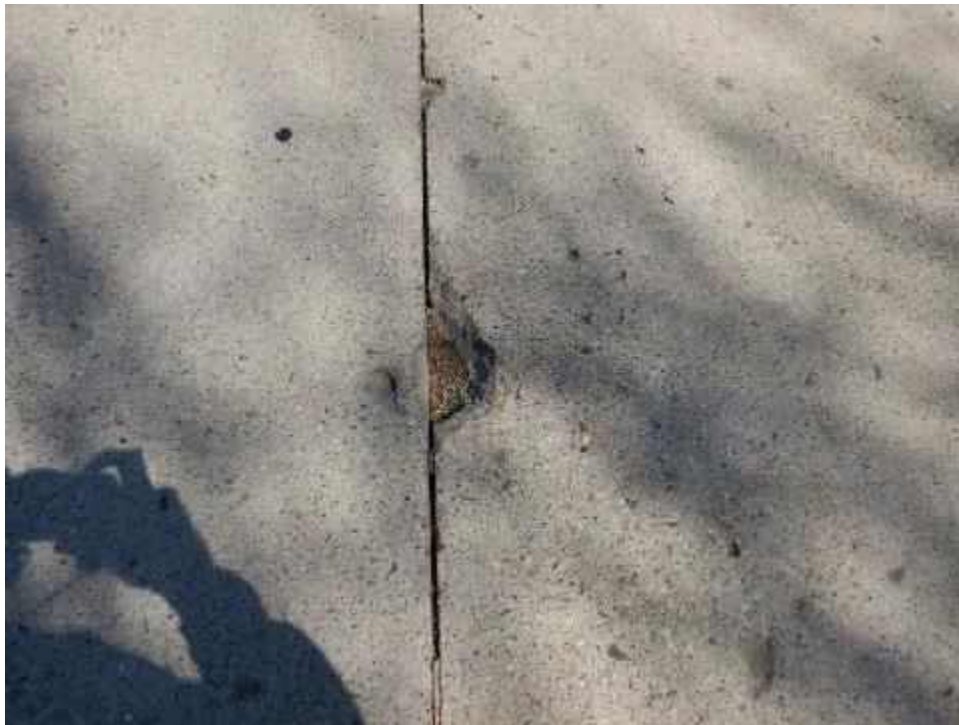
LNCLNAV-US19-Durability Cracking-(Sample Unit No. 01)

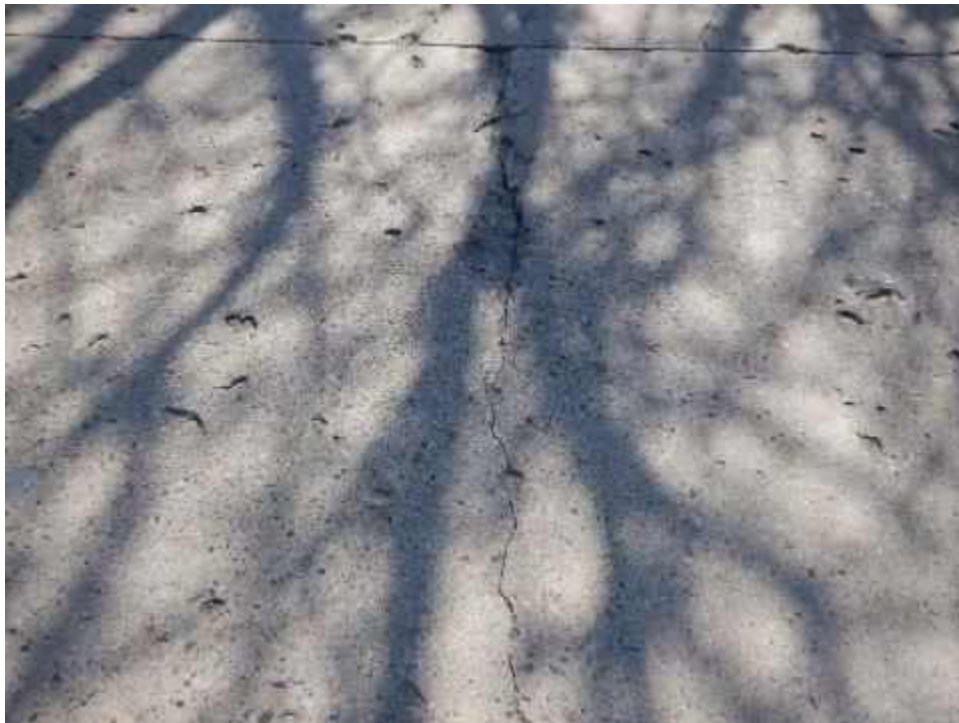
LNCLNAV-US19-Joint Spalling-(Sample Unit No. 01)

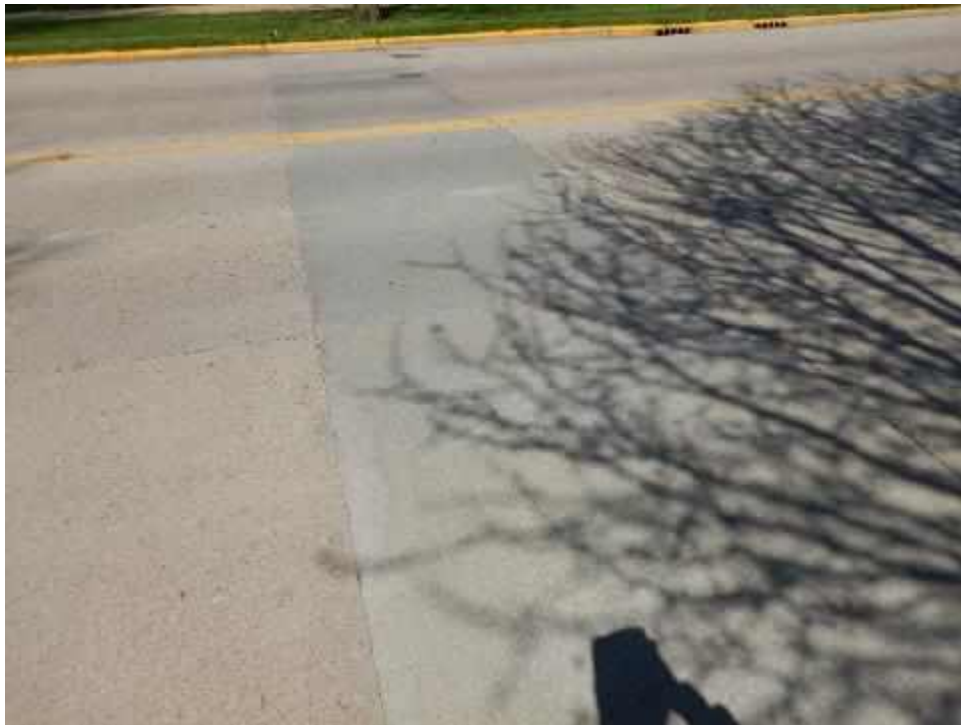
LNCLNAV-US19-LTD Cracking-(Sample Unit No. 01)

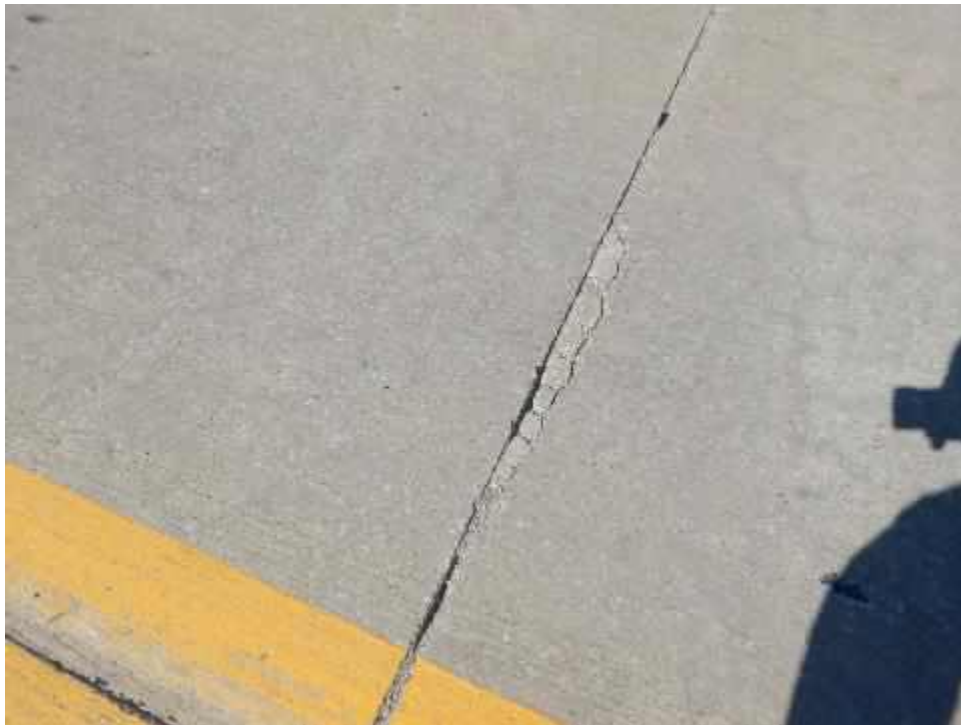
LNCLNAV-US23-Corner Spalling-(Sample Unit No. 01)

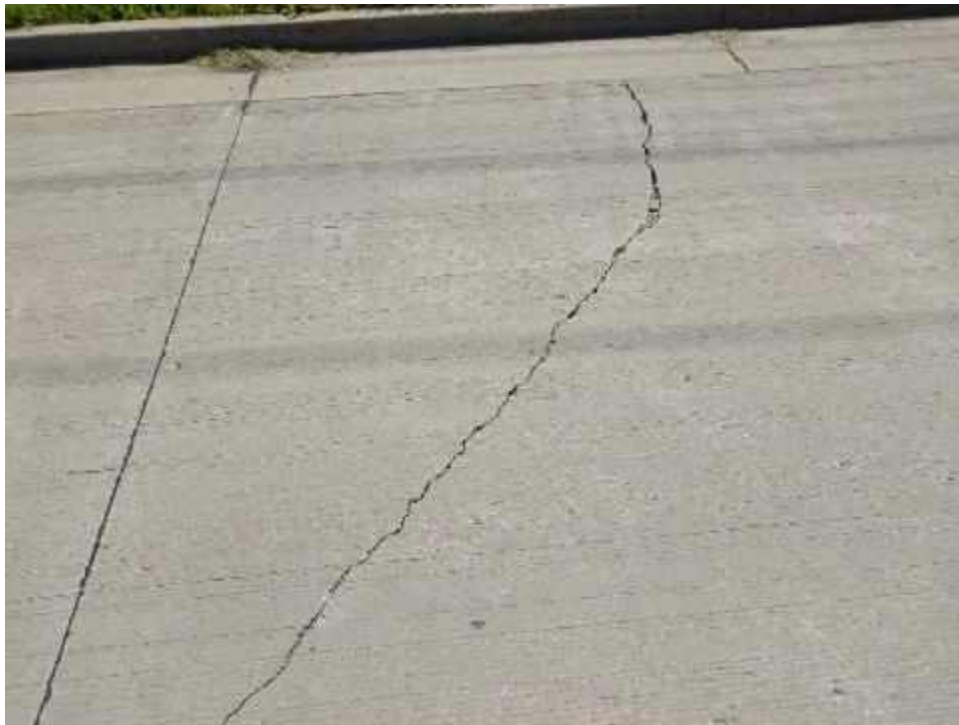
LNCLNAV-US23-Joint Spalling-(Sample Unit No. 01)

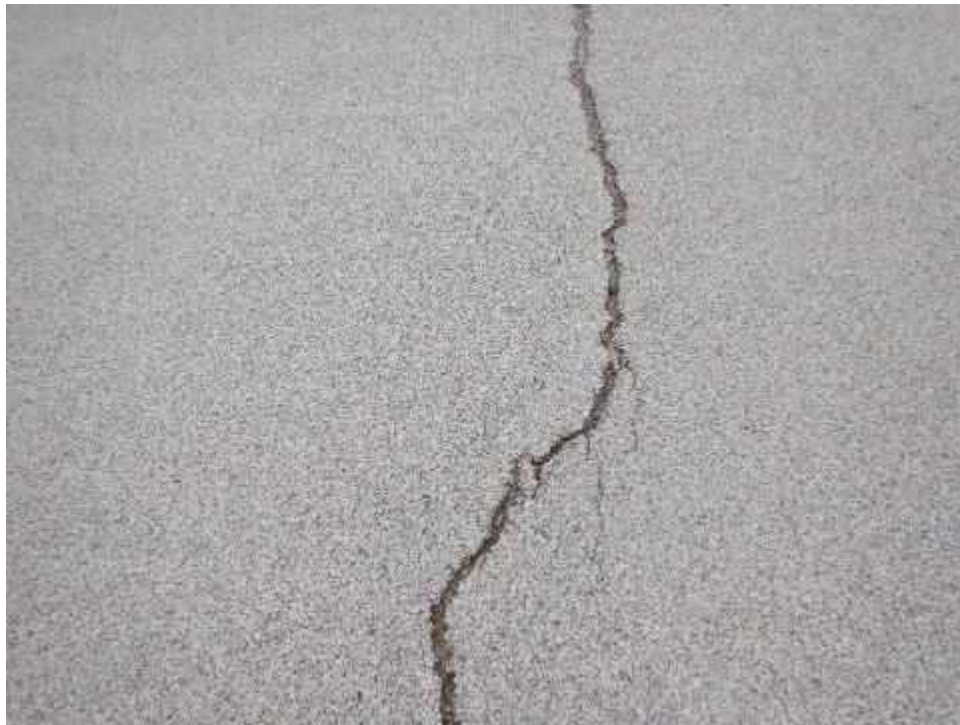
LORADOTD-UW12-Alligator Cracking-(Sample Unit No. 01)

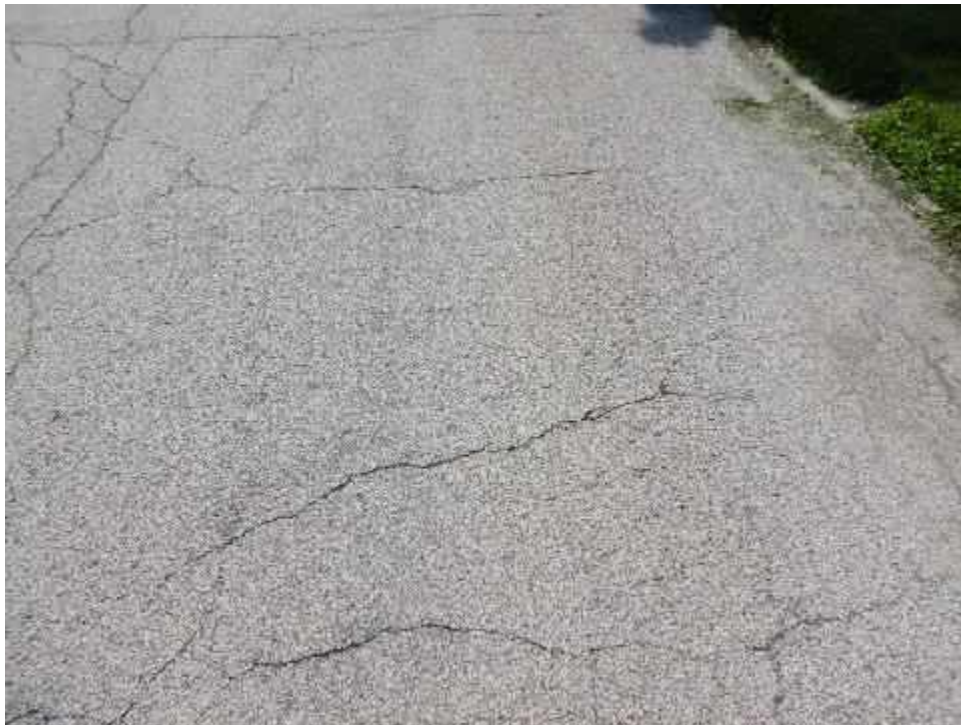
MAINS-UW11AN-Alligator Cracking-(Sample Unit No. 01)

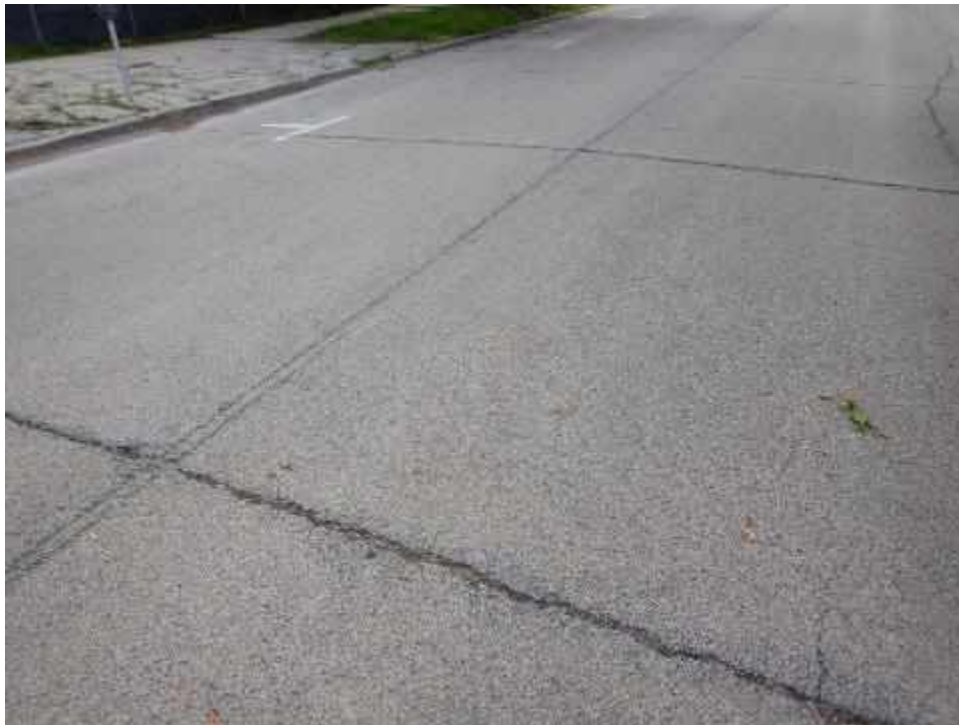
MAINS-UW11AS-Weathering-(Sample Unit No. 01)

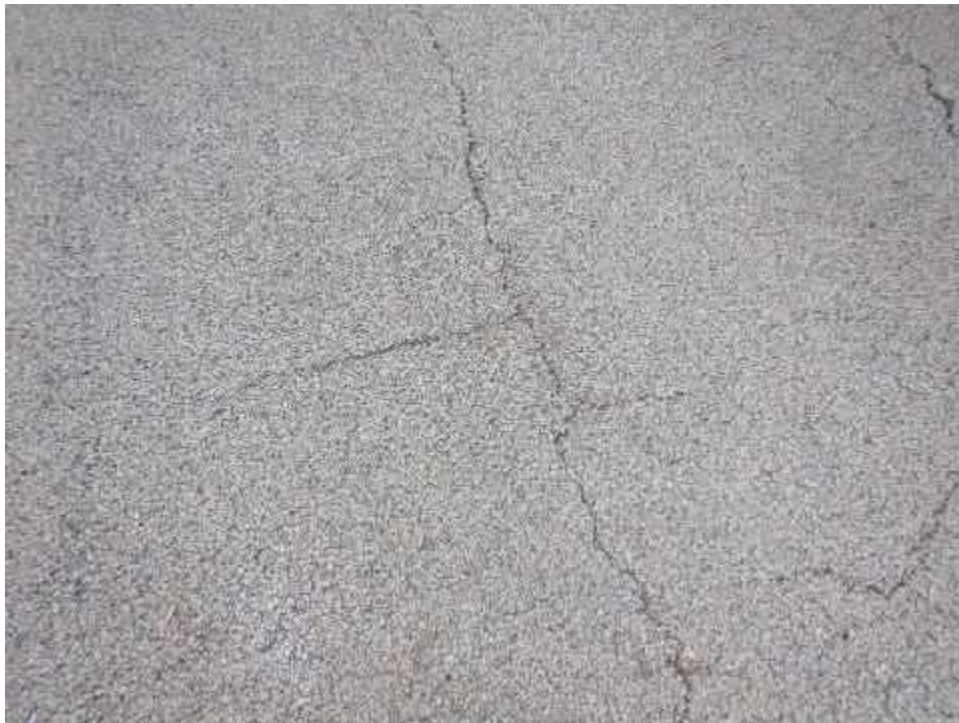
MAINS-UW11B-Joint Reflection Cracking-(Sample Unit No. 01)

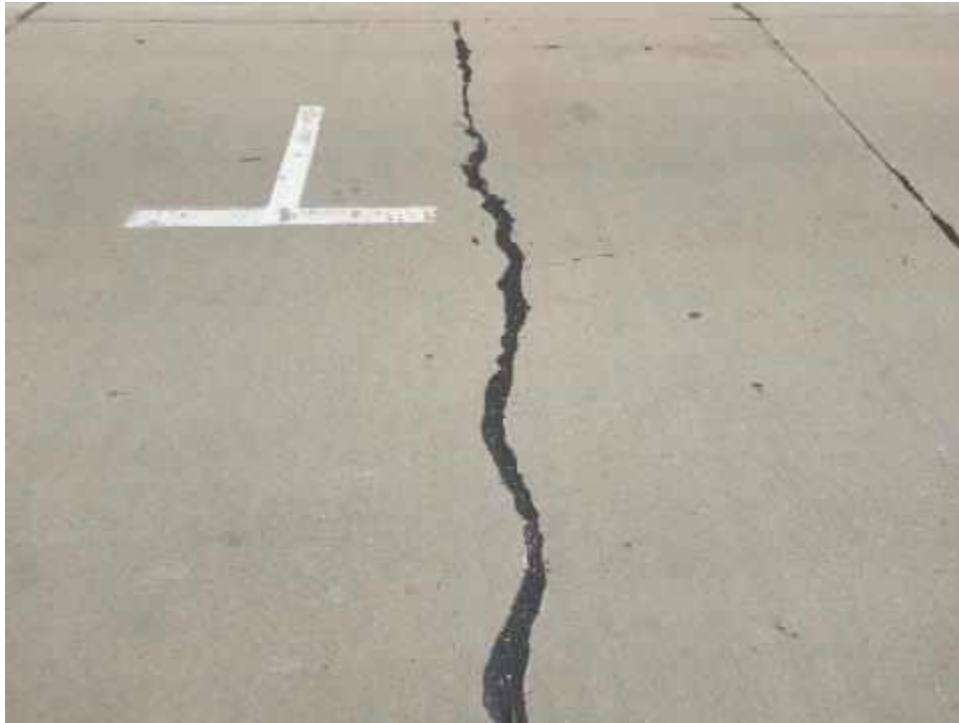
MAINS-UW11B-Raveling-(Sample Unit No. 01)

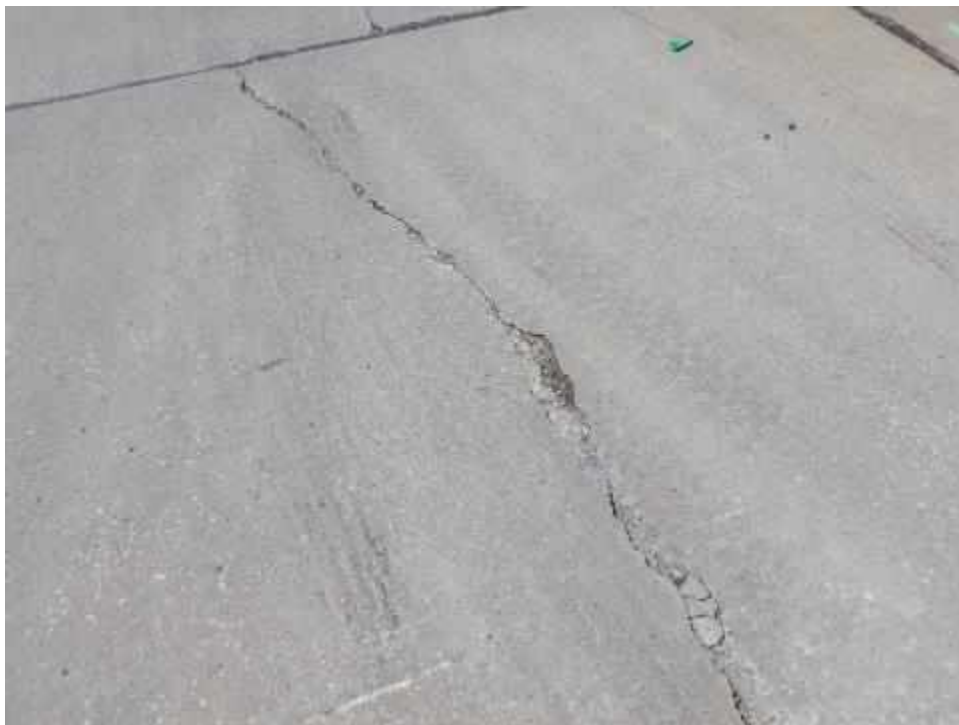
OAKS-S10A-Joint Spalling-(Sample Unit No. 01)

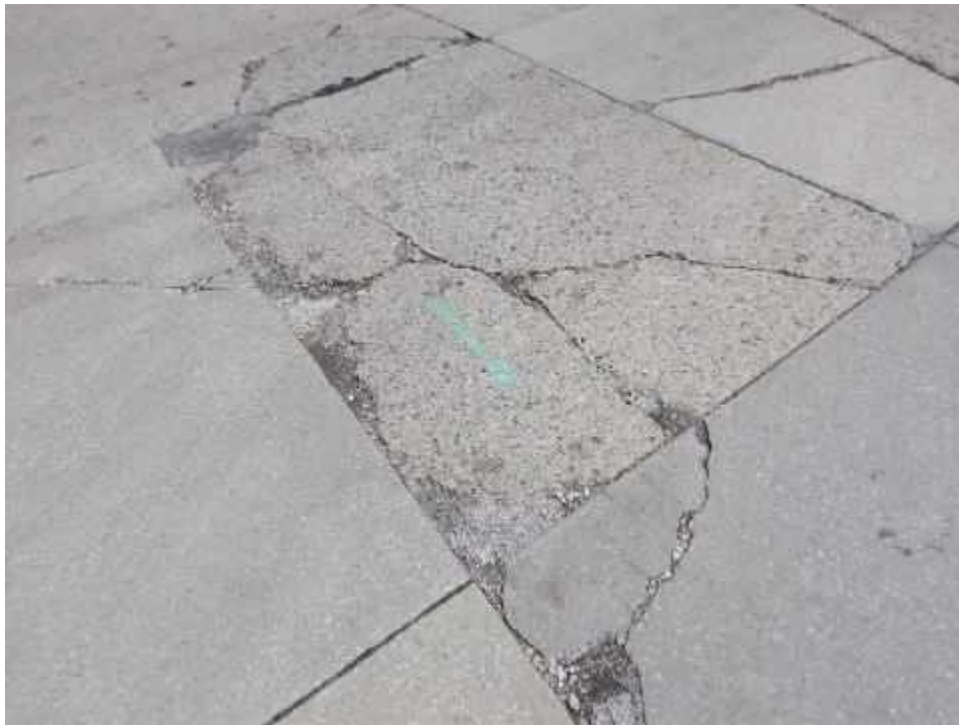
OAKS-S10A-LTD Cracking-(Sample Unit No. 01)

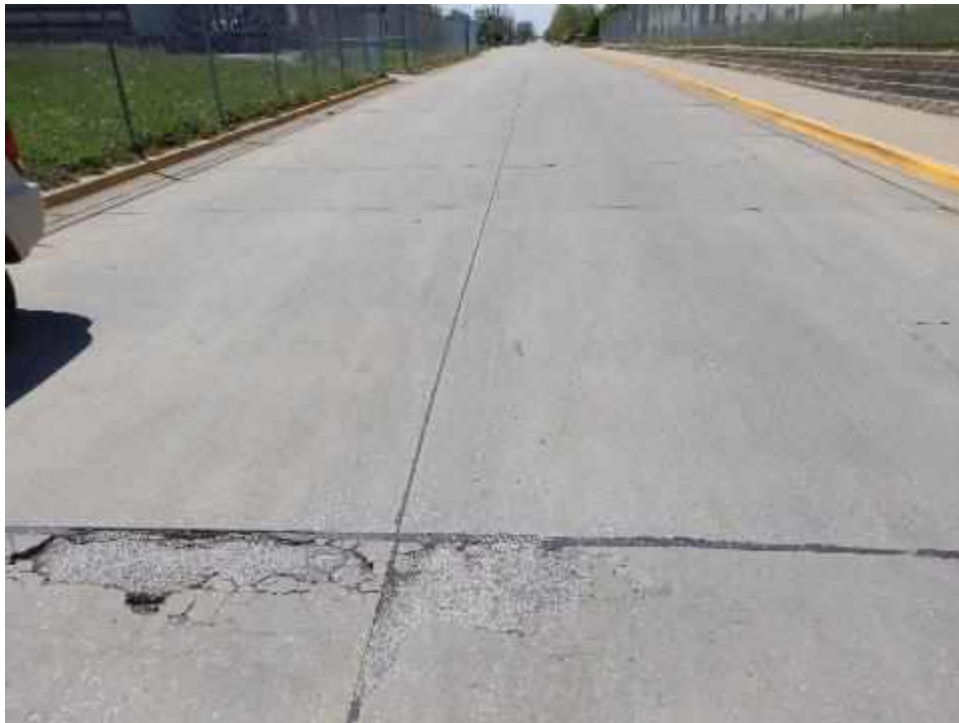
OAKS-S10A-Large Patching-(Sample Unit No. 01)

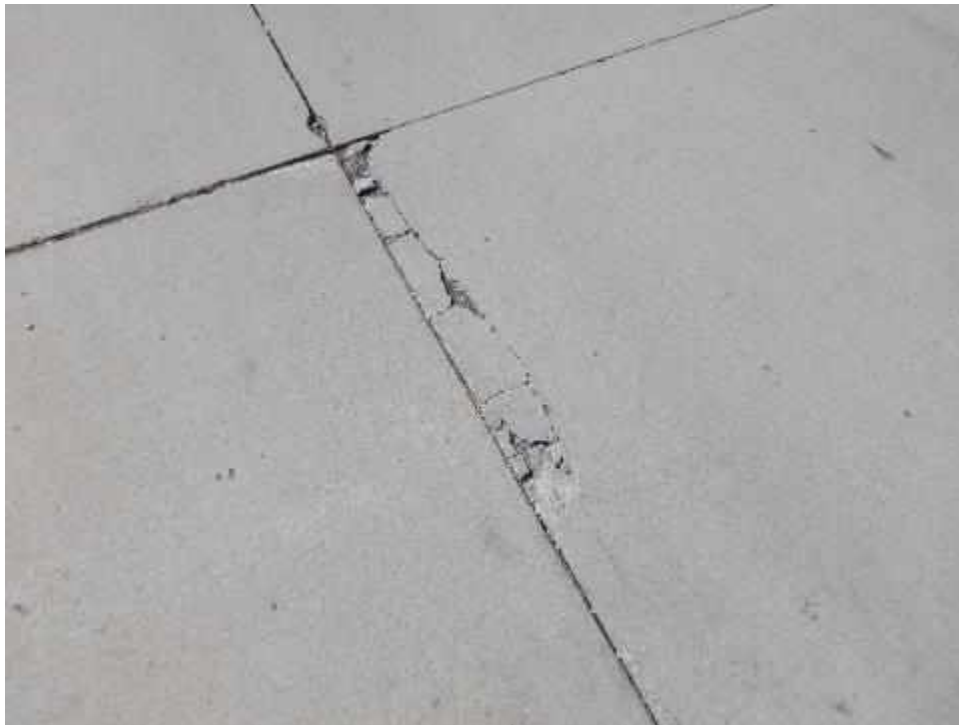
OAKS-S10C-Joint Seal Damage-(Sample Unit No. 01)

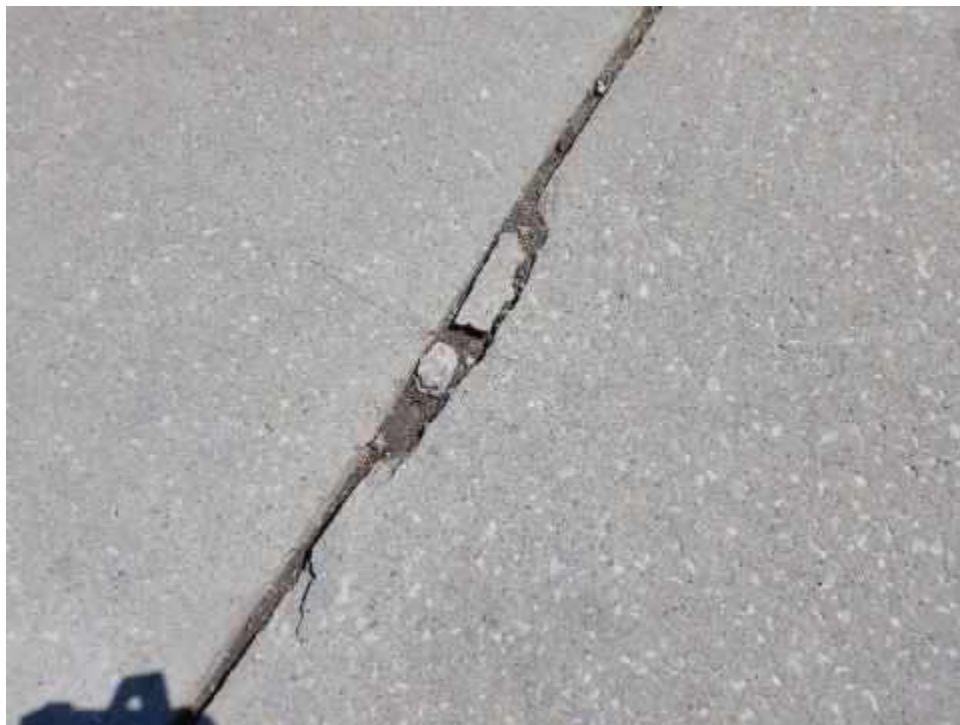
OAKS-S12-Corner Spalling-(Sample Unit No. 01)

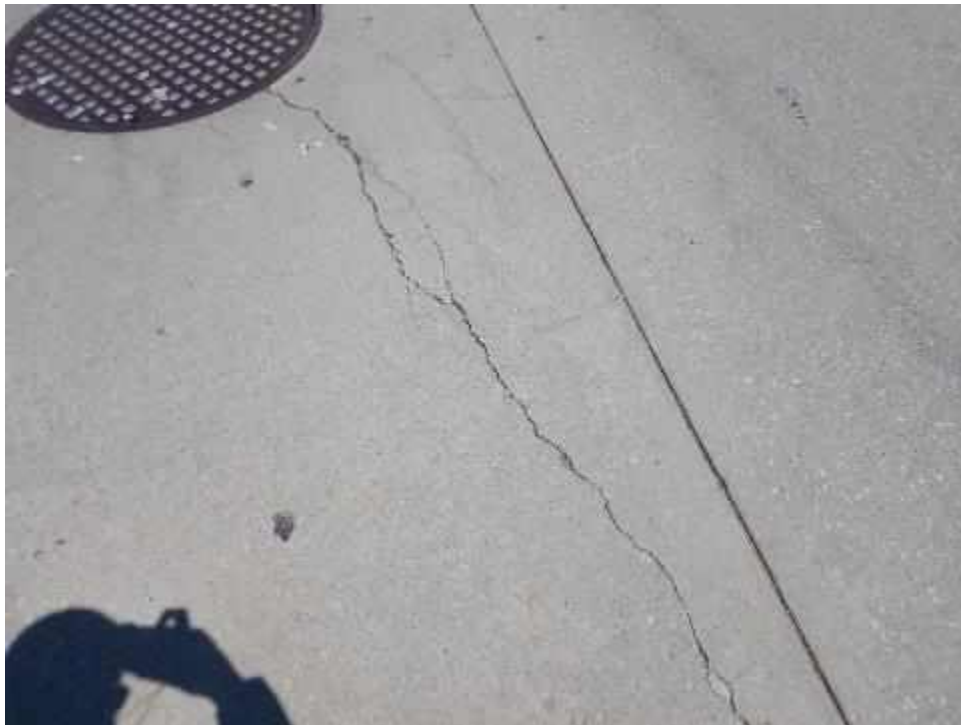
OAKS-S12-Joint Spalling-(Sample Unit No. 01)

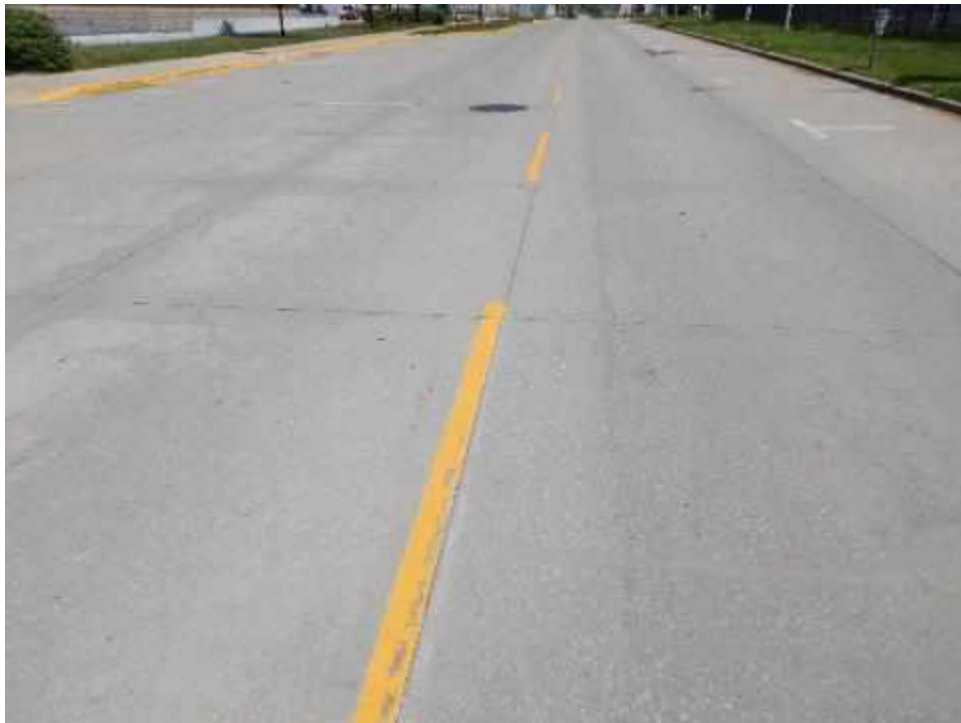
OAKS-S12-LTD Cracking-(Sample Unit No. 01)

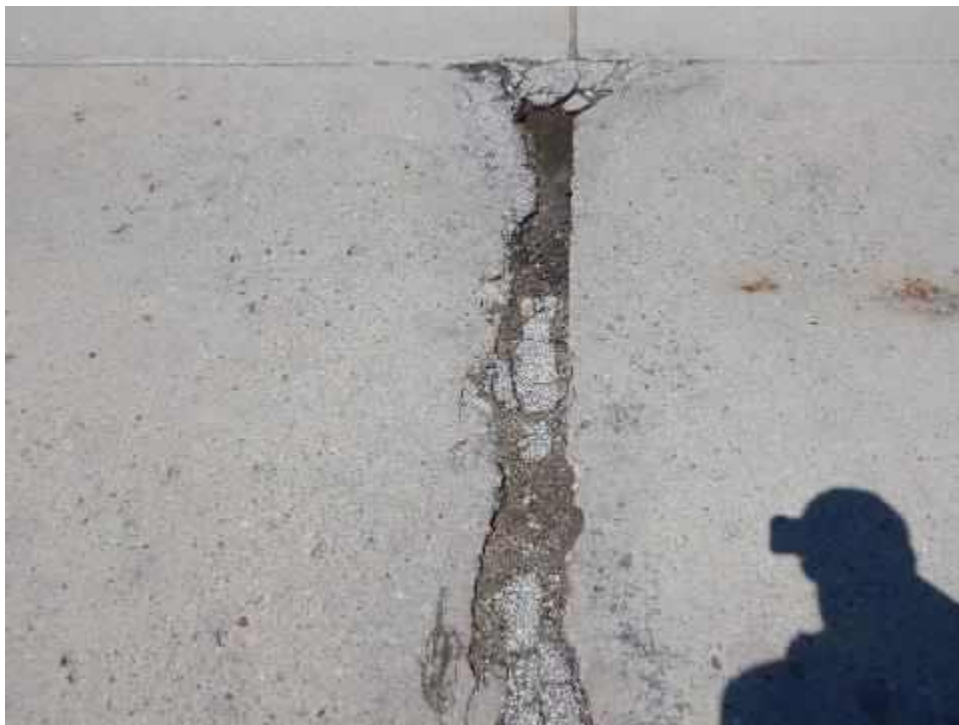
OAKS-S13-Durability Cracking-(Sample Unit No. 01)

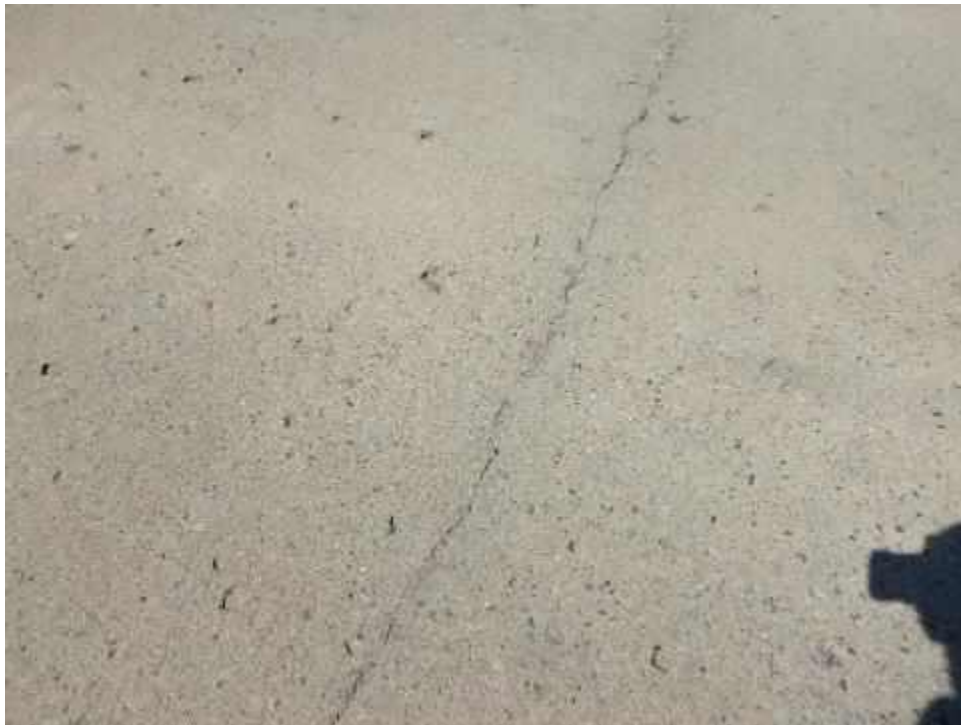
OAKS-S13-Durability Cracking-(Sample Unit No. 02)

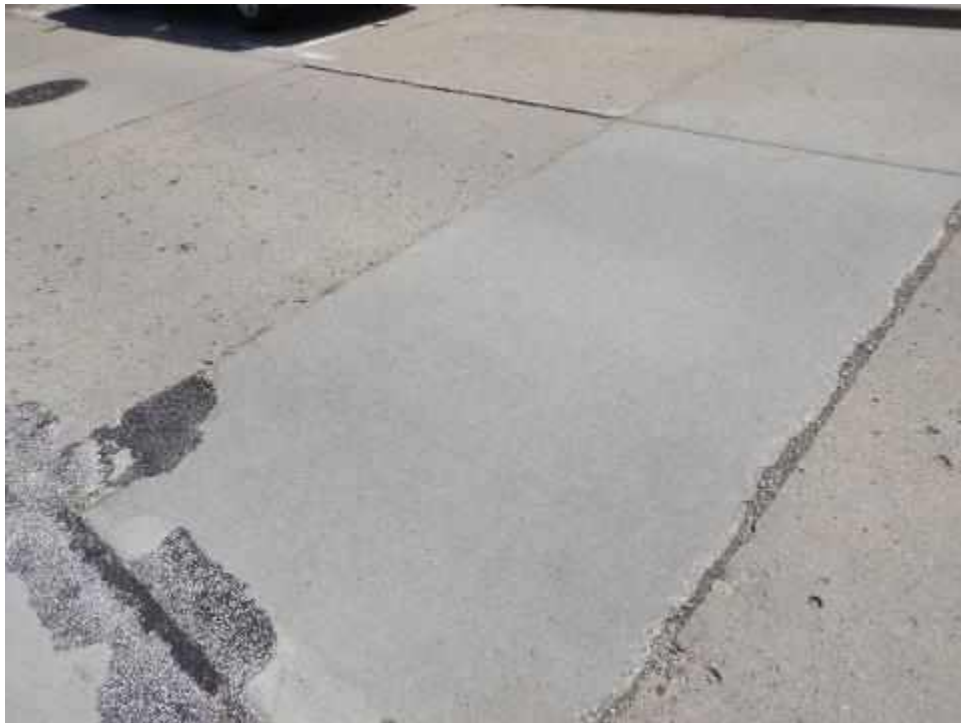
OAKS-S13-LTD Cracking-(Sample Unit No. 01)

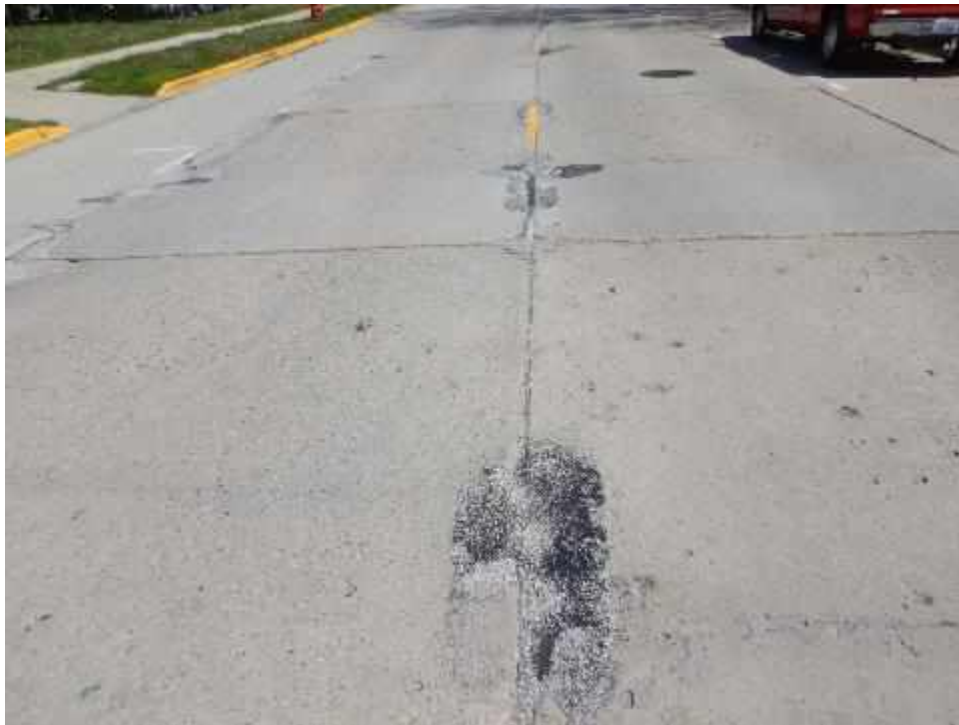
OAKS-S13-Large Patching-(Sample Unit No. 01)

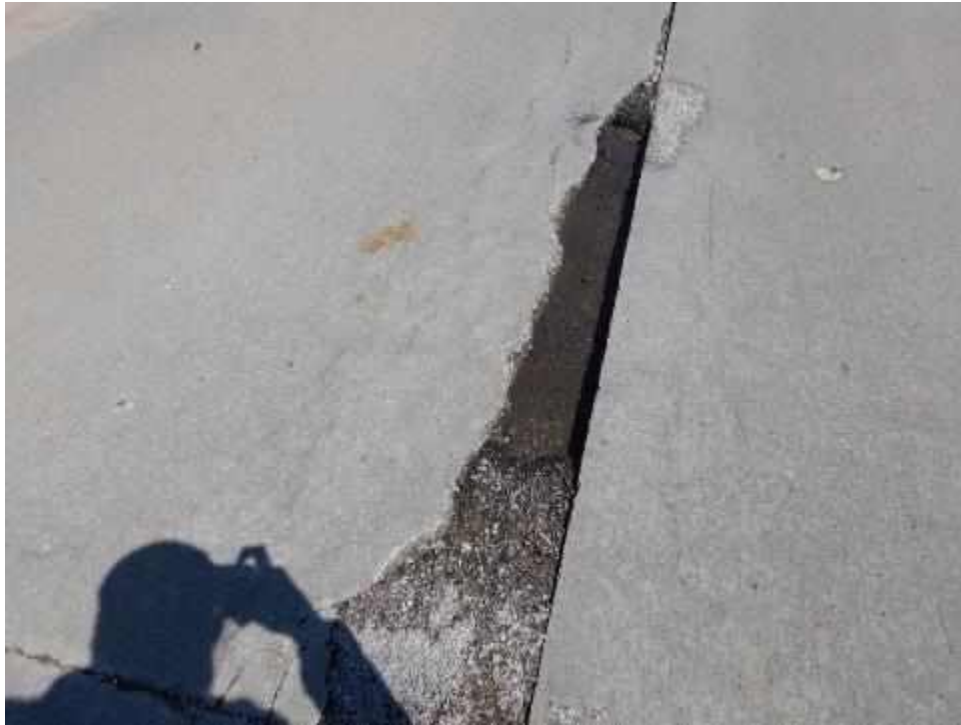
OAKS-S16-Durability Cracking-(Sample Unit No. 01)

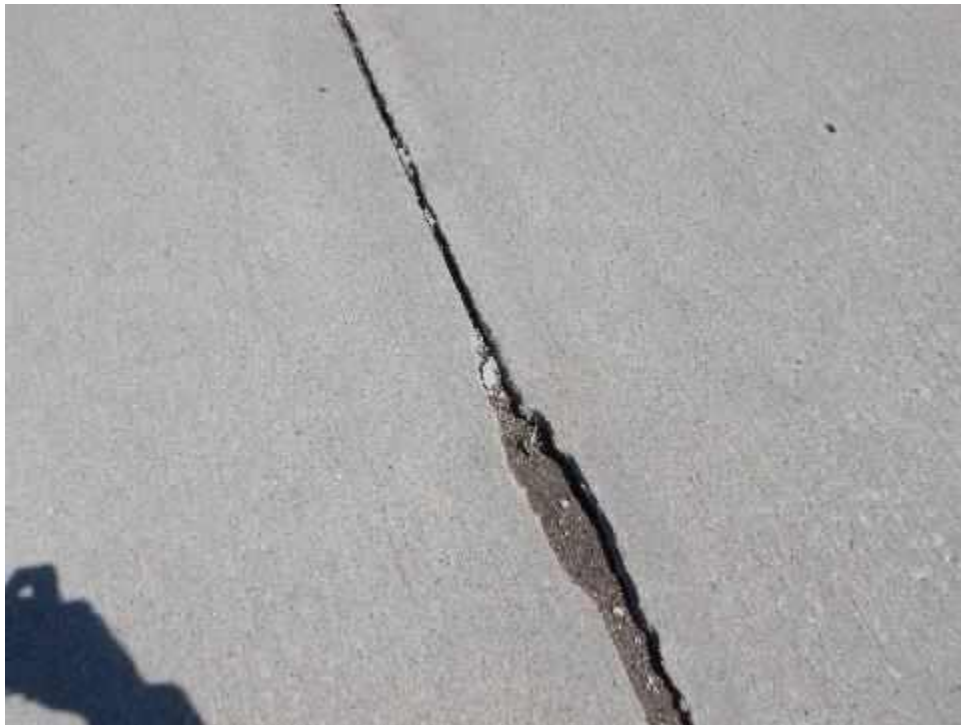
OAKS-S16-Durability Cracking-(Sample Unit No. 02)

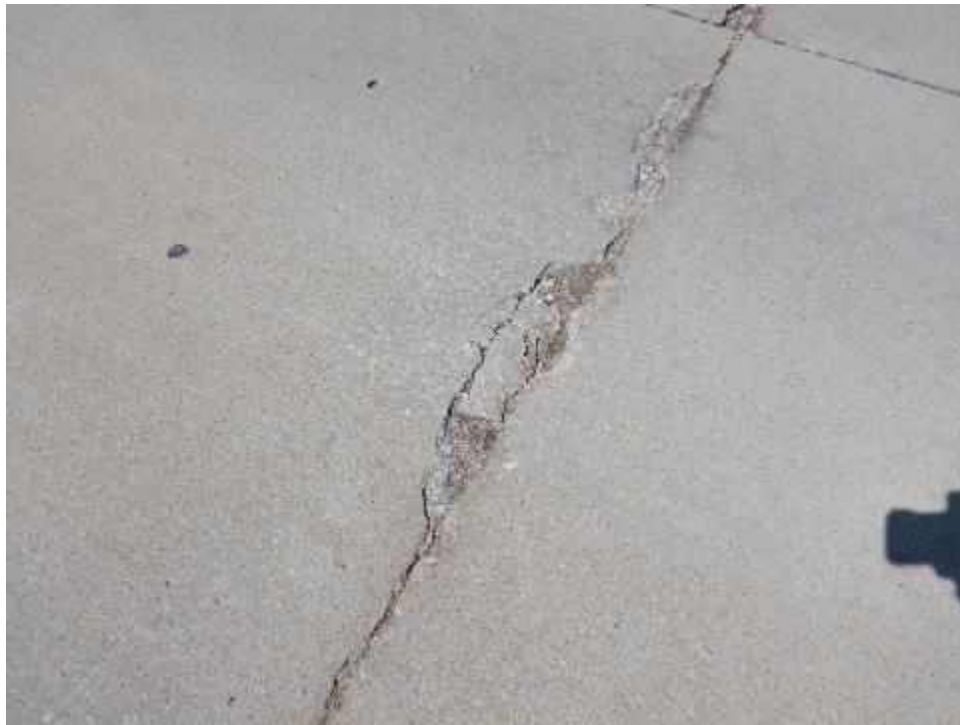
OAKS-S16-Joint Seal Damage-(Sample Unit No. 01)

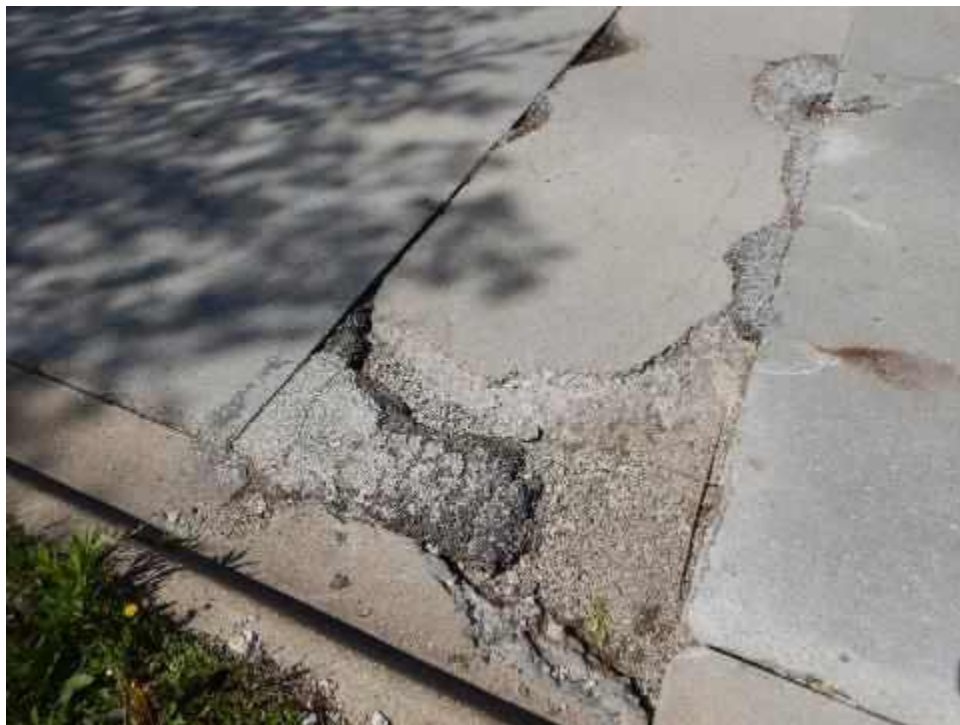
OAKS-S16-Joint Spalling-(Sample Unit No. 01)

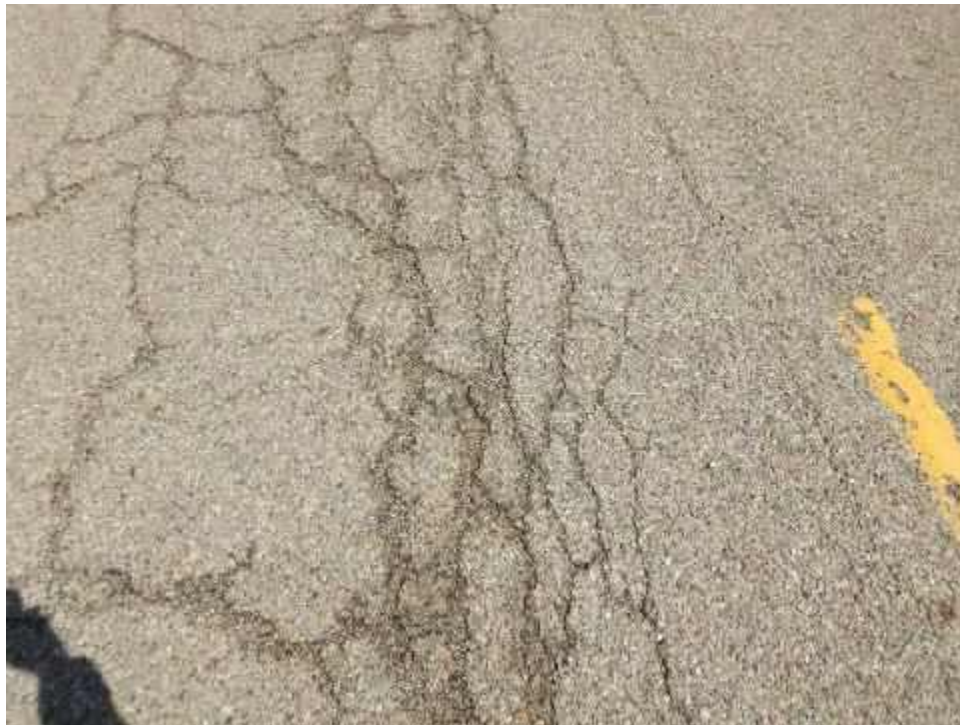
OAKS-S18A-Alligator Cracking-(Sample Unit No. 01)

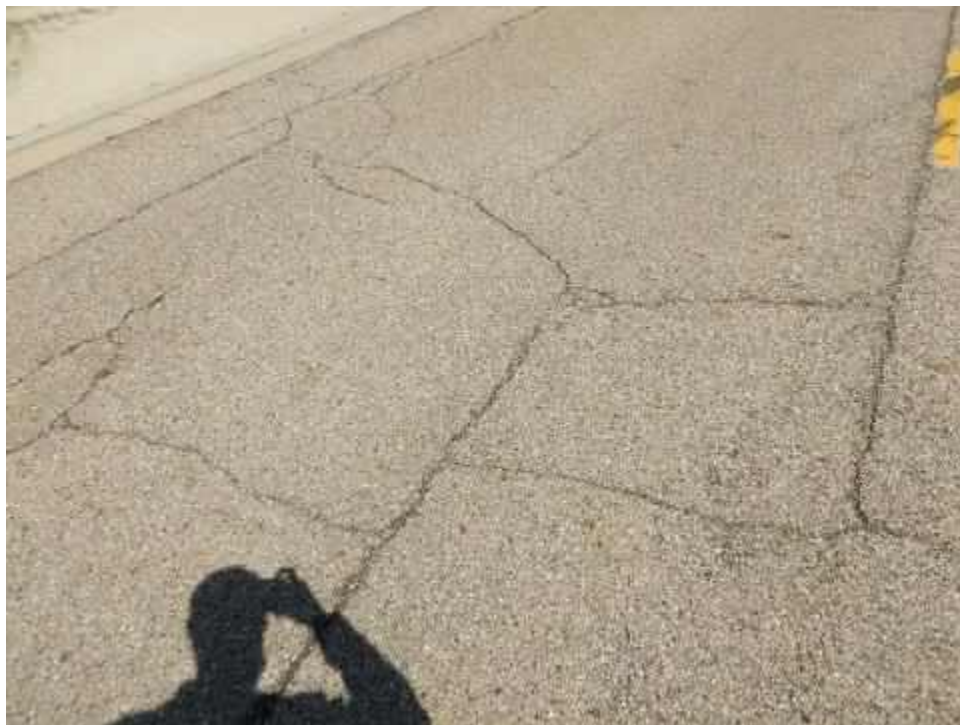
OAKS-S18A-Alligator Cracking-(Sample Unit No. 02)

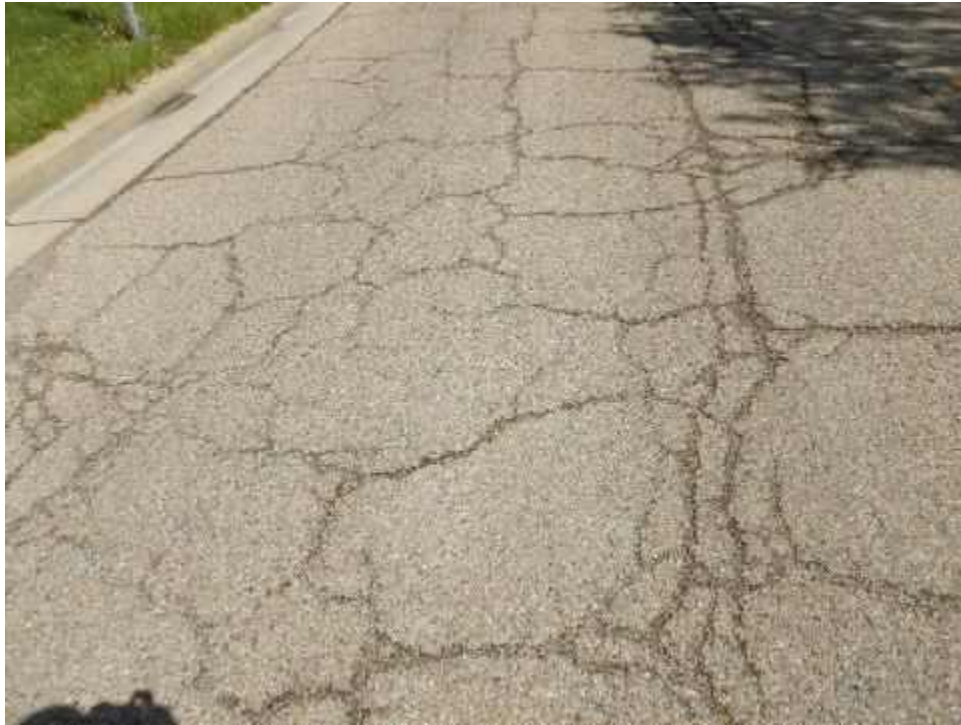
OAKS-S18A-Block Cracking-(Sample Unit No. 01)

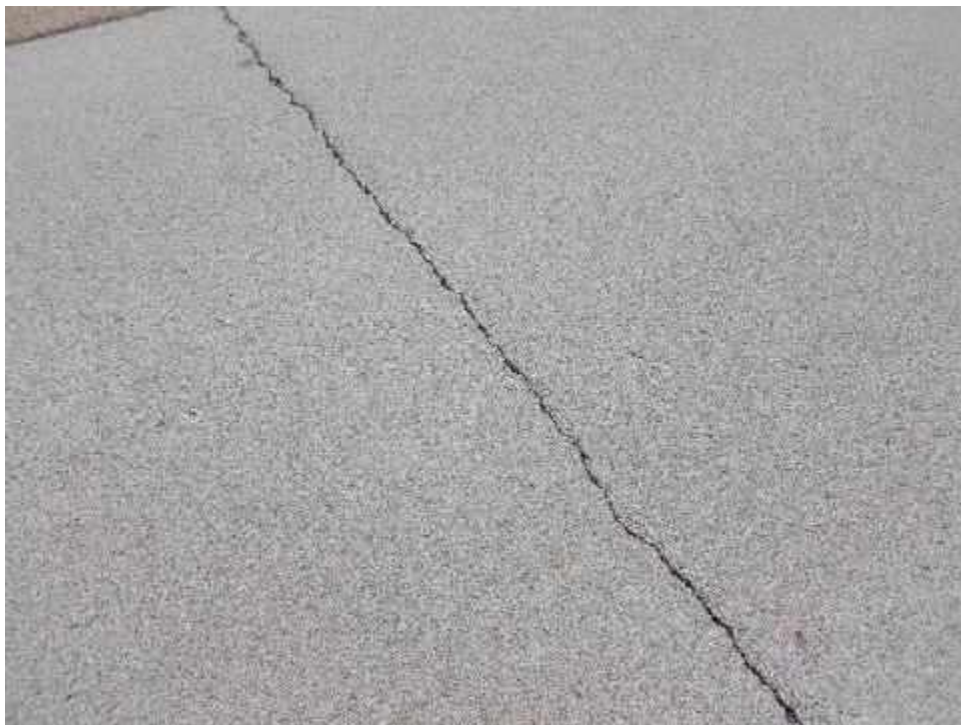
OAKS-S18A-Weathering-(Sample No. 01)
