# U20069: Pavement Analysis Study 2020 University of Illinois at Urbana-Champaign

## Final Report

Applied Pavement Technology, Inc.  
115 West Main Street, Suite 400  
Urbana, Illinois 61801  
(217) 398-3977  
[www.appliedpavement.com](http://www.appliedpavement.com)

**AUGUST 2020**

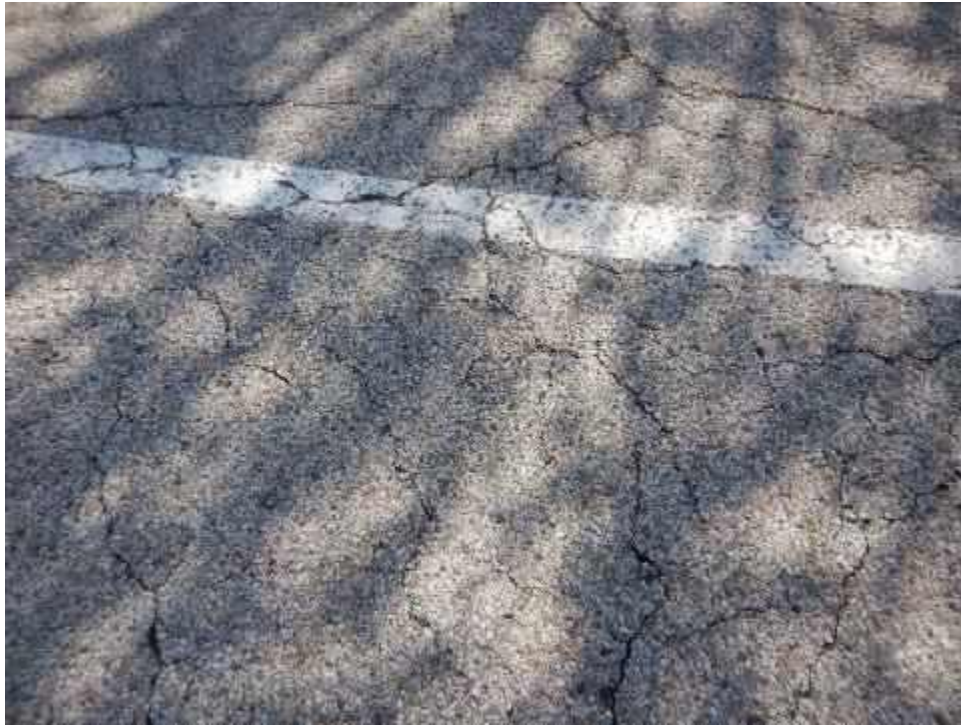
OAKS-S18B-Weathering-(Sample Unit No. 05)

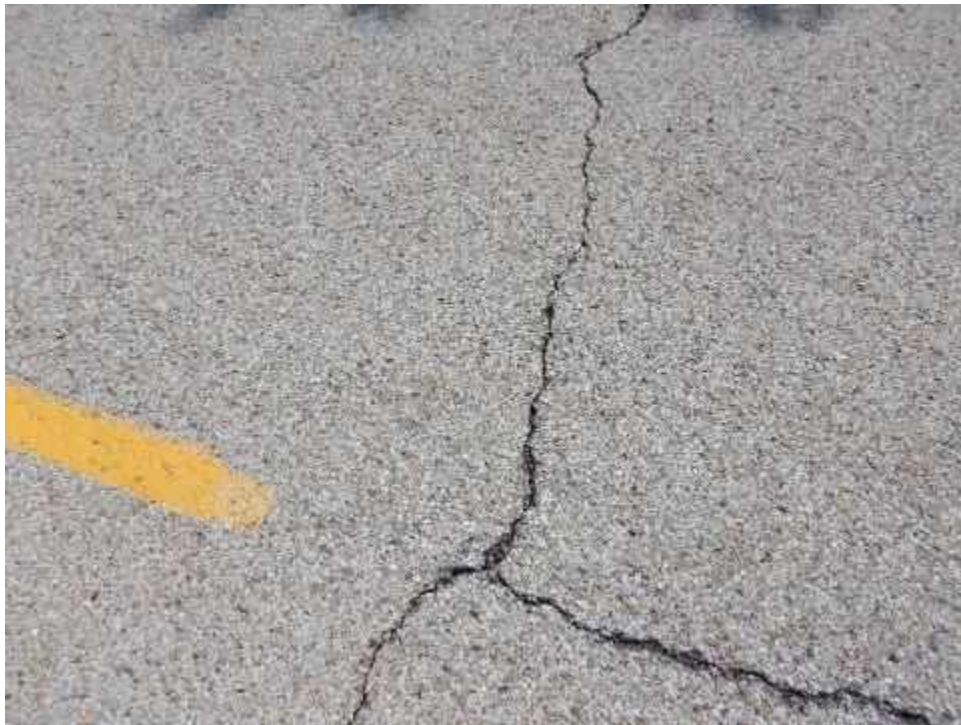
OAKS-S20A-Alligator Cracking-(Sample Unit No. 01)

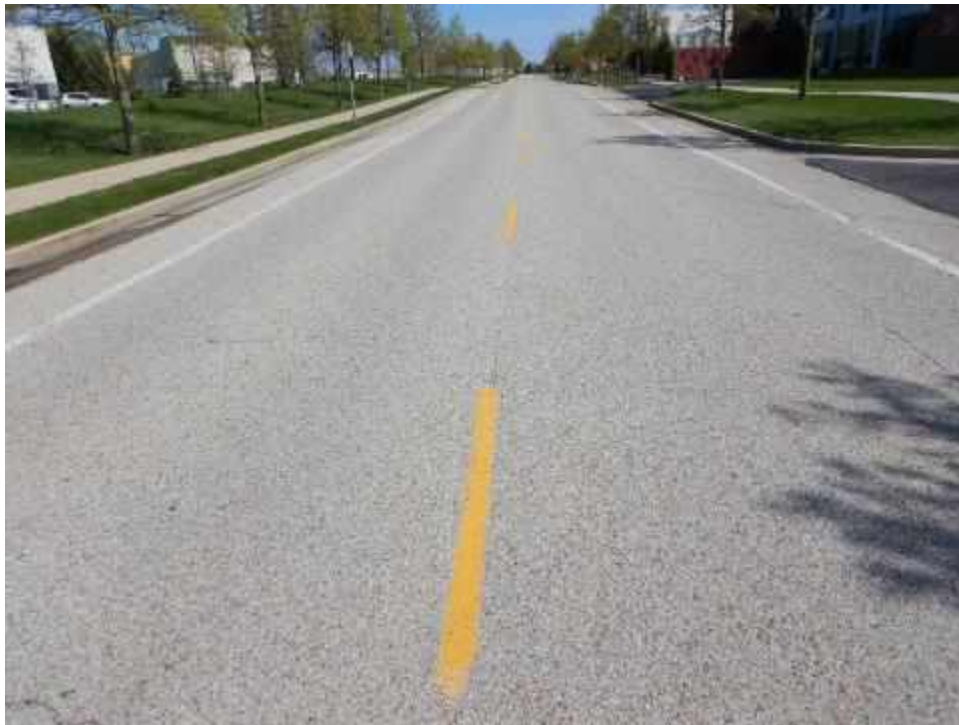
OAKS-S20A-L&T Cracking-(Sample Unit No. 01)

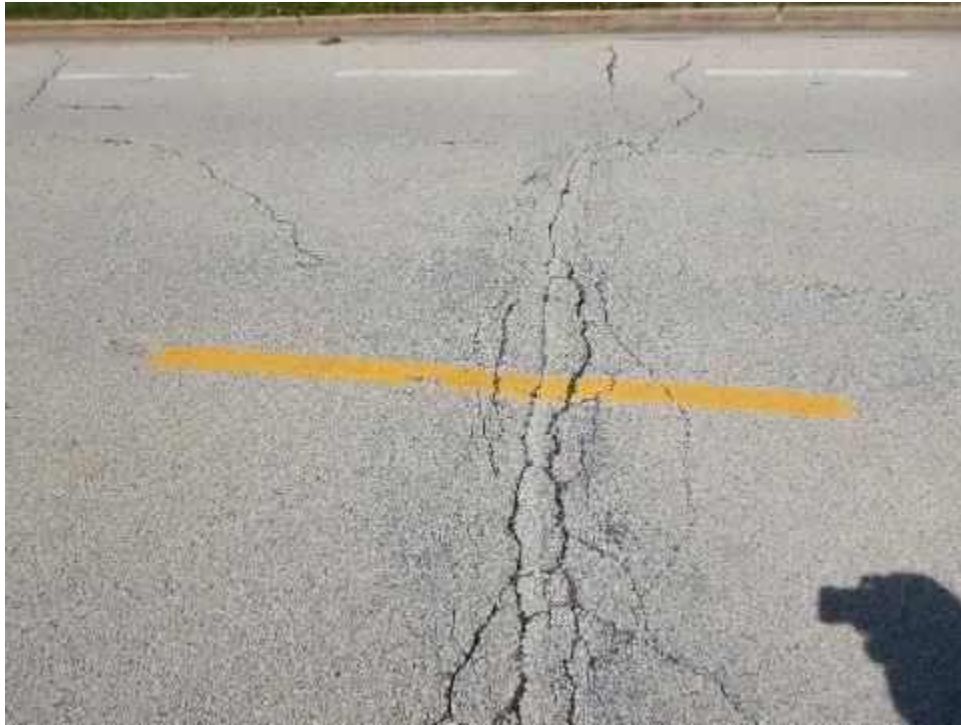
OAKS-S20B-Alligator Cracking-(Sample Unit No. 01)

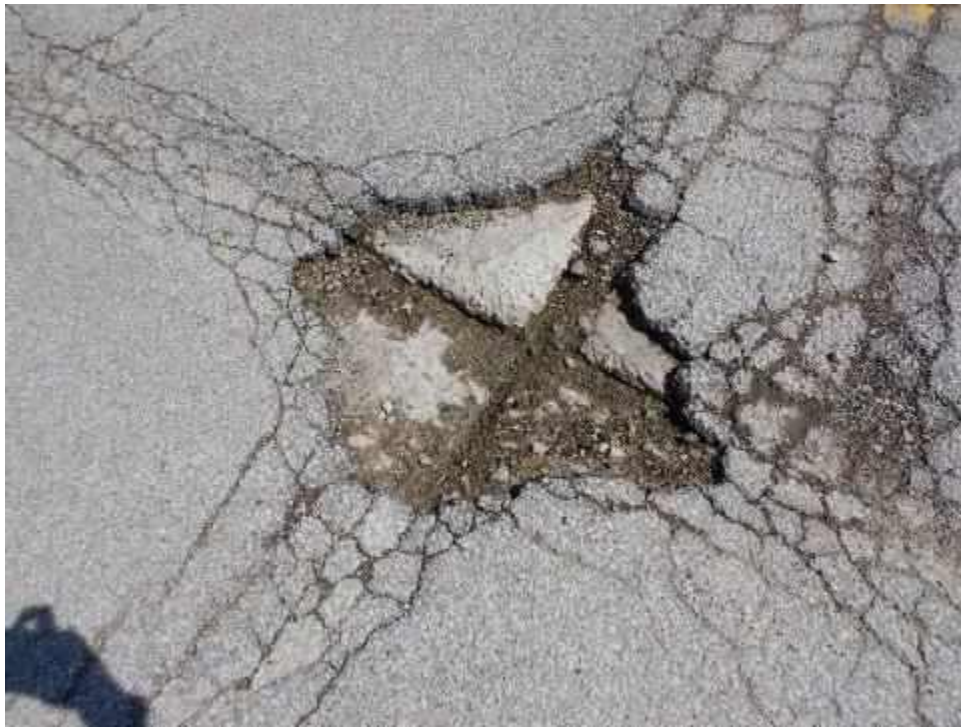
PEABYD-E01A-Patching-(Sample Unit No. 02)

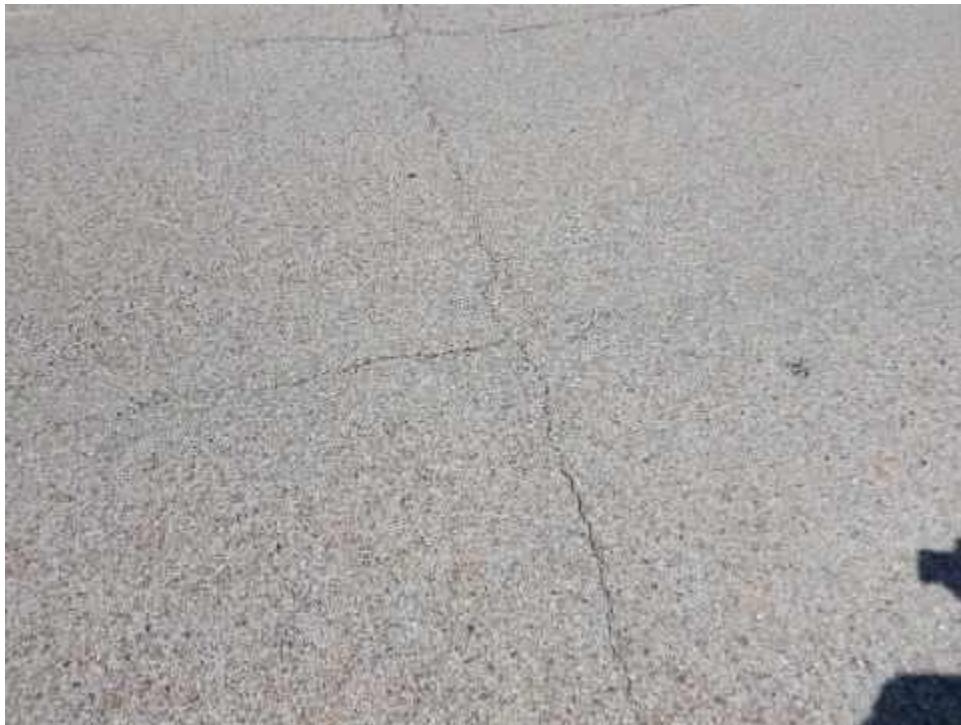
PEABYD-E01A-Pothole-(Sample Unit No. 01)

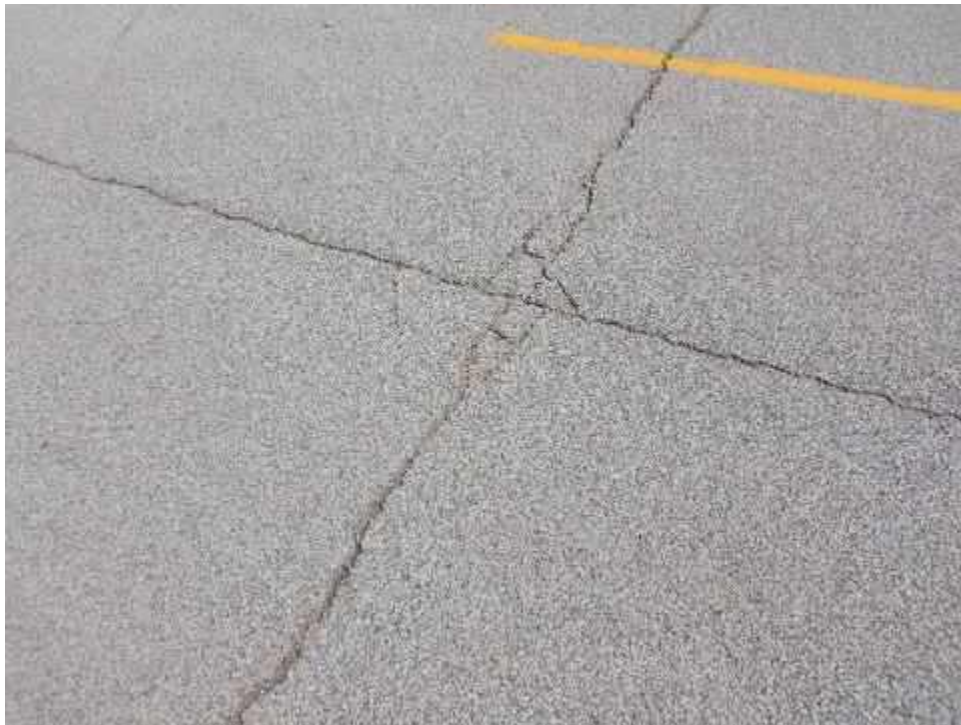
PEABYD-E03-Alligator Cracking-(Sample Unit No. 01)

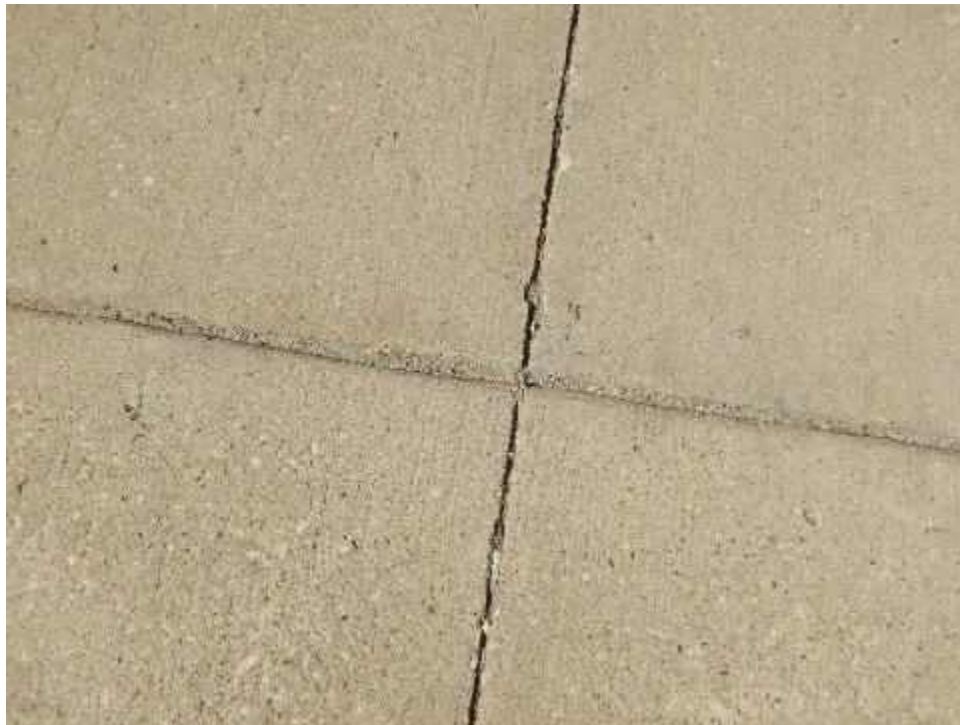
PEABYD-E04B-Corner Spalling-(Sample Unit No. 01)

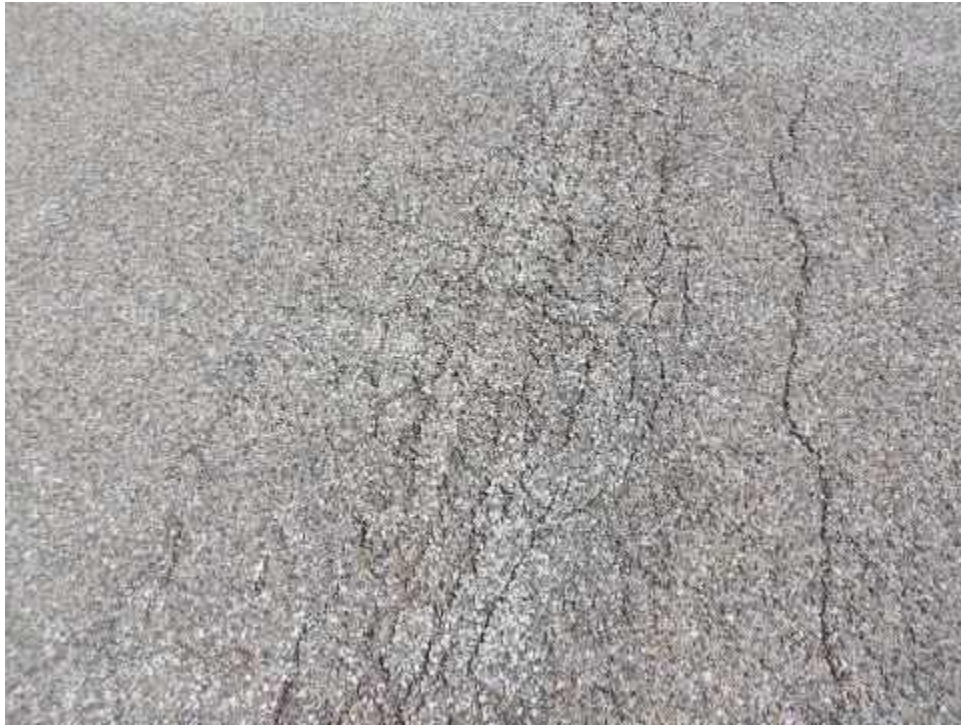
PEABYD-E06A-Raveling-(Sample Unit No. 01)

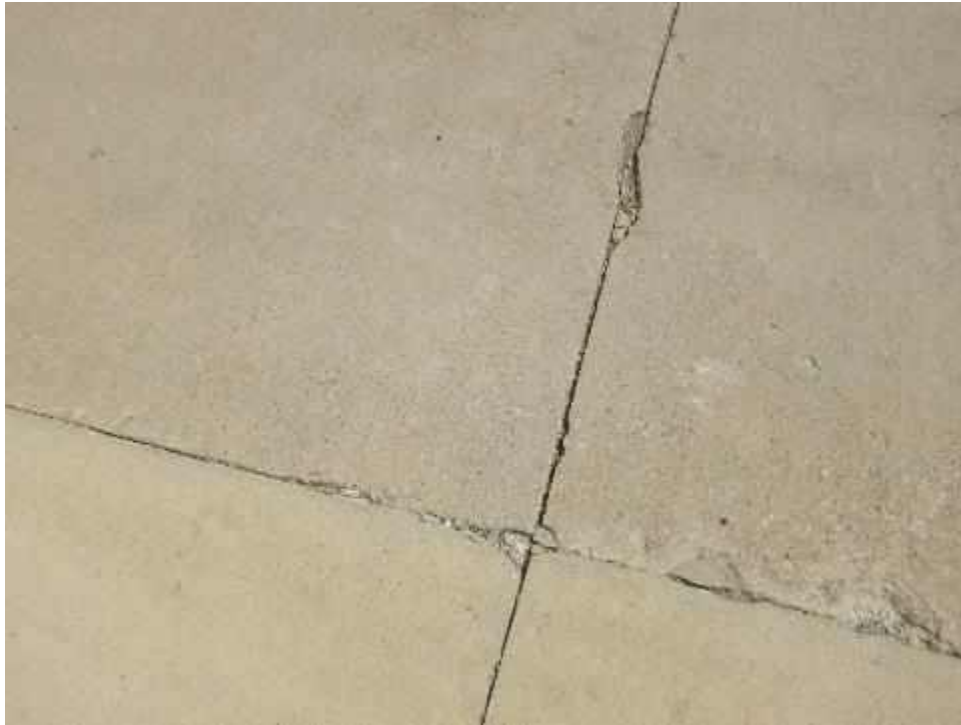
PEABYD-E06B-Weathering-(Sample Unit No. 01)

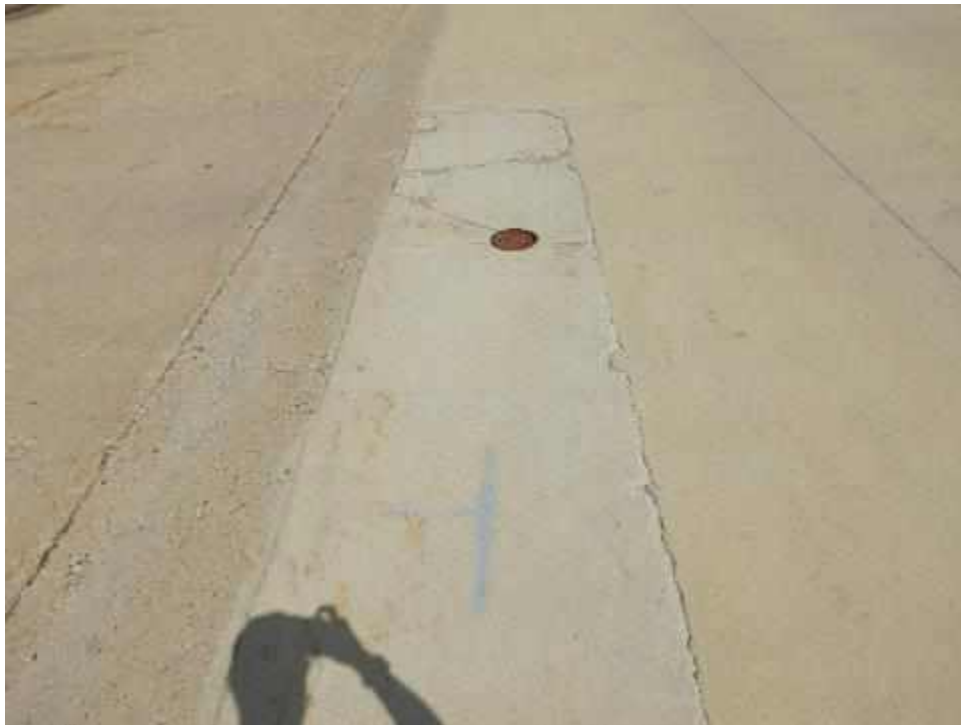
PEABYD-UW11-Joint Seal Damage-(Sample Unit No. 01)

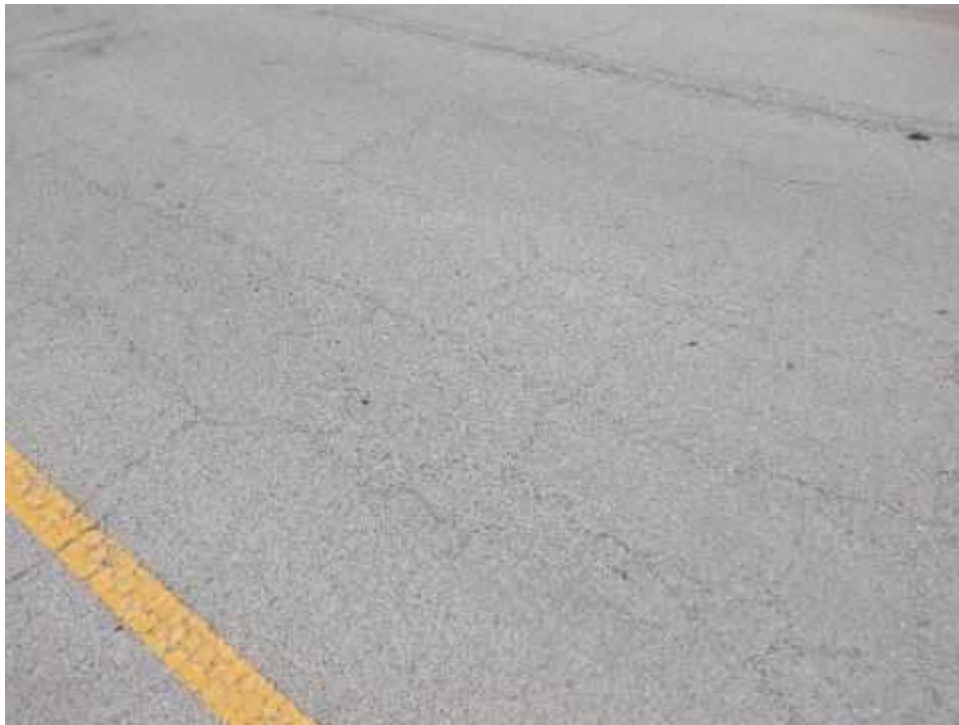
PENSYA-UW09A-Alligator Cracking-(Sample Unit No. 01)

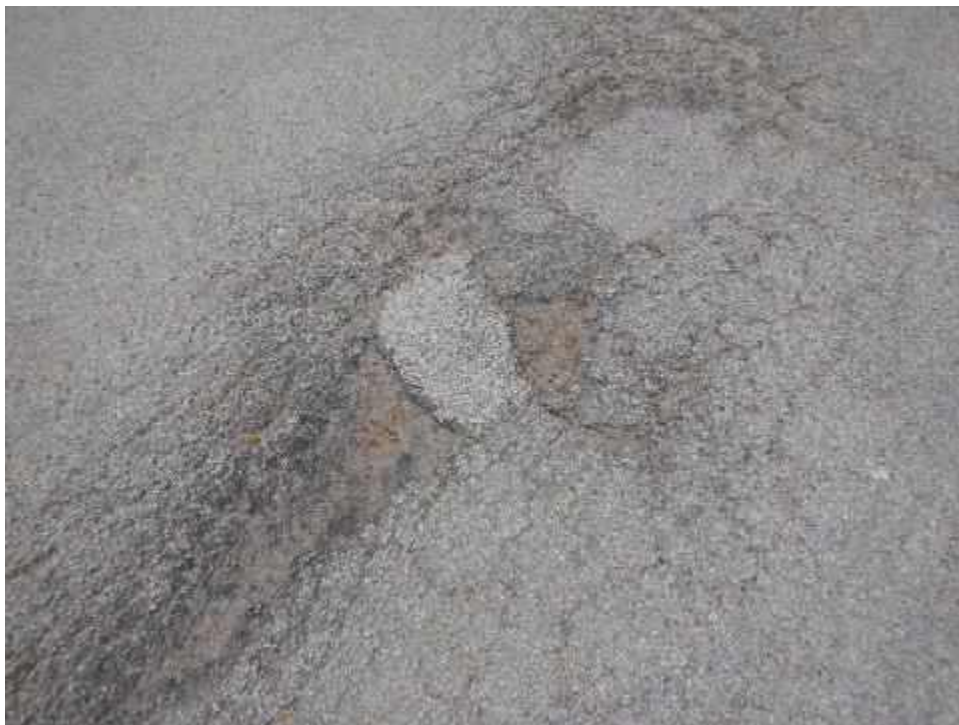
PENSYA-UW09A-Weathering-(Sample Unit No. 01)

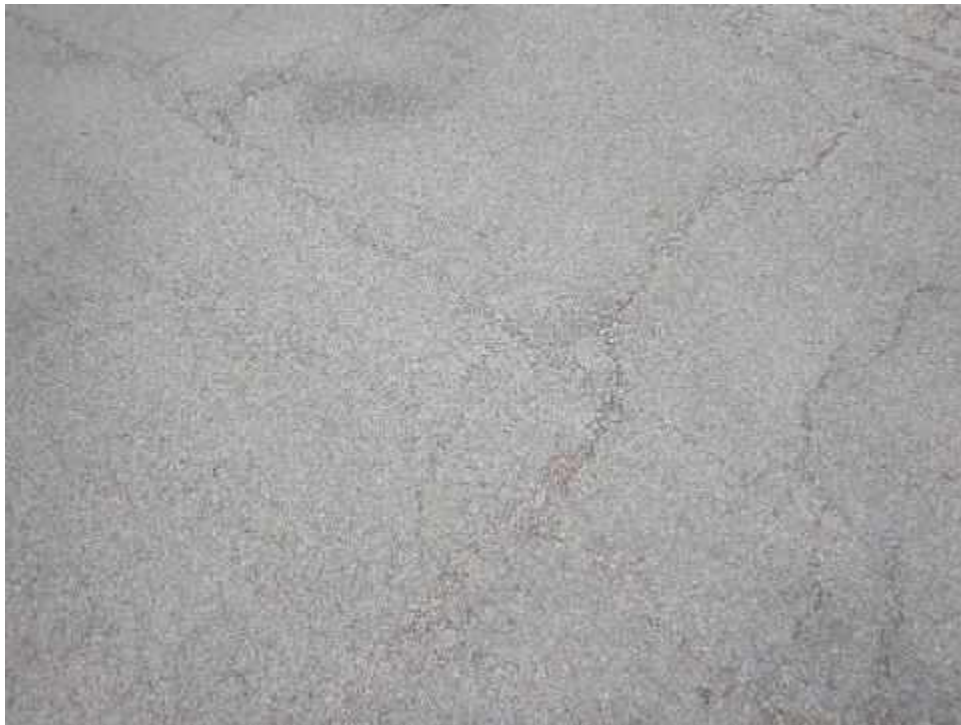
PENSYA-UW09B-Alligator Cracking-(Sample Unit No. 01)

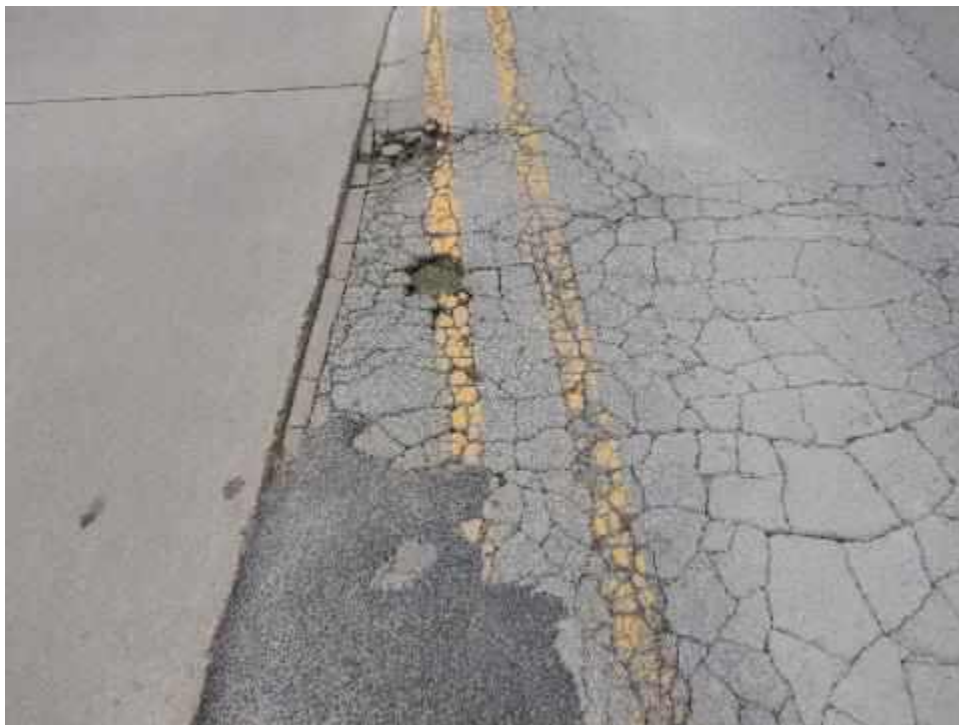
PENSYA-UW09B-Raveling-(Sample Unit No. 01)

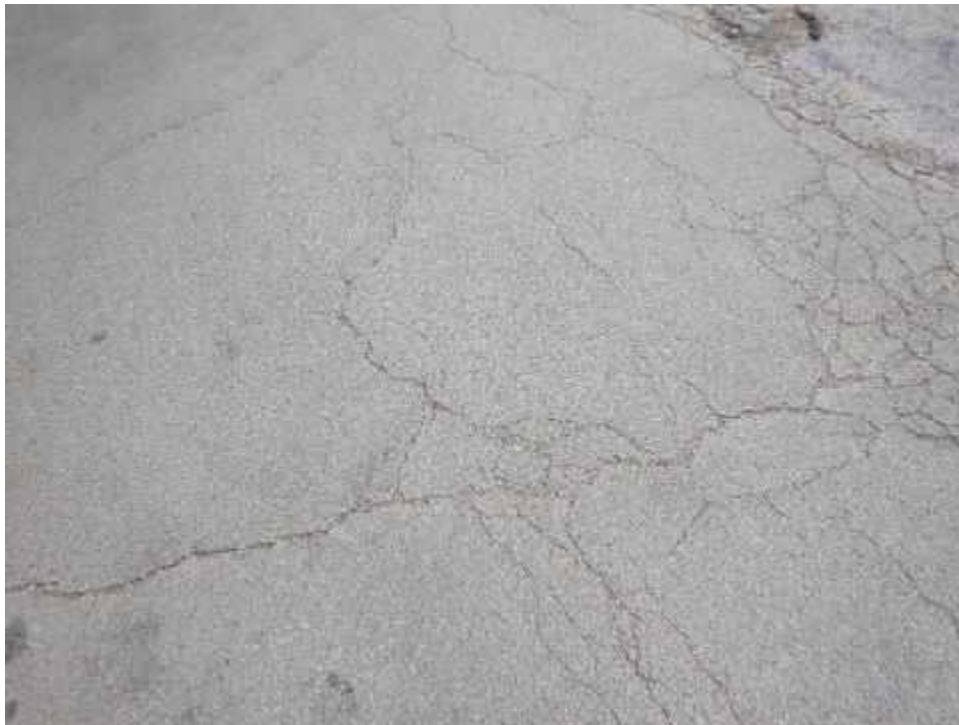
PENSYA-UW11A-Alligator Cracking-(Sample Unit No. 01)

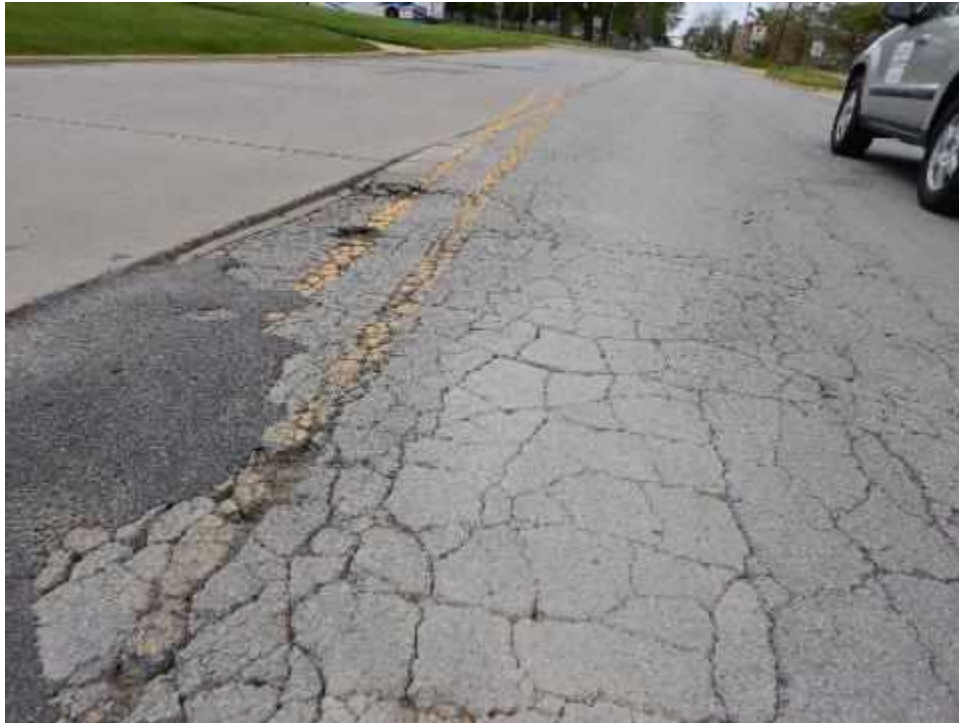
PENSYA-UW11A-Pothole-(Sample Unit No. 01)

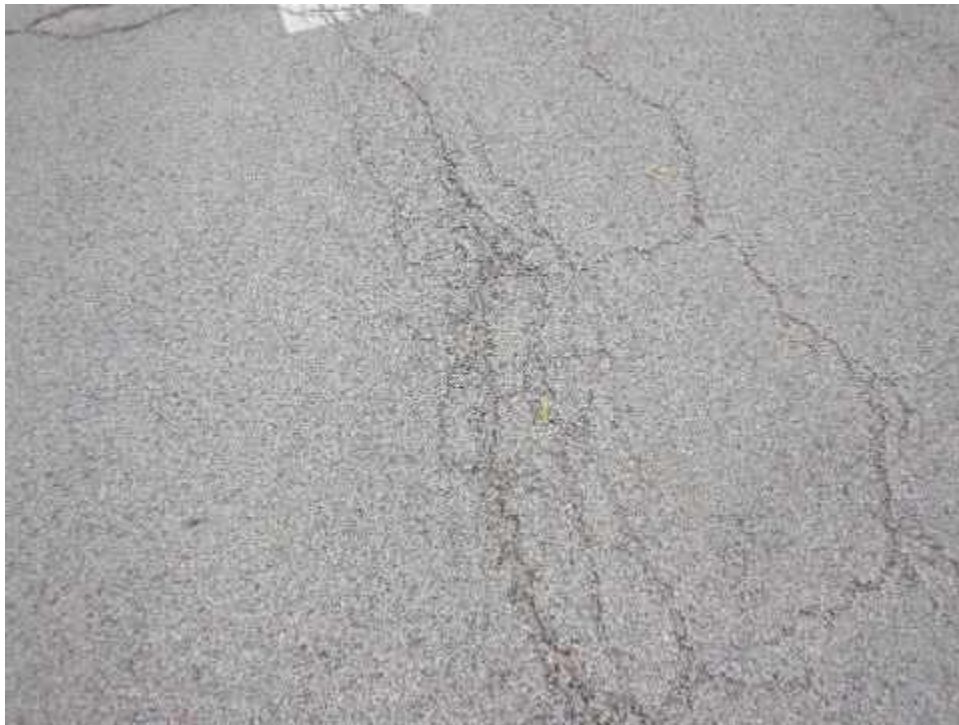
PENSYA-UW11B-Alligator Cracking-(Sample Unit No. 01)

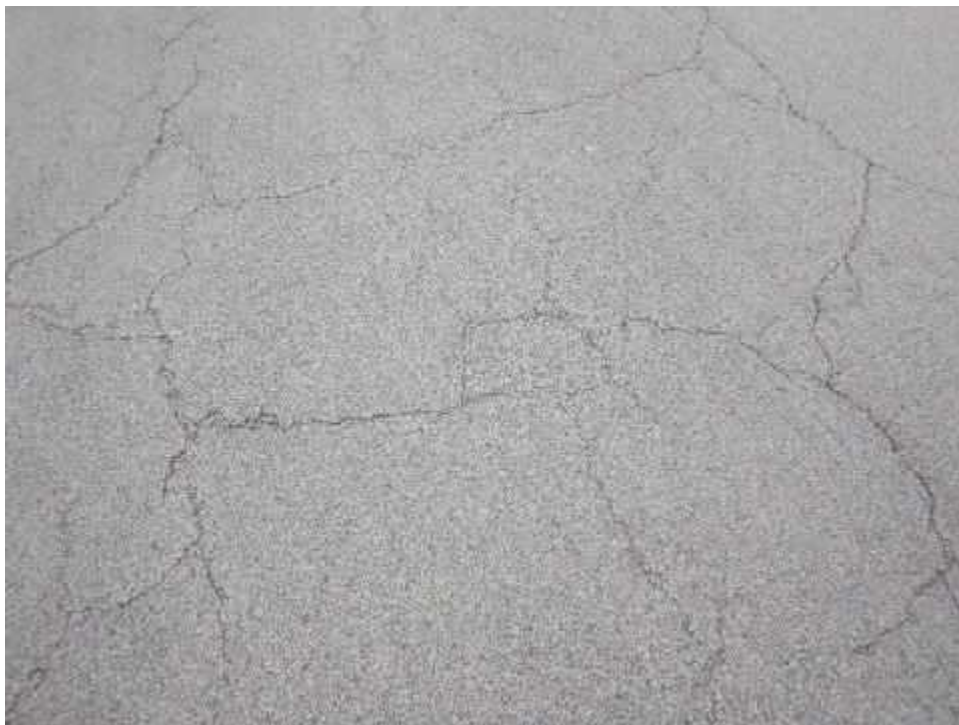
PENSYA-UW11B-Block Cracking-(Sample Unit No. 01)

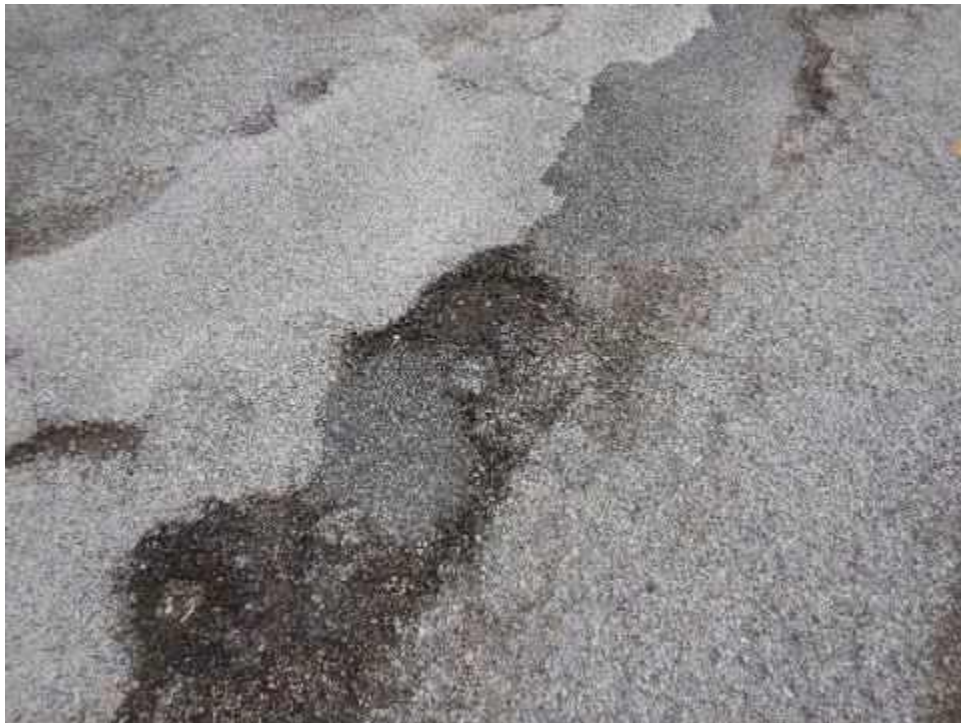
PENSYA-UW11B-Pothole-(Sample Unit No. 02)

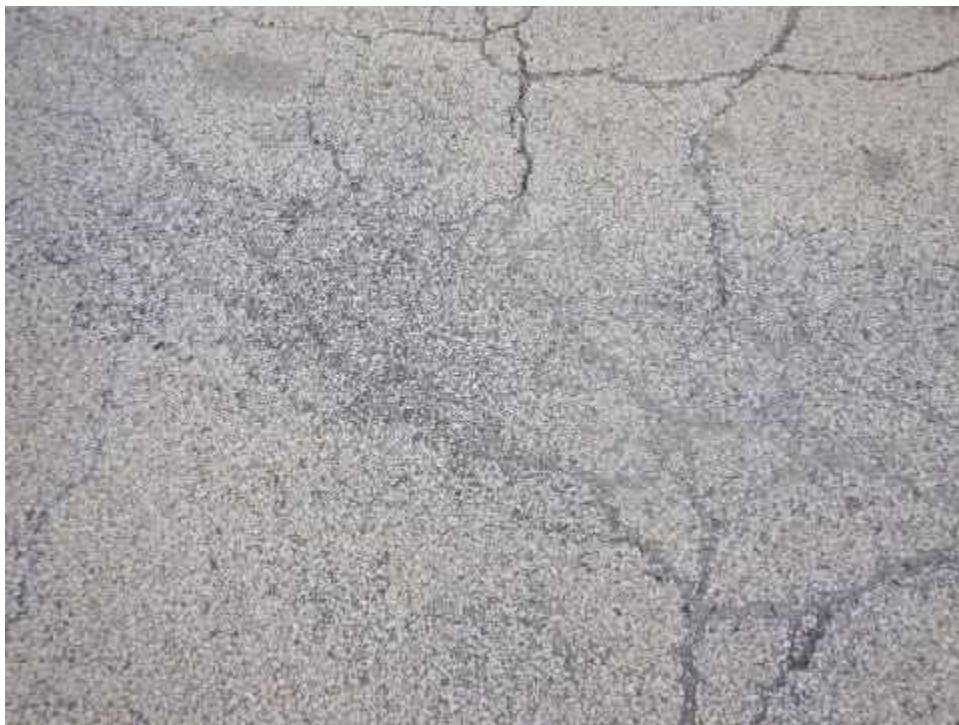
PENSYA-UW12A-Alligator Cracking-(Sample Unit No. 01)

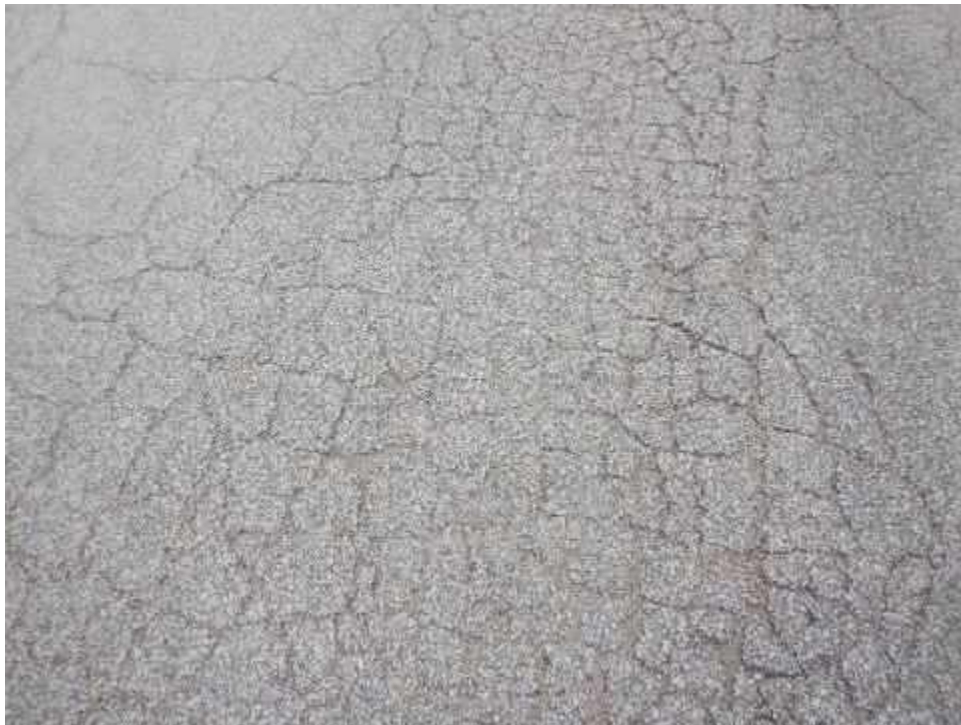
PENSYA-UW12B-Alligator Cracking-(Sample Unit No. 01)

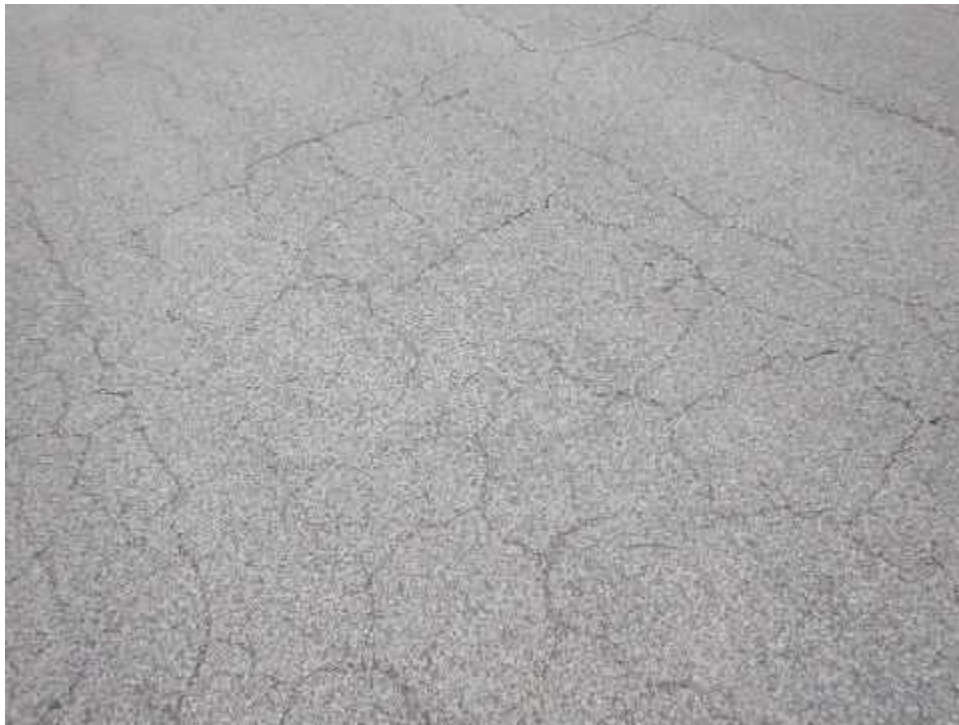
PENSYA-UW12B-Block Cracking-(Sample Unit No. 01)

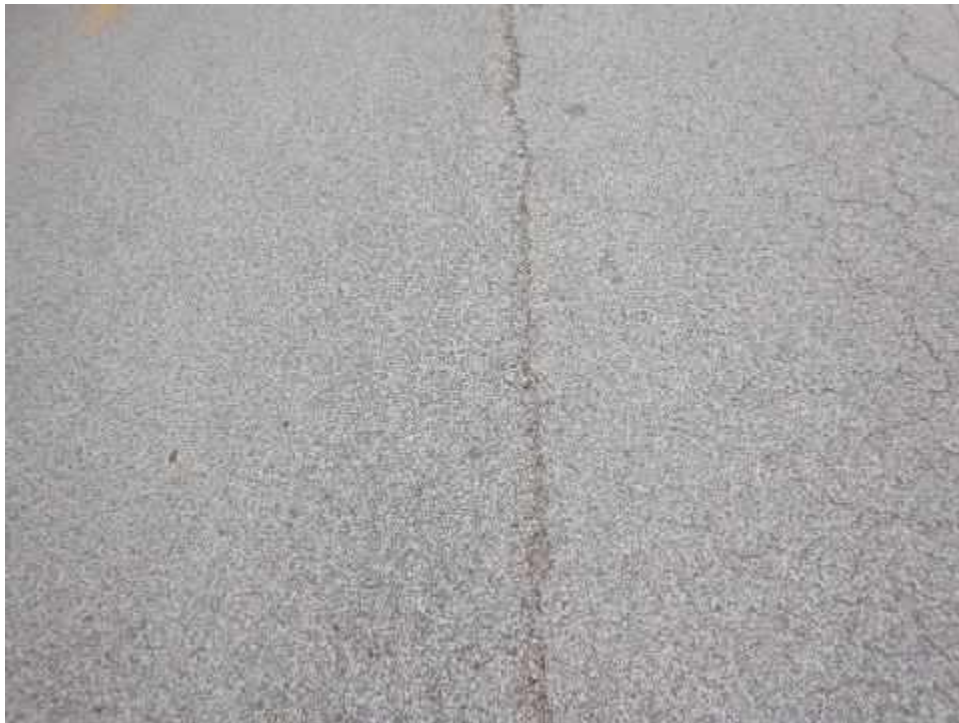
PENSYA-UW12B-L&T Cracking-(Sample Unit No. 01)

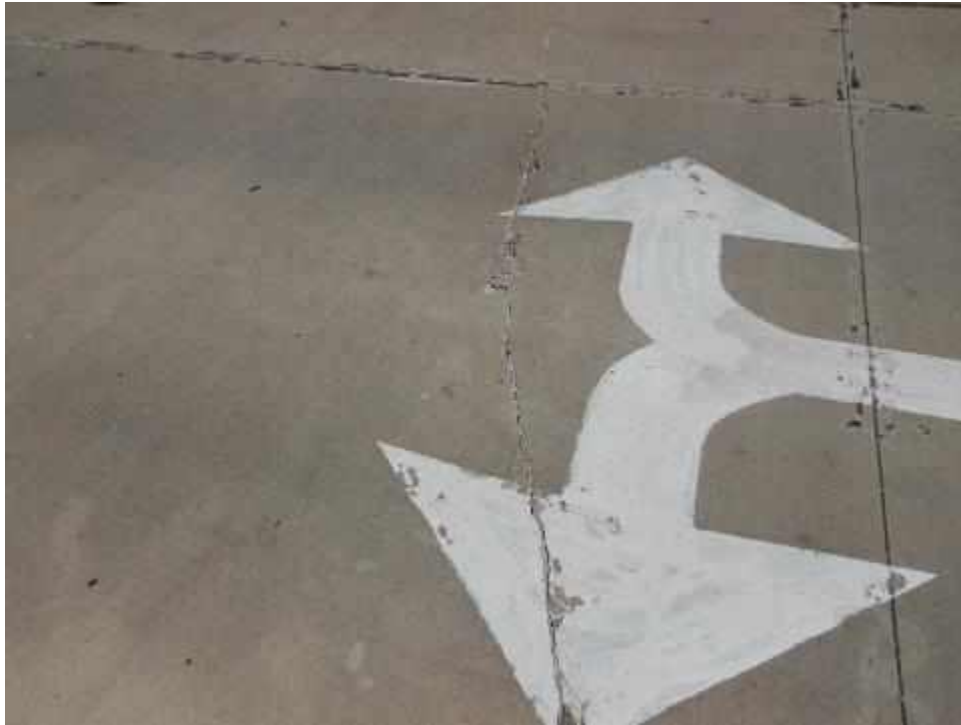
SIXTHS-S10-LTD Cracking-(Sample Unit No. 01)

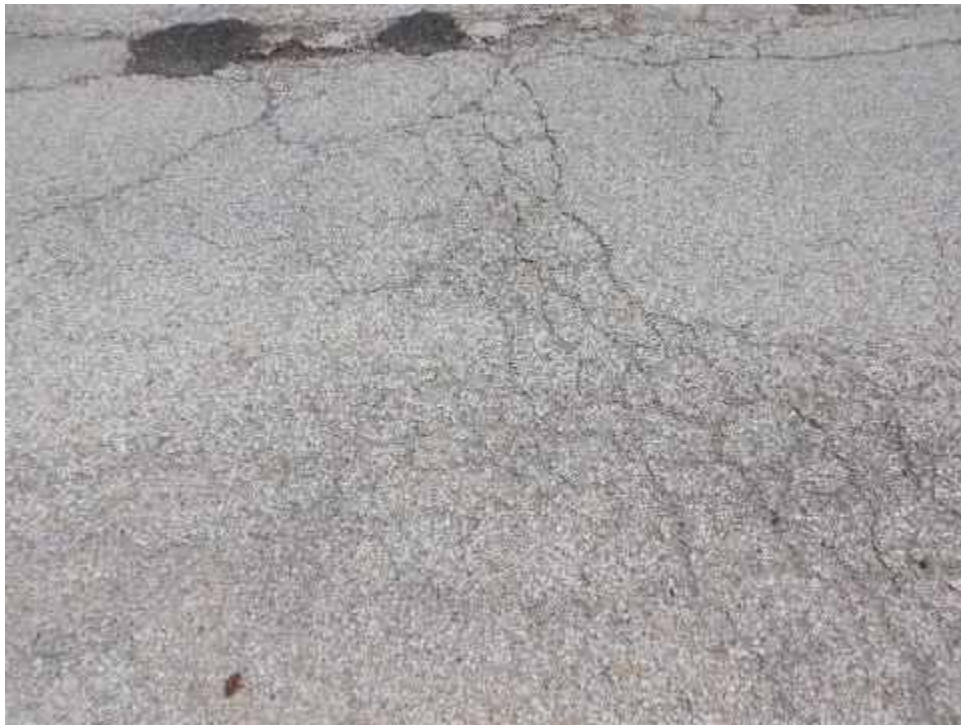
SIXTHS-S11-Alligator Cracking-(Sample Unit No. 01)

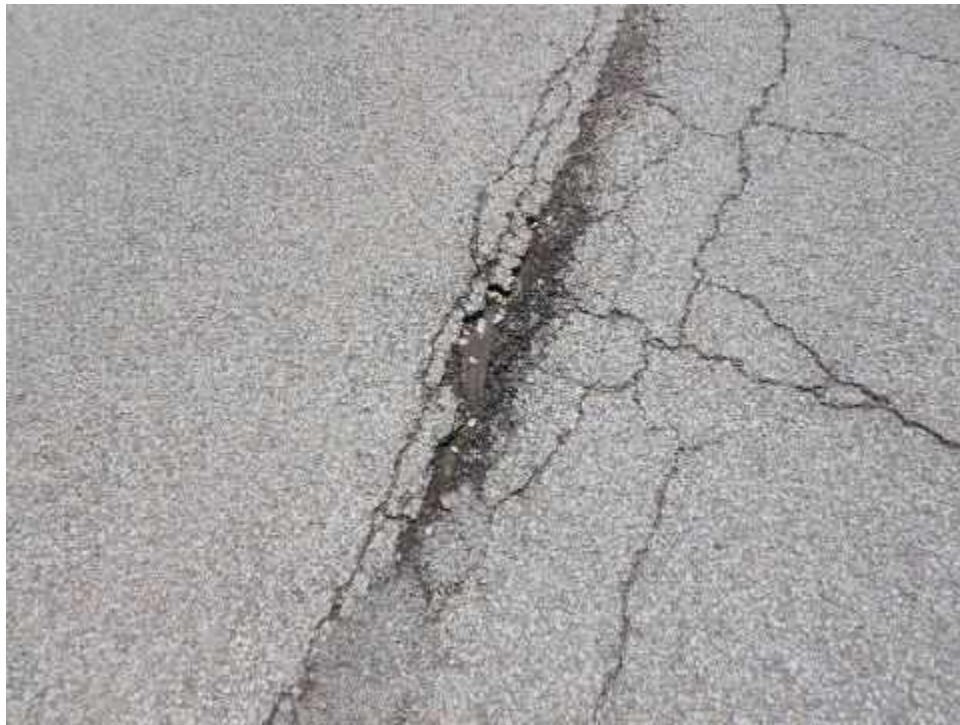
SIXTHS-S11-L&T Cracking-(Sample Unit No. 01)

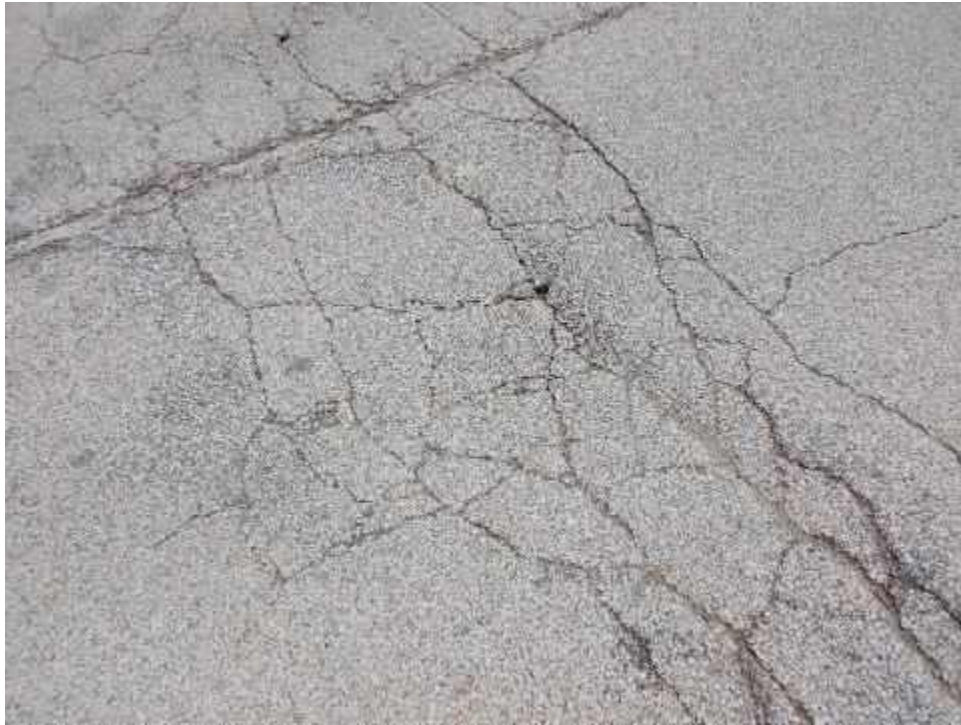
SIXTHS-S13-Alligator Cracking-(Sample Unit No. 01)

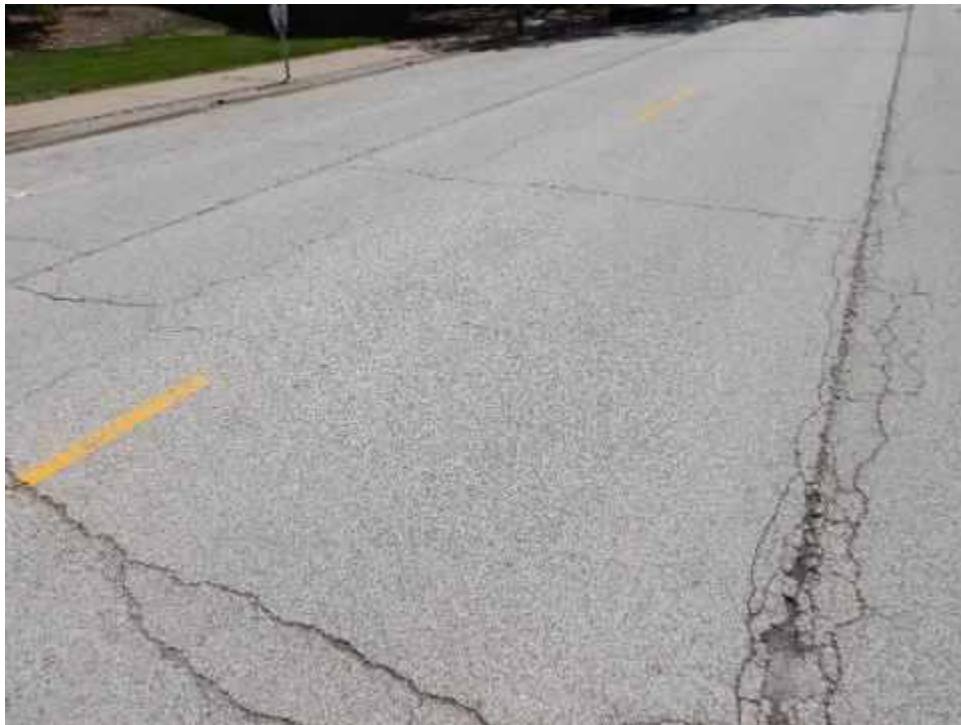
SIXTHS-S13-Joint Reflection Cracking-(Sample Unit No. 01)

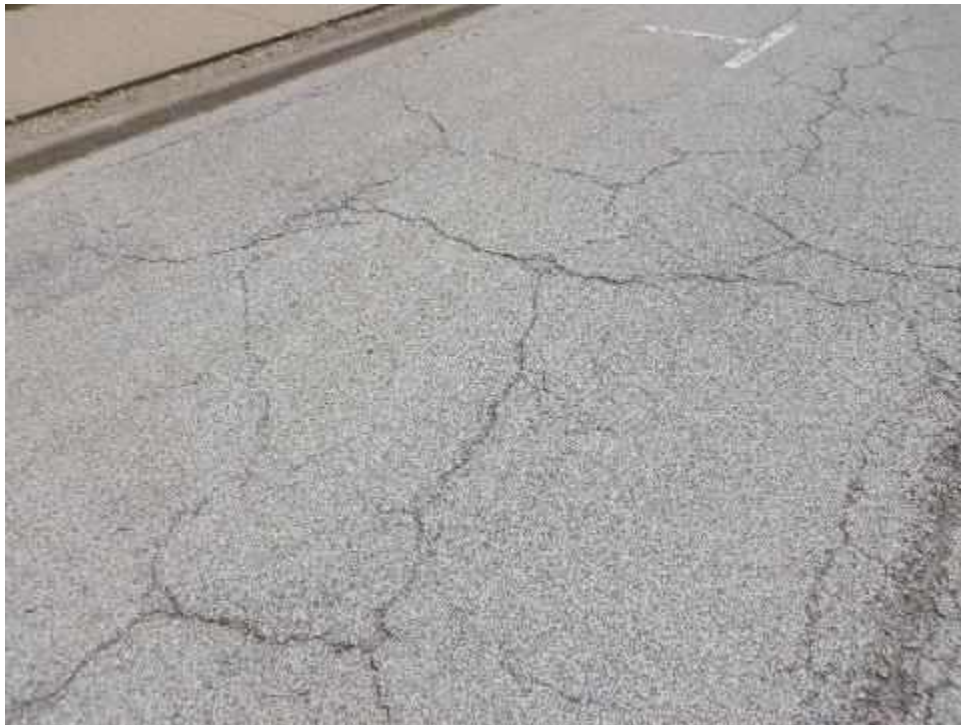
SIXTHS-S14-Block Cracking-(Sample Unit No. 01)

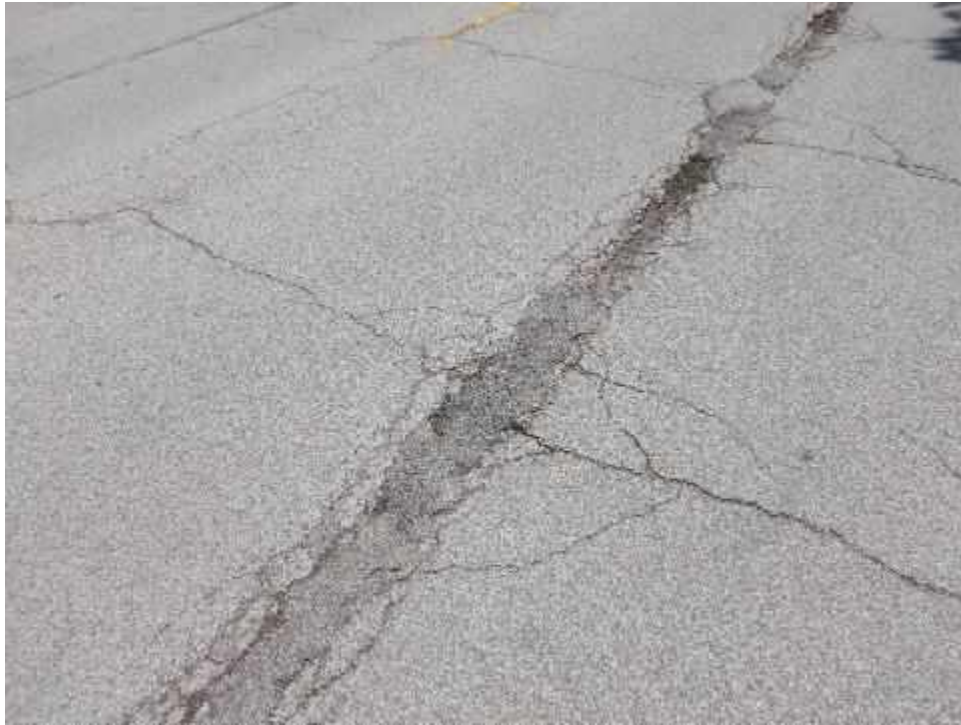
SIXTHS-S14-Joint Reflection Cracking-(Sample Unit No. 01)

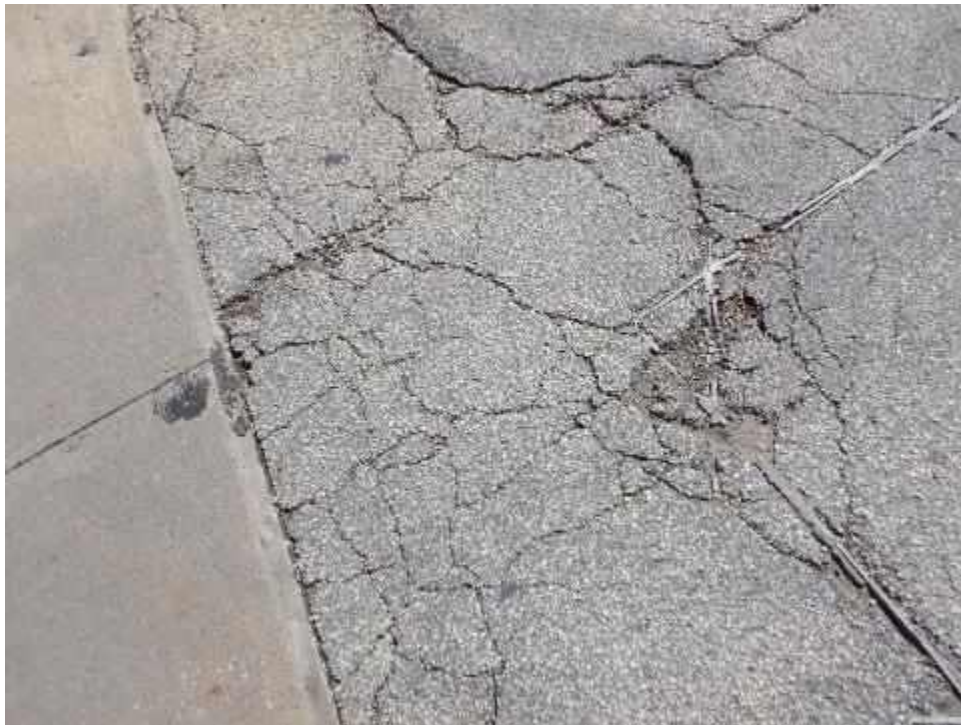
STADMD-E00A-Alligator Cracking-(Sample Unit No. 01)
