# U20069: Pavement Analysis Study 2020 University of Illinois at Urbana-Champaign

## Final Report

Applied Pavement Technology, Inc.  
115 West Main Street, Suite 400  
Urbana, Illinois 61801  
(217) 398-3977  
[www.appliedpavement.com](http://www.appliedpavement.com)

**AUGUST 2020**

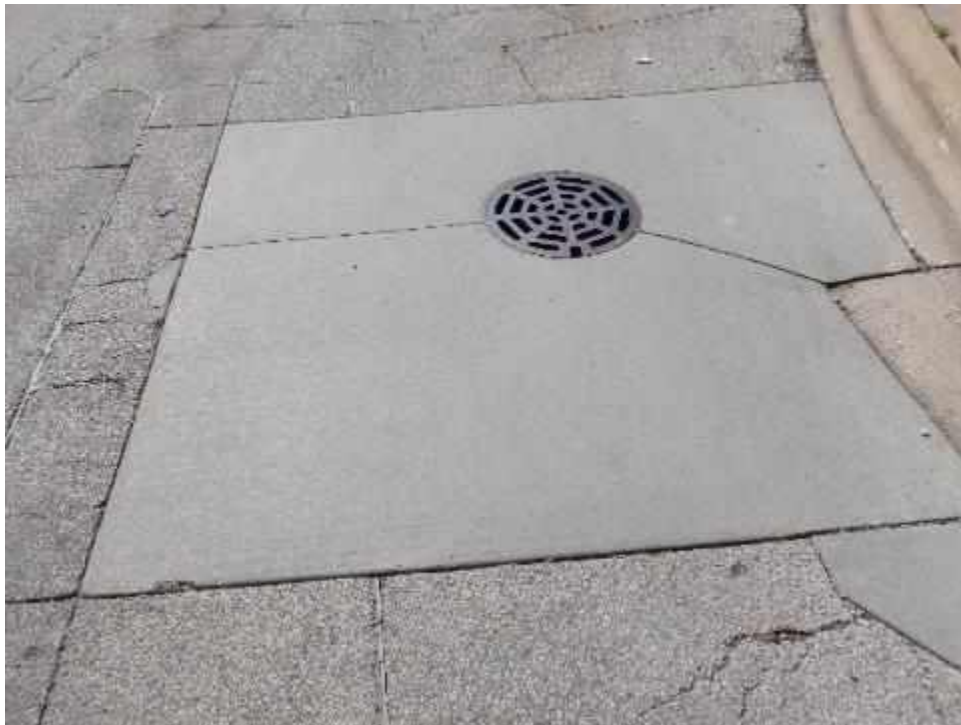
STADMD-E00A-Patching-(Sample Unit No. 01)

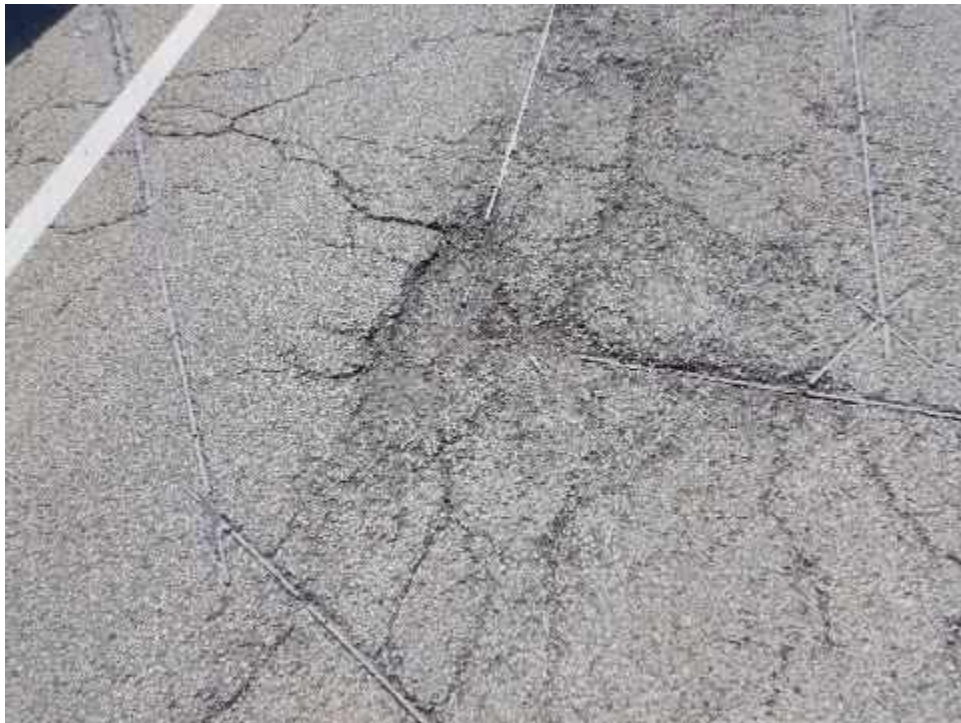
STADMD-E00A-Raveling-(Sample Unit No. 01)

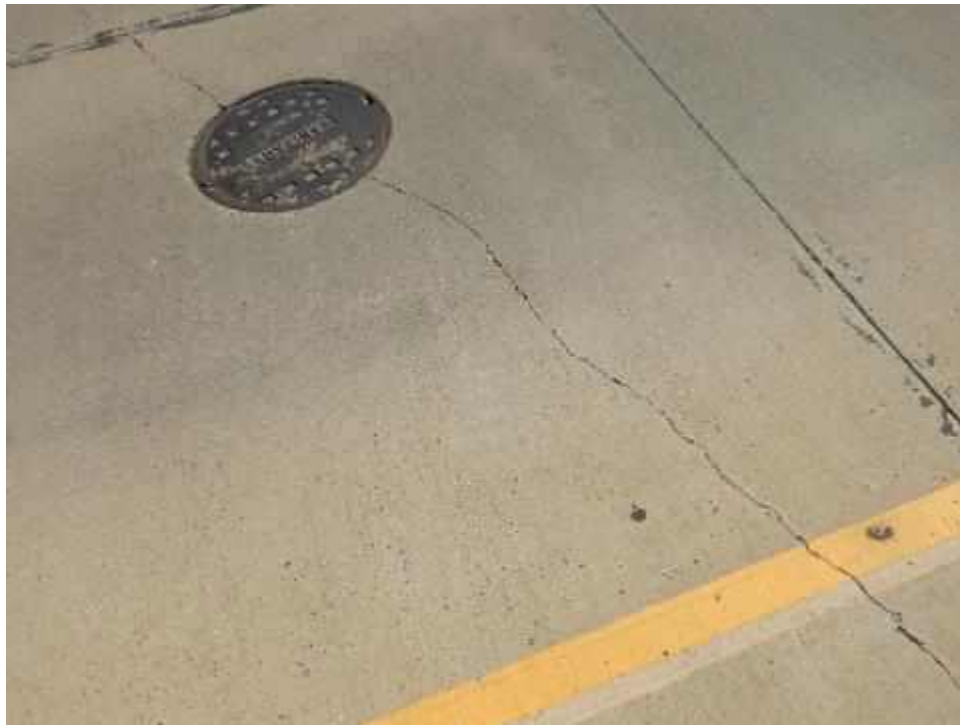
STADMD-E00B-LTD Cracking-(Sample Unit No. 01)

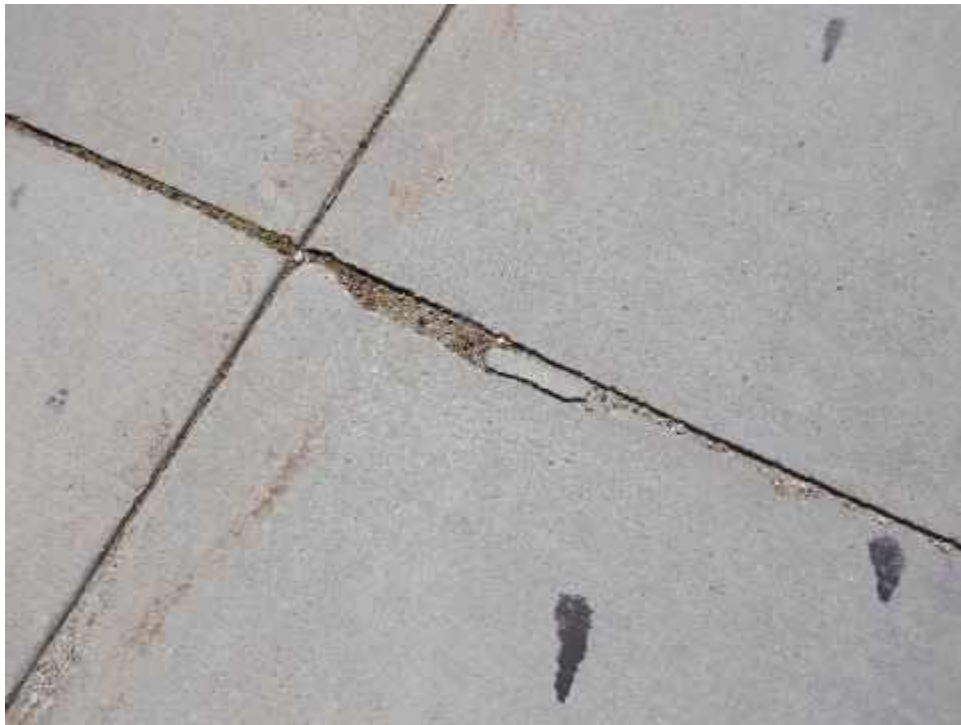
STADMD-E00C-Joint Spalling-(Sample Unit No. 071)

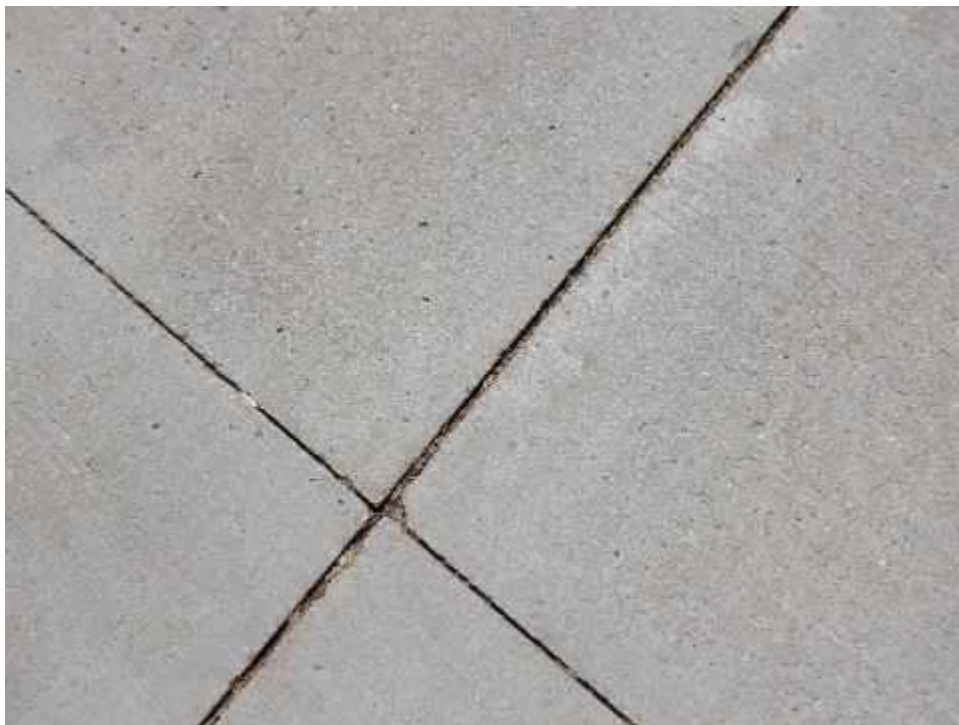
STADMD-E00D-Joint Seal Damage-(Sample Unit No. 02)

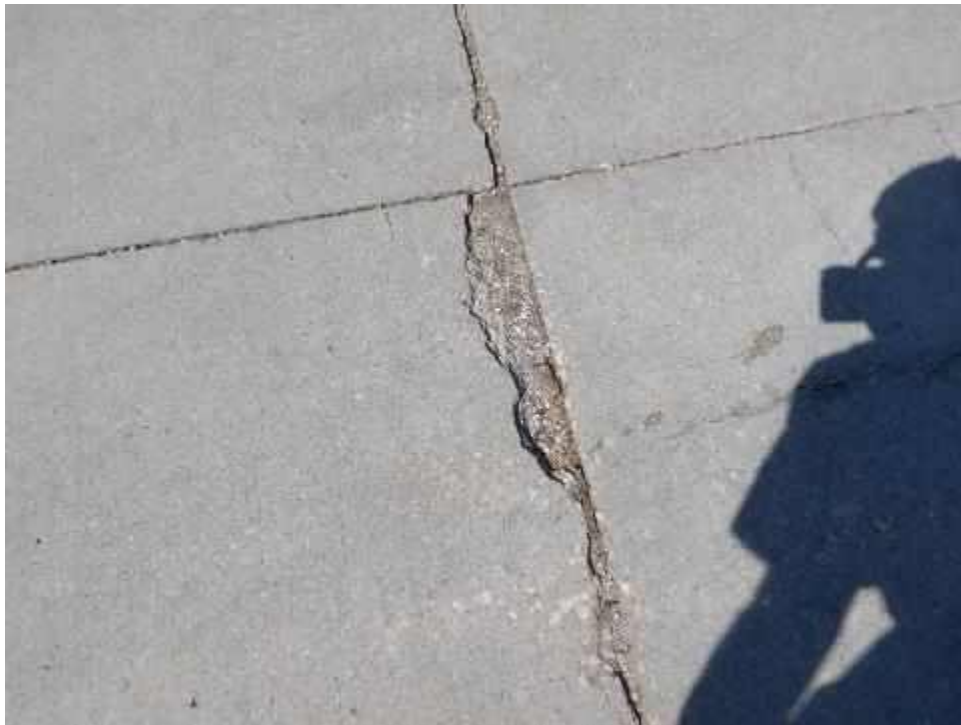
STADMD-E00D-Joint Spall-(Sample Unit No. 01)

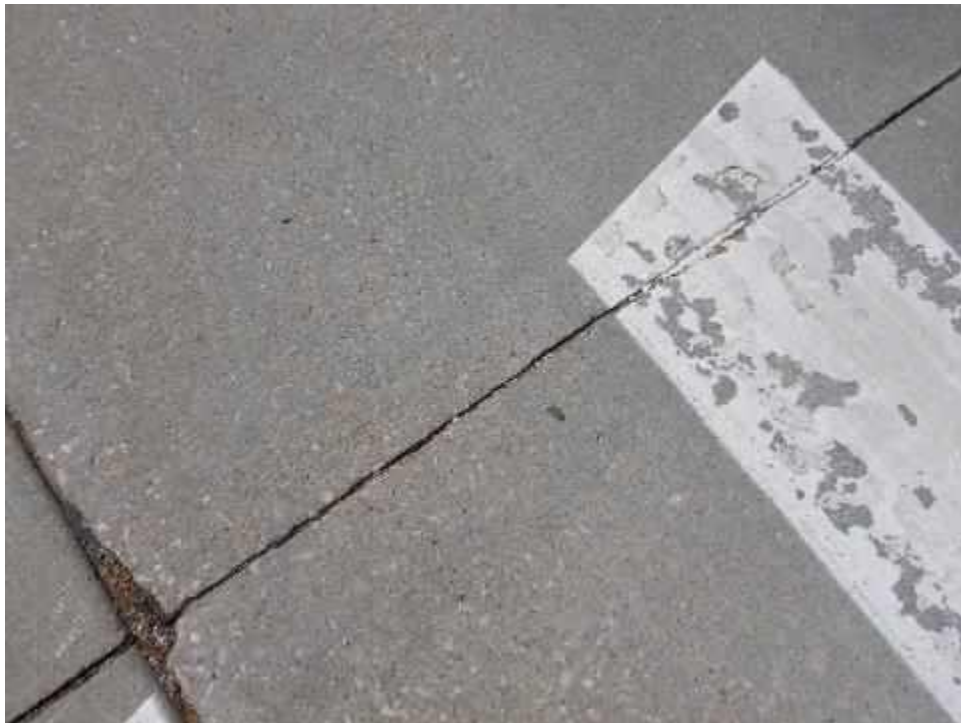
STADMD-E00D-Joint Spalling-(Sample Unit No. 01)

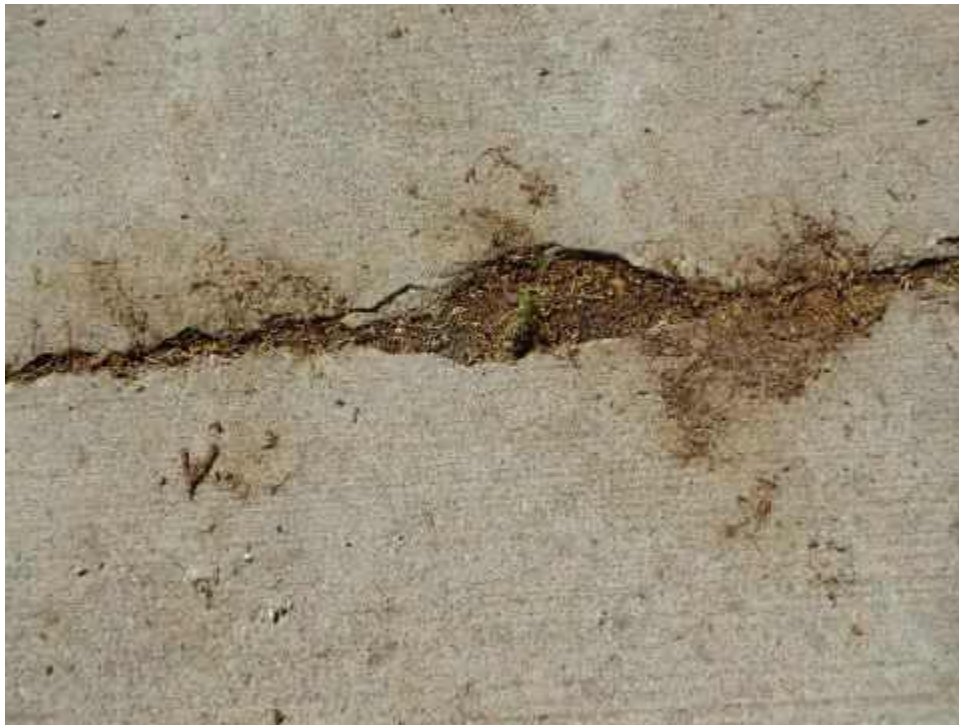
STADMD-E00D-Joint Spalling-(Sample Unit No. 02)

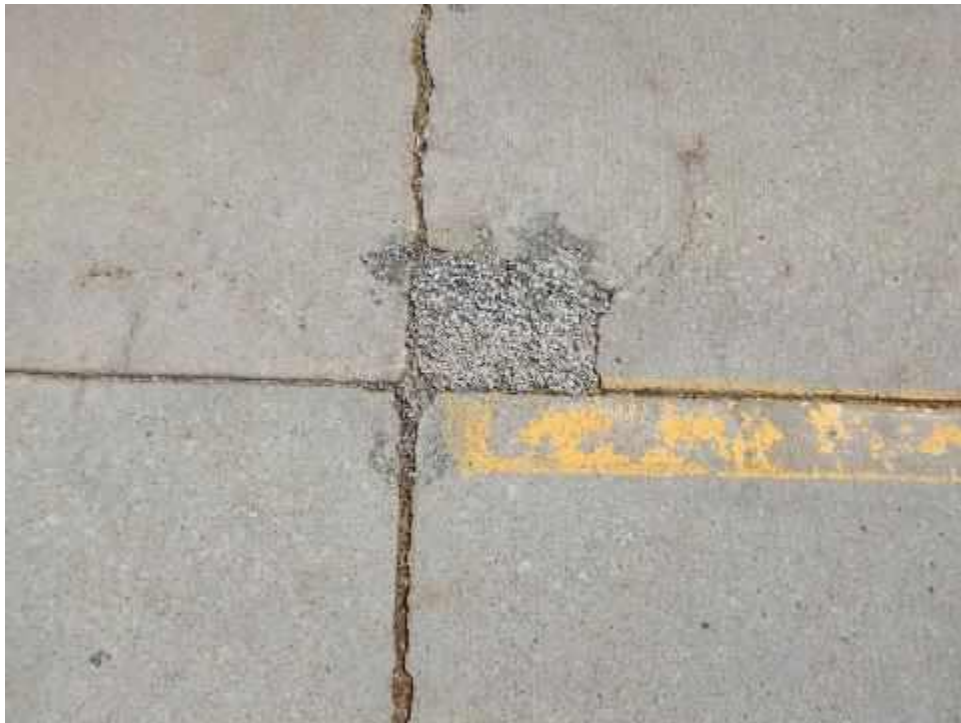
STADMD-E00D-Small Patching-(Sample Unit No. 02)

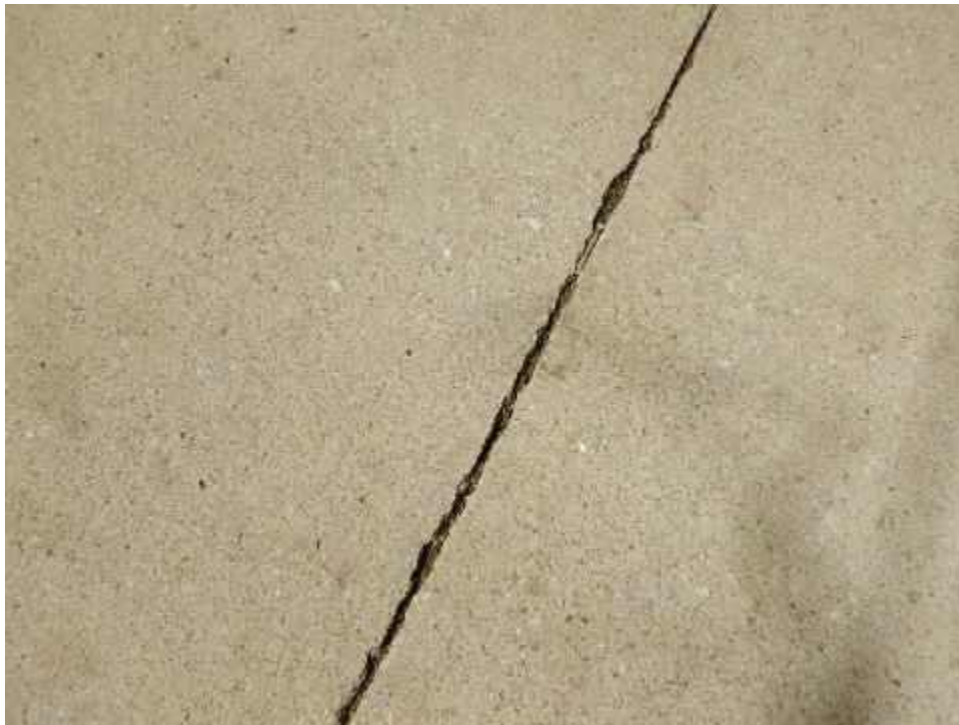
STADMD-E00E-Joint Seal Damage-(Sample Unit No. 01)

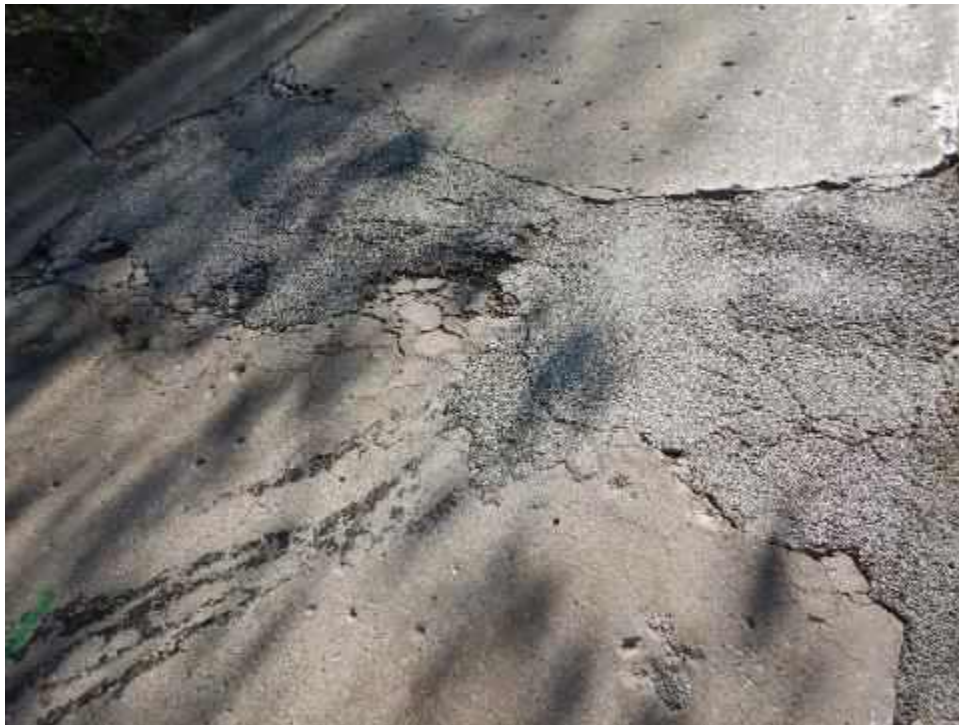
STMARR-E00B-Corner Break-(Sample Unit No. 01)

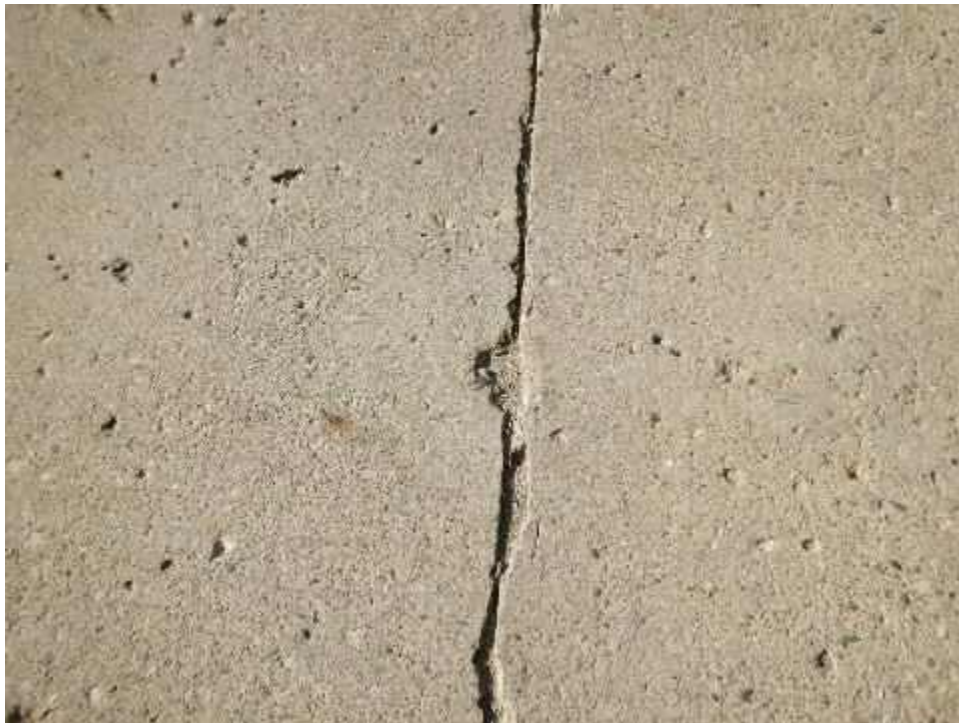
STMARR-E00B-Durability Cracking-(Sample Unit No. 01)

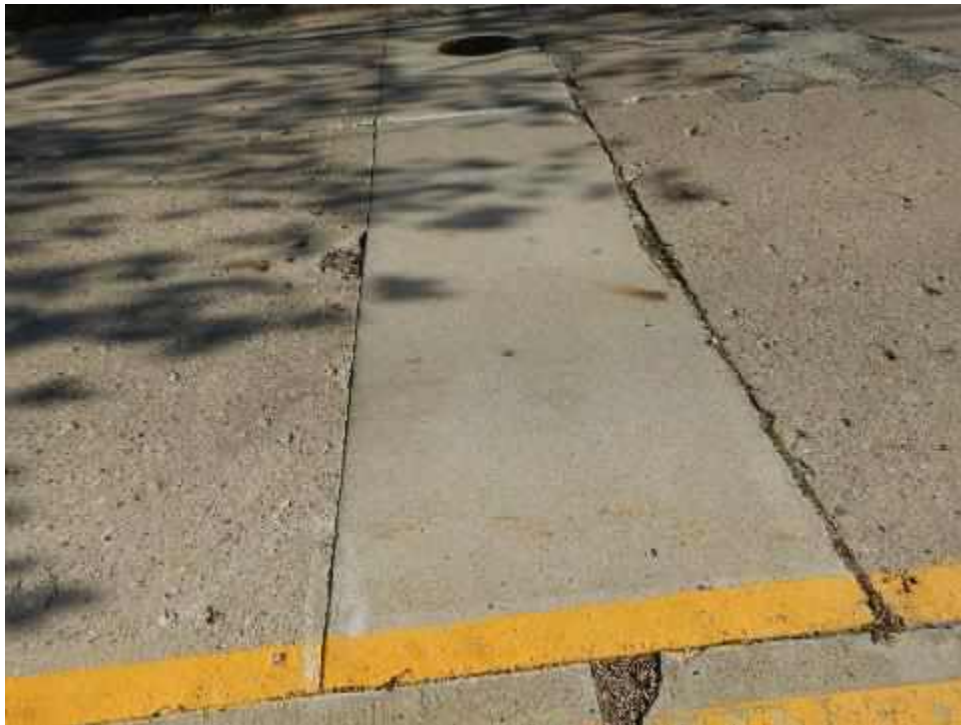
STMARR-E00B-Joint Seal Damage-(Sample Unit No. 01)

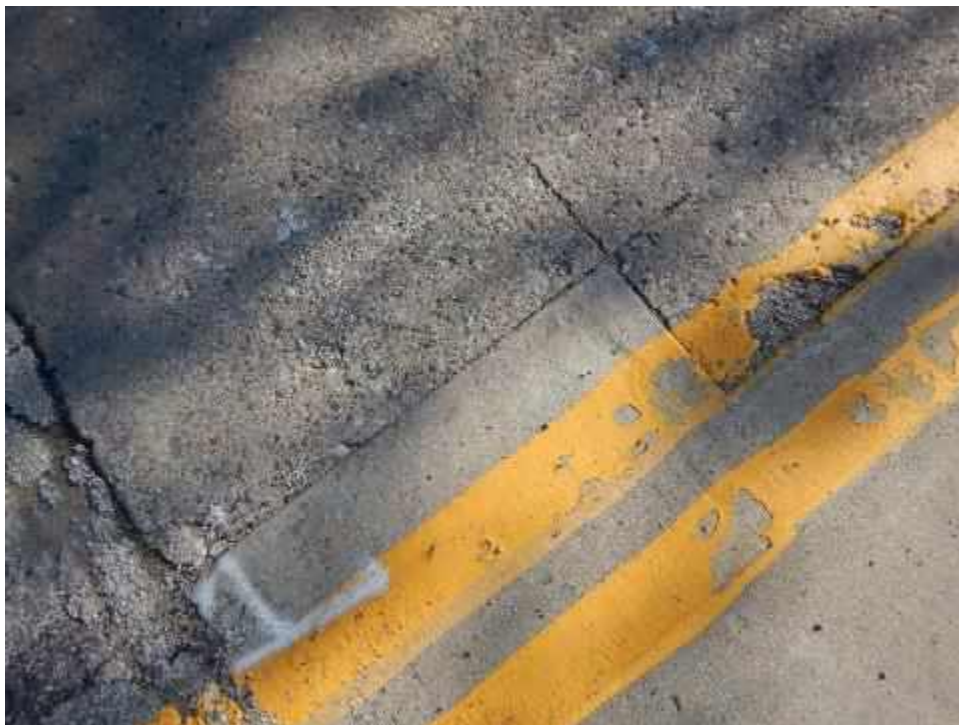
STMARR-E00B-Popouts-(Sample Unit No. 01)

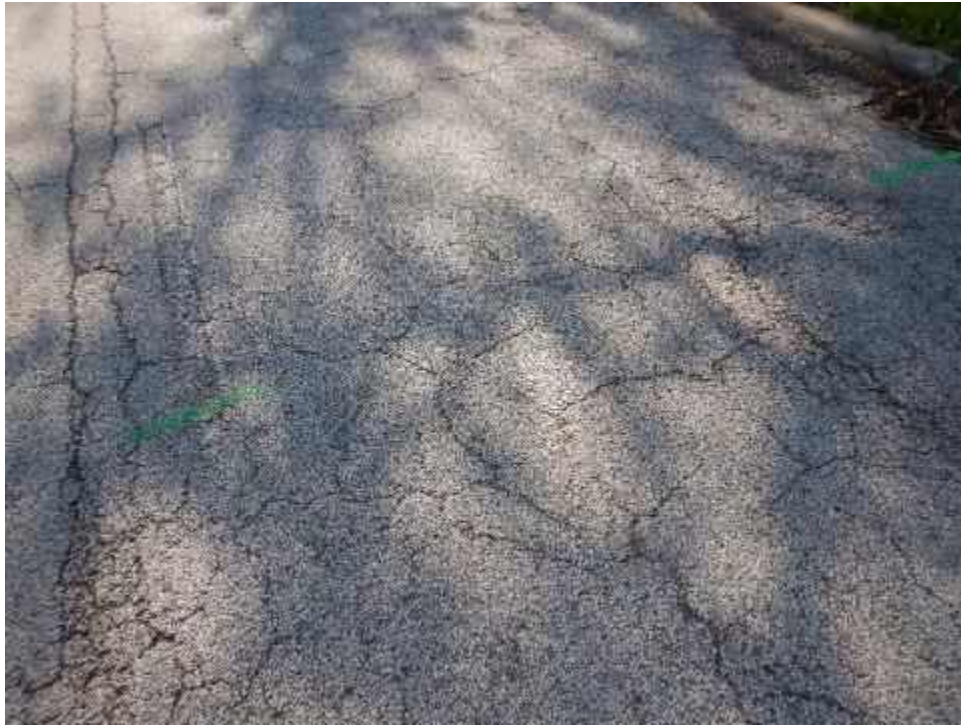
STMARR-E00B-Small Patching-(Sample Unit No. 01)

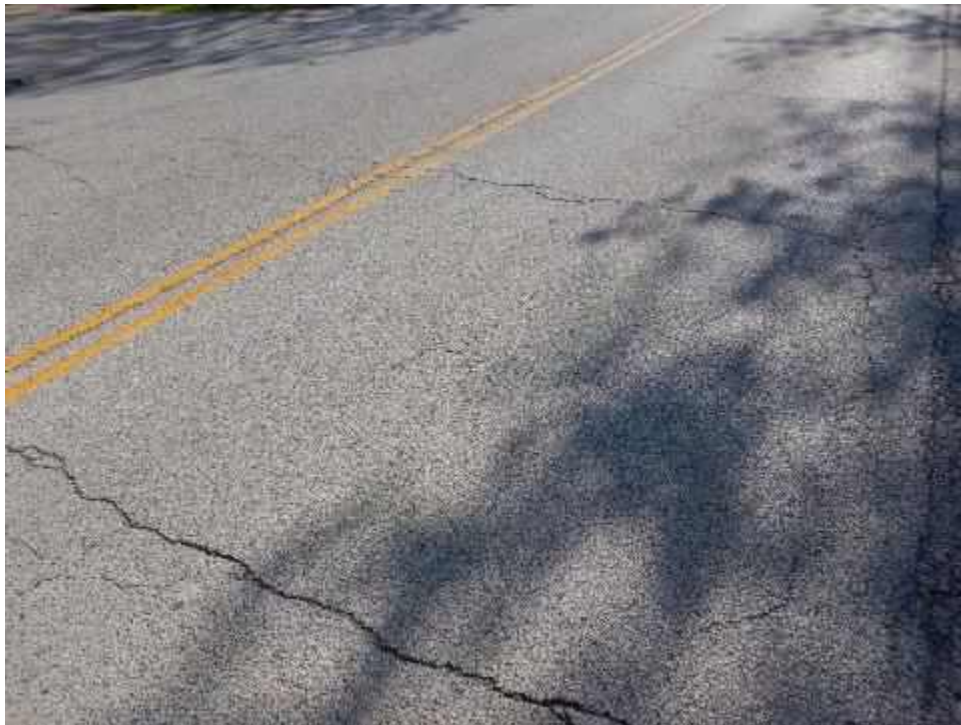
STMARR-E00C-Block Cracking-(Sample Unit No. 01)

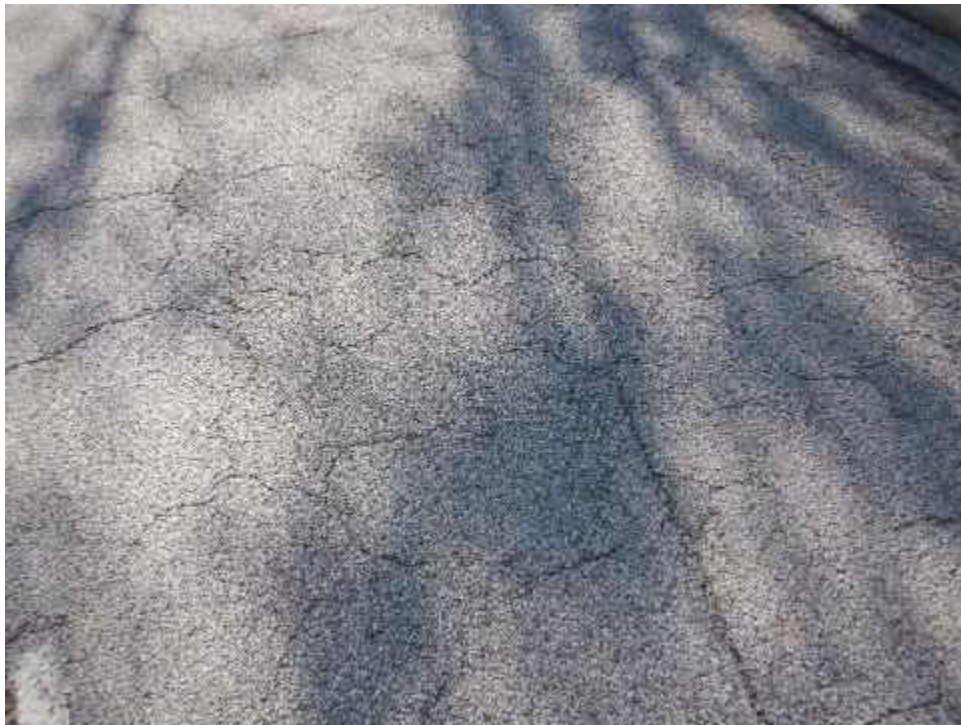
STMARR-E00D-Alligator Cracking-(Sample Unit No. 01)

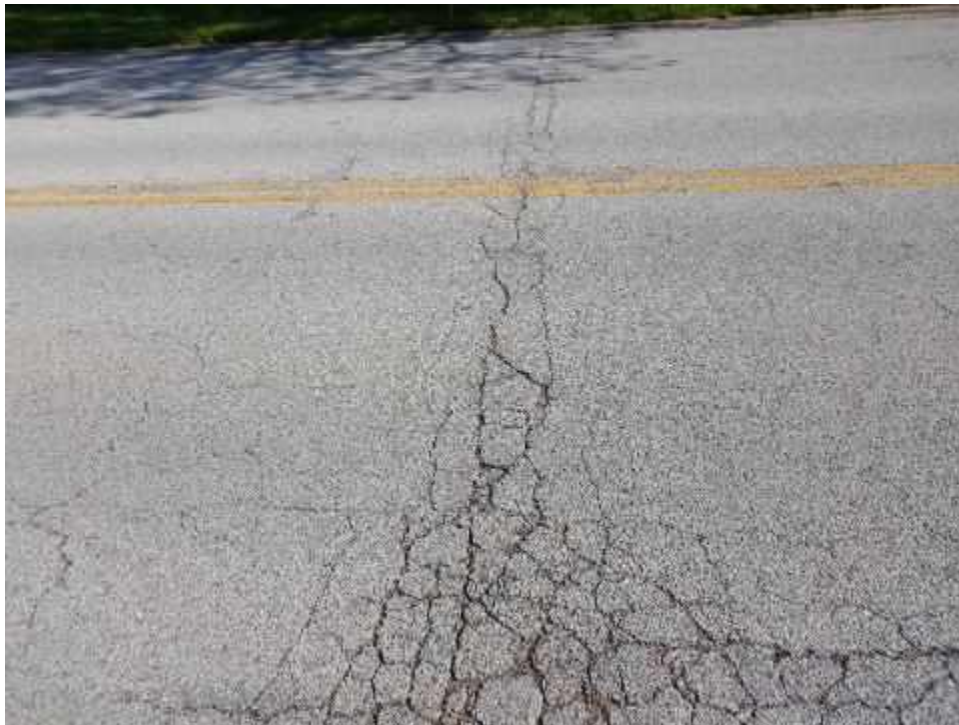
STMARR-E00D-Block Cracking-(Sample Unit No. 01)

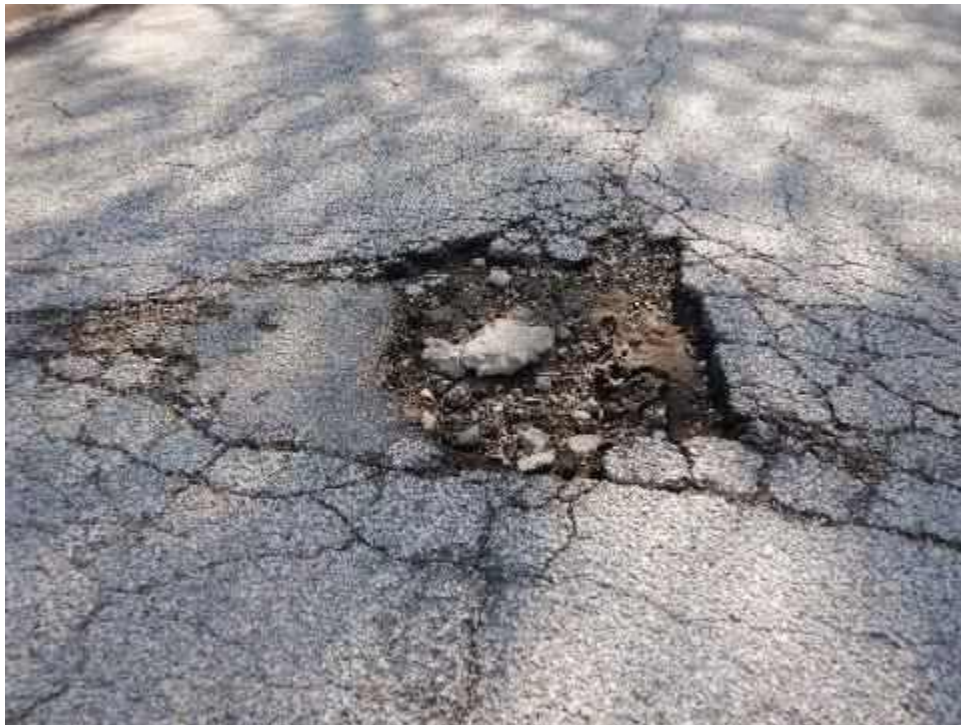
STMARR-E00D-Pothole-(Sample Unit No. 02) (1)

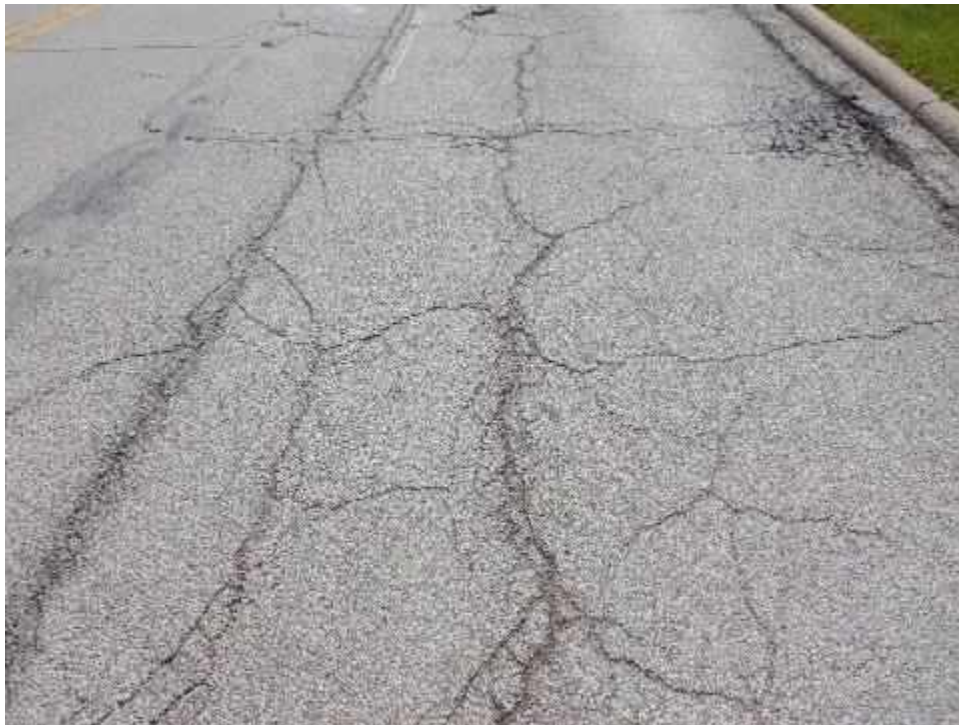
STMARR-E00D-Pothole-(Sample Unit No. 02) (2)

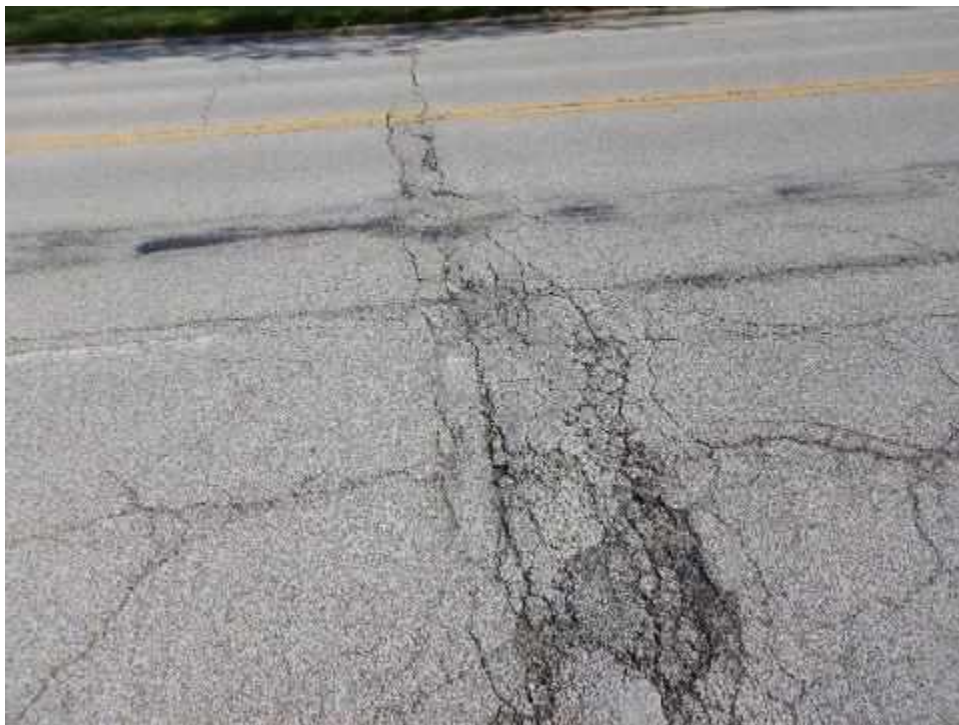
STMARR-E01-Block Cracking-(Sample Unit No. 01)

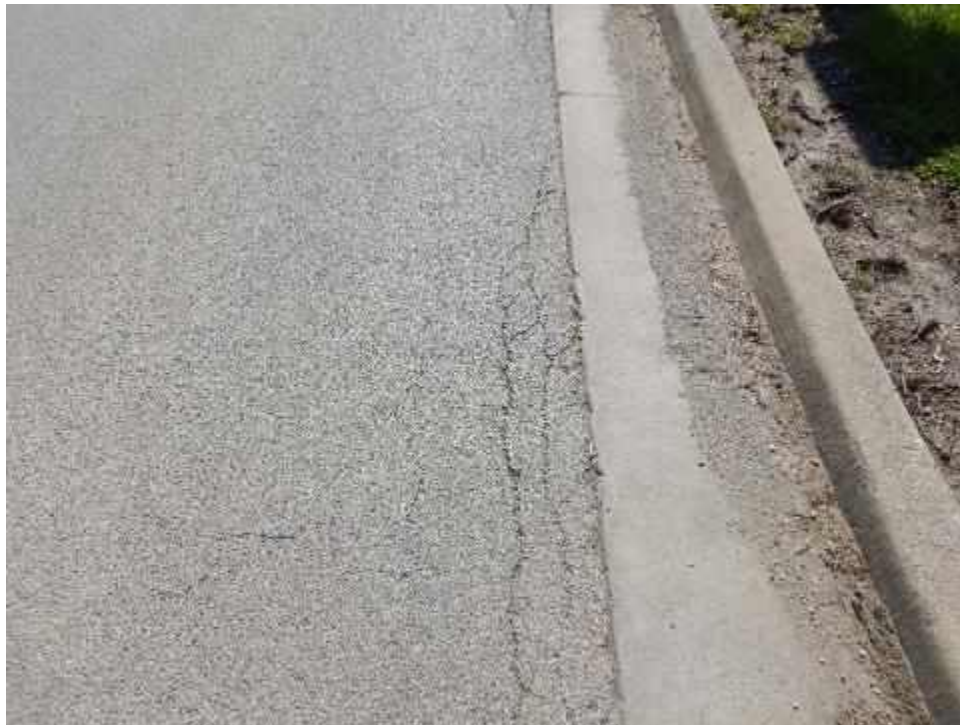
STMARR-E01-Weathering-(Sample Unit No. 01)

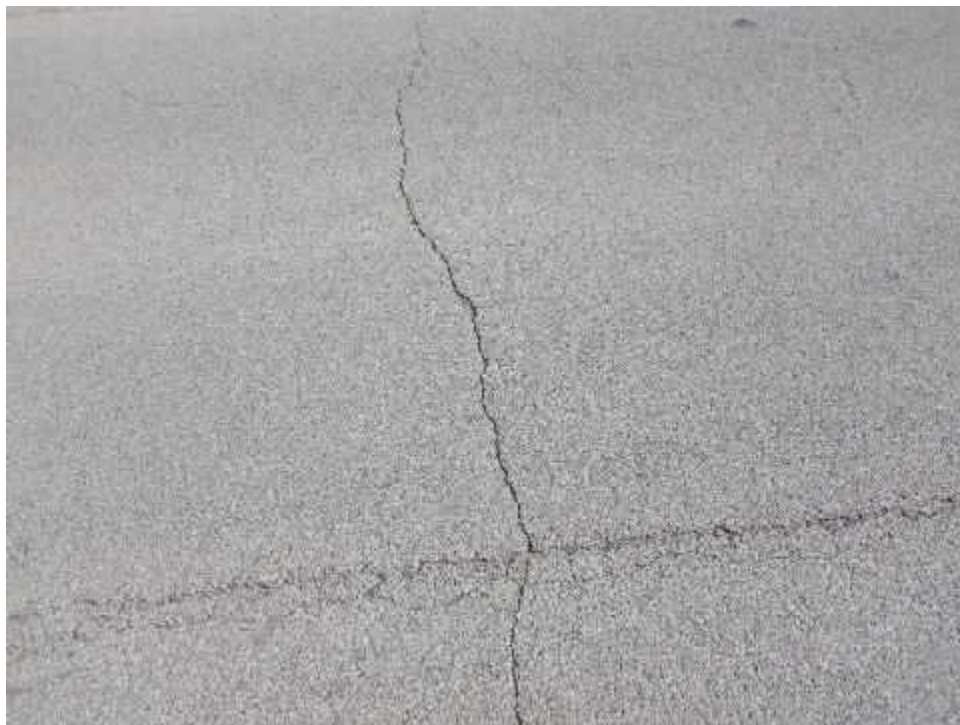
STMARR-E04A-Edge Cracking-(Sample Unit No. 01)

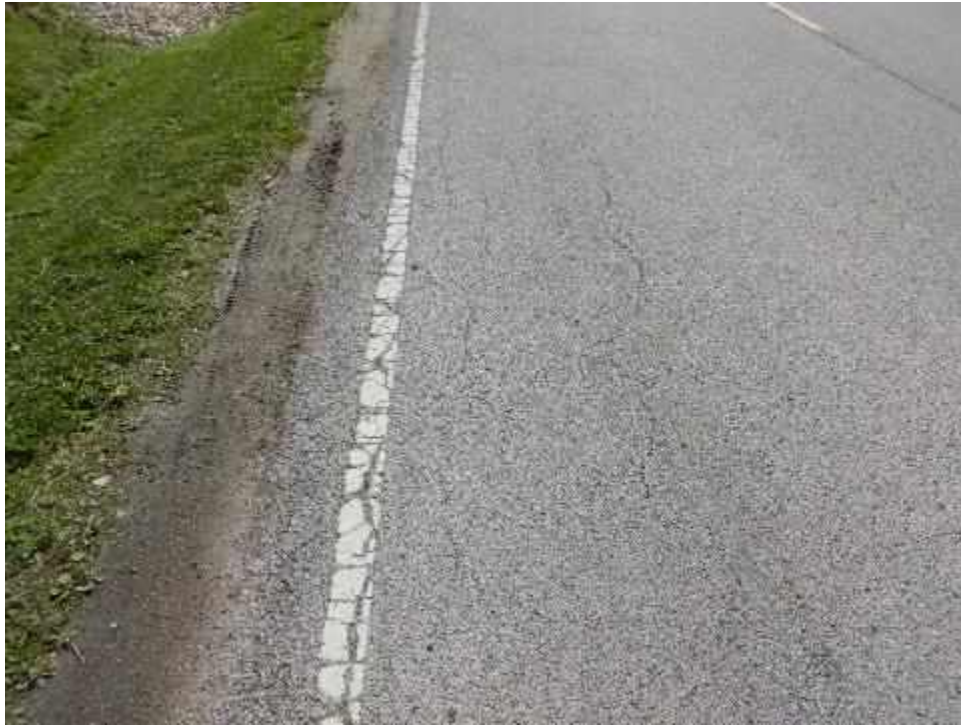
STMARR-E04B-Weathering-(Sample Unit No. 01)

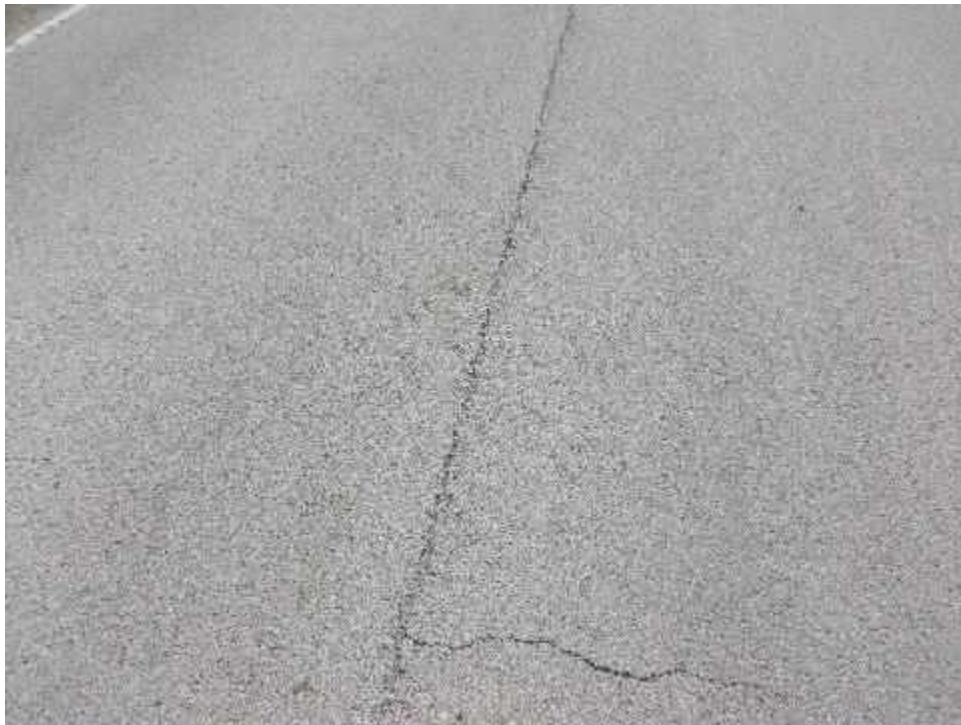
STMARR-UW09A-Alligator Cracking-(Sample Unit No. 01)

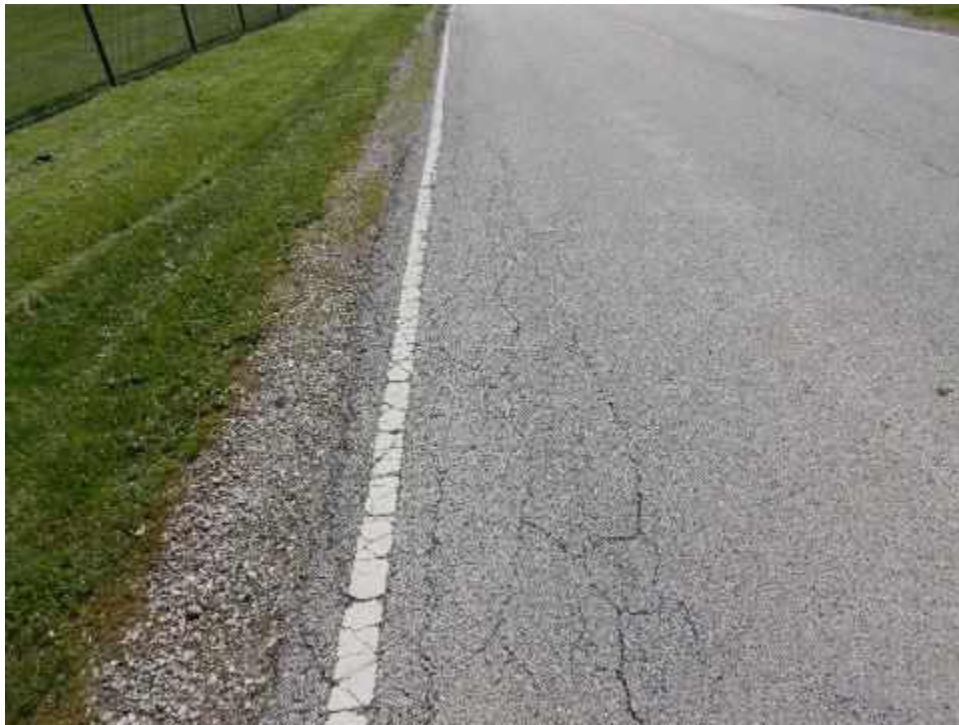
STMARR-UW09B-Weathering-(Sample Unit No. 01)

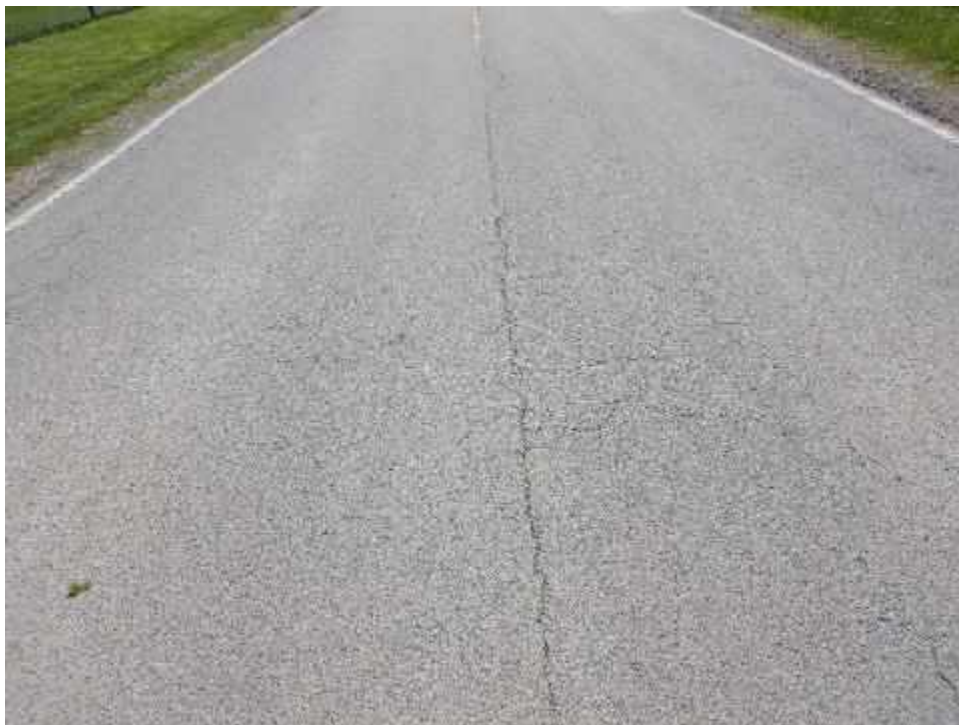
STMARR-UW09C-Alligator Cracking-(Sample Unit No. 01)

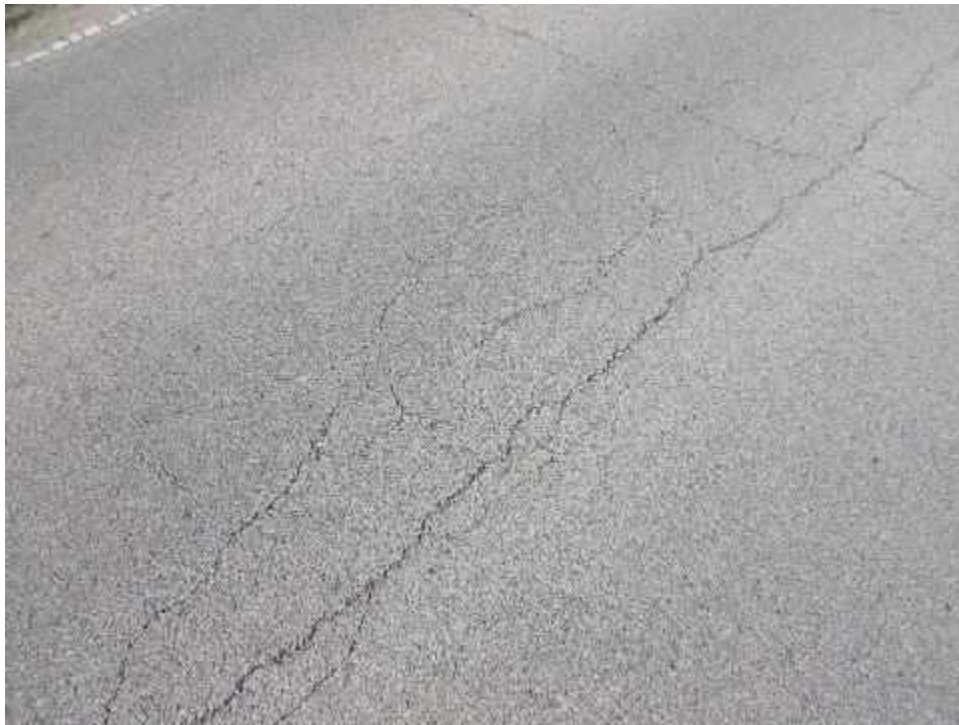
STMARR-UW09C-Patching-(Sample Unit No. 01)

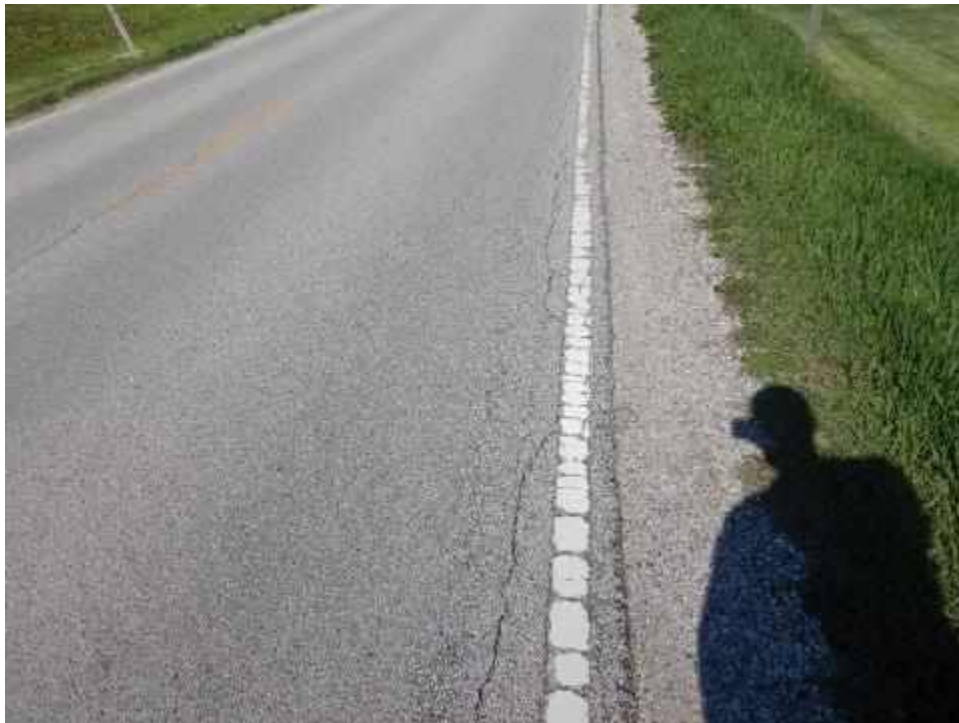
STMARR-UW12-Alligator Cracking-(Sample Unit No. 01)

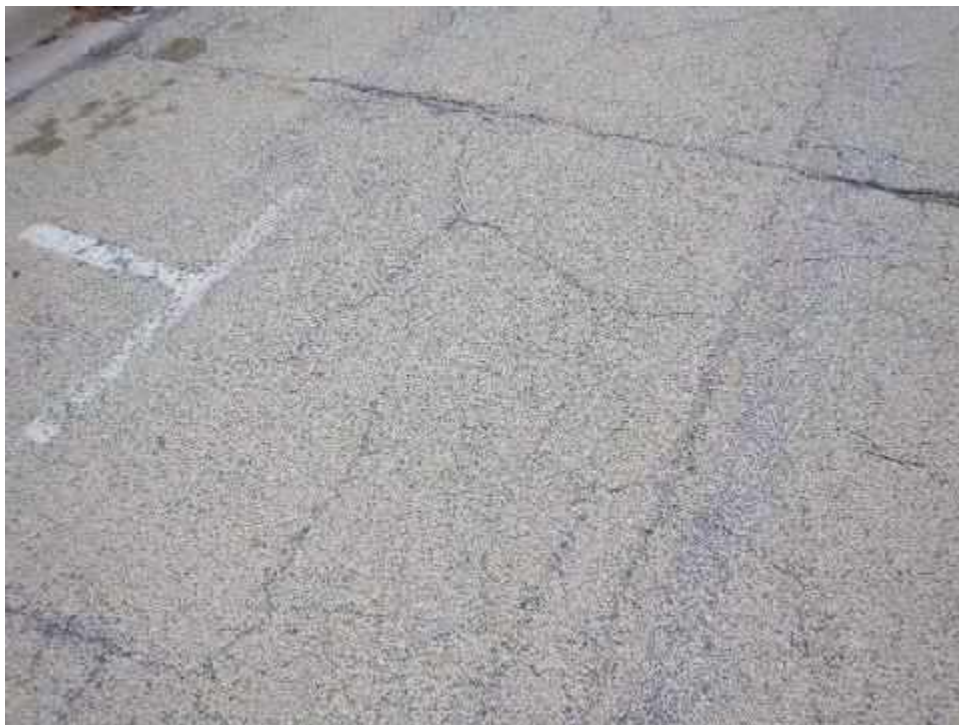
STOUGS-UW13-Alligator Cracking-(Sample Unit No. 02)

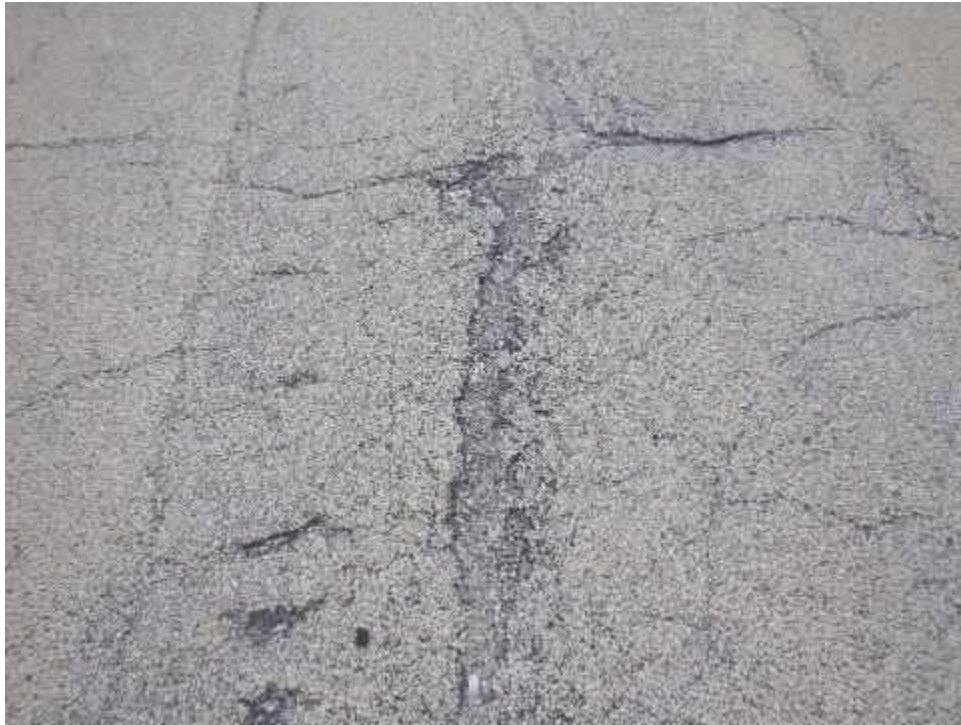
STOUGS-UW13-Block Cracking-(Sample Unit No. 02)

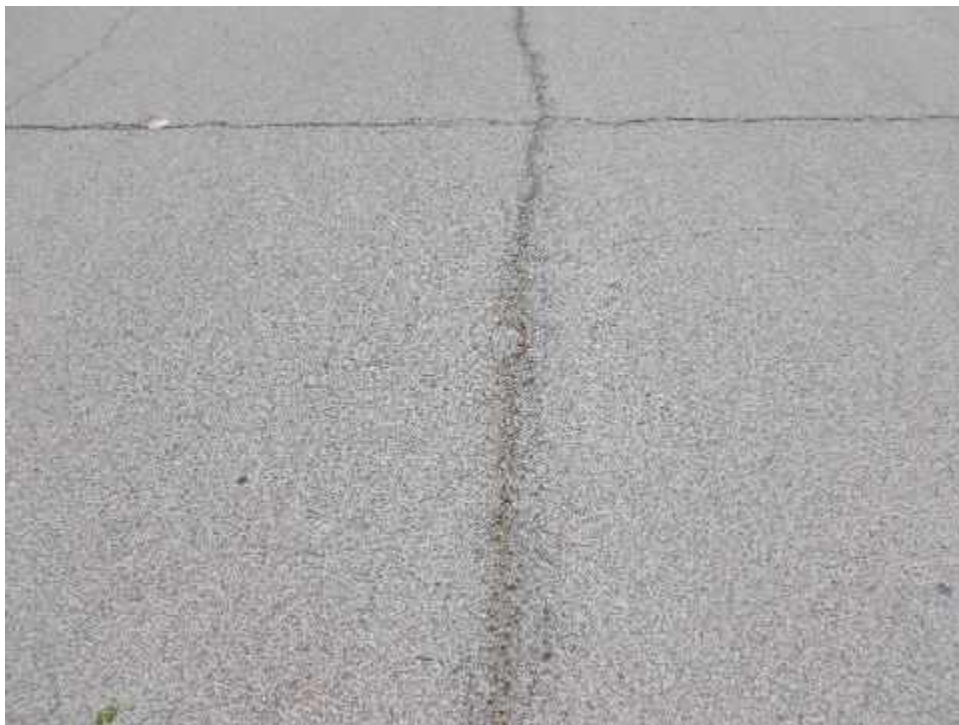
VRGNADR-US14A-Joint Reflection Cracking-(Sample Unit No. 01)
