# U20069: Pavement Analysis Study 2020 University of Illinois at Urbana-Champaign

## Final Report

Applied Pavement Technology, Inc.  
115 West Main Street, Suite 400  
Urbana, Illinois 61801  
(217) 398-3977  
[www.appliedpavement.com](http://www.appliedpavement.com)

**AUGUST 2020**

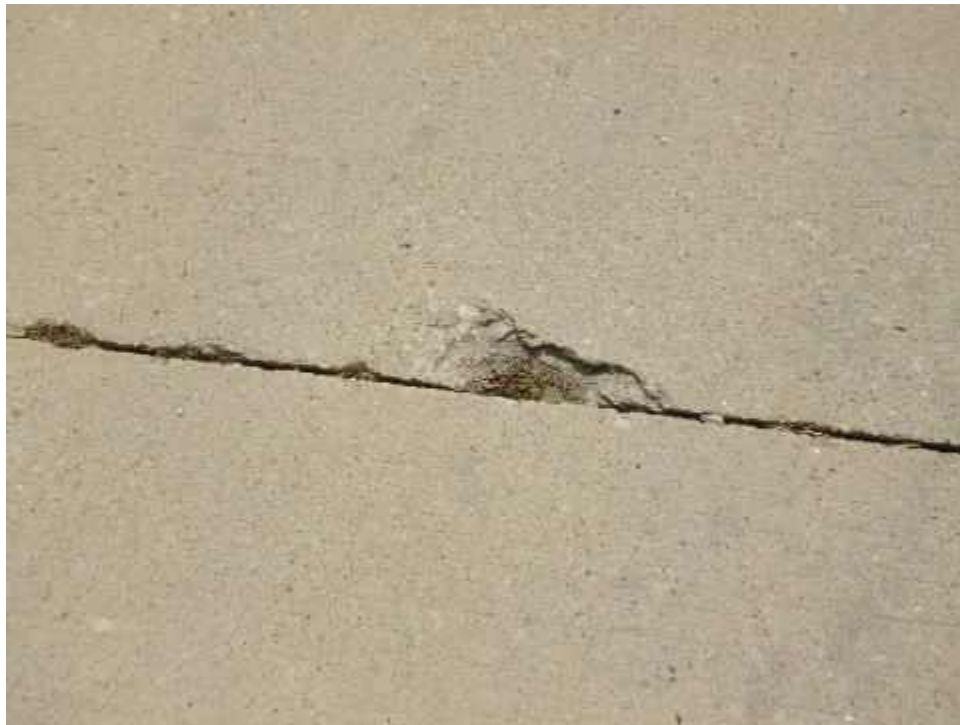
VRGNADR-US14A-Weathering-(Sample Unit No. 01)

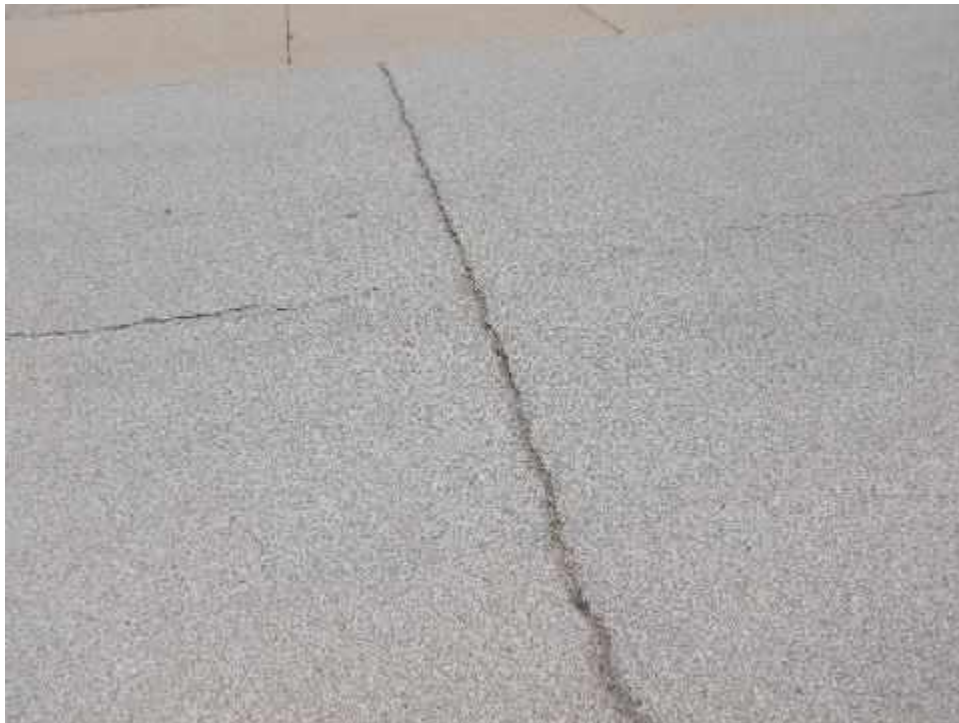
VRGNADR-US14BE-Shattered Slab-(Sample Unit No. 01)

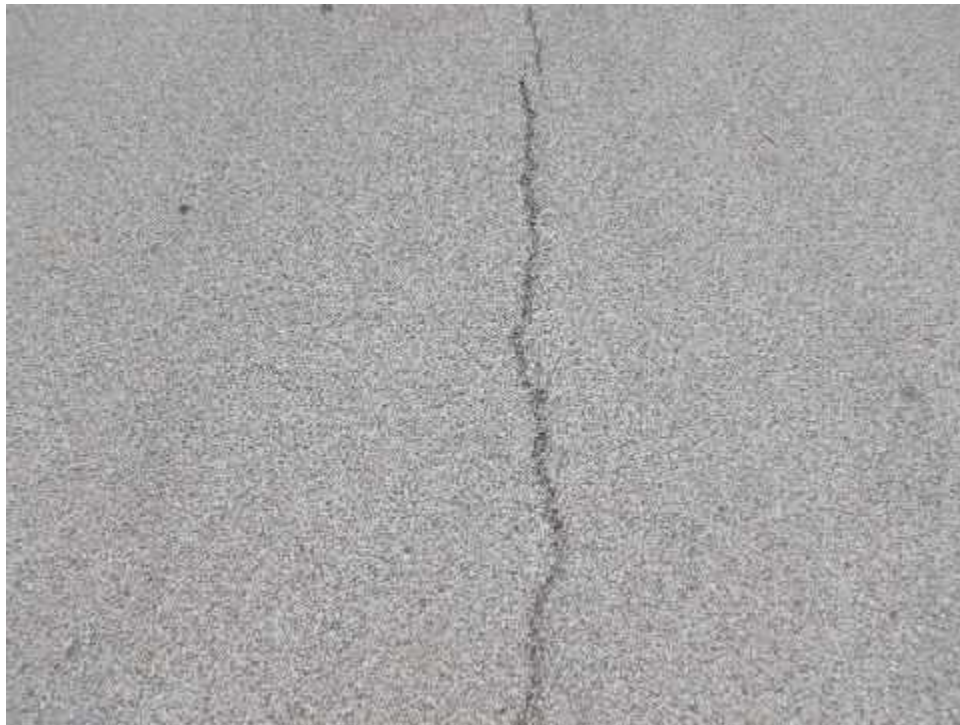
VRGNADR-US14BW-Joint Reflection Cracking-(Sample Unit No. 01)

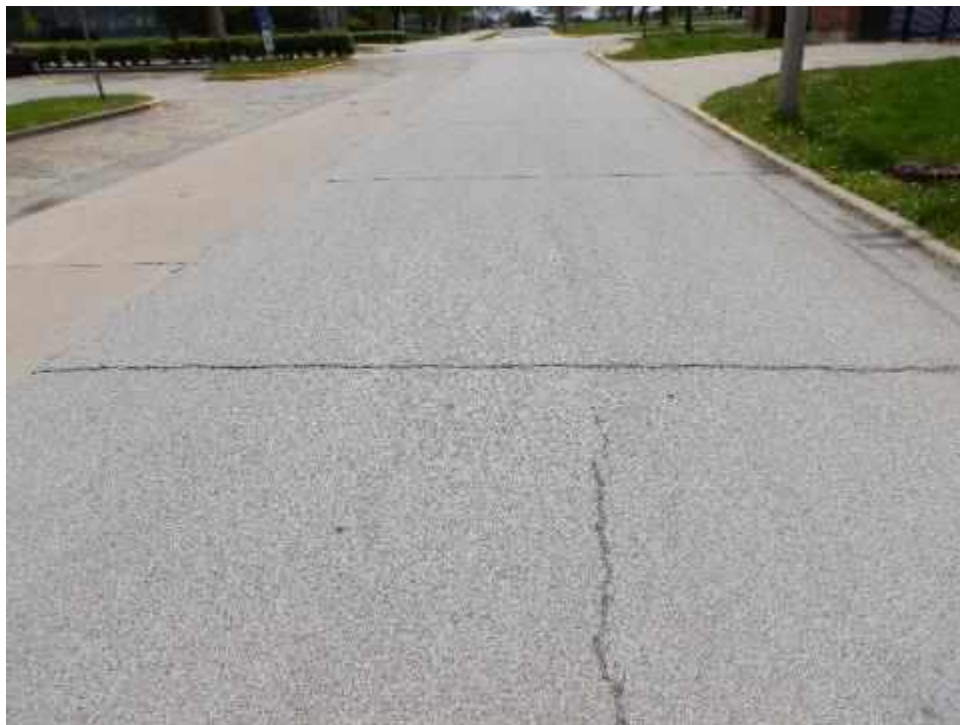
VRGNADR-US14BW-L&T Cracking-(Sample Unit No. 01)
