# U20069: Pavement Analysis Study 2020 University of Illinois at Urbana-Champaign

## Final Report

Applied Pavement Technology, Inc.  
115 West Main Street, Suite 400  
Urbana, Illinois 61801  
(217) 398-3977  
[www.appliedpavement.com](http://www.appliedpavement.com)

**AUGUST 2020**

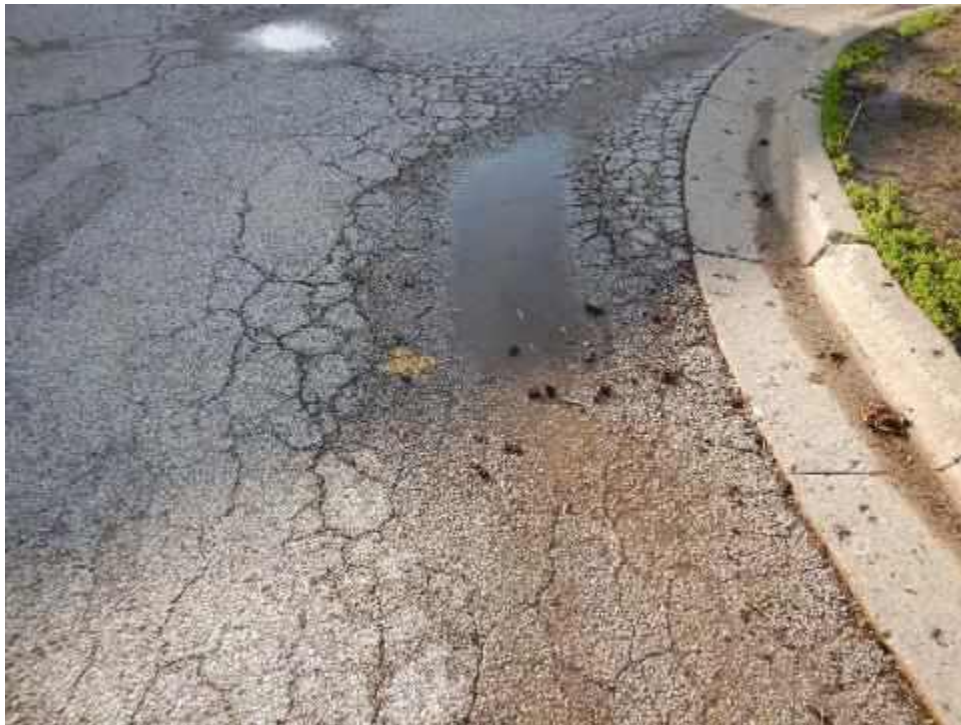
BAILEYD-E00-Rutting-(Sample Unit No. 01)

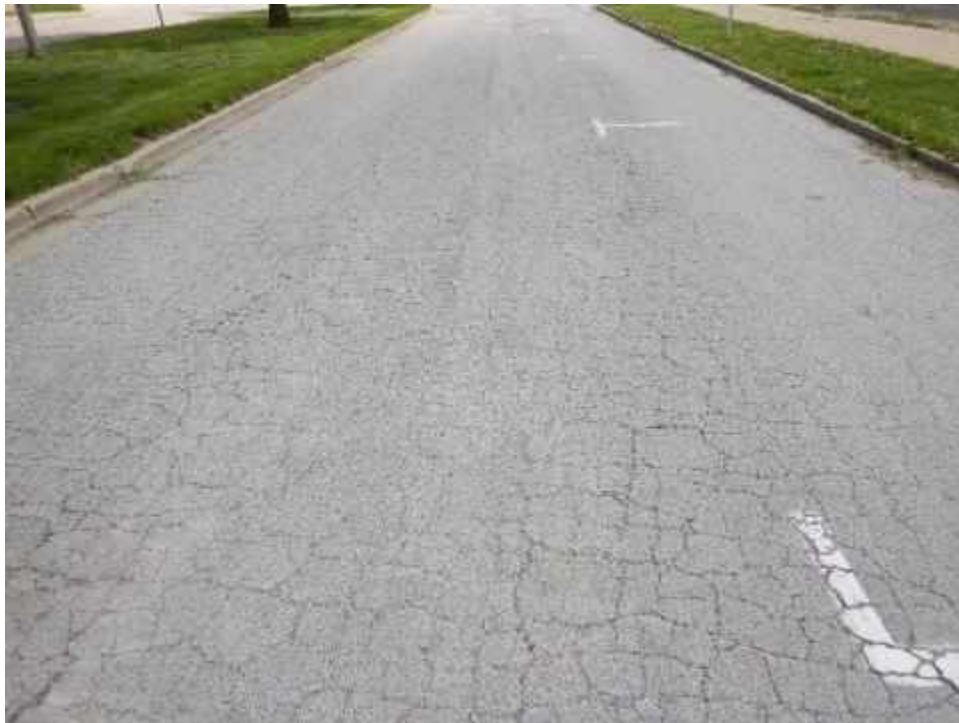
COLAGCT-UW09AN-Overview-(Sample Unit No. 01) (2)

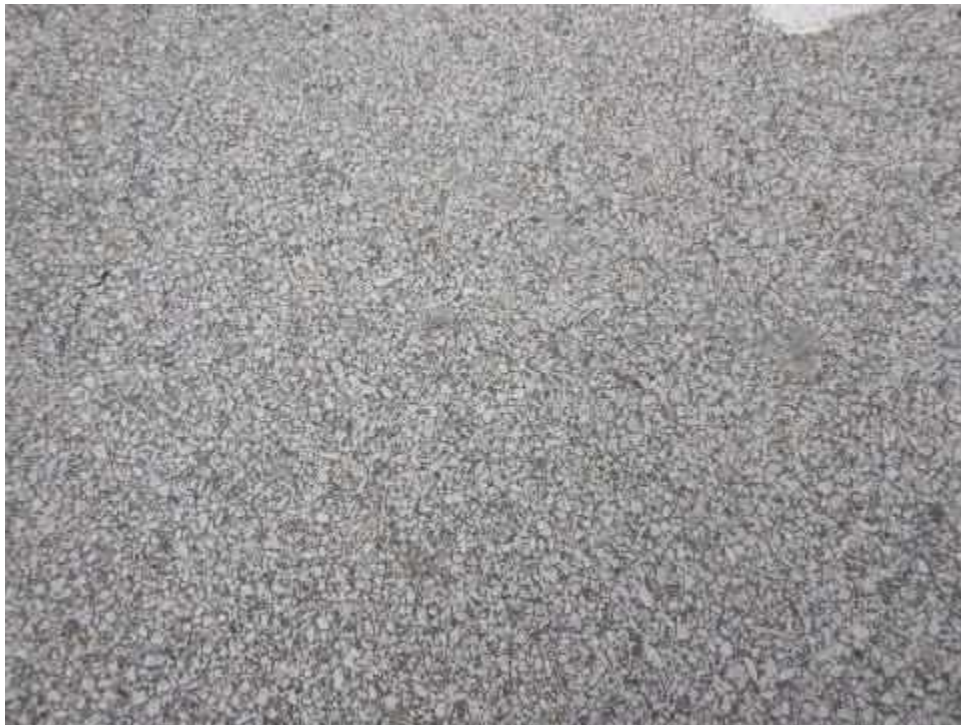
COLAGCT-UW09BN-Weathering-(Sample Unit No. 01)

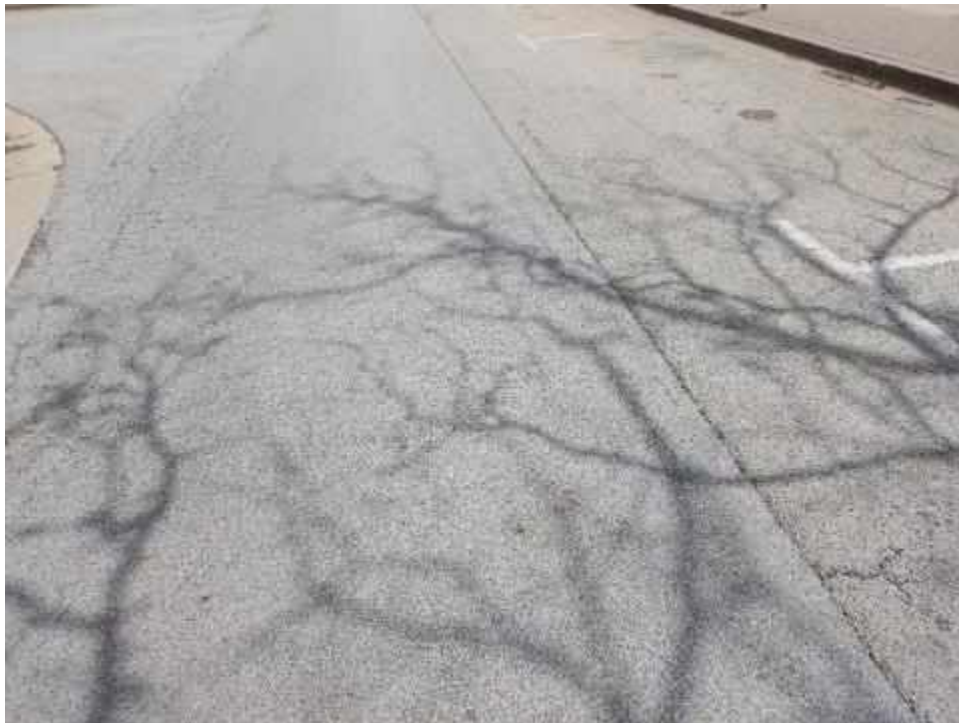
COLAGCT-UW09BS-Overview-(Sample Unit No. 01)

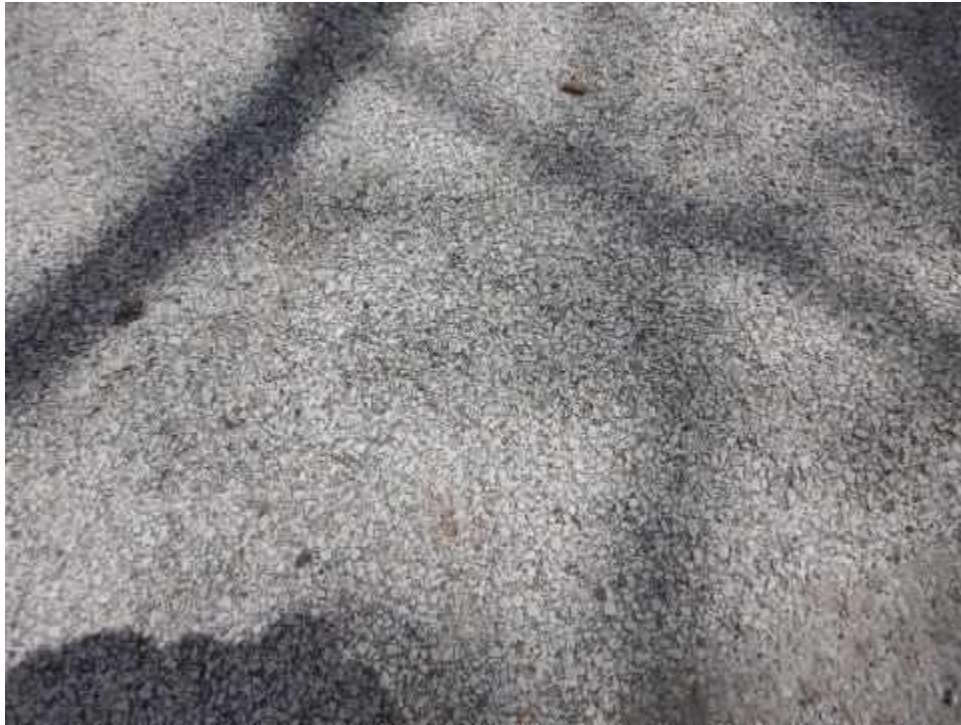
COLAGCT-UW09BS-Weathering-(Sample Unit No. 01)

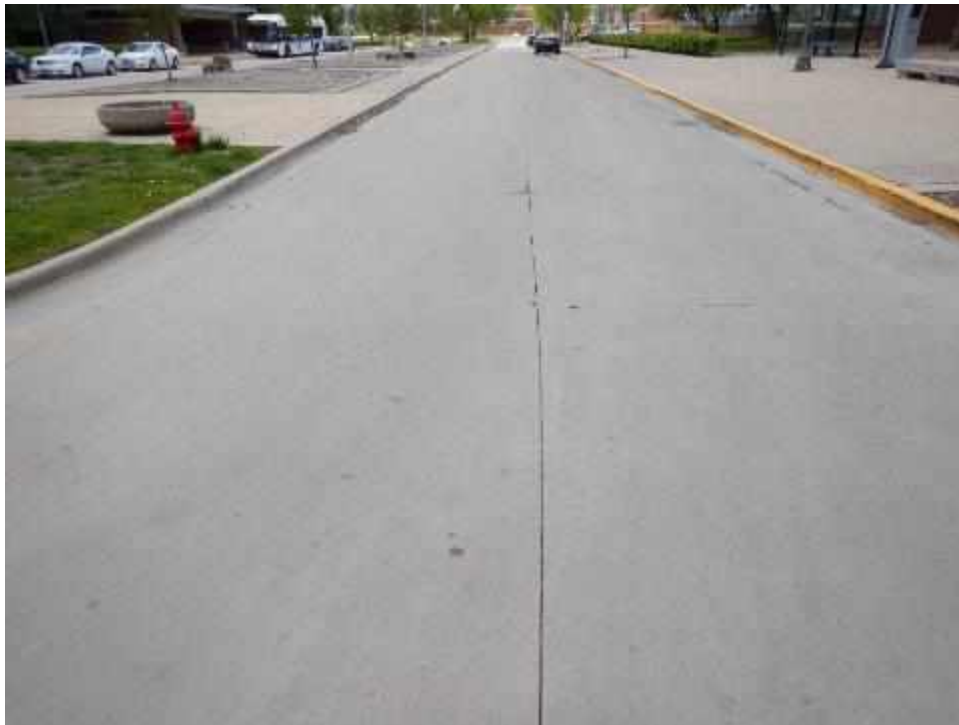
COLAGCT-UW09CN-Overview-(Sample Unit No. 01)

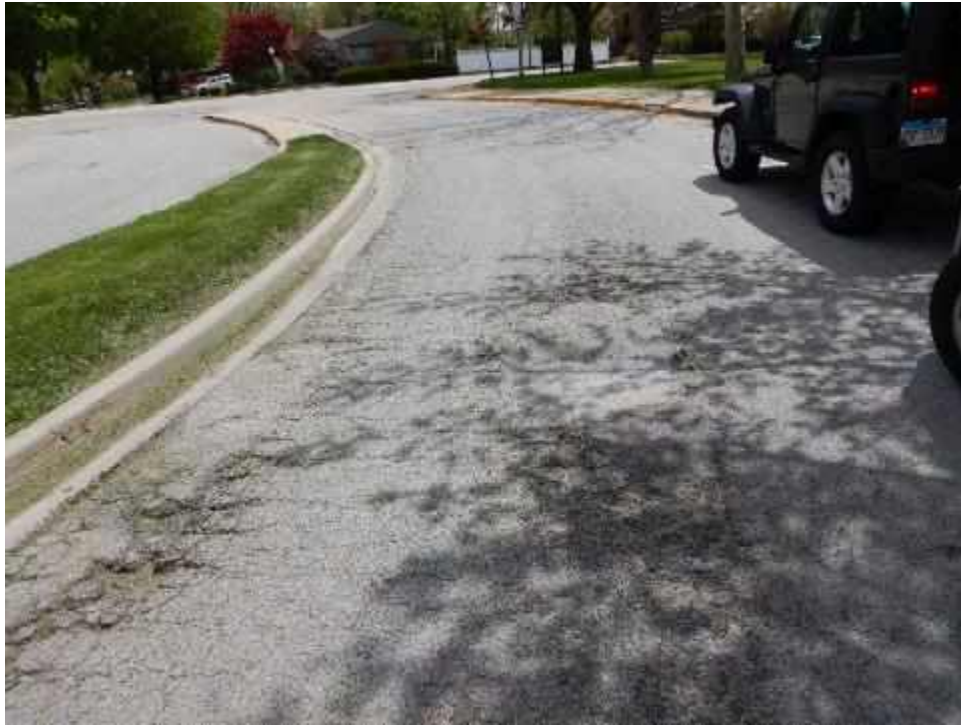
COLAGCT-UW09CS-Overview-(Sample Unit No. 01)

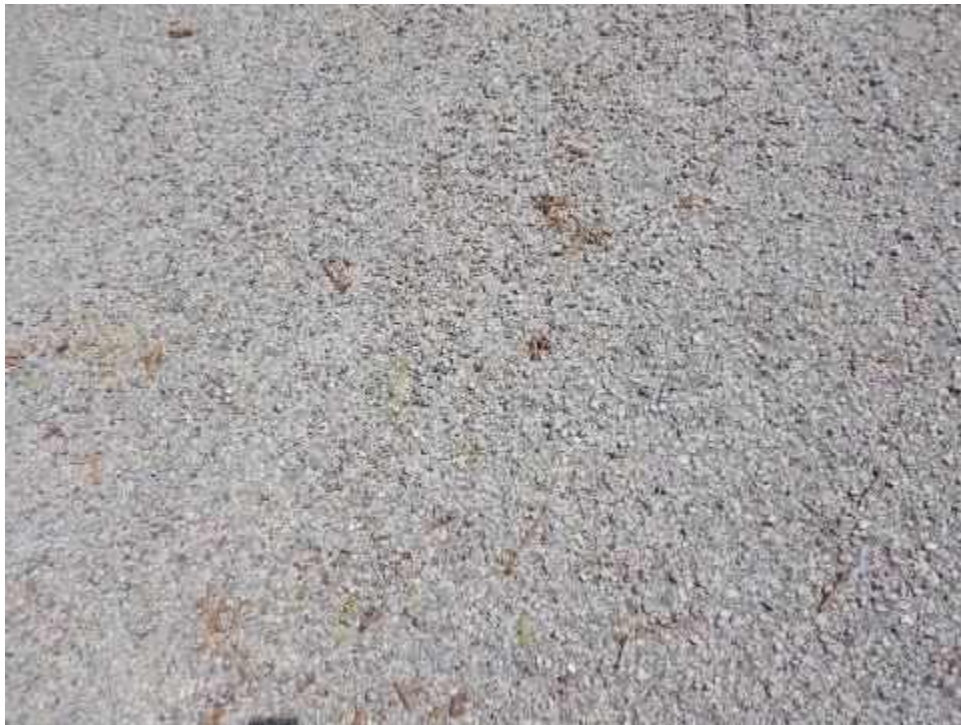
COLAGCT-UW09CS-Raveling-(Sample Unit No. 01)

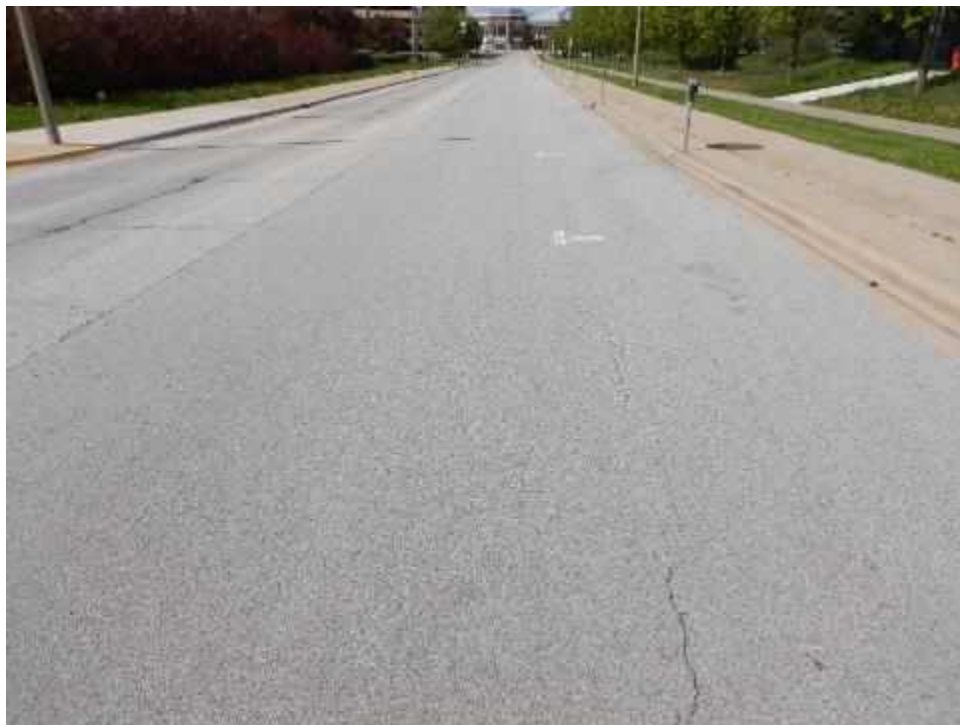
DORNRDR-US11AE-Overview-(Sample Unit No. 01)

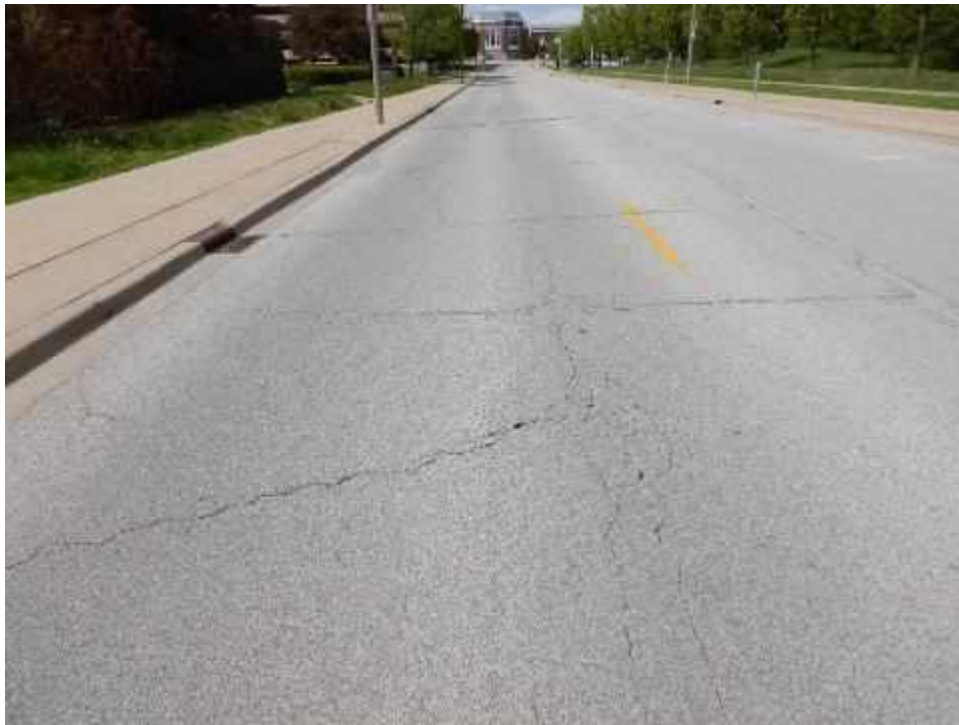
DORNRDR-US11AW-Overview-(Sample Unit No. 01)

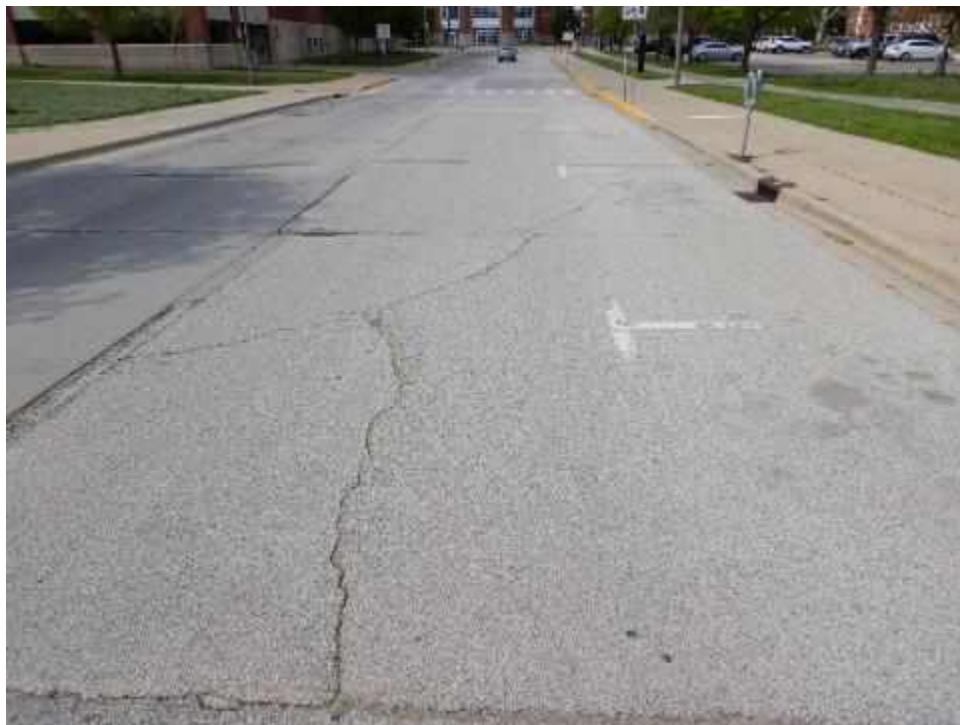
DORNRDR-US11BE-Overview-(Sample Unit No. 01)

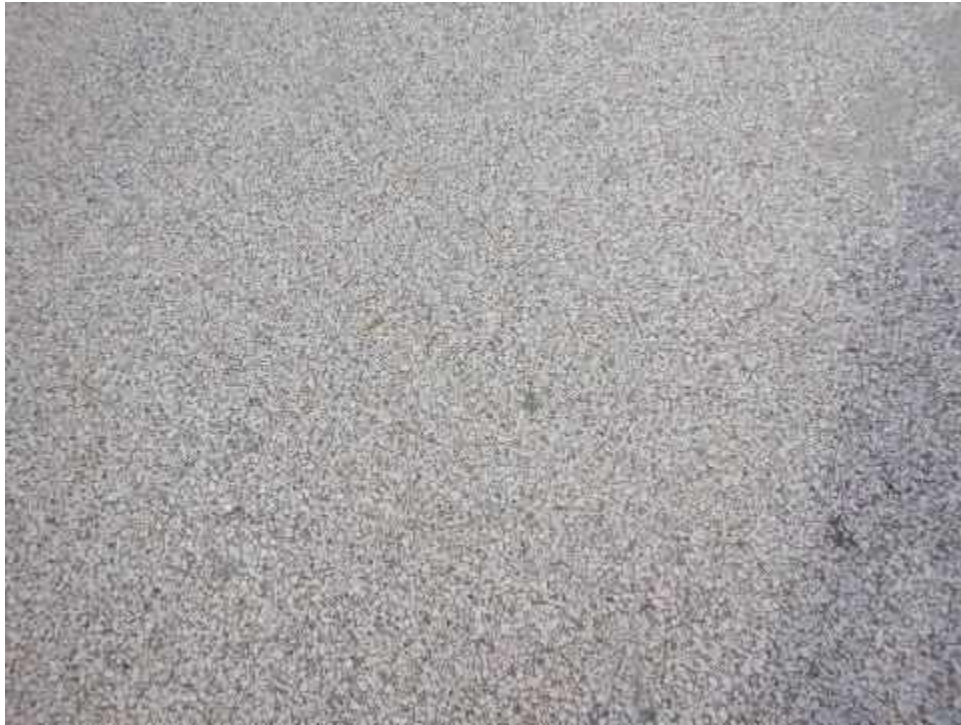
DORNRDR-US11BE-Weathering-(Sample Unit No. 01)

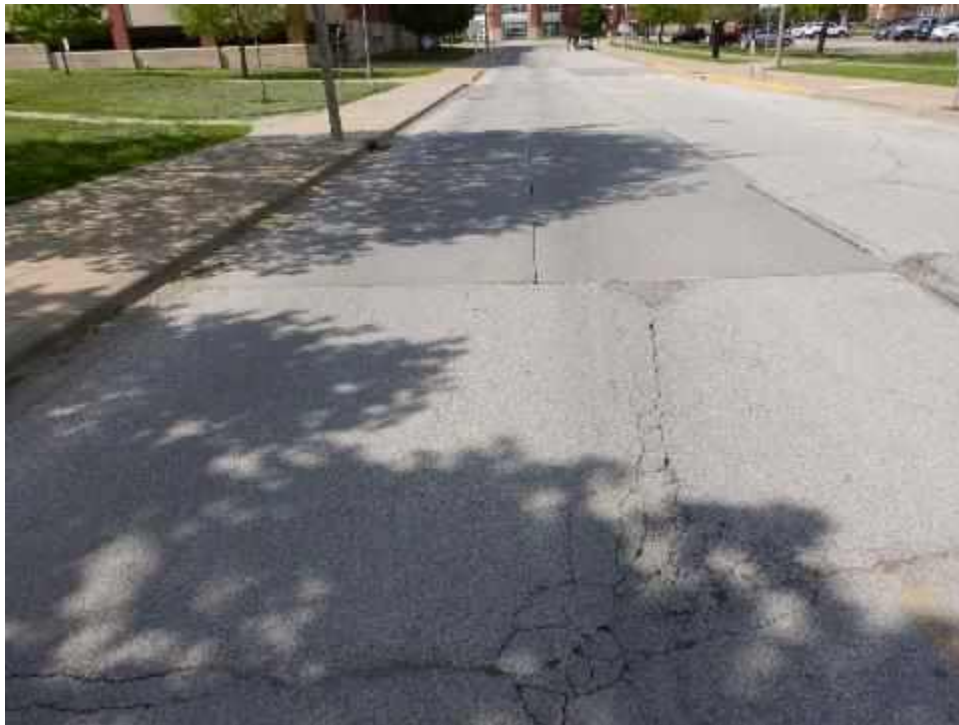
DORNRDR-US11BW-Overview-(Sample Unit No. 01)

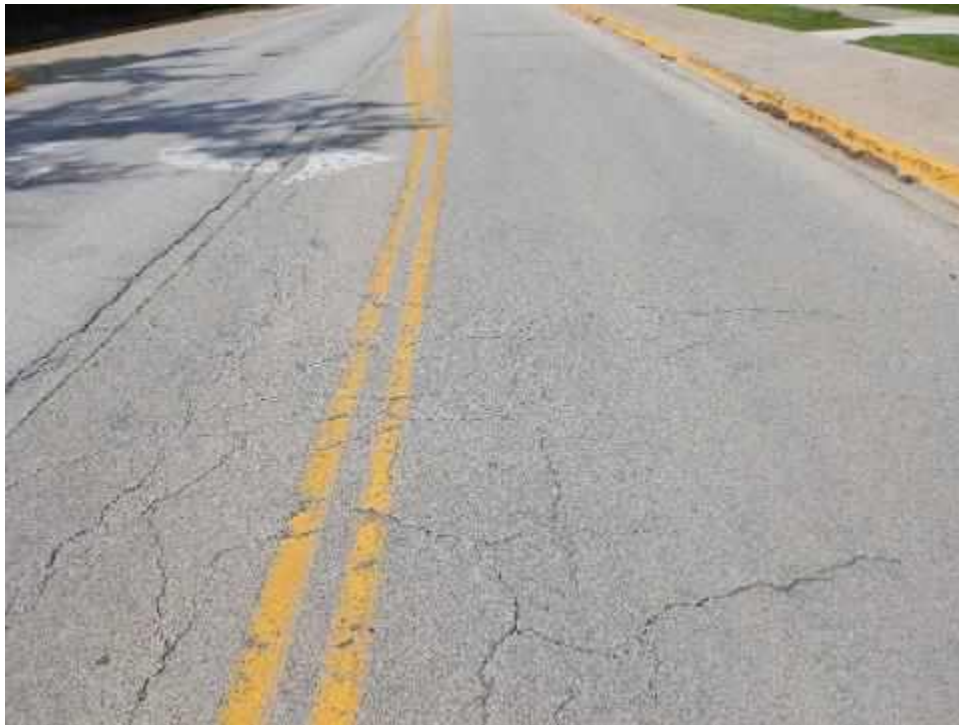
DORNRDR-US13E-Overview-(Sample Unit No. 01)

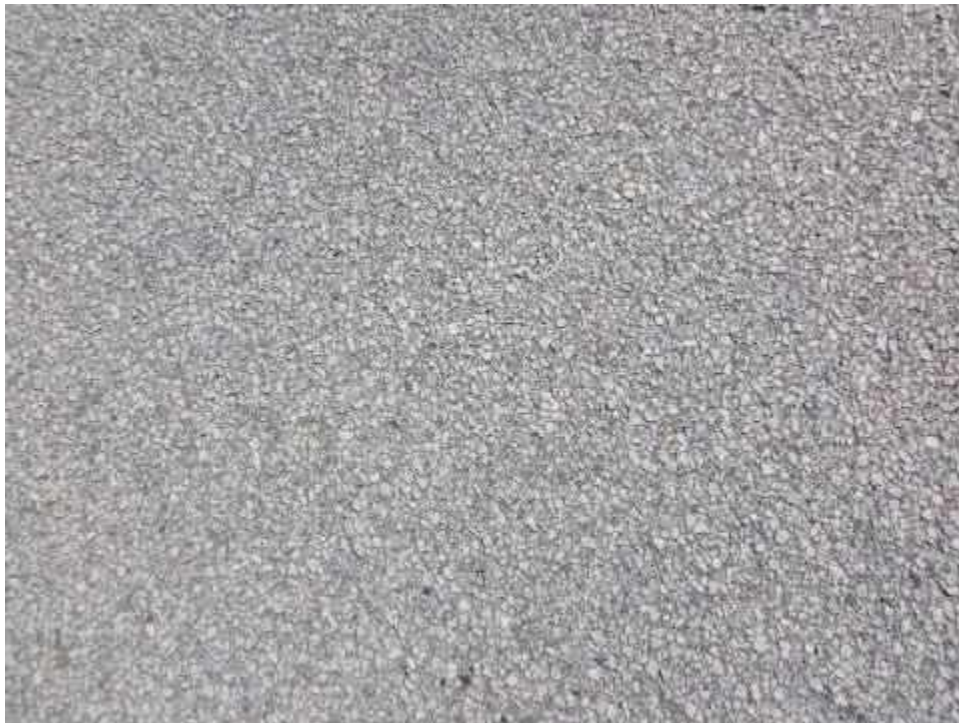
DORNRDR-US13E-Weathering-(Sample Unit No. 01)

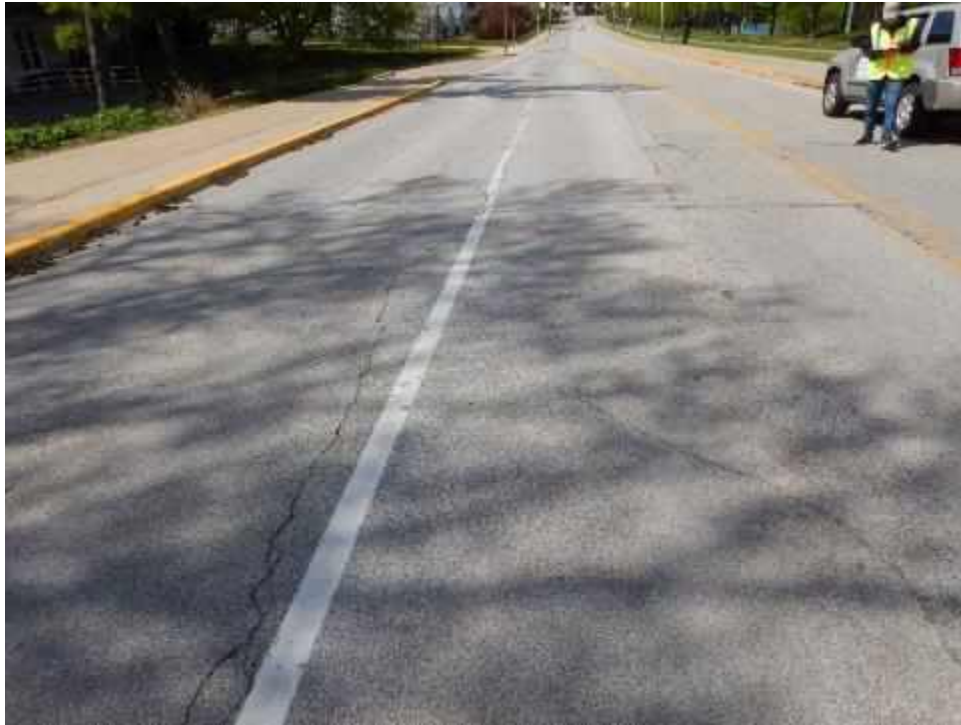
DORNRDR-US13W-Overview-(Sample Unit No. 01)

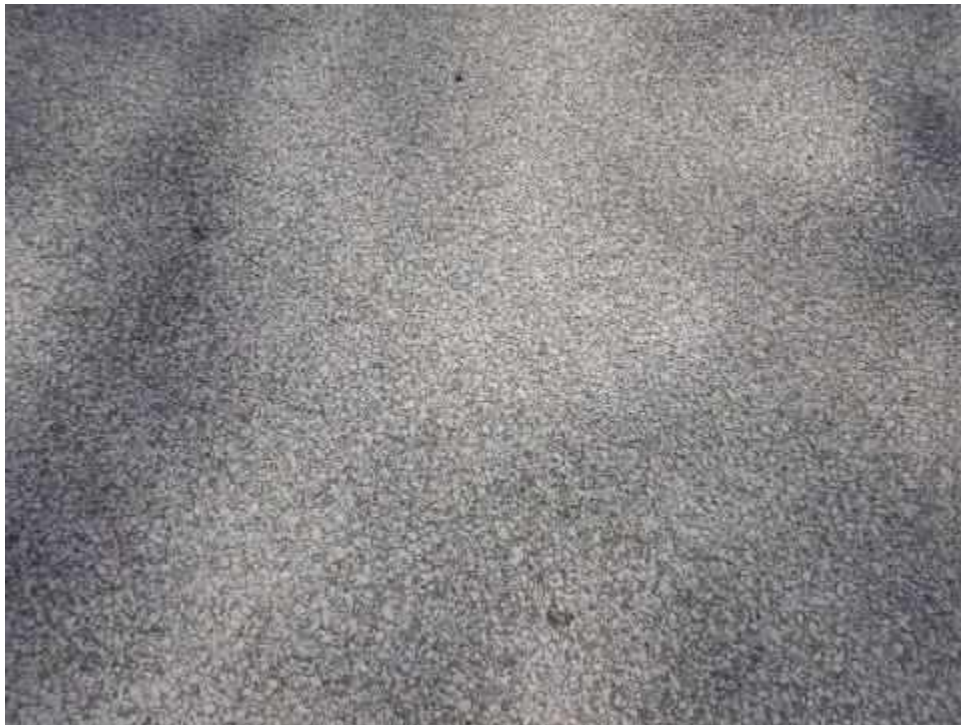
DORNRDR-US13W-Weathering-(Sample Unit No. 01)

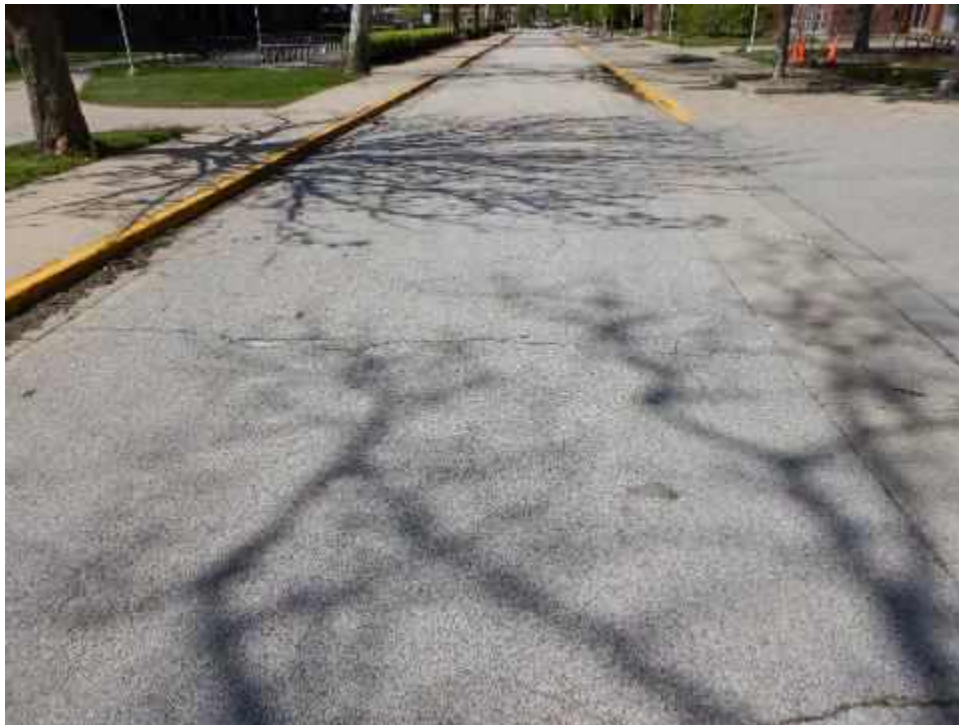
EUCLDS-S12-Overview-(Sample Unit No. 01)

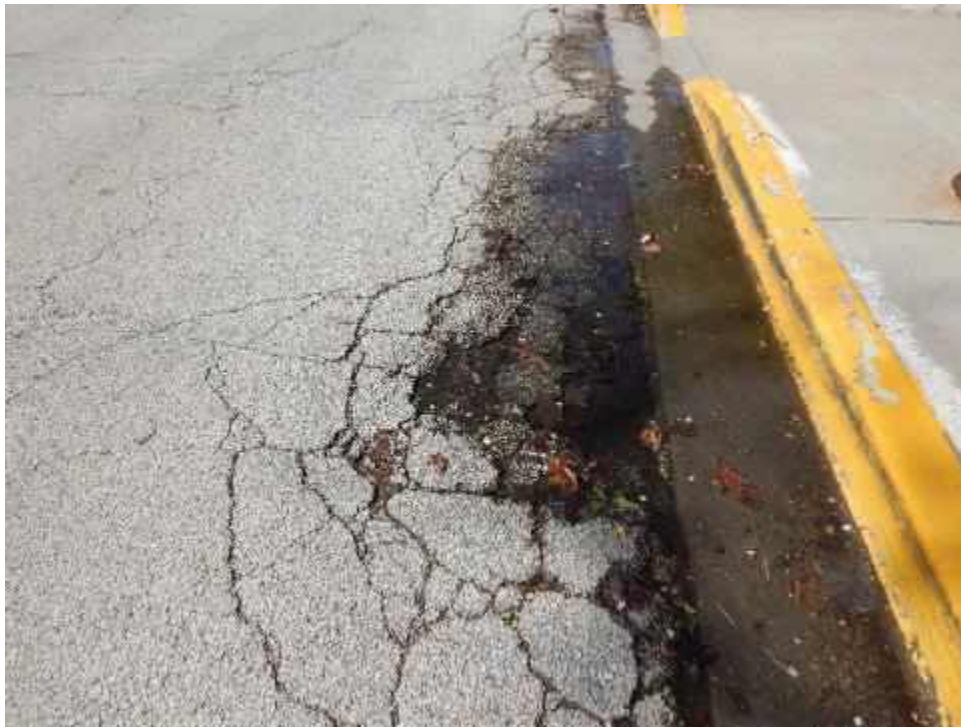
EUCLDS-S12-Rutting-(Sample Unit No. 072)

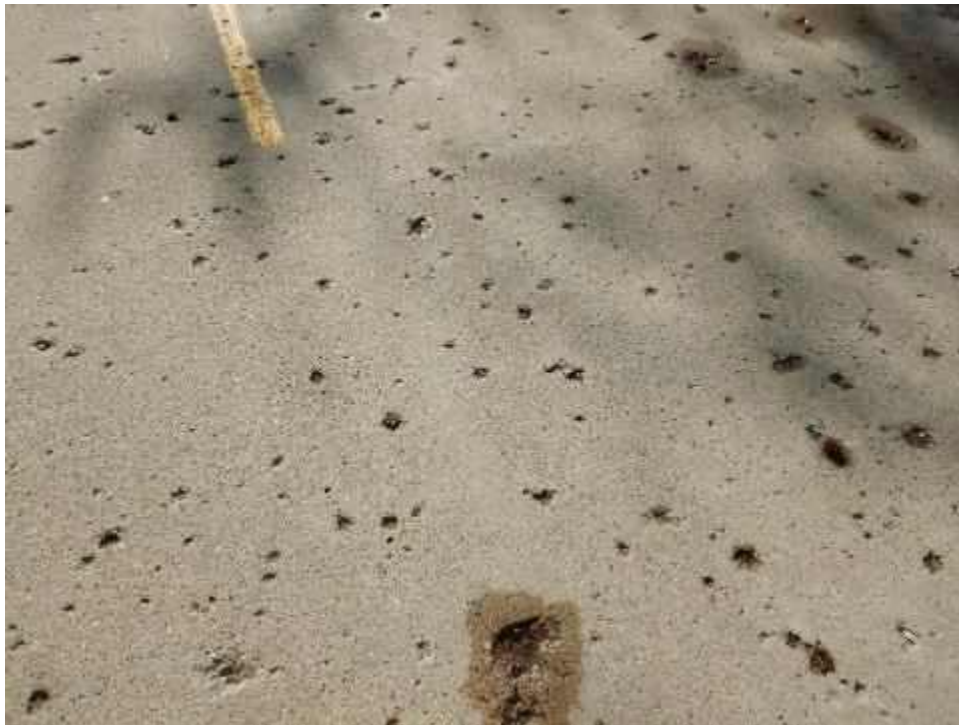
GERTYD-E00B-Popouts-(Sample Unit No. 01)

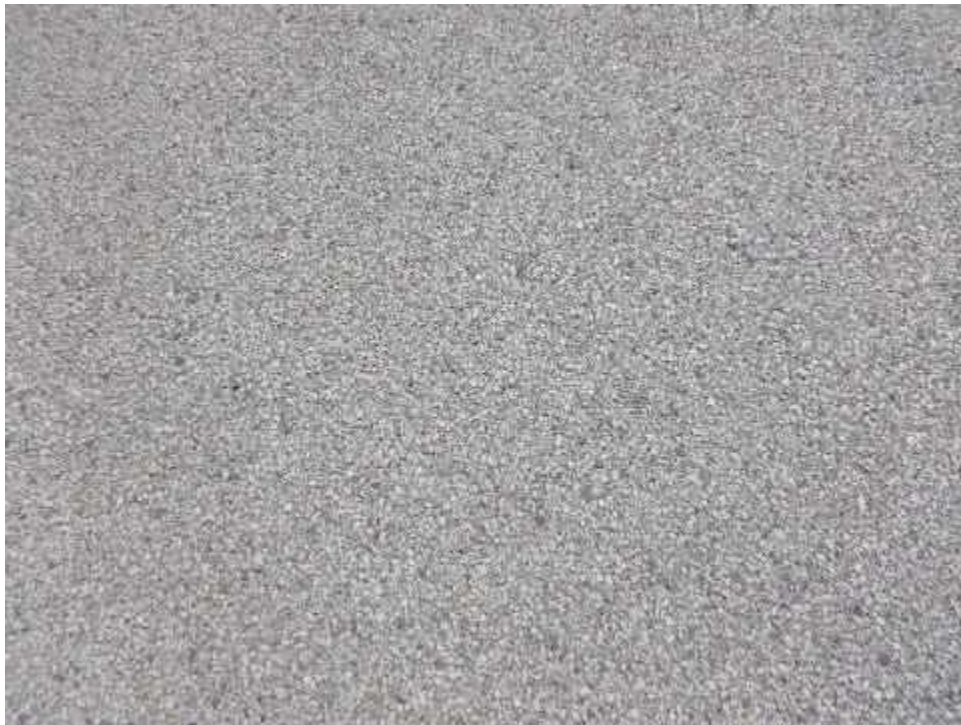
GHUFFDR-UW03-Weathering-(Sample Unit No. 01)

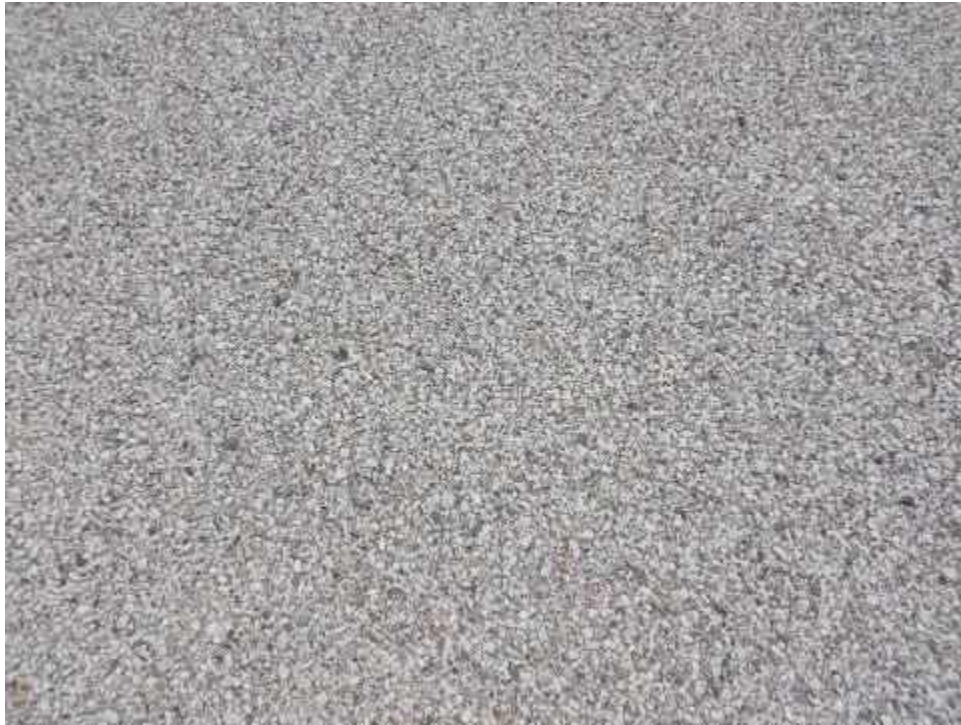
GHUFFDR-UW04AN-Weathering-(Sample Unit No. 01)

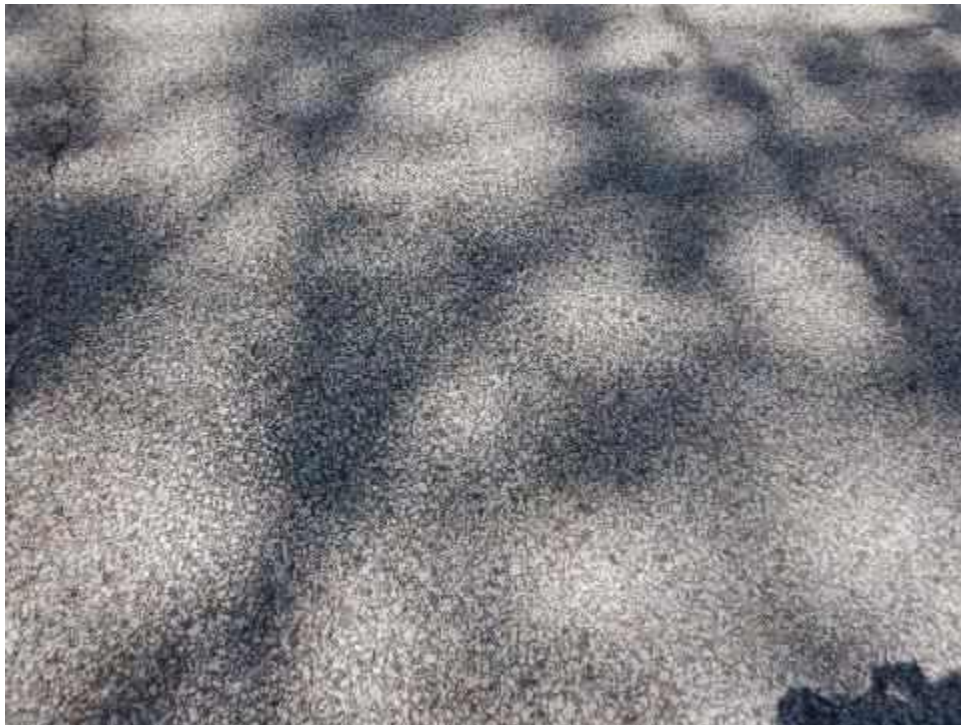
GHUFFDR-UW04S-Weathering-(Sample Unit No. 01)

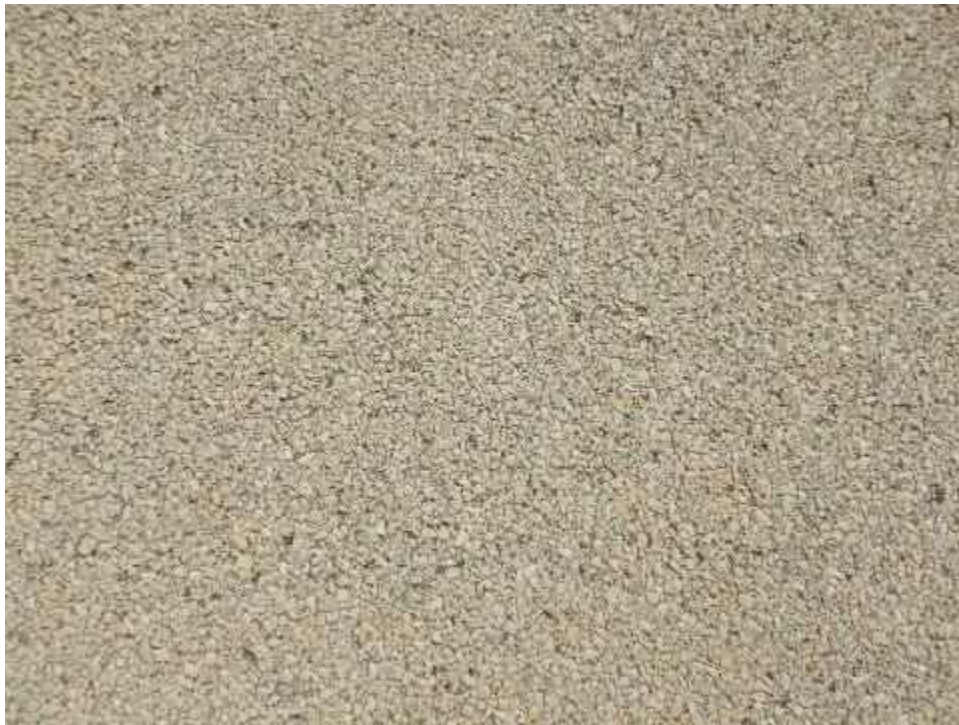
GOODWINA-US12-Weathering-(Sample Unit No. 01)

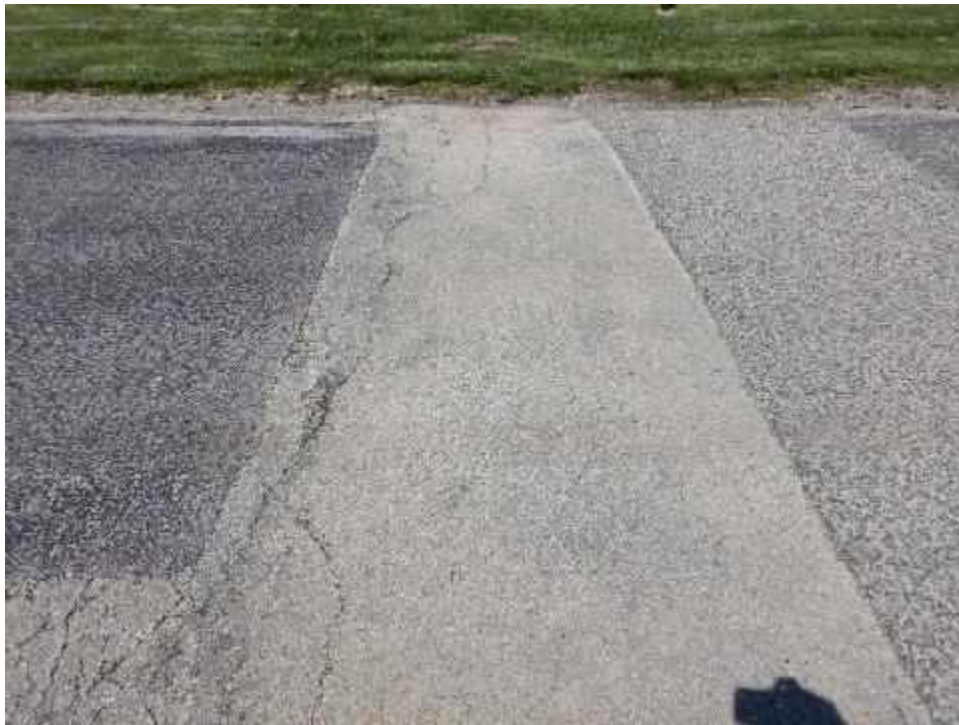
GOODWINA-US17-Patching-(Sample Unit No. 01)

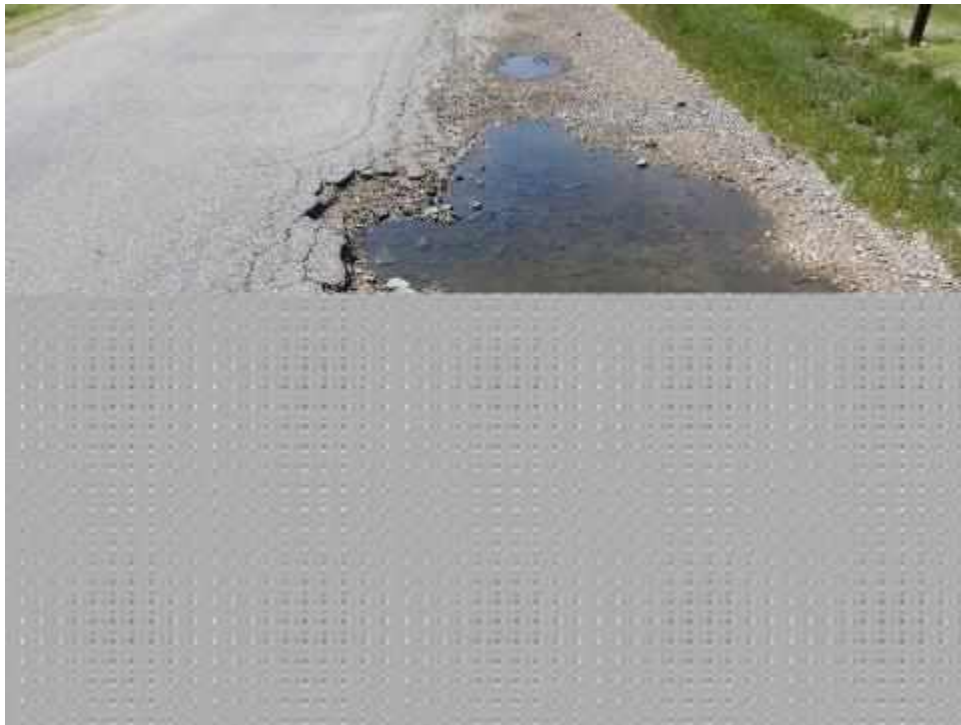
GOODWINA-US17-Raveling-(Sample Unit No. 01)

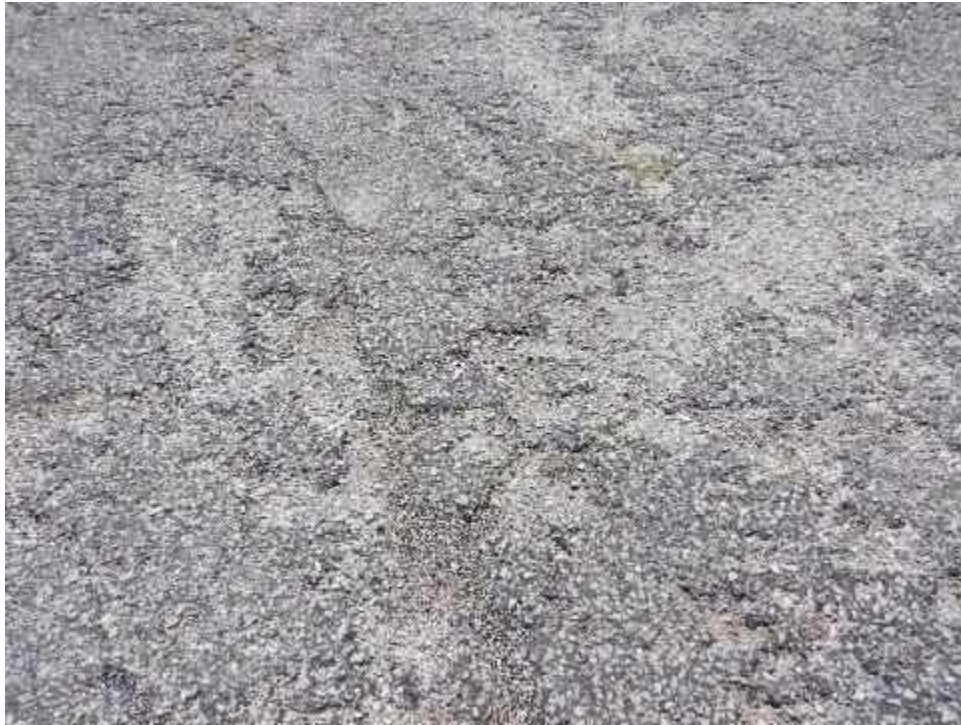
GOODWINA-US19-Raveling-(Sample Unit No. 02)

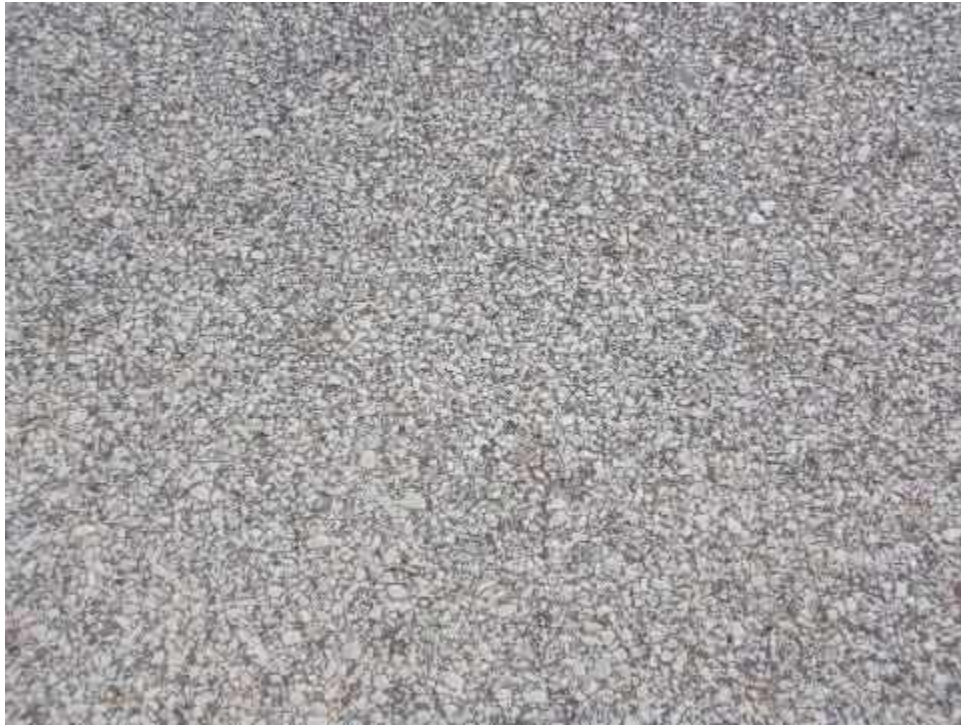
GREGYD-E01AS-Weathering-(Sample Unit No. 01)

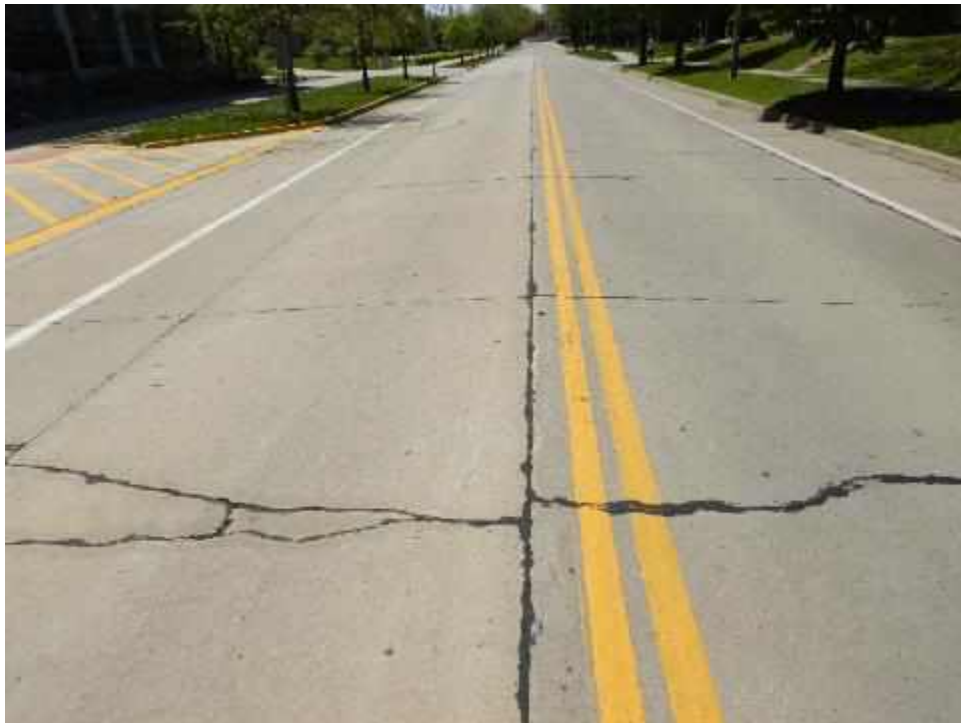
GREGYD-E02A-LTD Cracking-(Sample Unit No. 01)

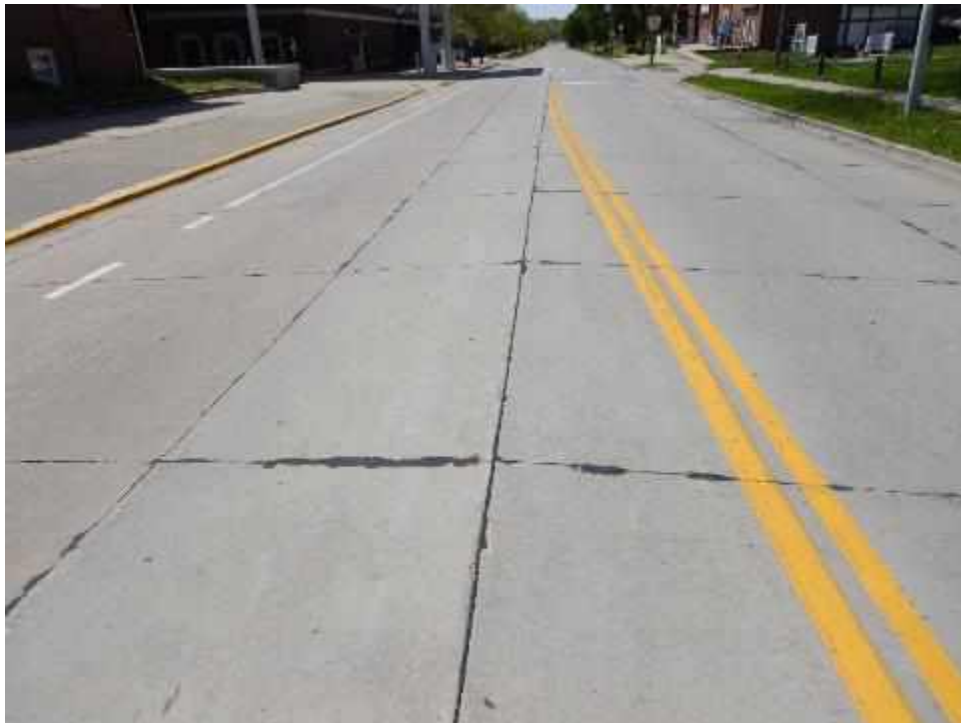
GREGYD-E03B-LTD Cracking-(Sample Unit No. 01)

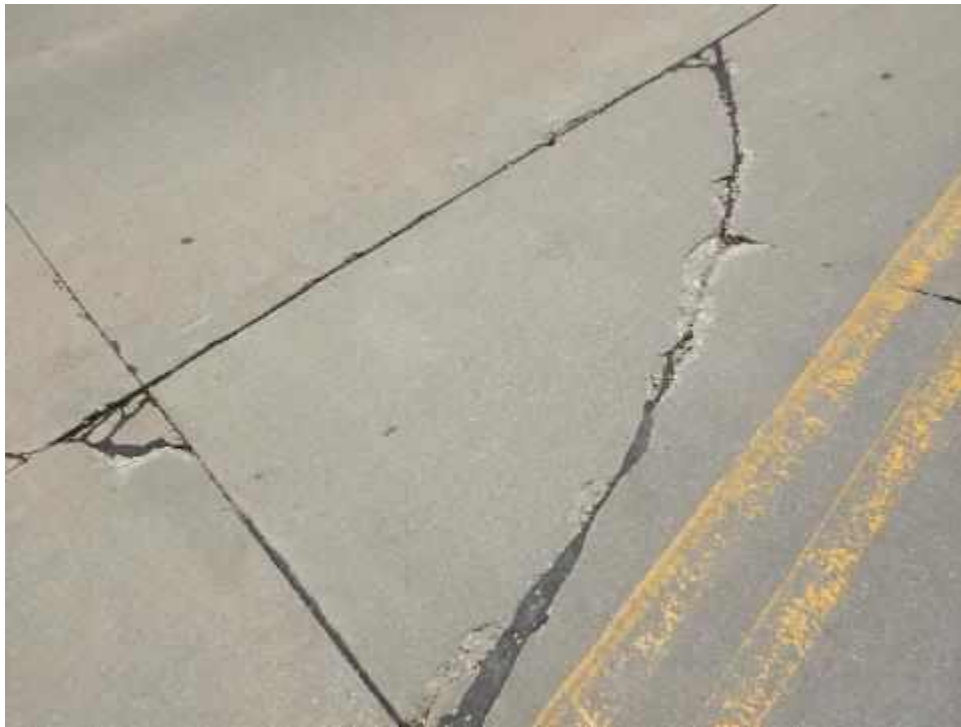
GREGYD-E04-Corner Break-(Sample Unit No. 01)

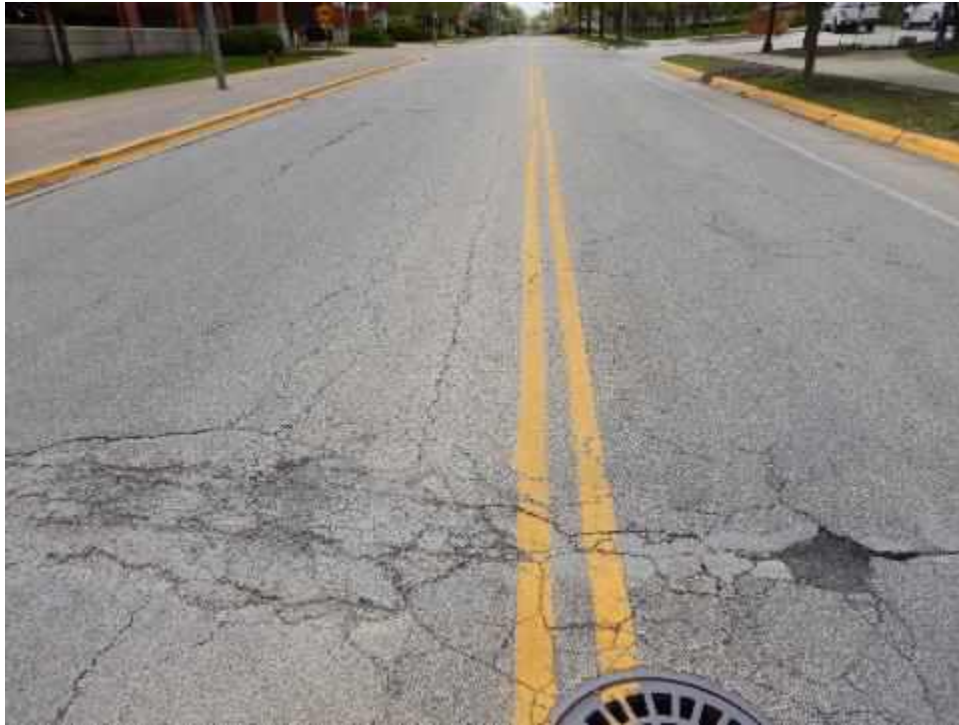
GREGYD-UW11-Block Cracking-(Sample Unit No. 01)
