# U20069: Pavement Analysis Study 2020 University of Illinois at Urbana-Champaign

## Final Report

Applied Pavement Technology, Inc.  
115 West Main Street, Suite 400  
Urbana, Illinois 61801  
(217) 398-3977  
[www.appliedpavement.com](http://www.appliedpavement.com)

**AUGUST 2020**

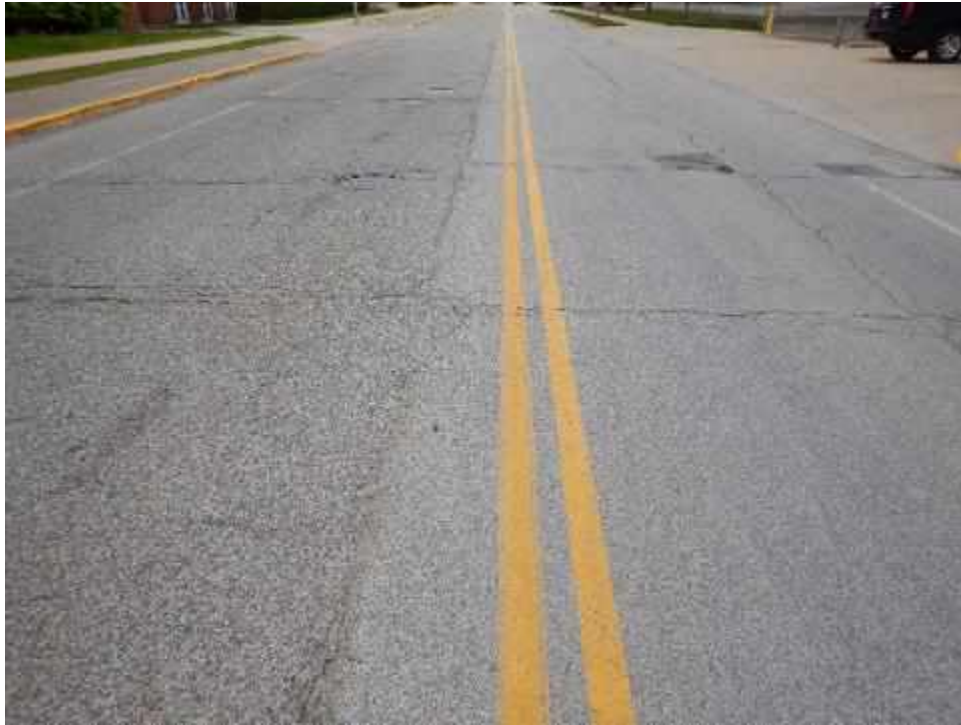
GREGYD-UW12A-Joint Reflection Cracking-(Sample Unit No. 01)

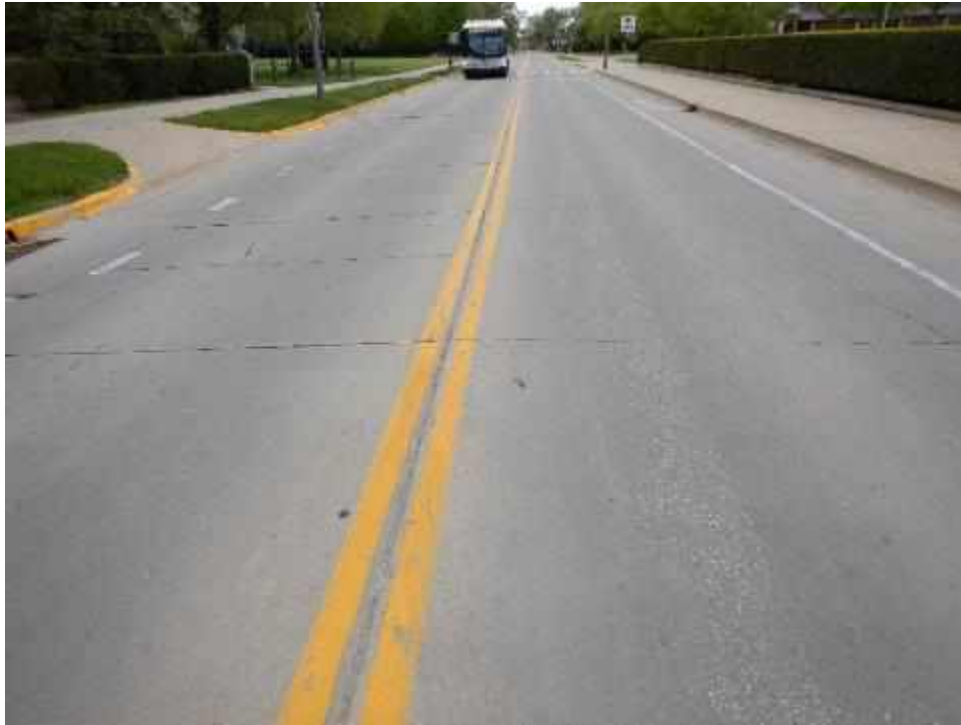
GREGYD-UW12B-Large Patching-(Sample Unit No. 01)

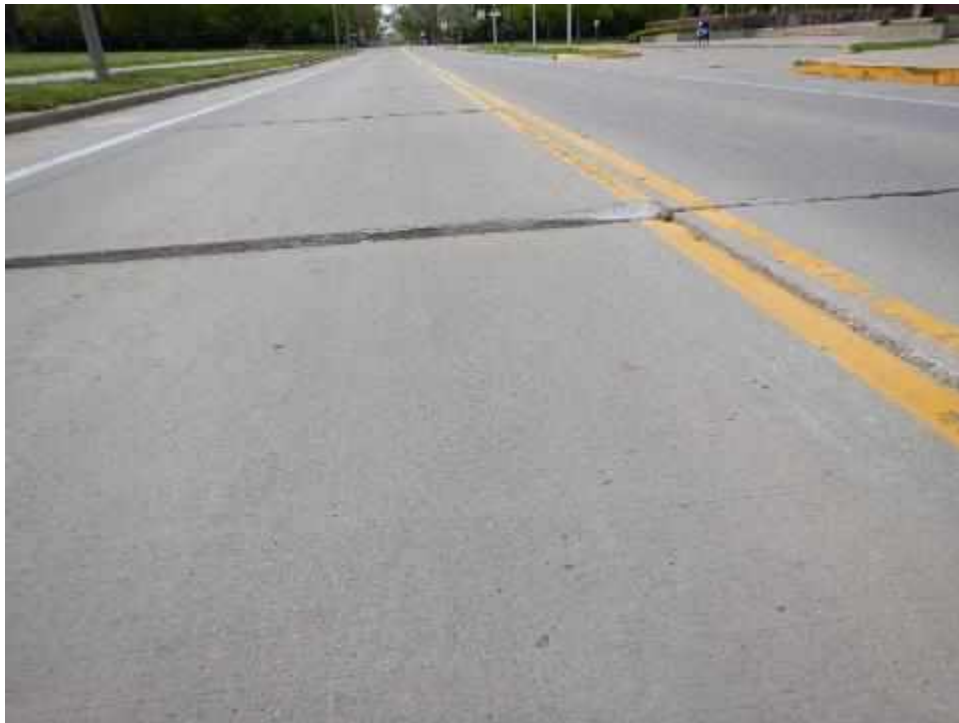
GREGYD-UW12C-Corner Spalling-(Sample Unit No. 01)

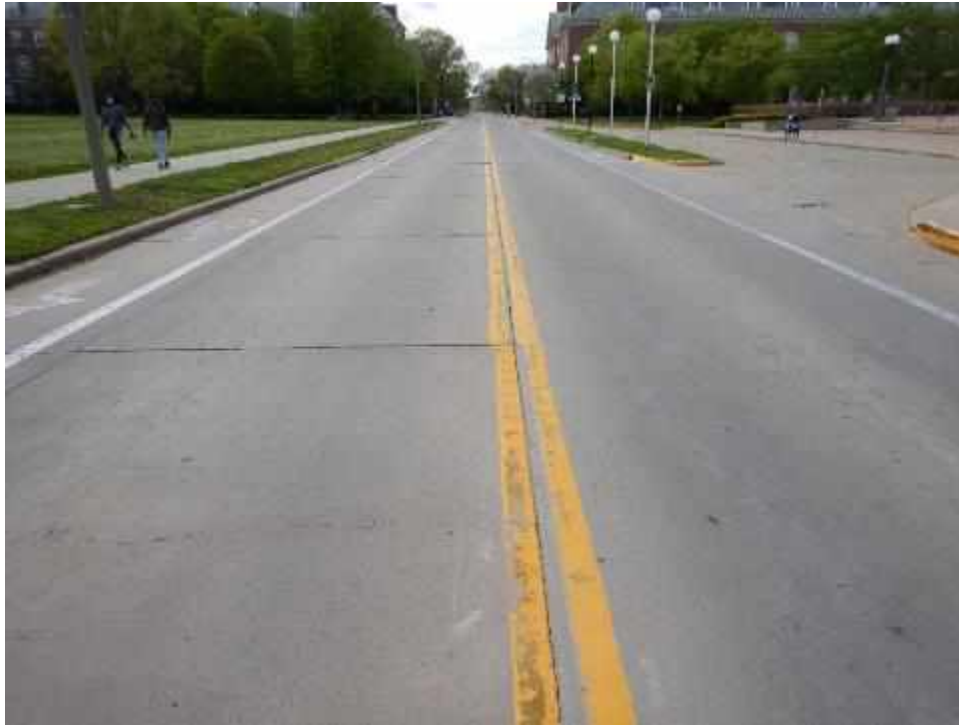
GREGYD-UW12C-Large Patching-(Sample Unit No. 01)

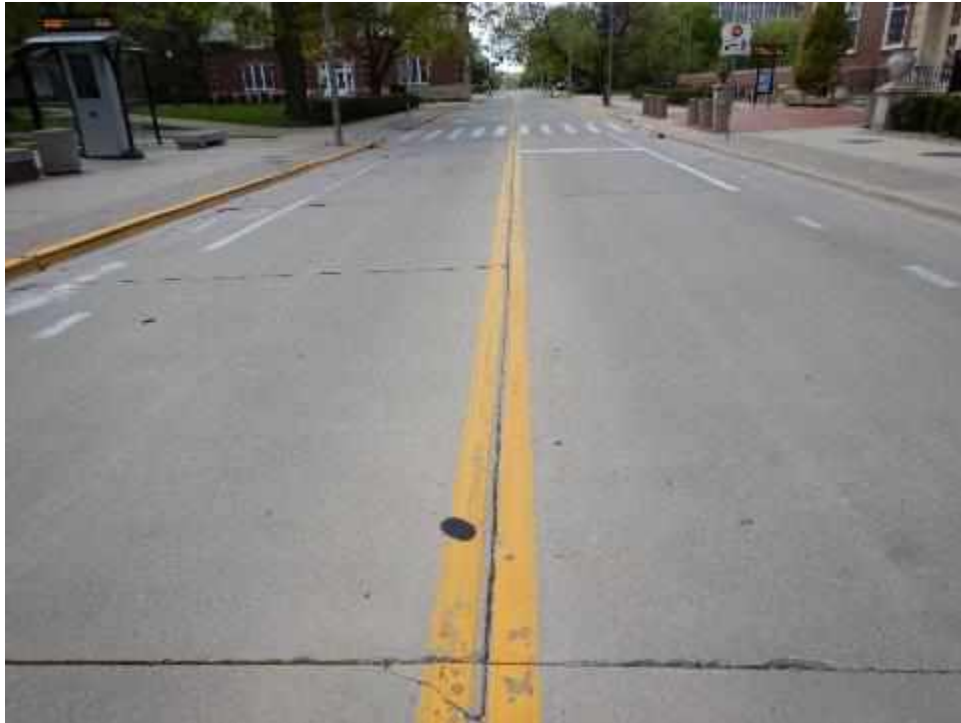
GREGYD-UW12D-Large Patching-(Sample Unit No. 01)

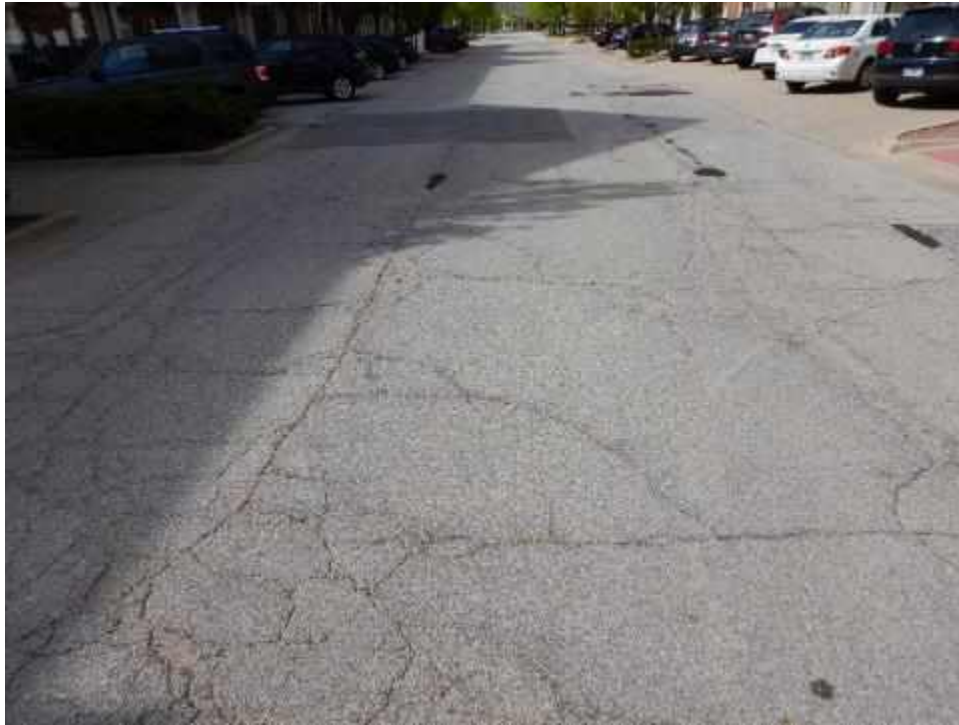
GRGRYST-US05-Block Cracking-(Sample Unit No. 01)

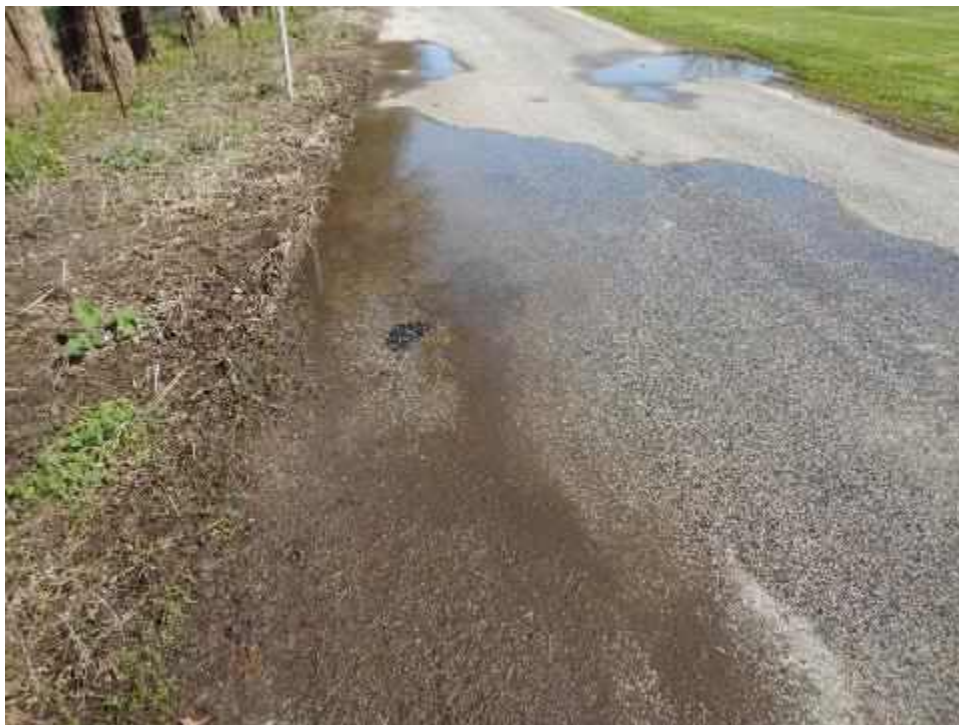
GRIFFITHD-S18-Alligator Cracking-(Sample Unit No. 01)

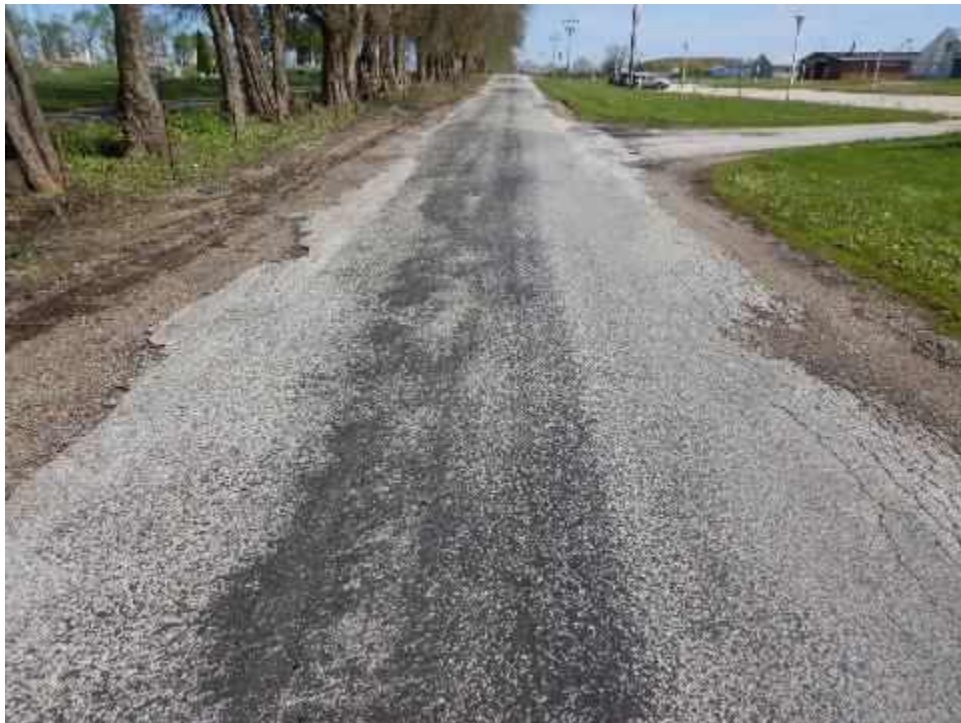
GRIFFITHD-S18-Edge Cracking-(Sample Unit No. 01)

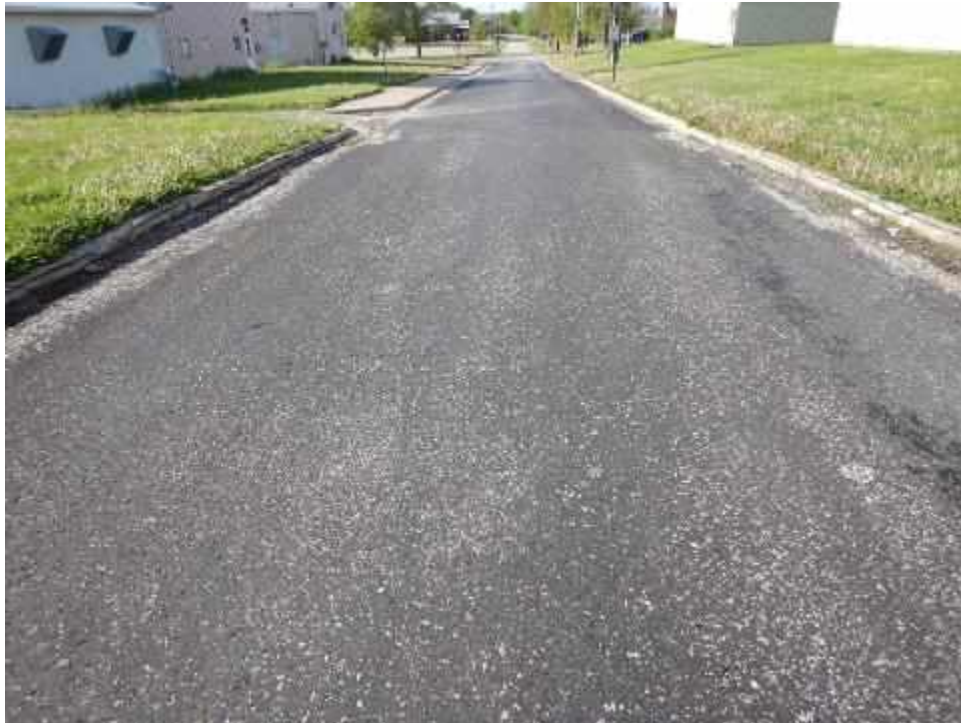
GRIFFITHD-S20-Edge Cracking-(Sample Unit No. 01)

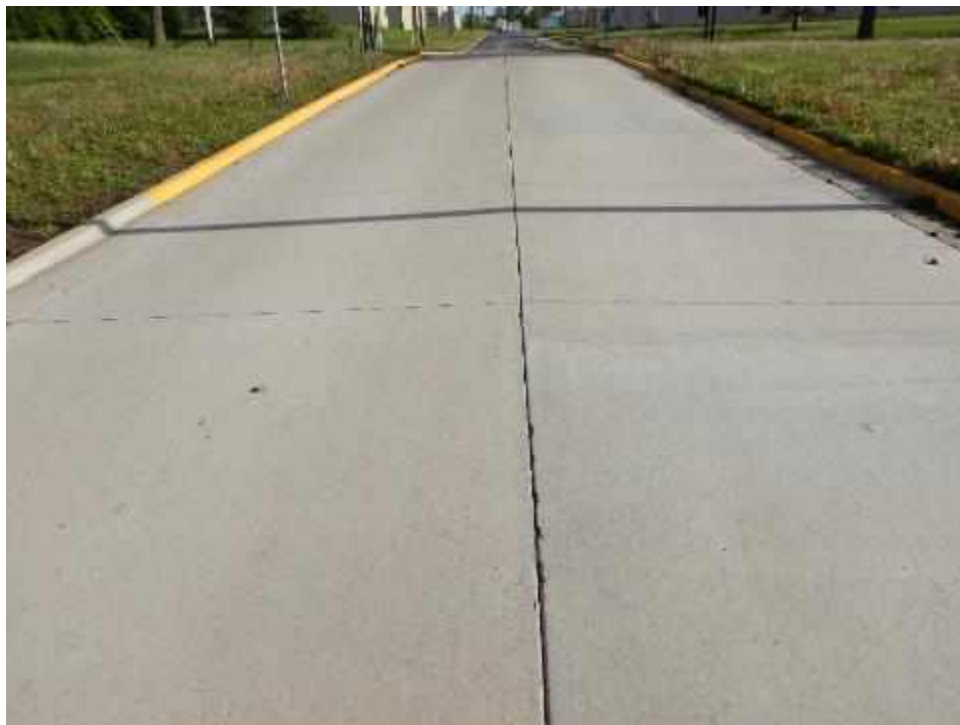
GRIFFITHD-S22A-Joint Seal Damage-(Sample Unit No. 01)

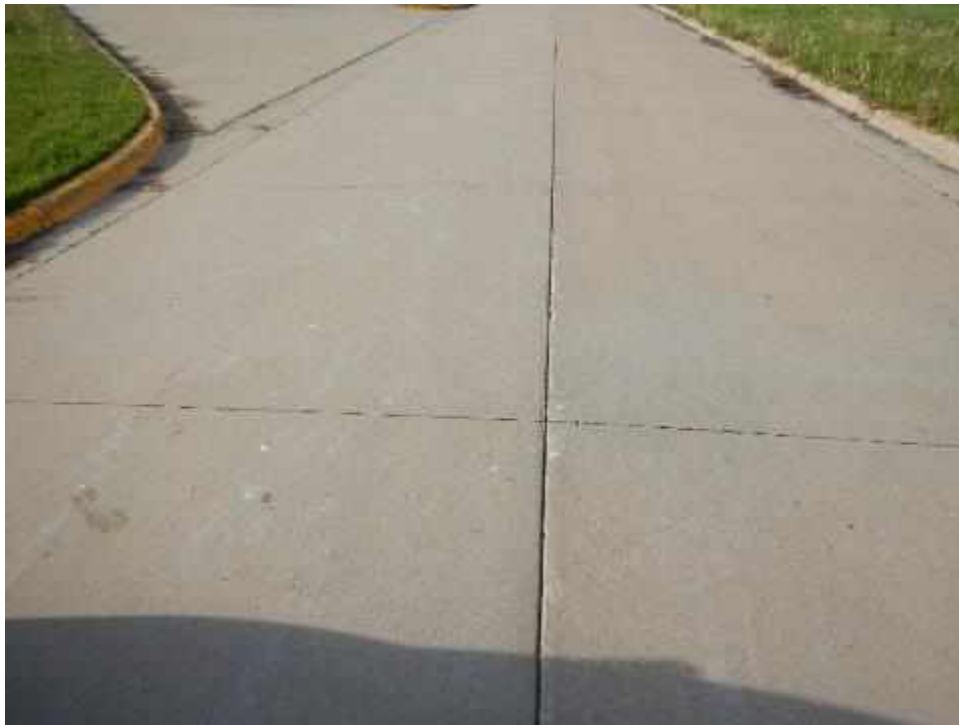
GRIFFITHD-S22C-Joint Seal Damage-(Sample Unit No. 01)

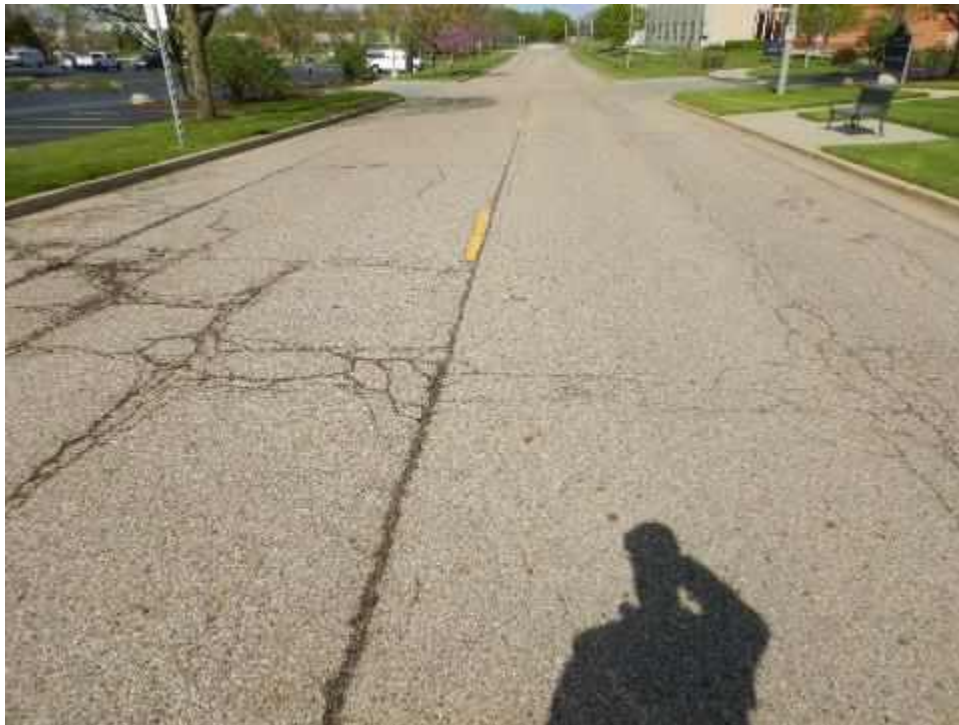
HAZELWDD-E00C-L&T Cracking-(Sample Unit No. 02)

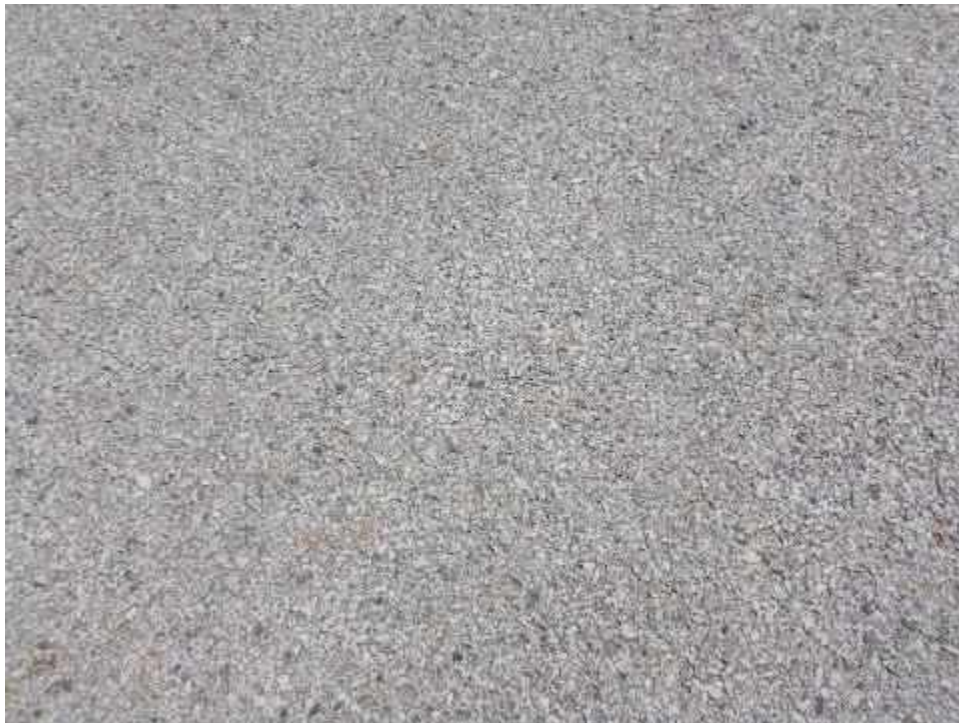
HAZELWDD-UW04-Weathering-(Sample Unit No. 01)

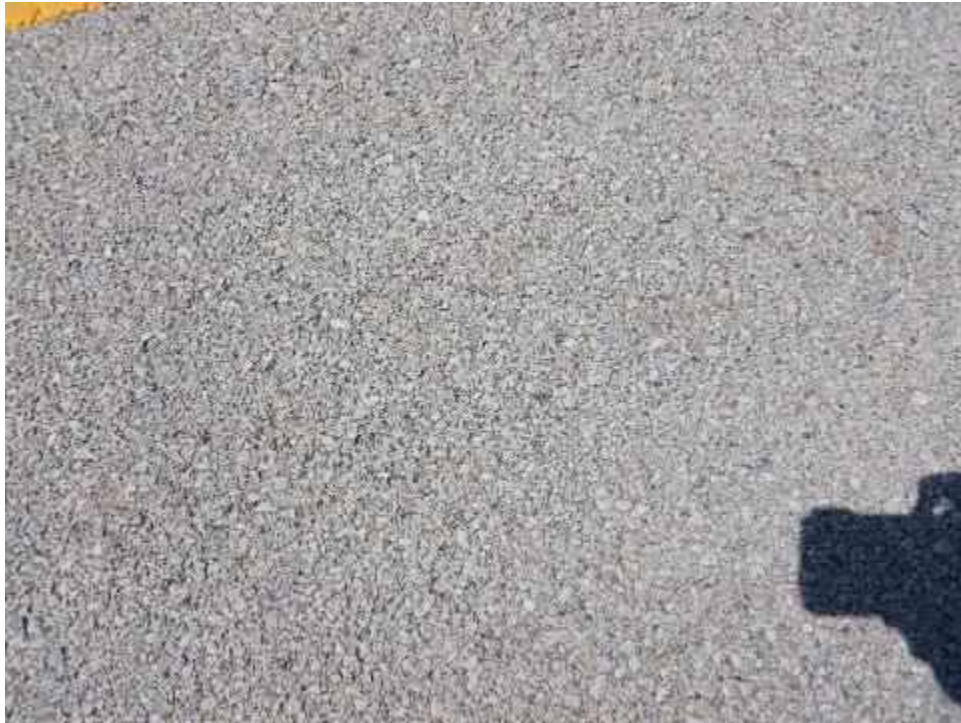
HAZELWDD-UW05-Weathering-(Sample Unit No. 01)

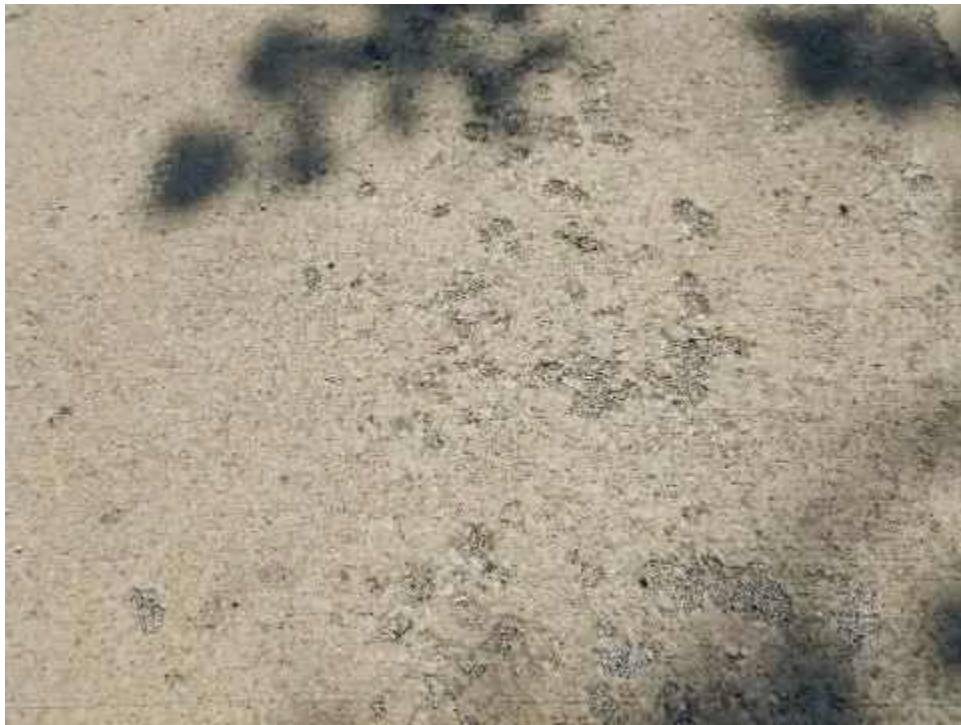
HAZELWDD-UW09-Scaling-(Sample Unit No. 01)

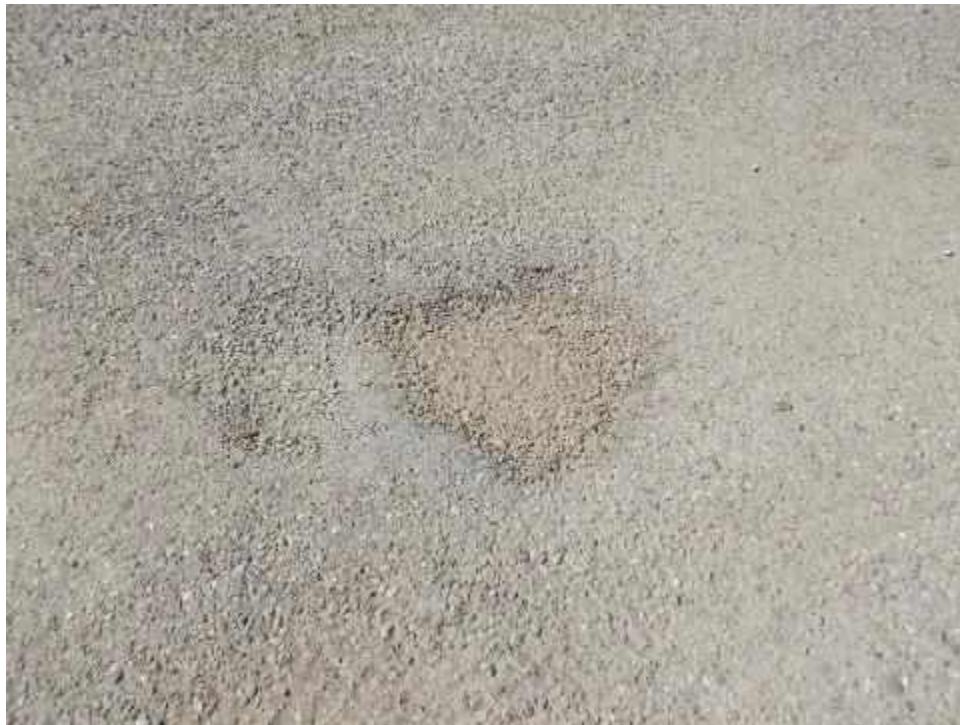
HAZELWDD-UW12A-Raveling-(Sample Unit No. 01)

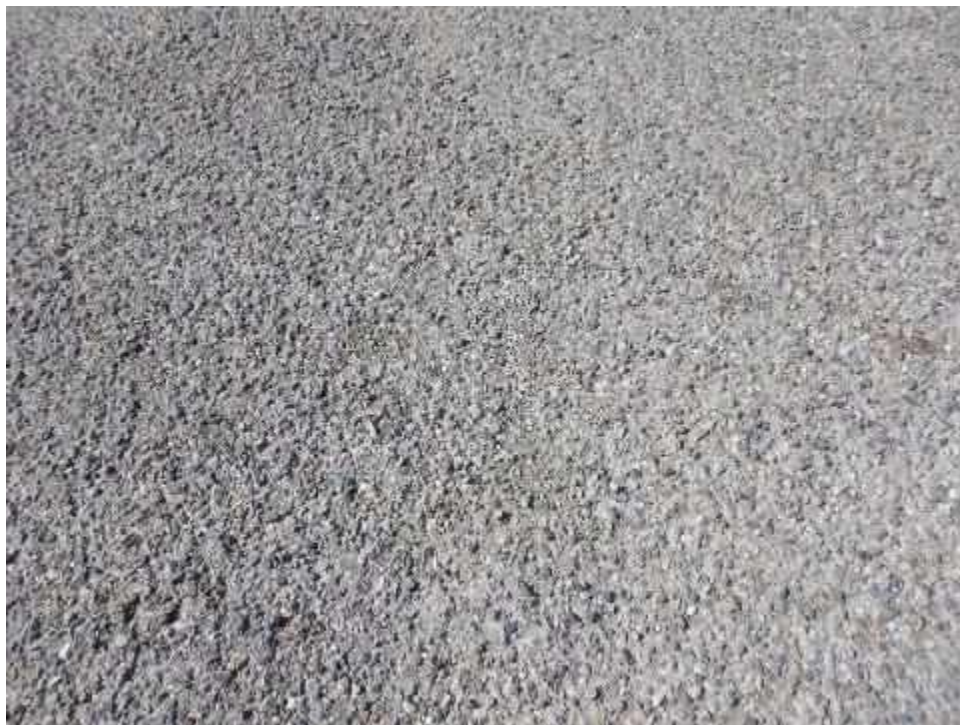
HAZELWDD-UW12A-Weathering-(Sample Unit No. 01)

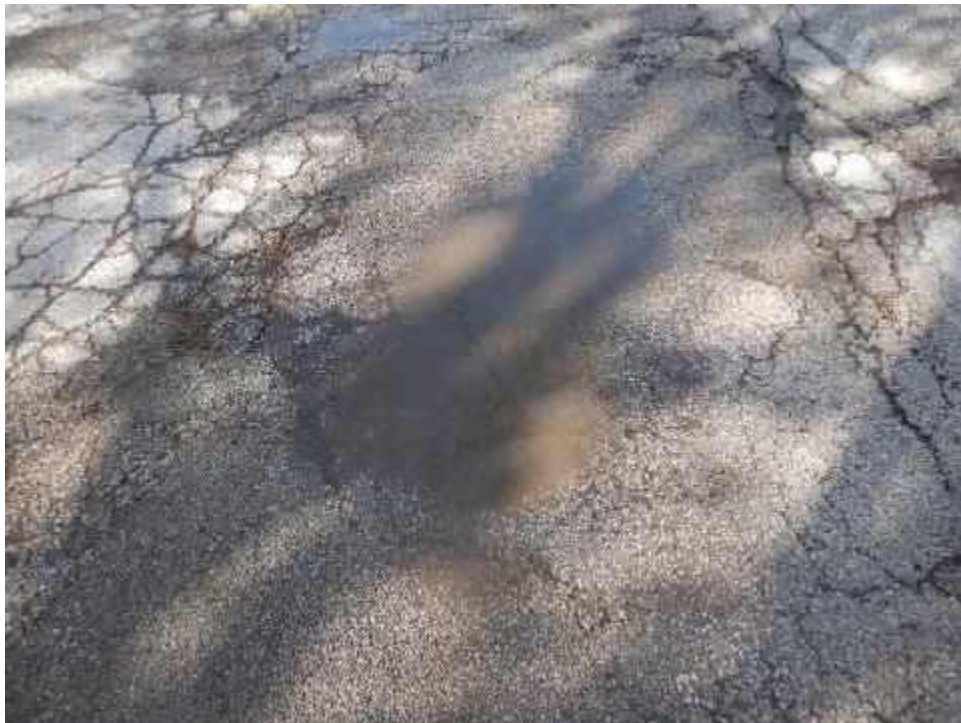
KIRKD-S20B-Depression-(Sample Unit No. 01)

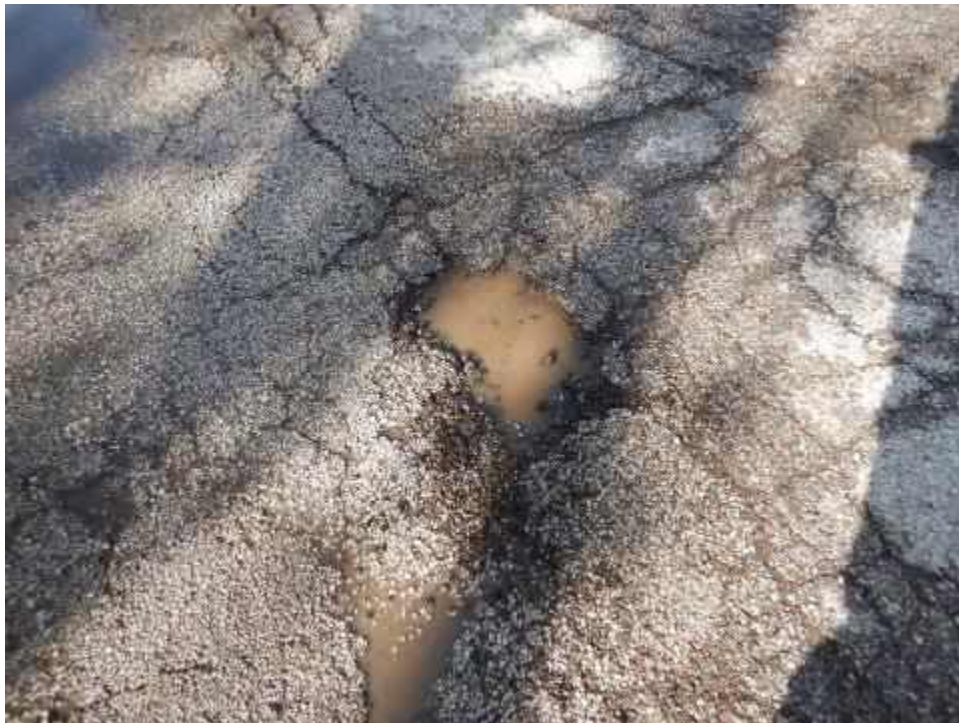
KIRKD-S20B-Pothole-(Sample Unit No. 01)

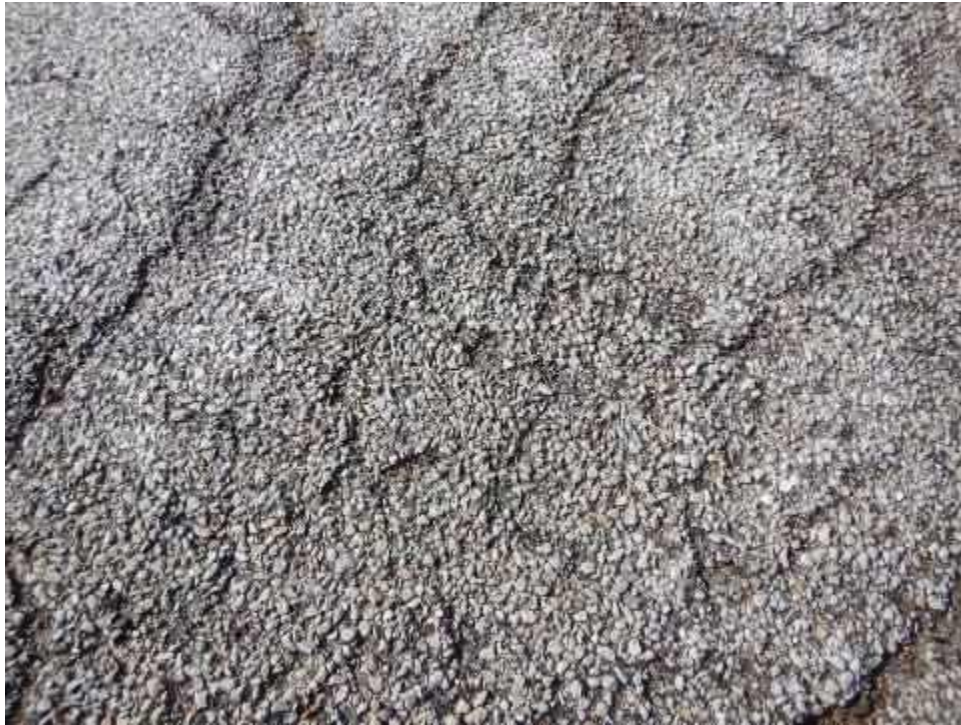
KIRKD-S20B-Raveling-(Sample Unit No. 01)

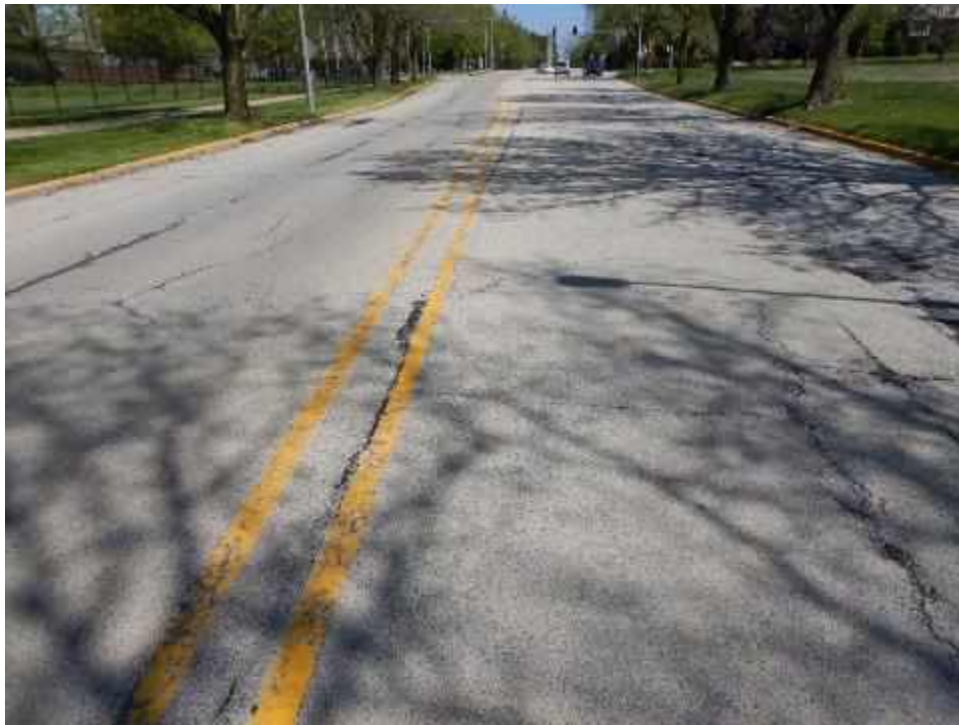
LNCLNAV-US17B-Joint Reflection Cracking-(Sample Unit No. 01)

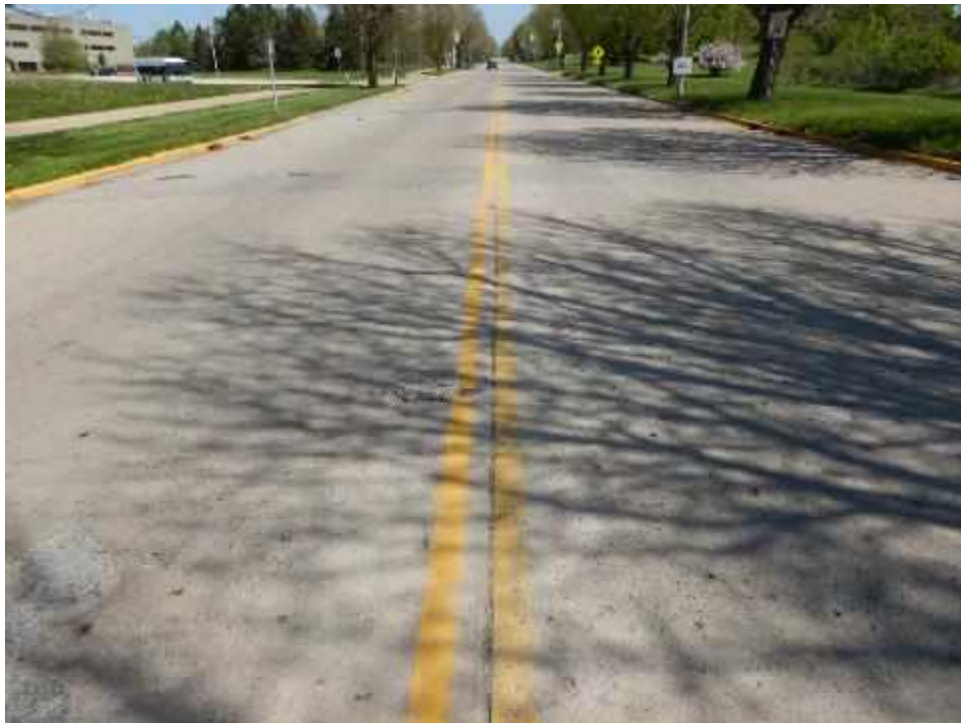
LNCLNAV-US19-Large Patching-(Sample Unit No. 01)

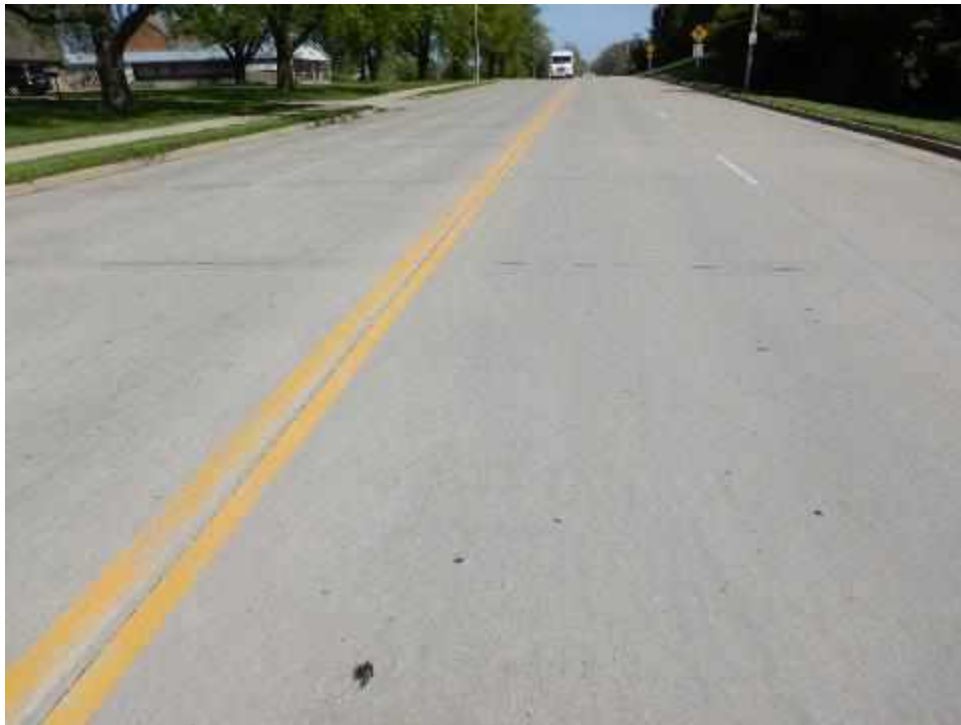
LNCLNAV-US21-Corner Break-(Sample Unit No - 04)

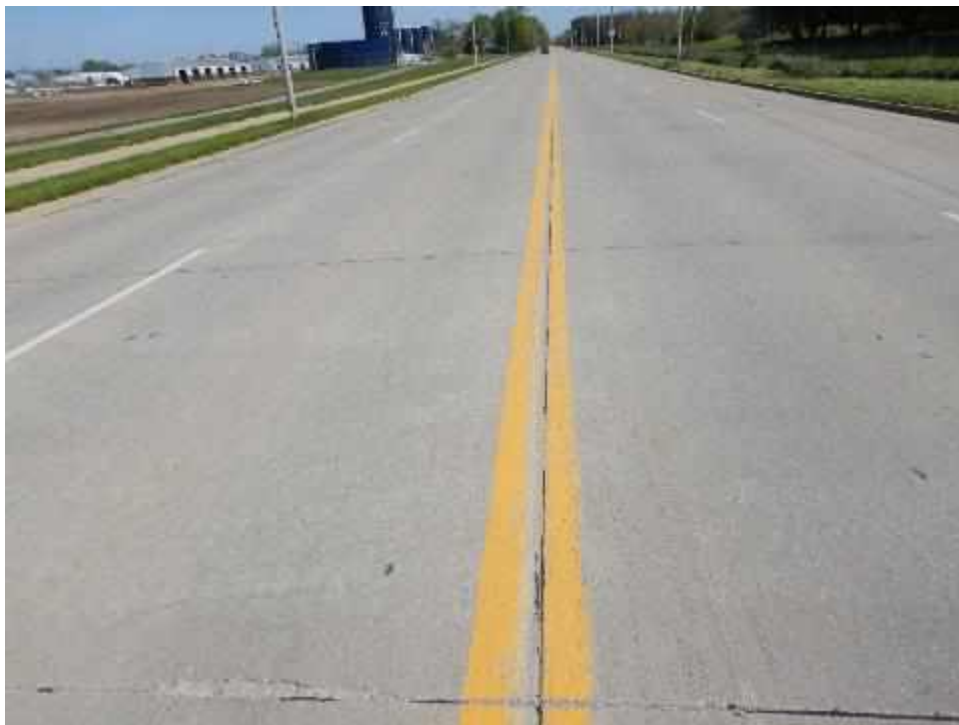
LNCLNAV-US23-LTD Cracking-(Sample Unit No. 01)

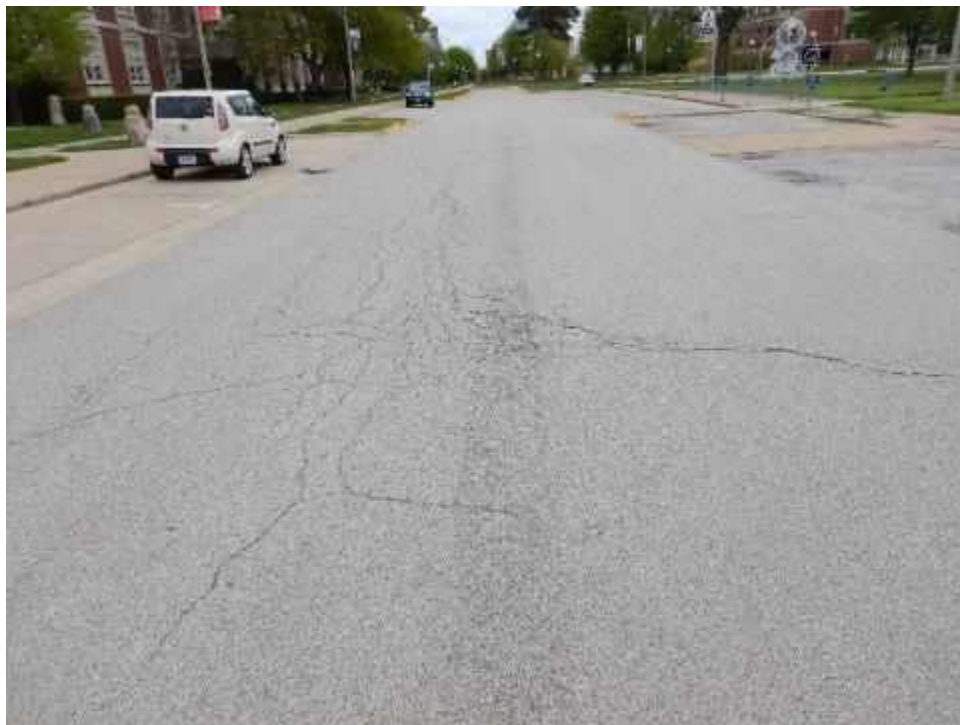
LORADOTD-UW12-L&T Cracking-(Sample Unit No. 01)

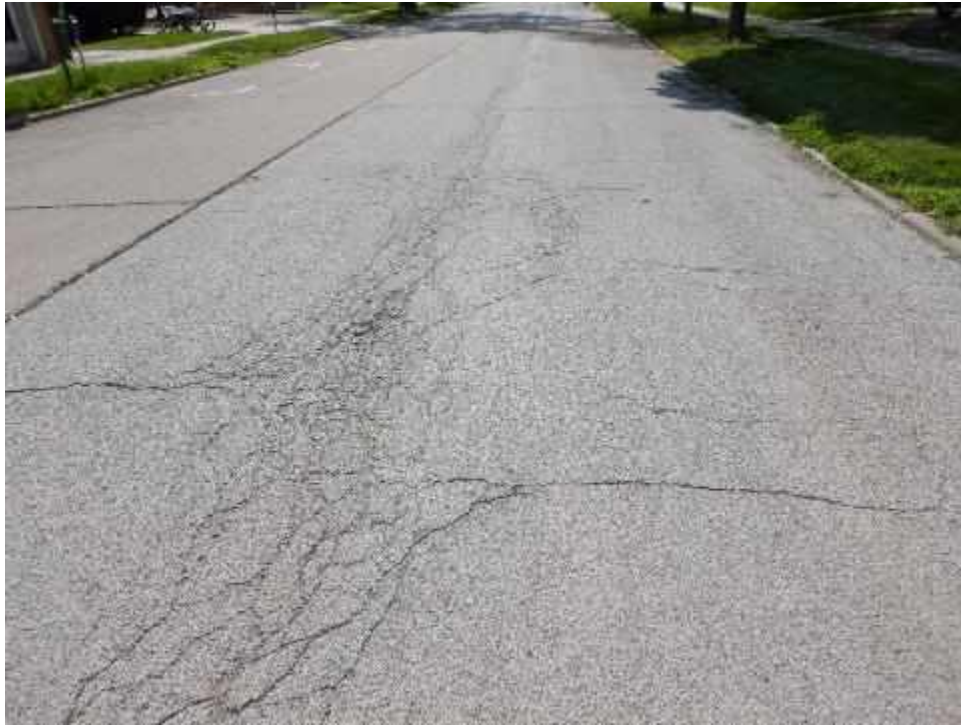
MAINS-UW11AN-Block Cracking-(Sample Unit No. 01)

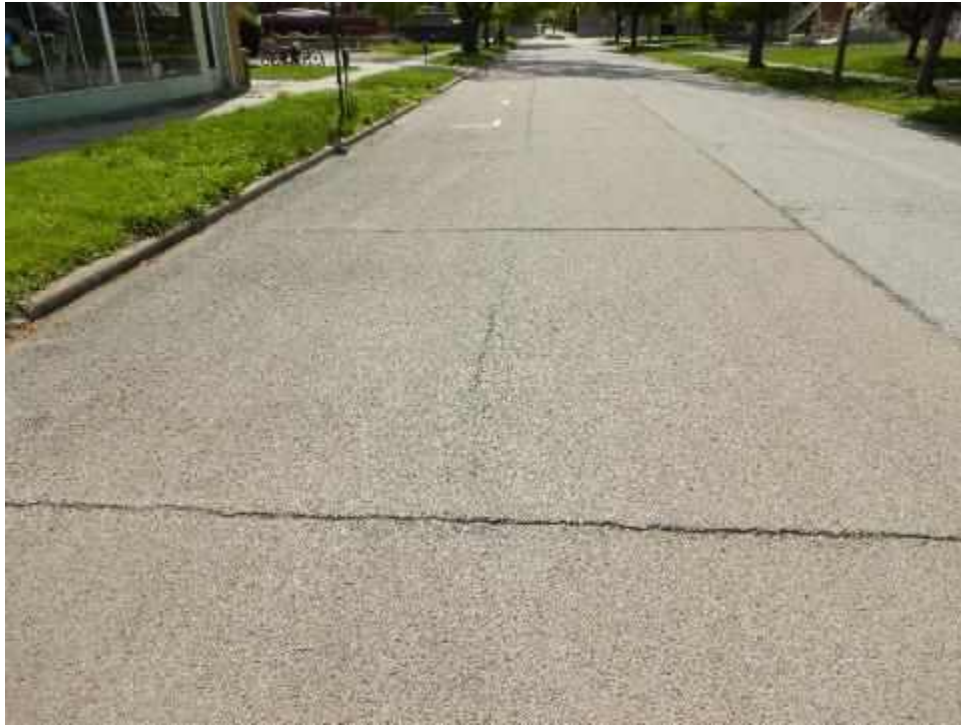
MAINS-UW11AS-Joint Reflection Cracking-(Sample Unit No. 01)

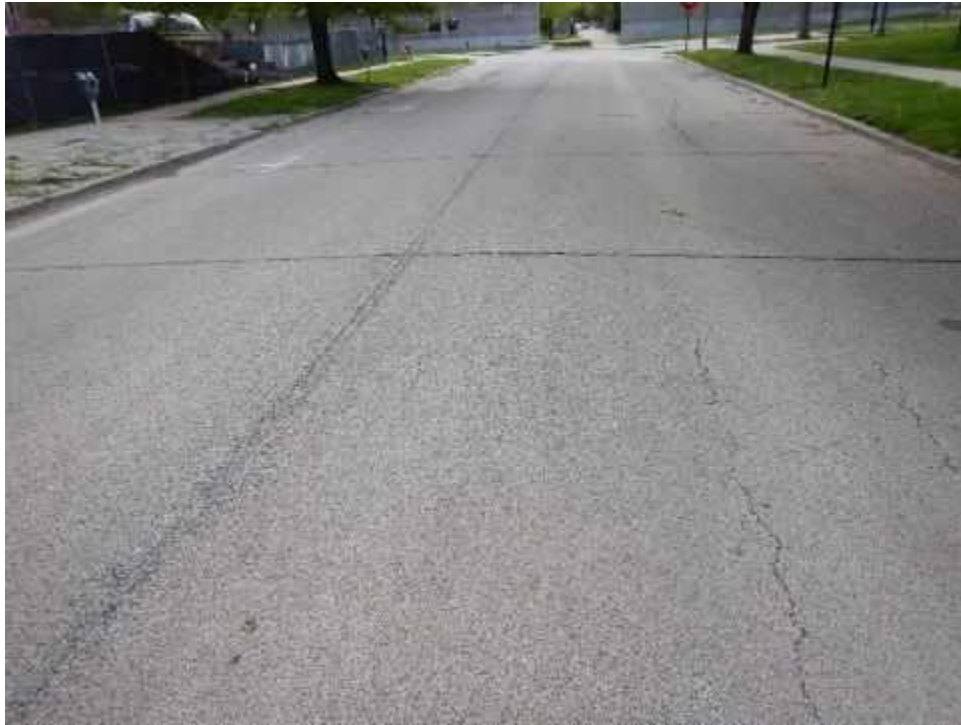
MAINS-UW11B-L&T Cracking-(Sample Unit No. 01)

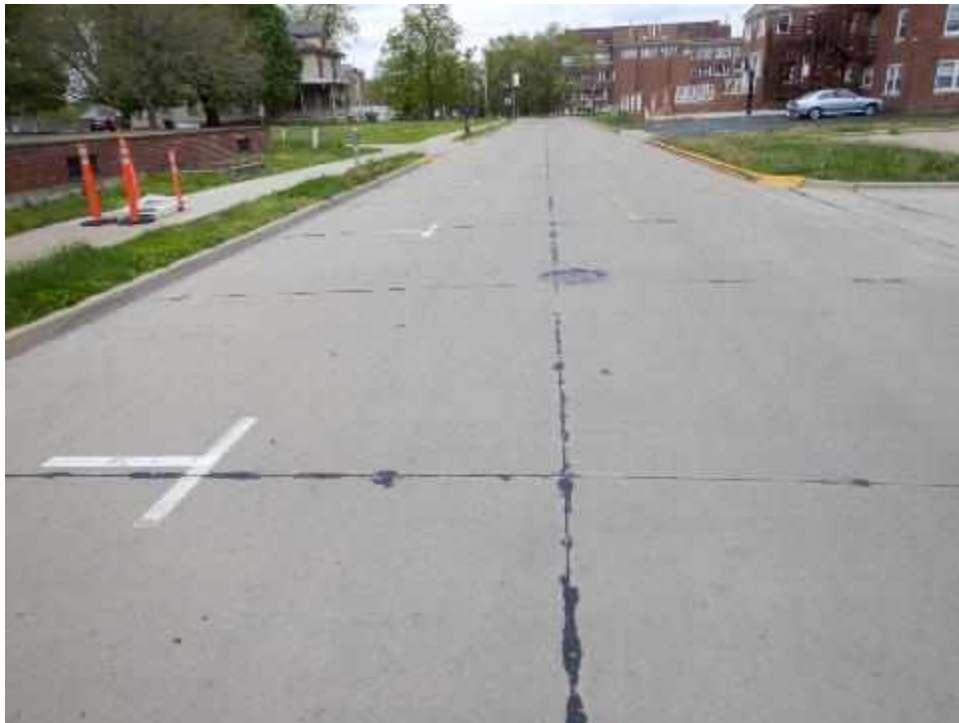
MRYLNDDR-US14-LTD Cracking-(Sample Unit No. 01)

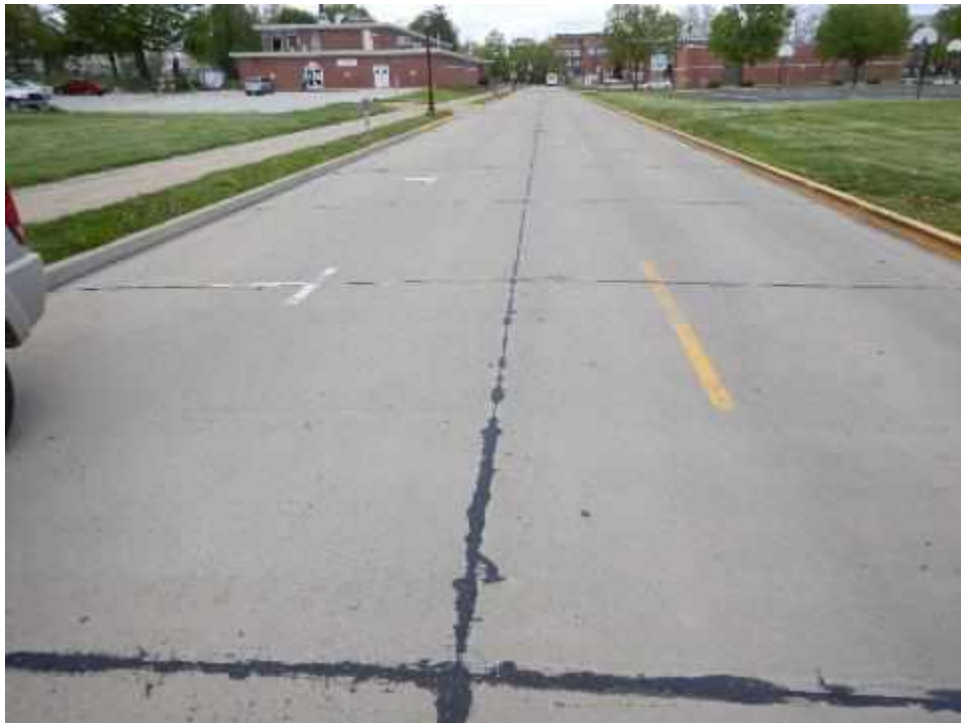
MRYLNDDR-US15-LTD Cracking-(Sample Unit No. 01)

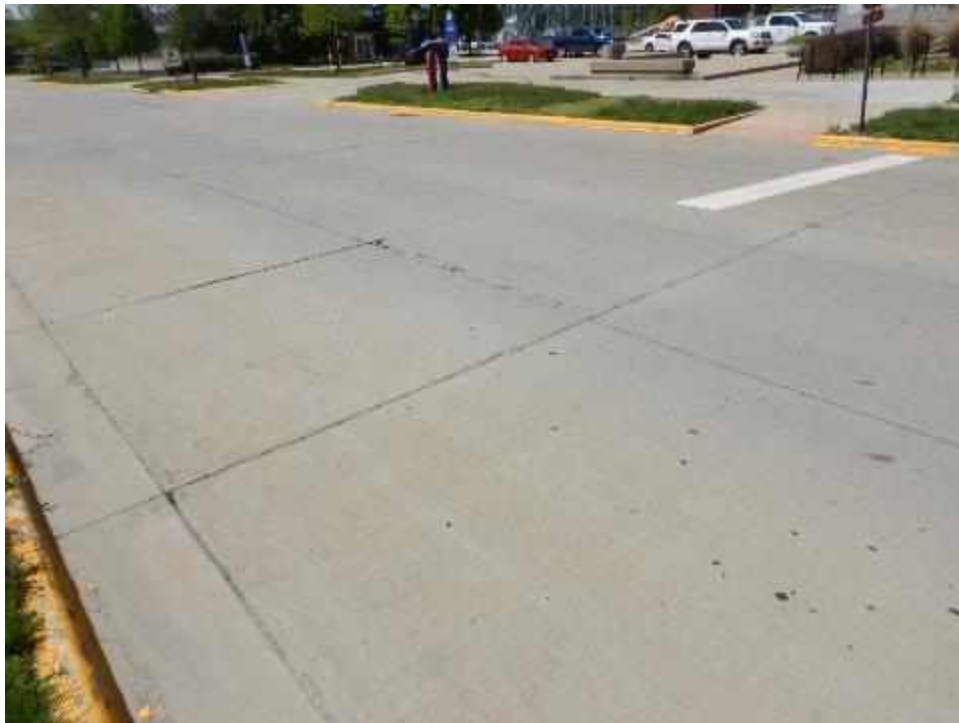
OAKS-S10C-Joint Spalling-(Sample Unit No. 01)

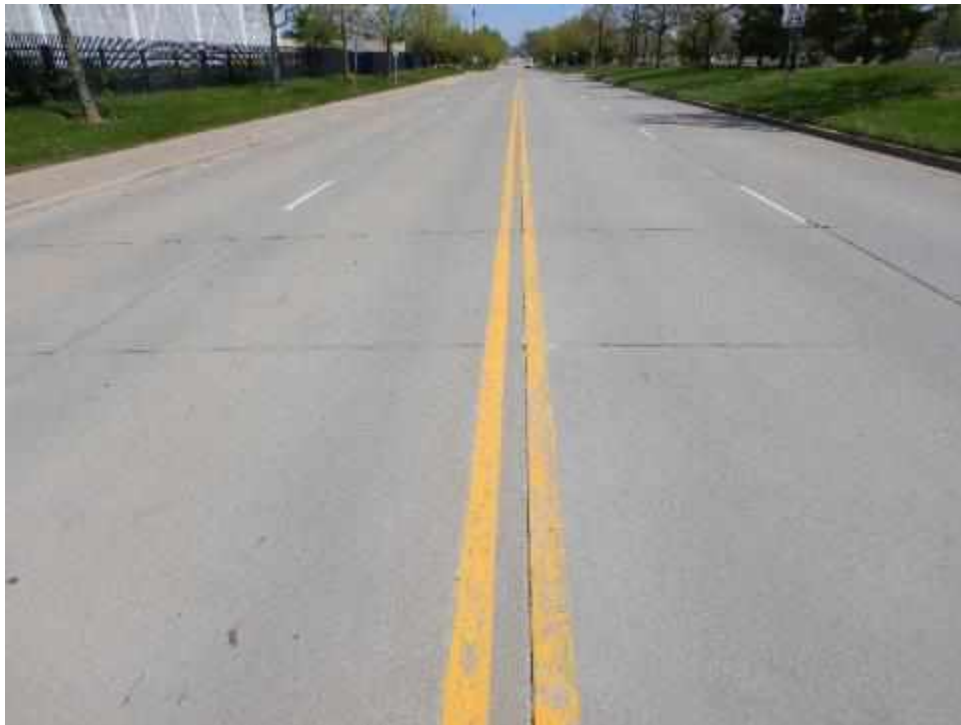
OAKS-S16-Large Patching-(Sample Unit No. 004)
