# U20069: Pavement Analysis Study 2020 University of Illinois at Urbana-Champaign

## Final Report

Applied Pavement Technology, Inc.  
115 West Main Street, Suite 400  
Urbana, Illinois 61801  
(217) 398-3977  
[www.appliedpavement.com](http://www.appliedpavement.com)

**AUGUST 2020**

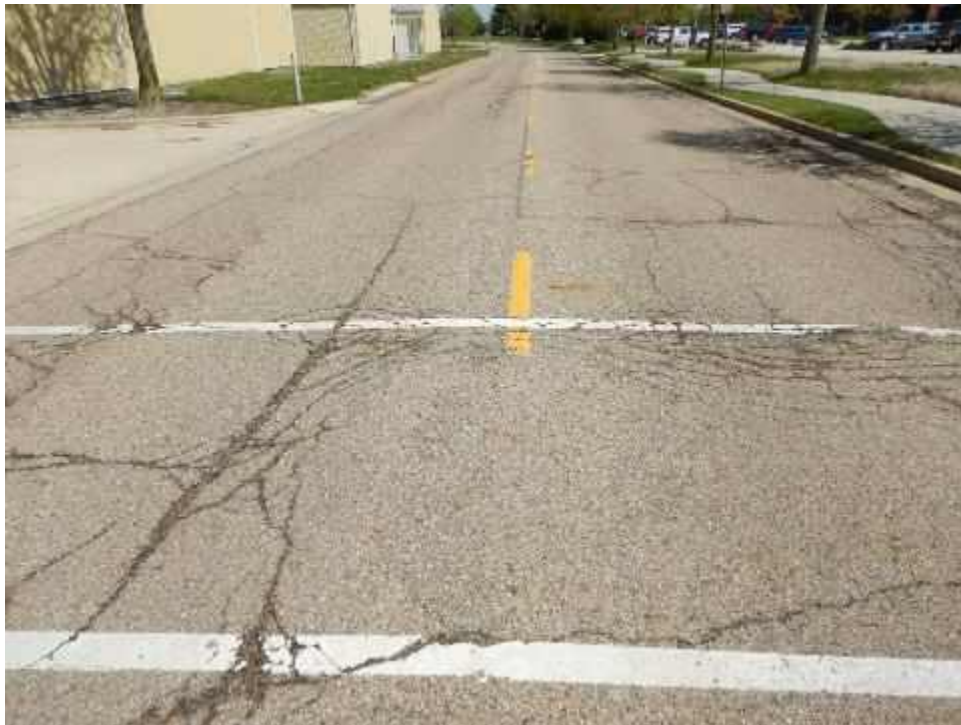
OAKS-S18A-Block Cracking-(Sample Unit No. 02)

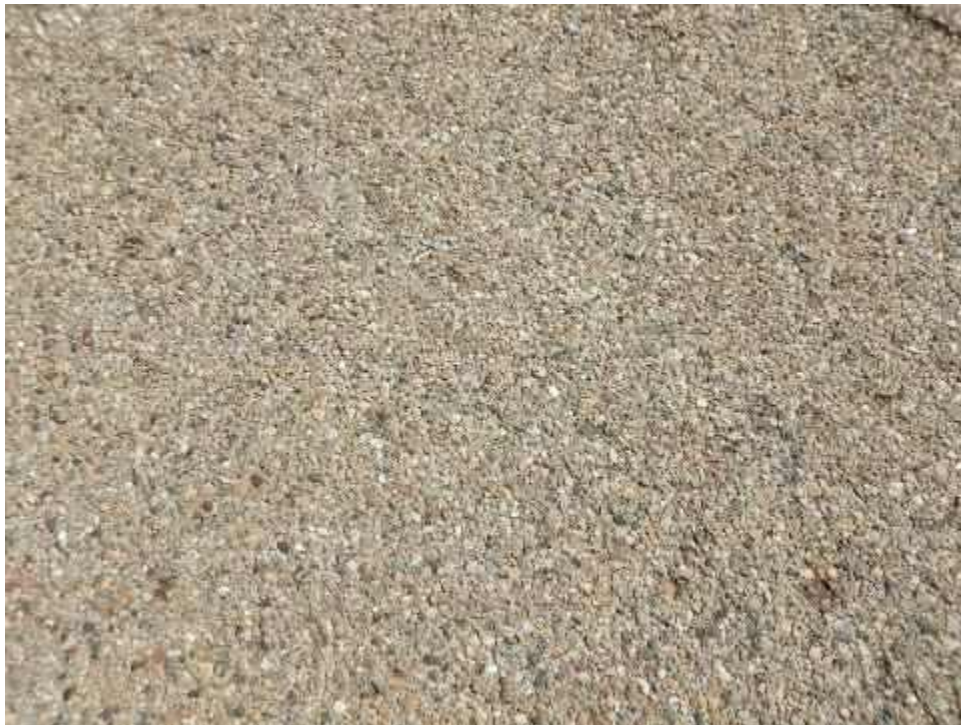
OAKS-S18A-Patching-(Sample Unit No. 02)

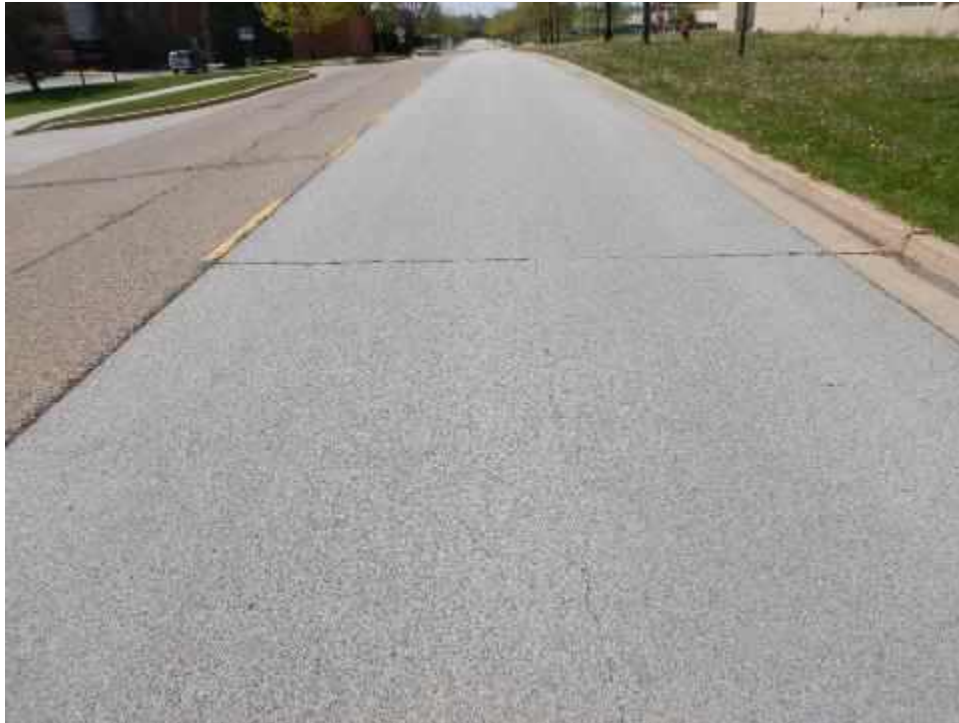
OAKS-S18B-L&T Cracking-(Sample Unit No. 05)

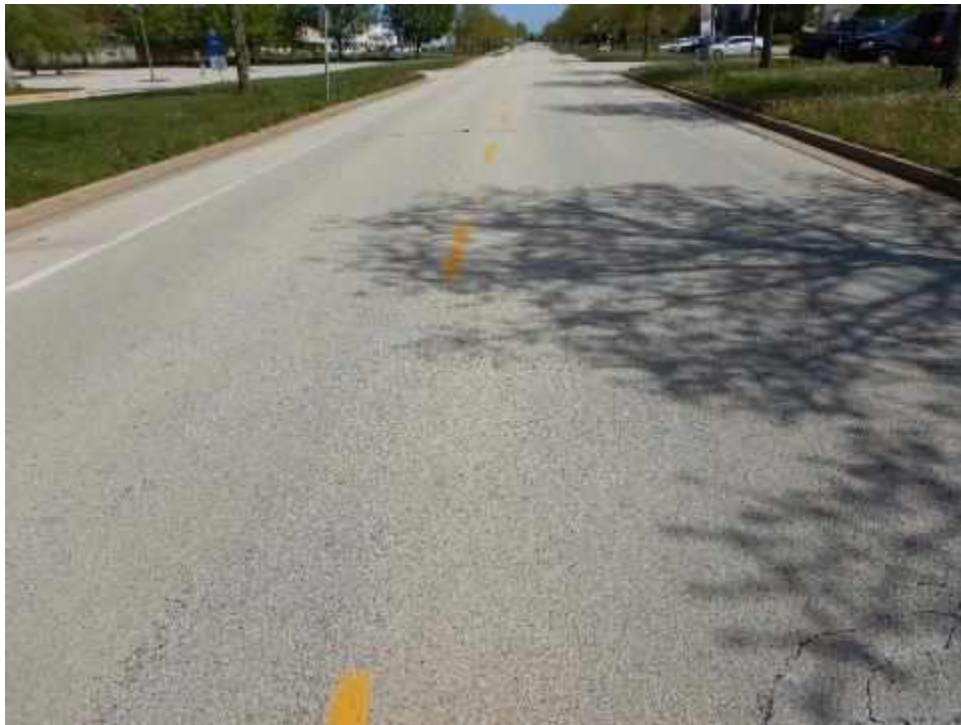
OAKS-S20B-L&T Cracking-(Sample Unit No. 01)

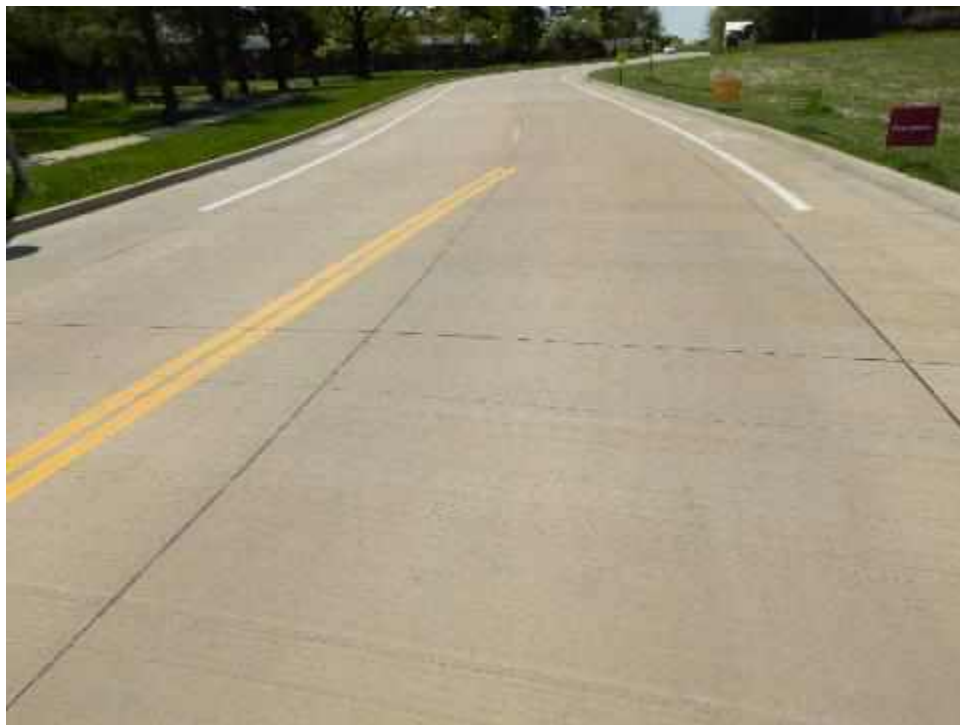
OAKS-S20B-Weathering-(Sample Unit No. 01)

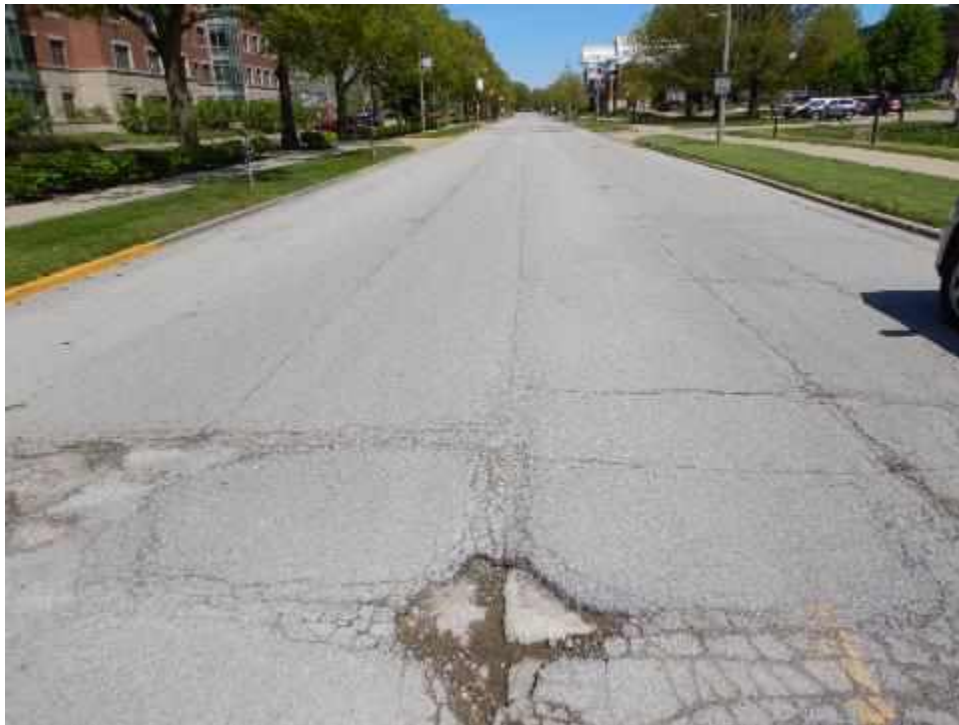
PEABYD-E01A-Joint Reflection Cracking-(Sample Unit No. 01)

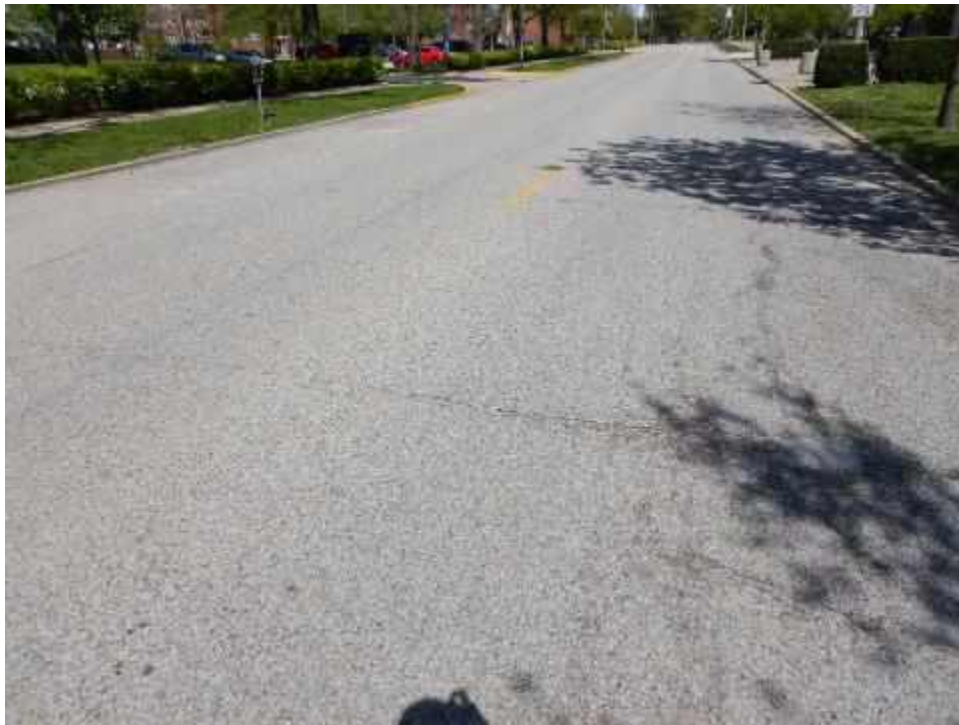
PEABYD-E01B-Joint Reflection Cracking-(Sample Unit No. 01)

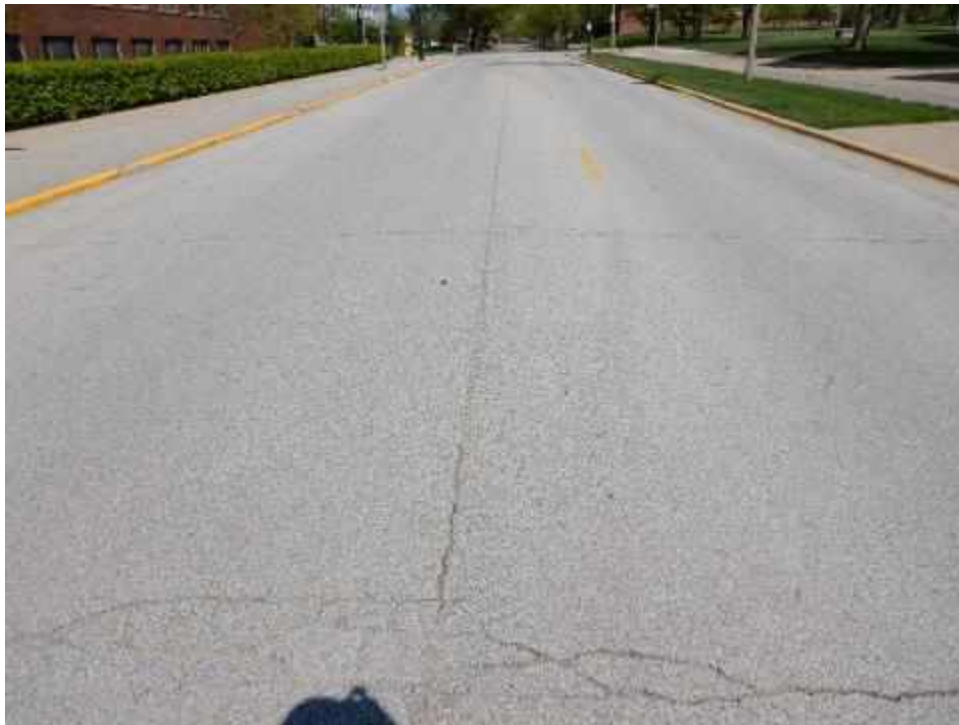
PEABYD-E03-Joint Reflection Cracking-(Sample Unit No. 01)

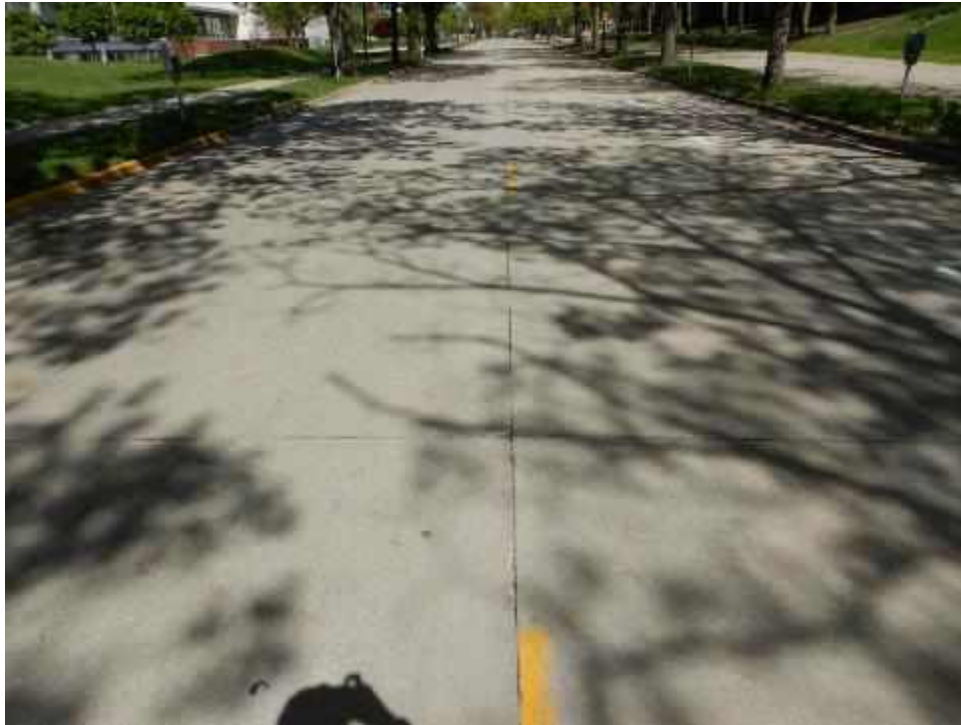
PEABYD-E04A-Joint Seal Damage-(Sample Unit No. 01)

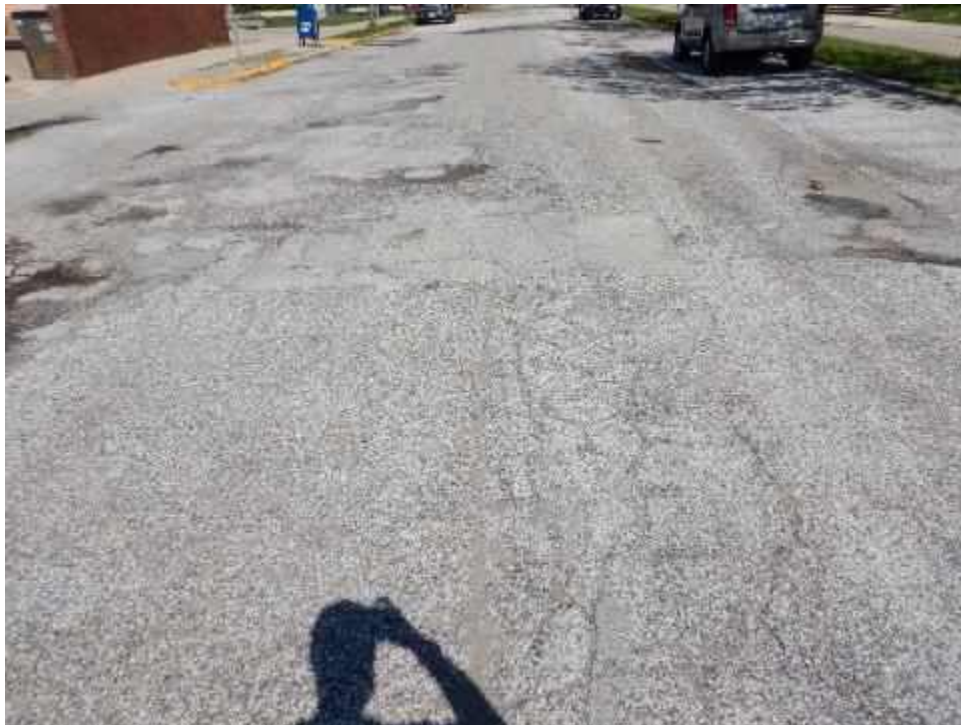
PEABYD-E06A-Alligator Cracking-(Sample Unit No. 01)

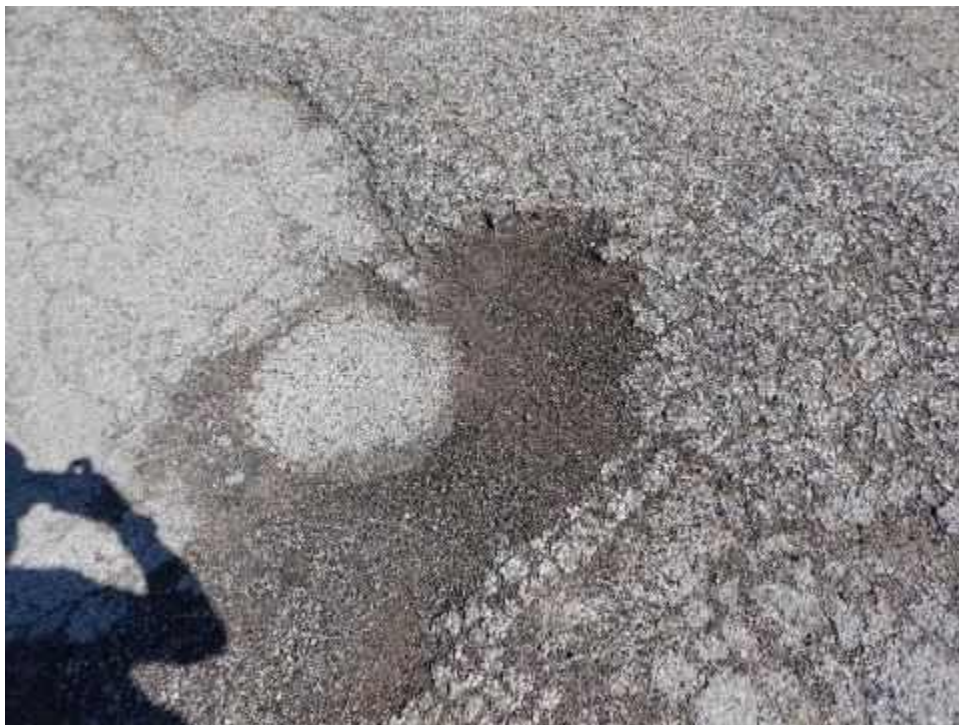
PEABYD-E06A-Patching-(Sample Unit No. 01)

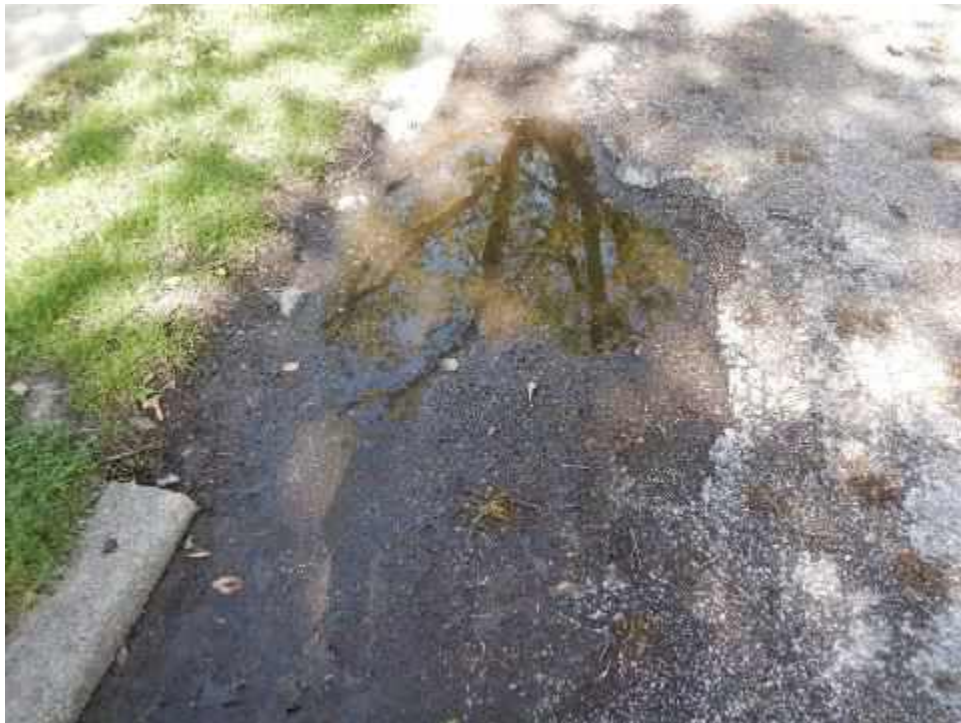
PEABYD-E06B-Alligator Cracking-(Sample Unit No. 01)

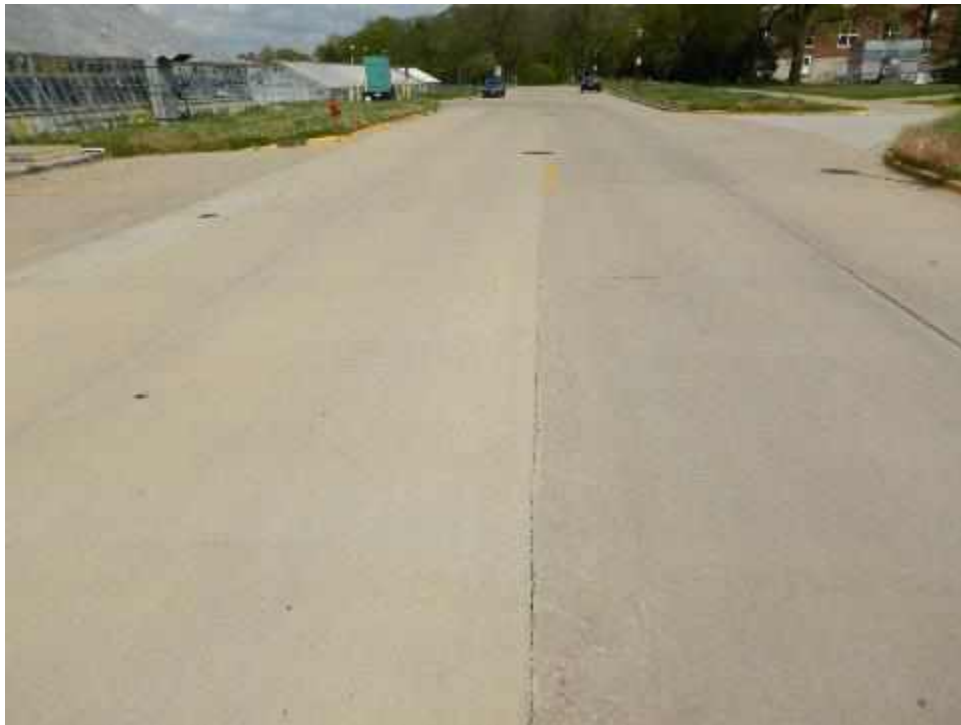
PEABYD-UW11-Large Patching-(Sample Unit No. 01)

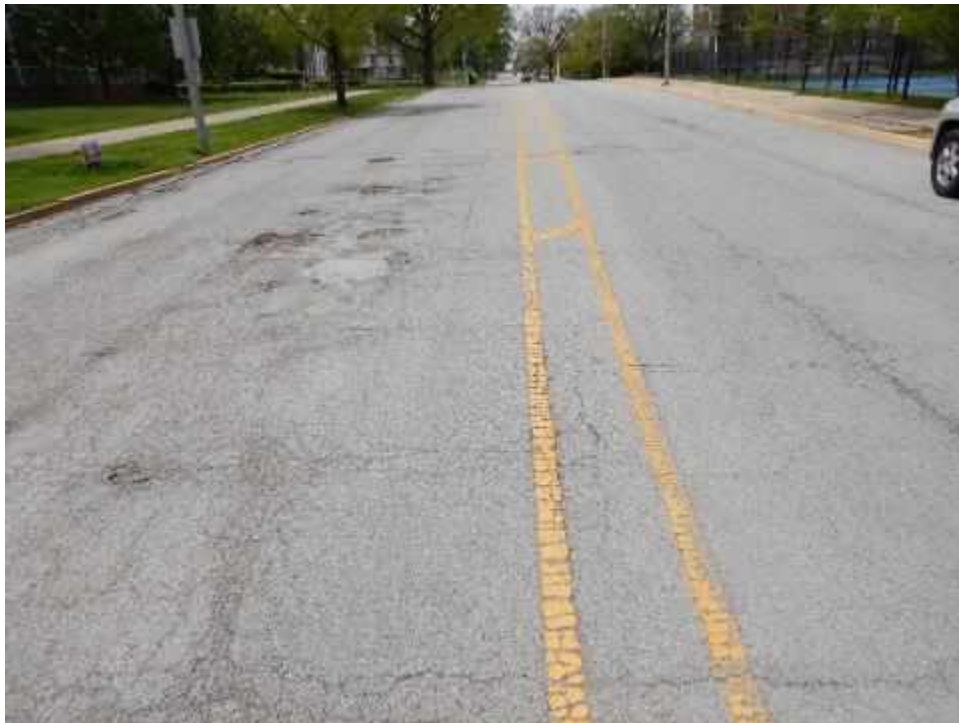
PENSYA-UW09A-Block Cracking-(Sample Unit No. 01)

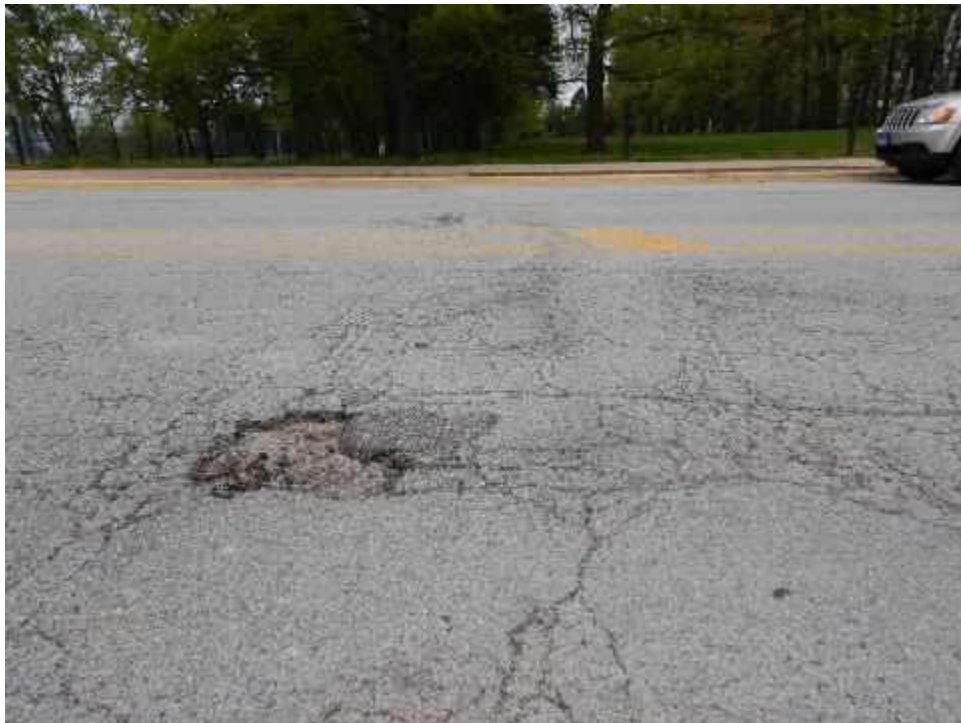
PENSYA-UW09A-Pothole-(Sample Unit No. 01)

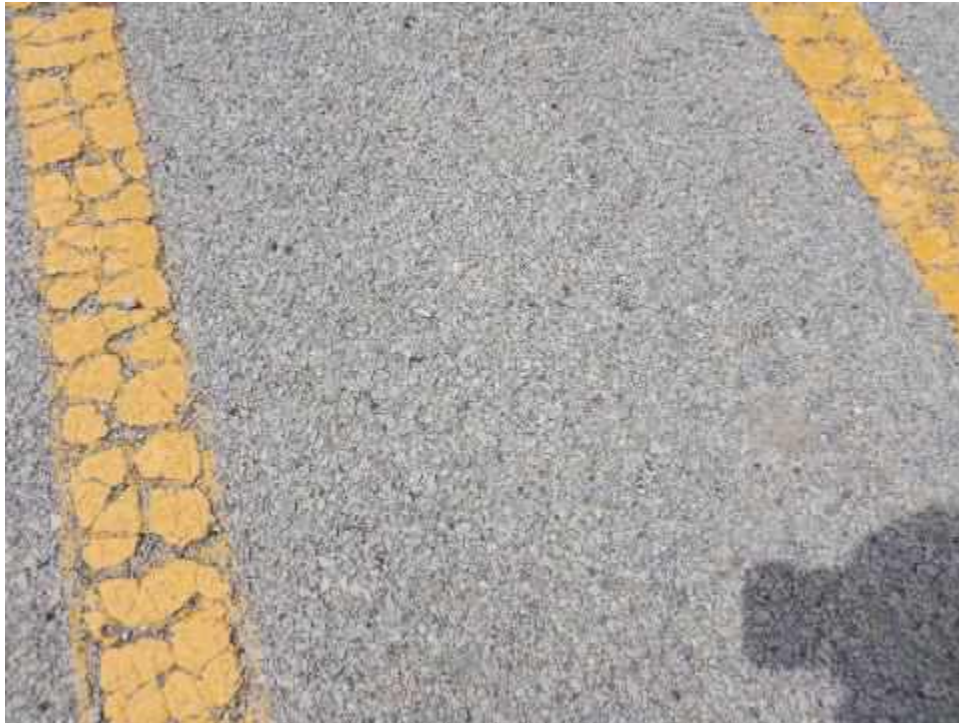
PENSYA-UW09A-Swelling-(Sample Unit No. 01)

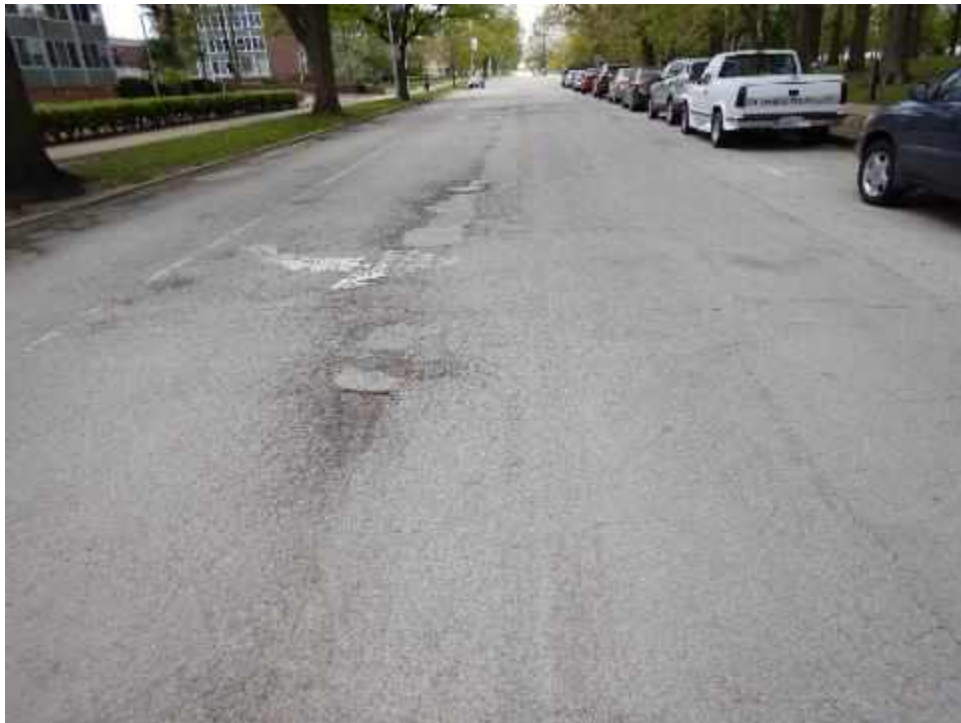
PENSYA-UW09B-Block Cracking-(Sample Unit No. 01)

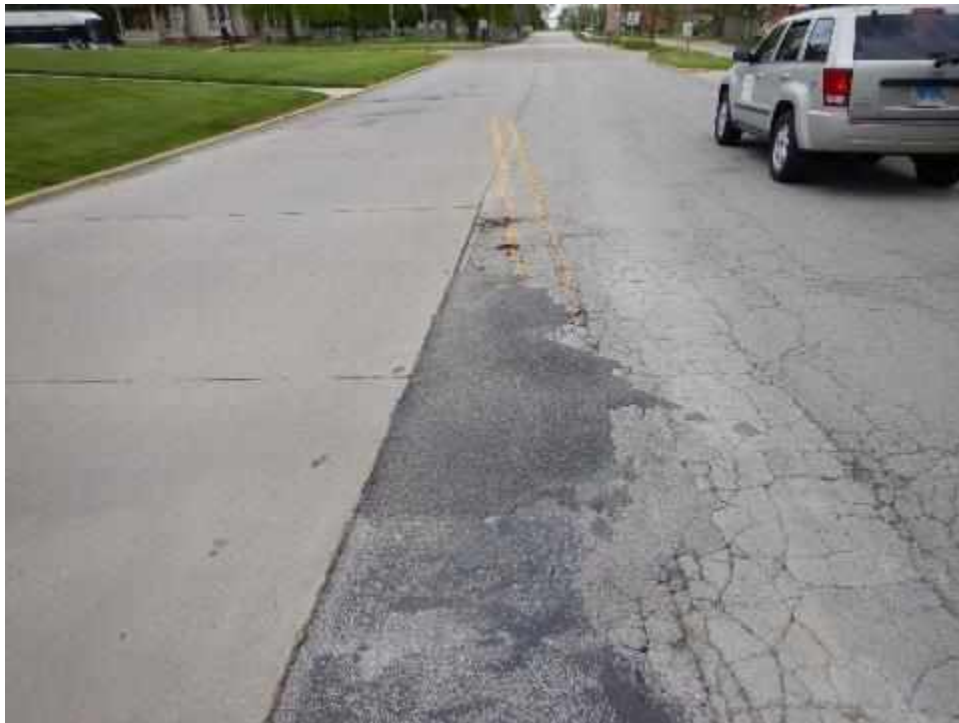
PENSYA-UW11A-Block Cracking-(Sample Unit No. 01)

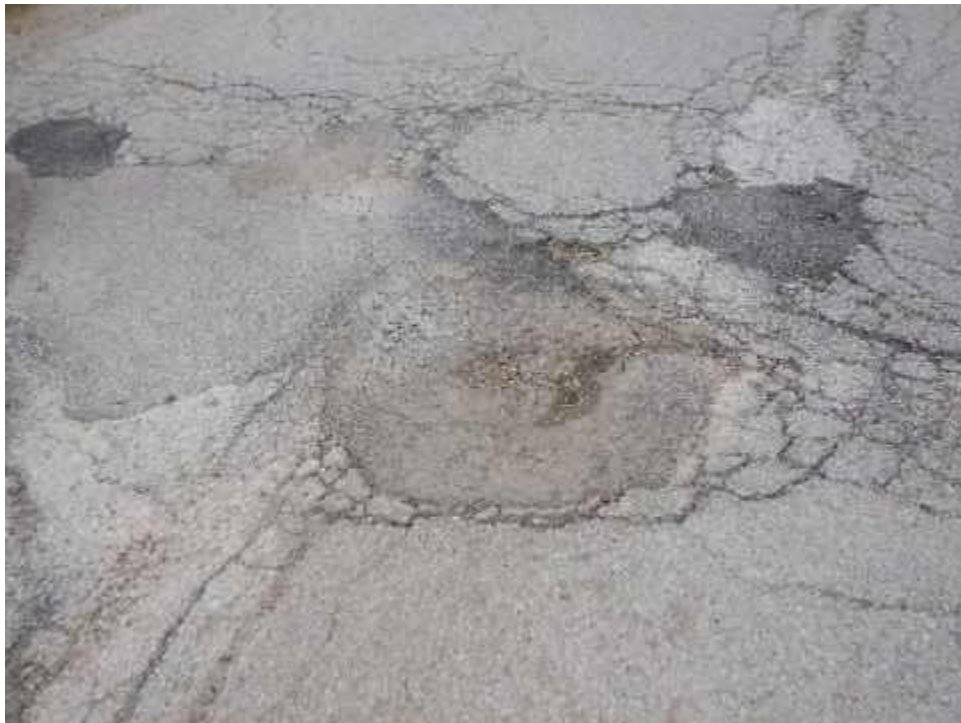
PENSYA-UW11A-Patching-(Sample Unit No. 01)

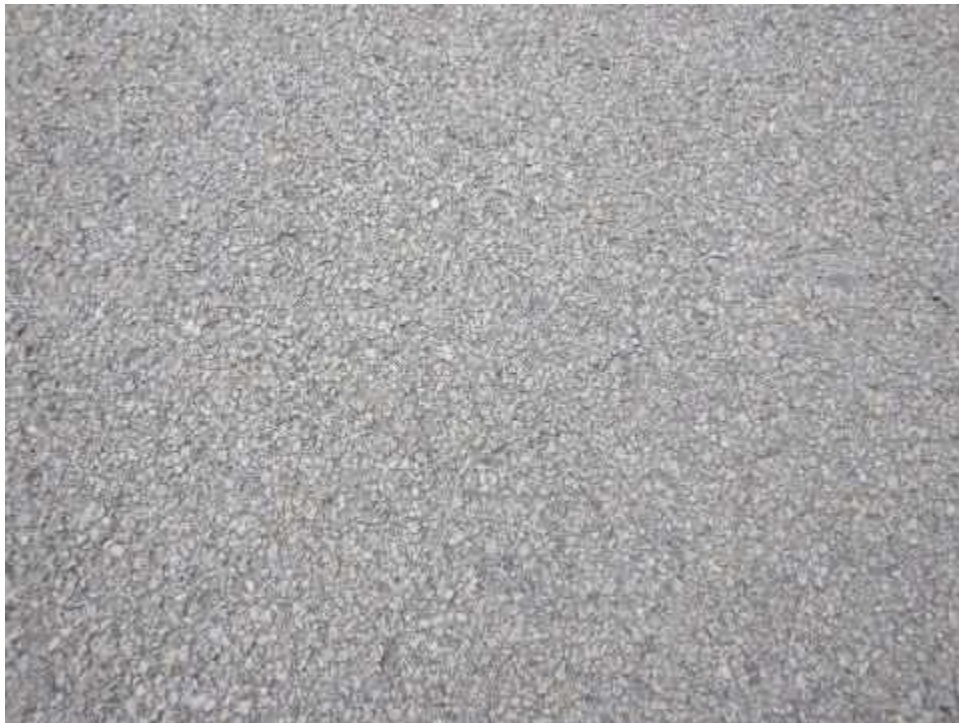
PENSYA-UW11A-Rutting-(Sample Unit No. 01)

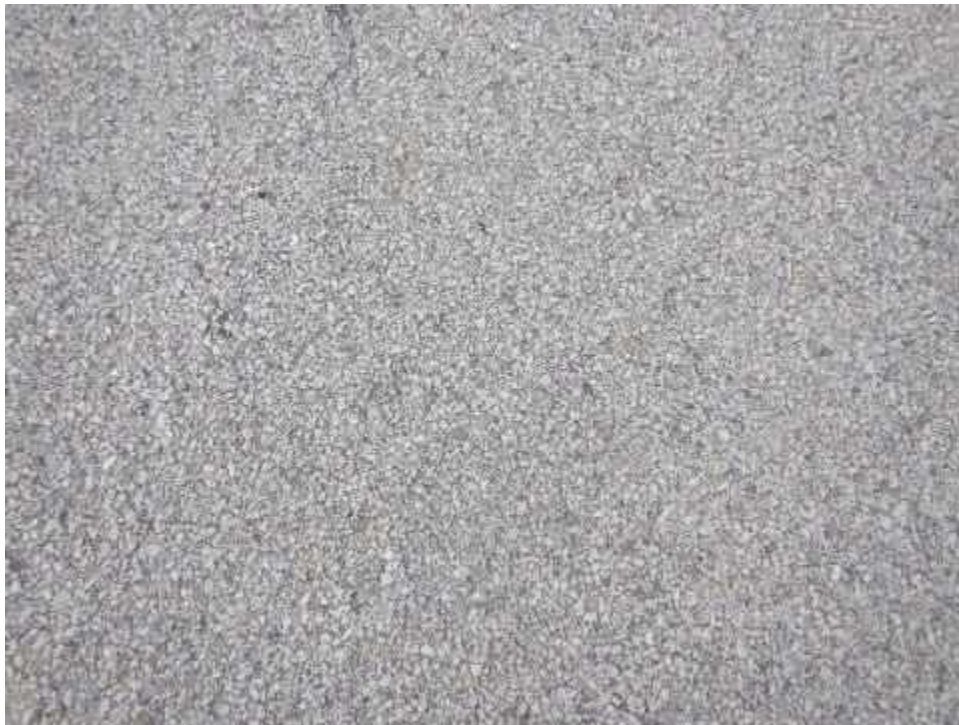
PENSYA-UW11B-Weathering-(Sample Unit No. 01)

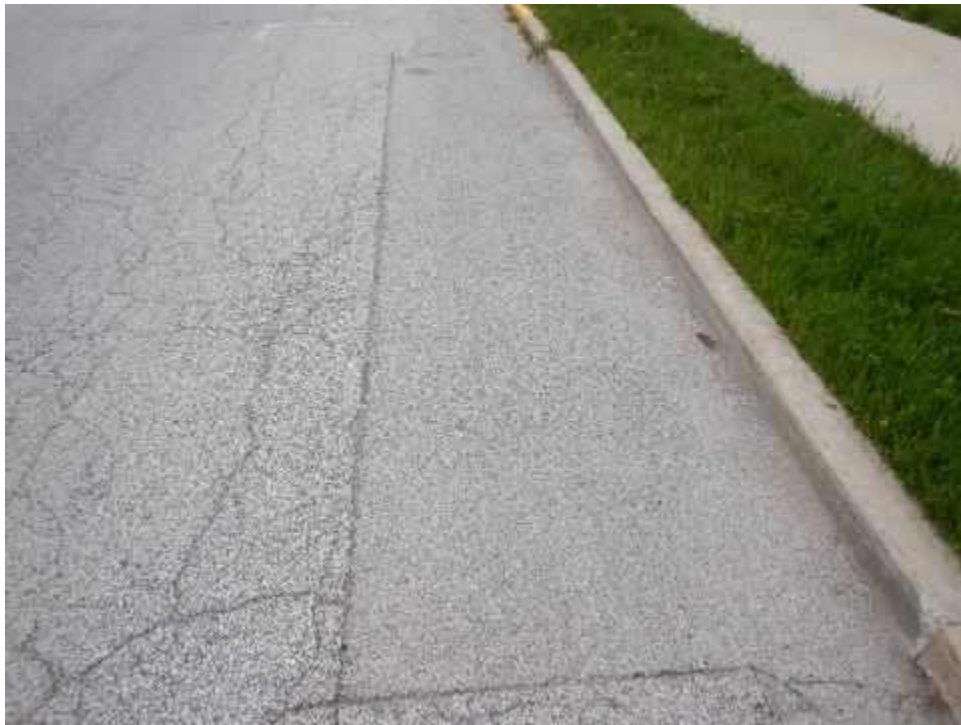
PENSYA-UW12B-Patching-(Sample Unit No. 02)

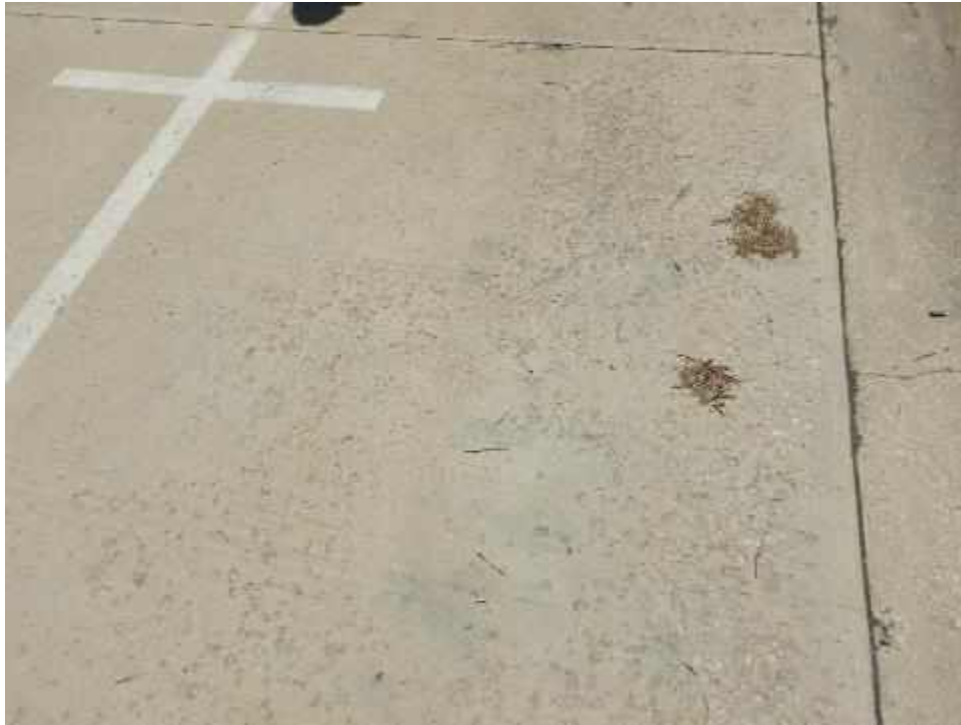
SIXTHS-S10-Scaling-(Sample Unit No. 01)

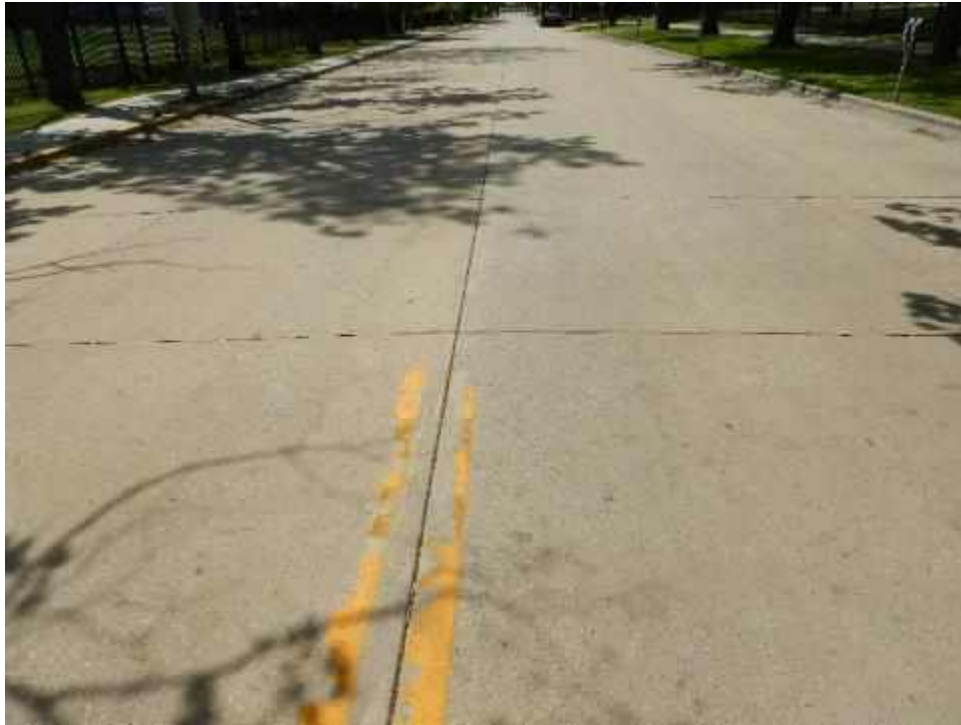
STADMD-E00E-Joint Spalling-(Sample Unit No. 01)

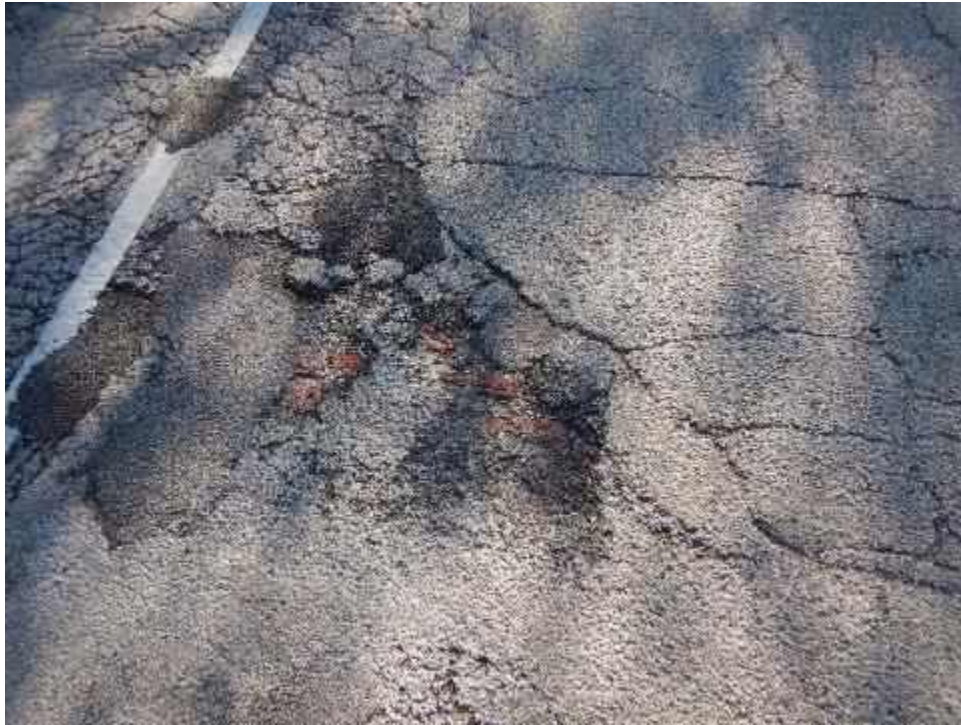
STMARR-E00A-Patching-(Sample Unit No. 01)

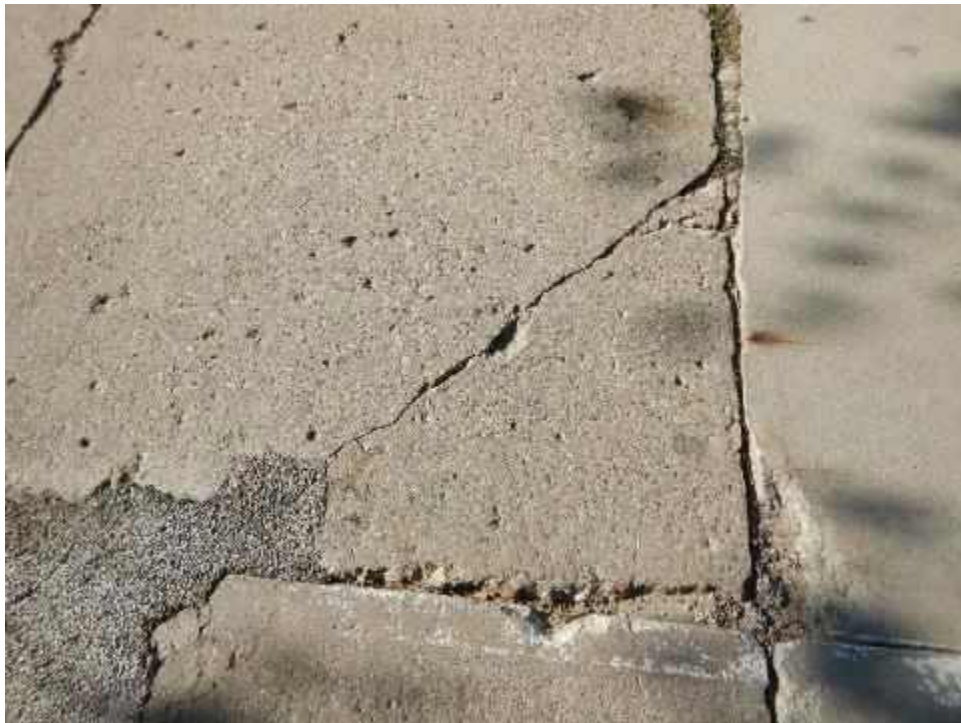
STMARR-E00A-Rutting-(Sample Unit No. 01)

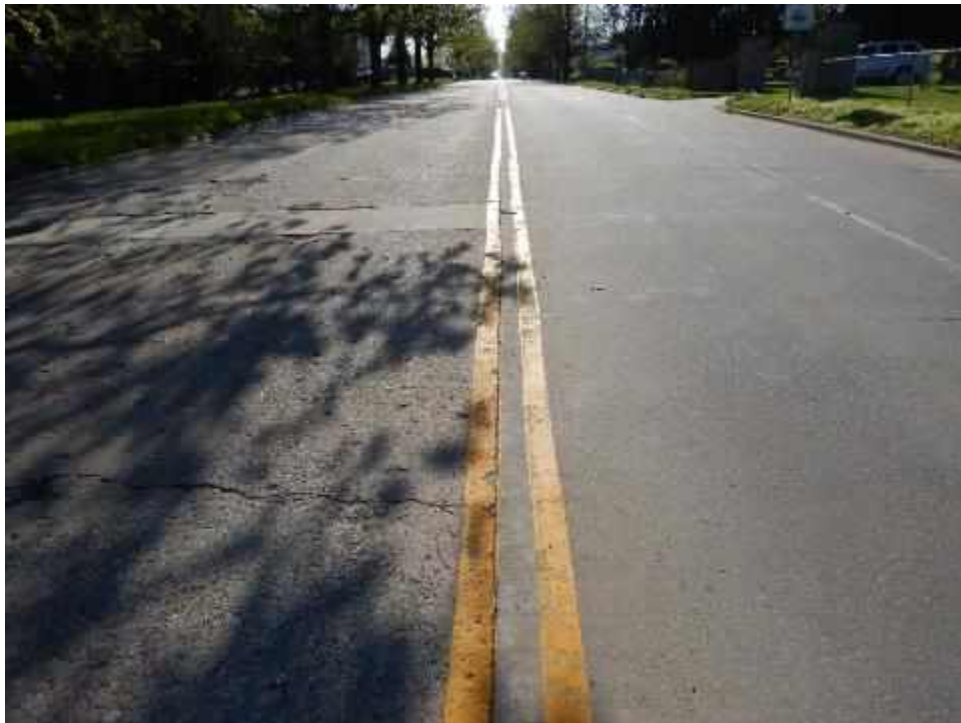
STMARR-E00B-Large Patching-(Sample Unit No. 01)

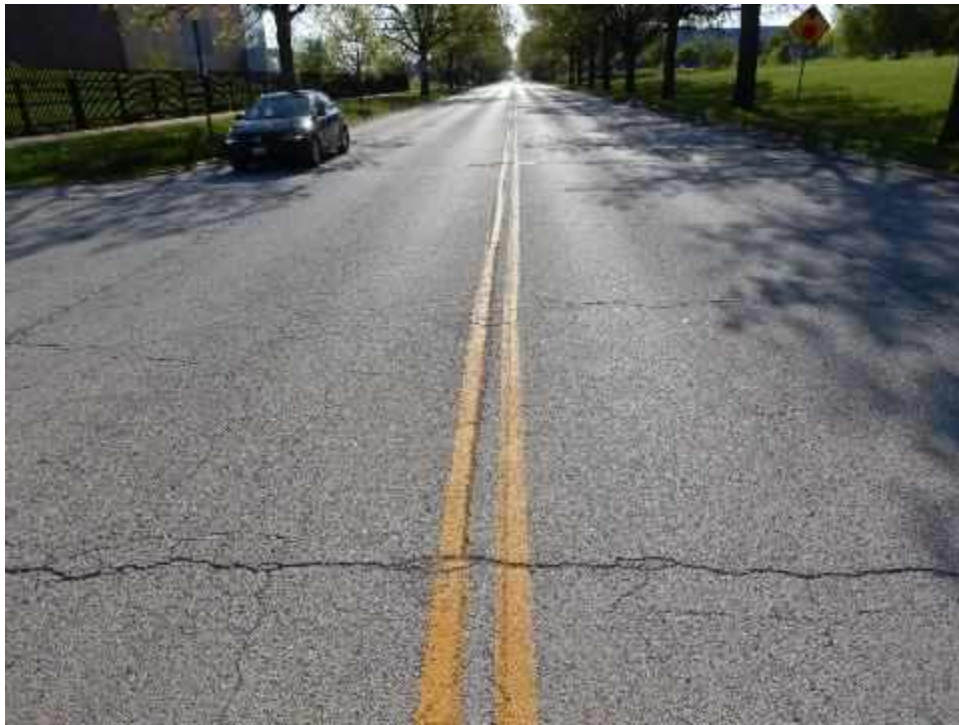
STMARR-E00C-Joint Reflection Cracking-(Sample Unit No. 01)

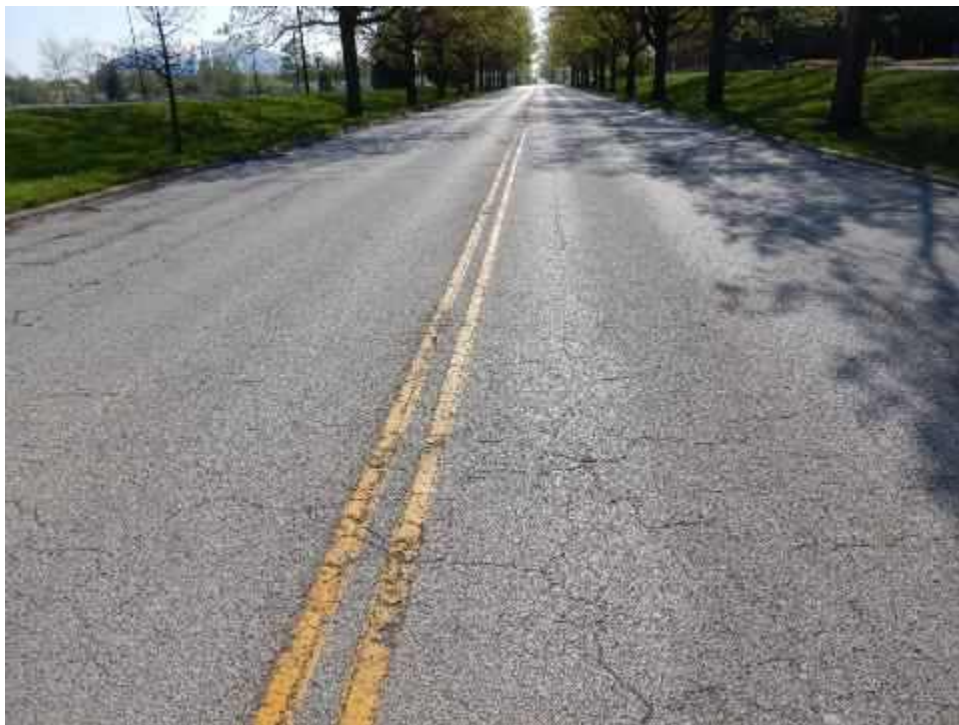
STMARR-E00D-Joint Reflection Cracking-(Sample Unit No. 01)

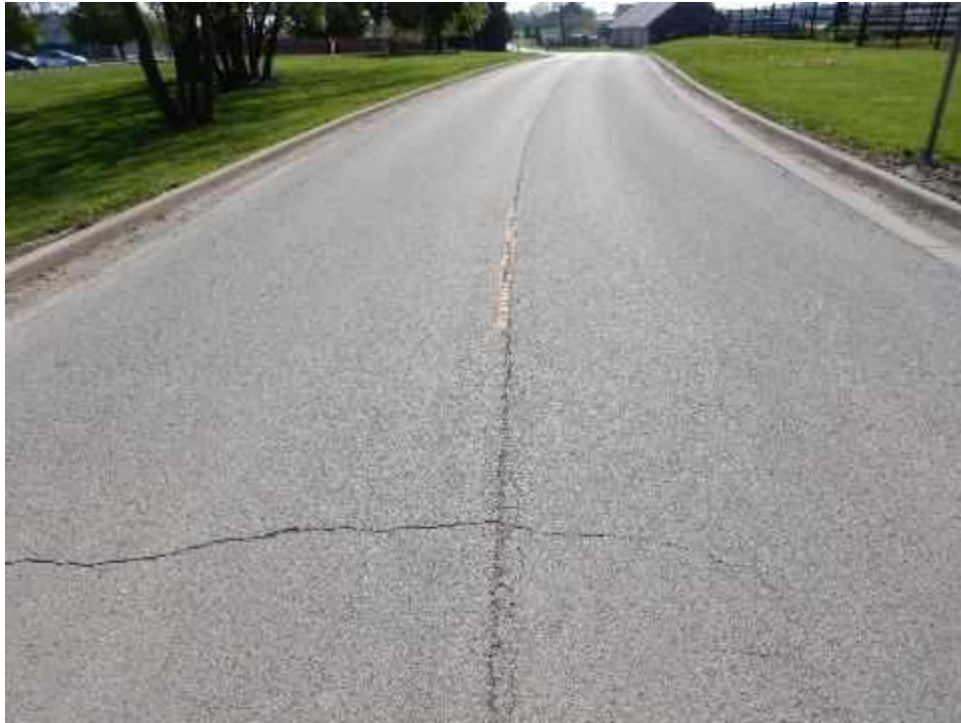
STMARR-E04A-L&T Cracking-(Sample Unit No. 01)

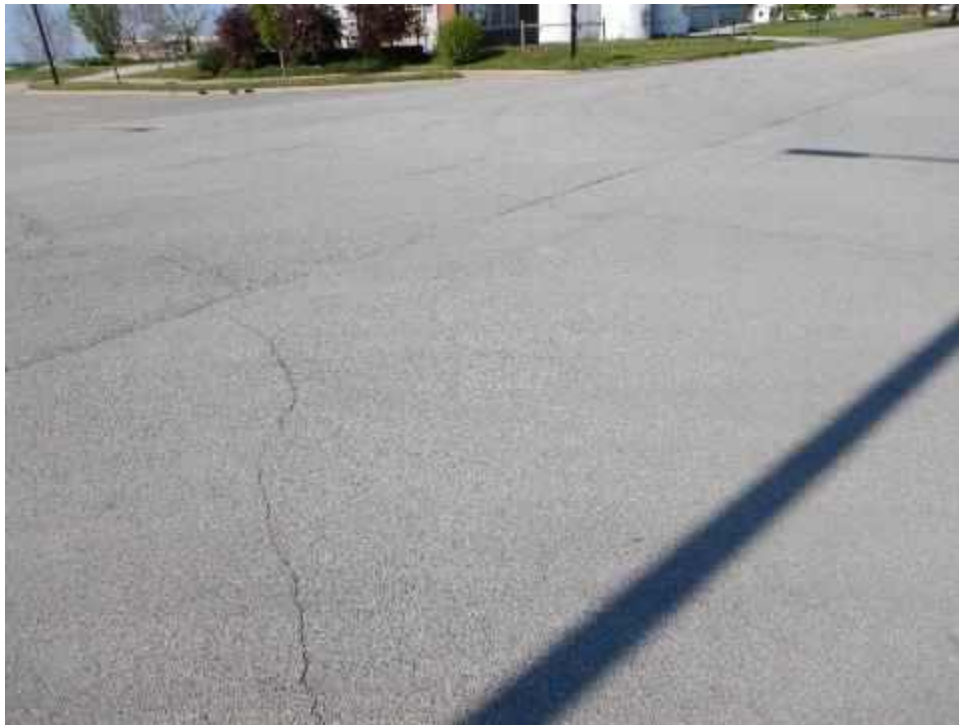
STMARR-E04B-L&T Cracking-(Sample Unit No. 01)

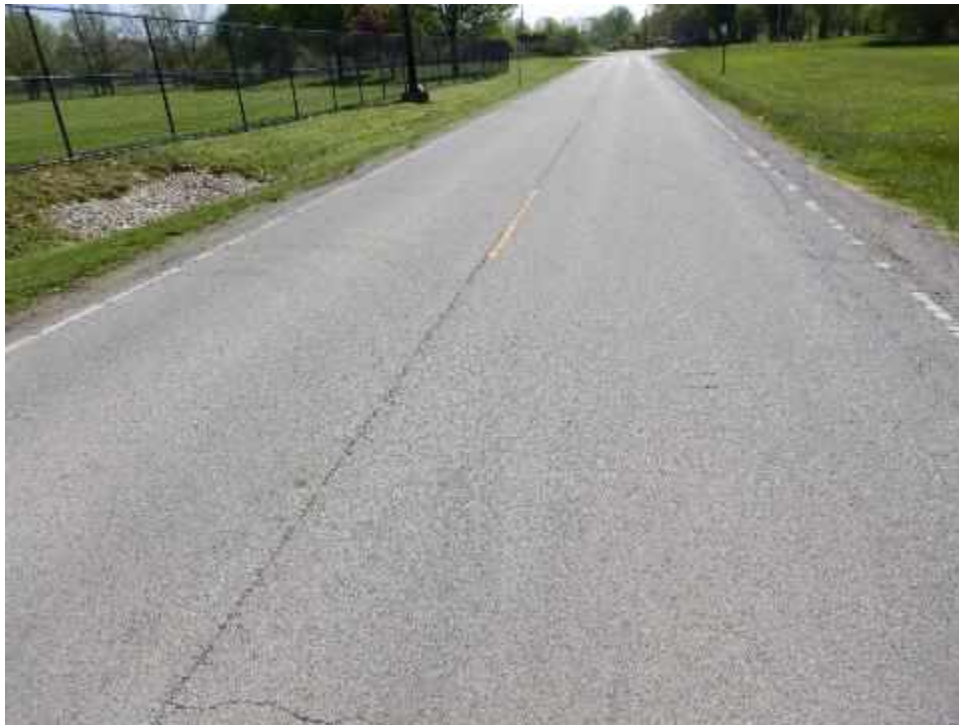
STMARR-UW09A-L&T Cracking-(Sample Unit No. 01)
