# U20069: Pavement Analysis Study 2020 University of Illinois at Urbana-Champaign

## Final Report

Applied Pavement Technology, Inc.  
115 West Main Street, Suite 400  
Urbana, Illinois 61801  
(217) 398-3977  
[www.appliedpavement.com](http://www.appliedpavement.com)

**AUGUST 2020**

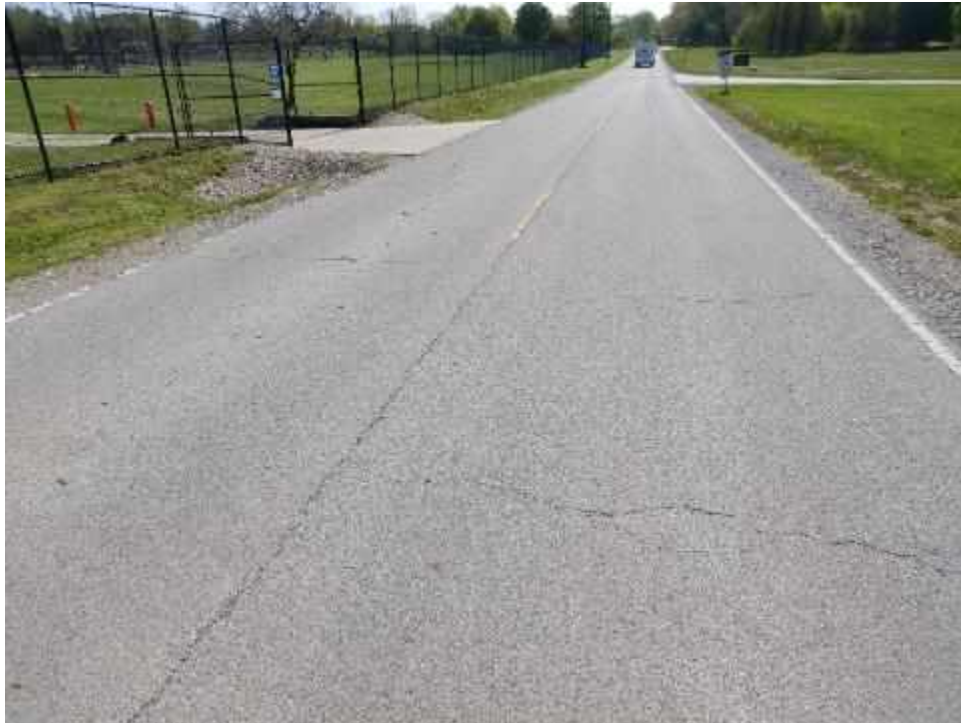
STMARR-UW09B-L&T Cracking-(Sample Unit No. 01)

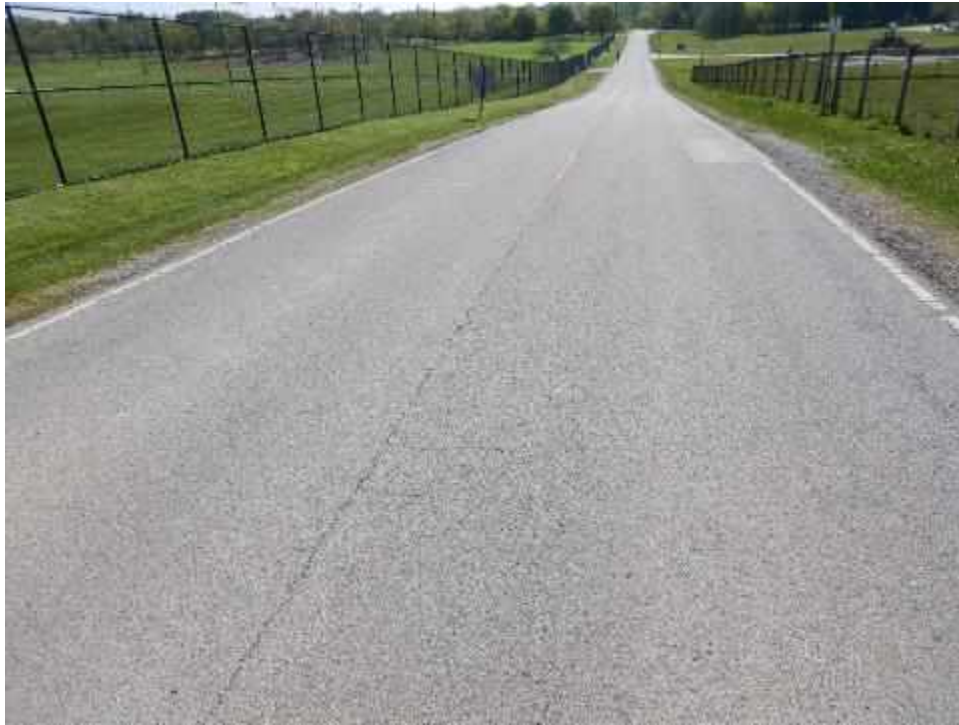
STMARR-UW09C-L&T Cracking-(Sample Unit No. 01)

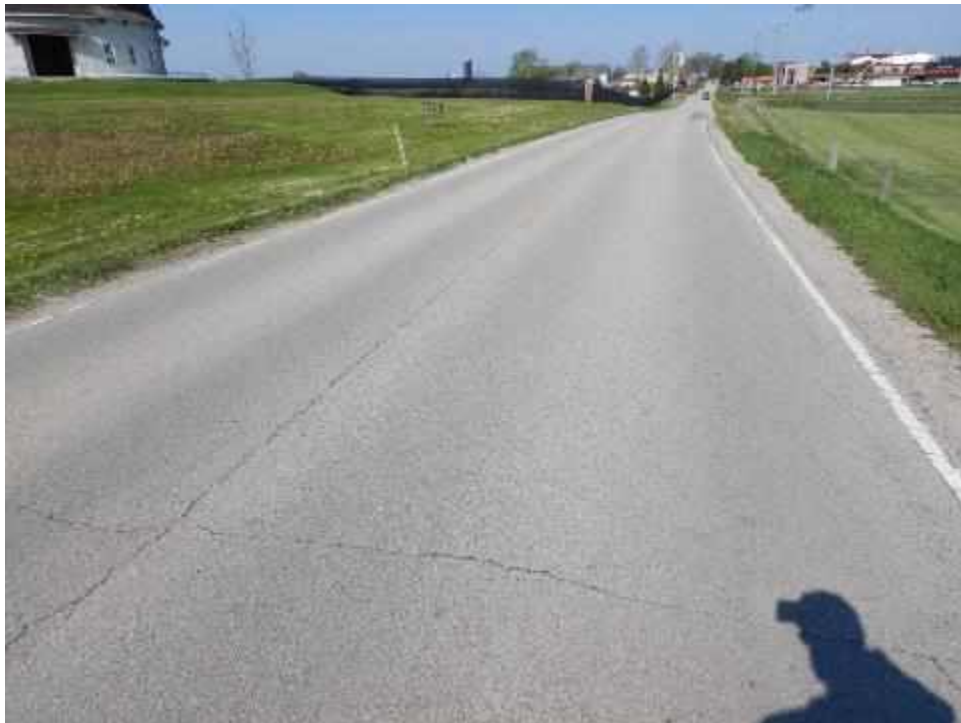
STMARR-UW12-L&T Cracking-(Sample Unit No. 01)

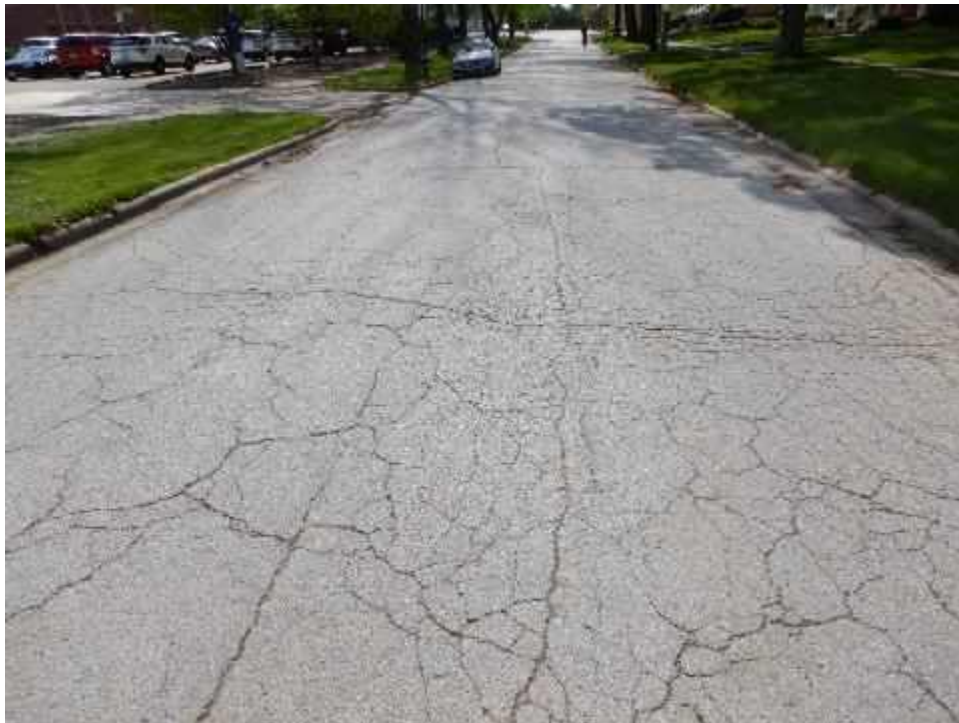
STOUGS-UW11-Alligator Cracking-(Sample Unit No. 01)

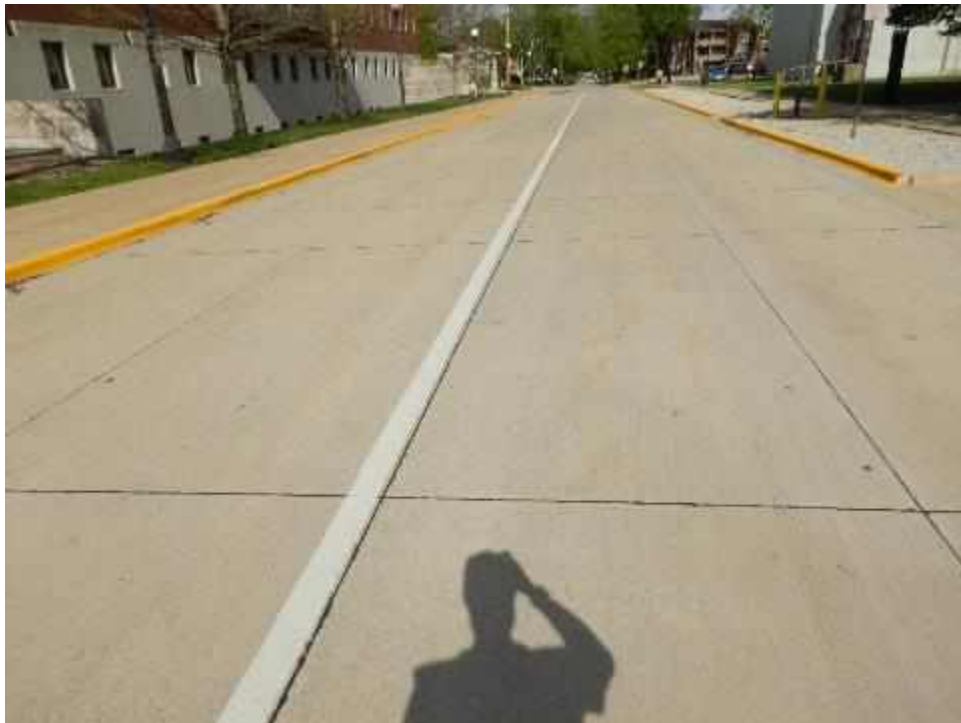
STOUGS-UW12-Joint Seal Damage-(Sample Unit No. 01)

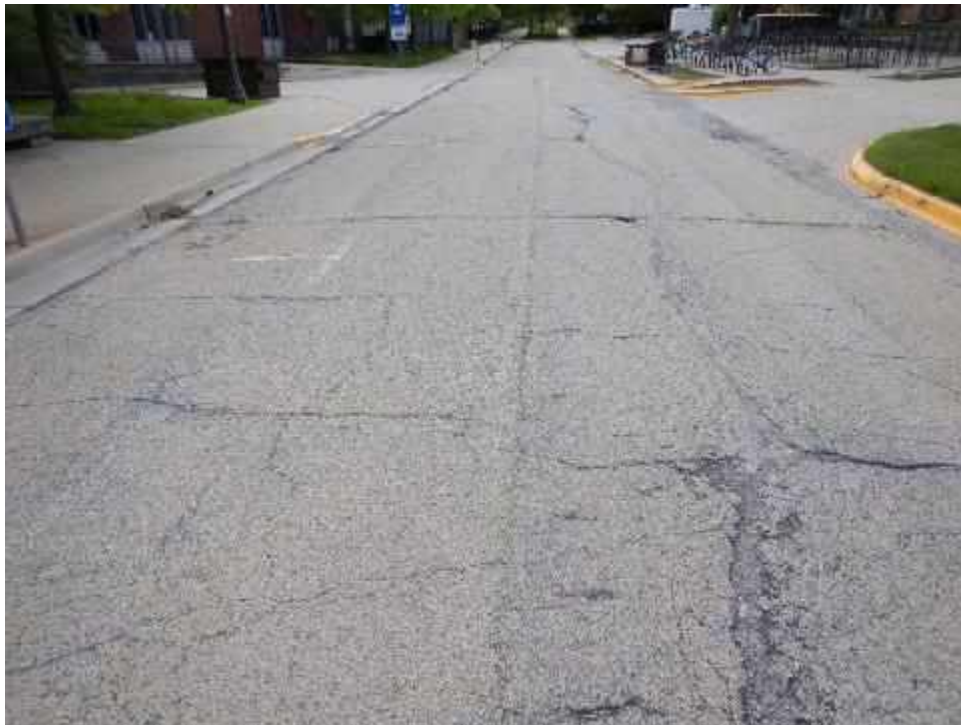
STOUGS-UW13-L&T Cracking-(Sample Unit No. 02)

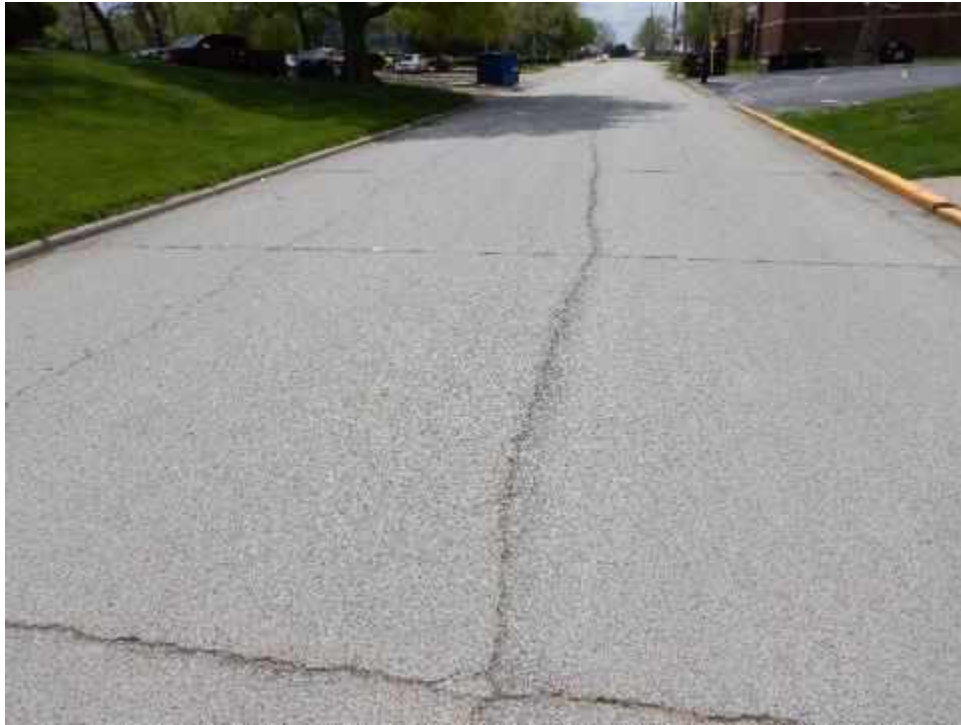
VRGNADR-US14A-L&T Cracking-(Sample Unit No. 01)

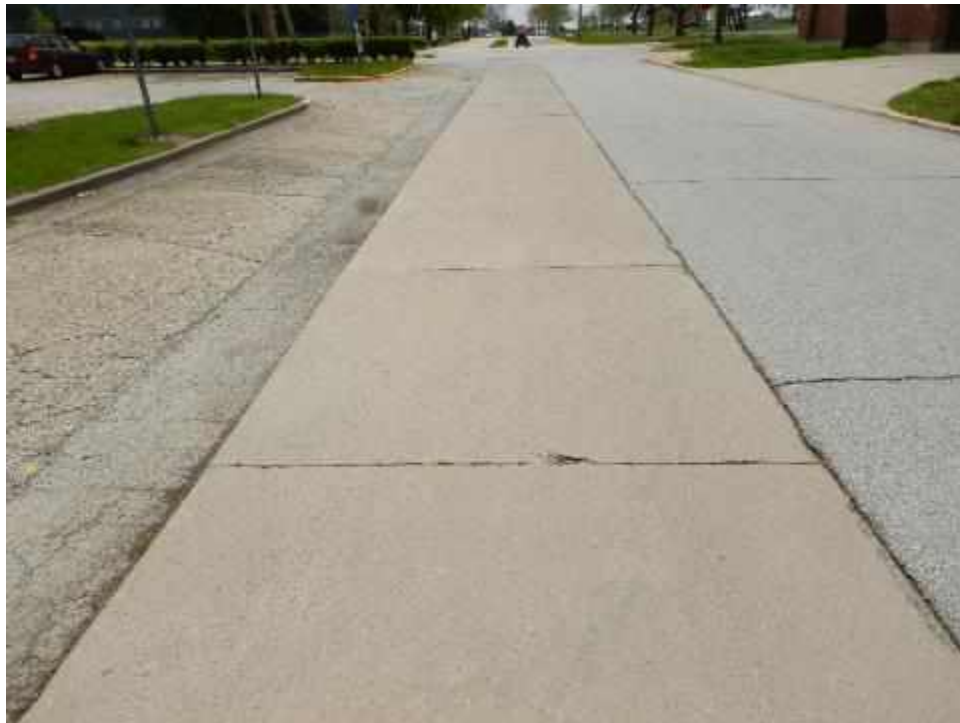
VRGNADR-US14BE-Joint Spalling-(Sample Unit No. 01)

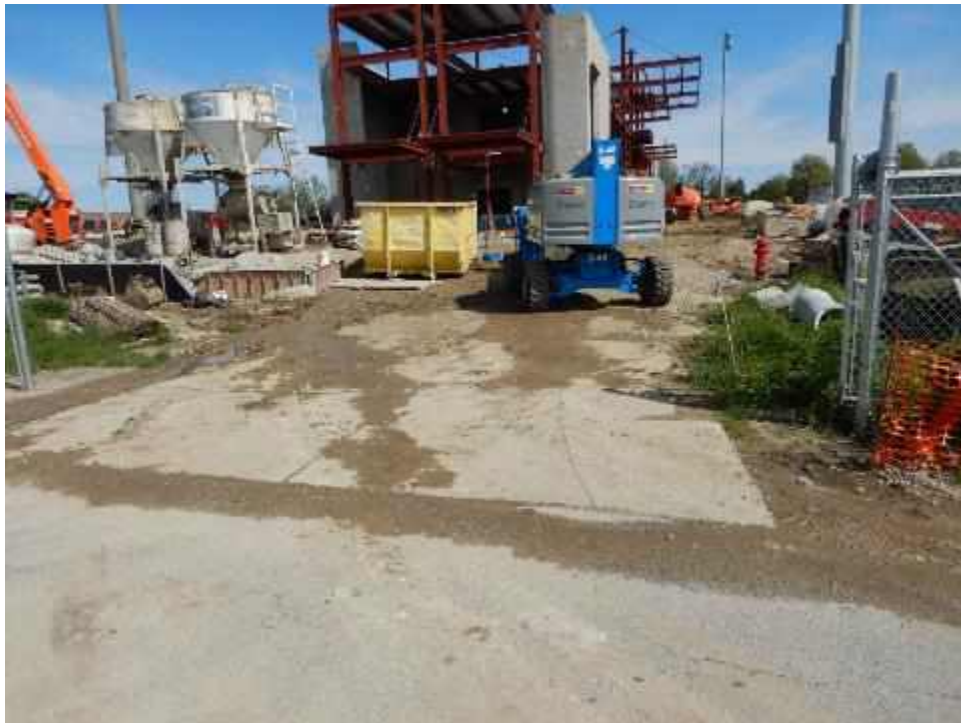
VRGNADR-US14BW-Weathering-(Sample Unit No. 01)

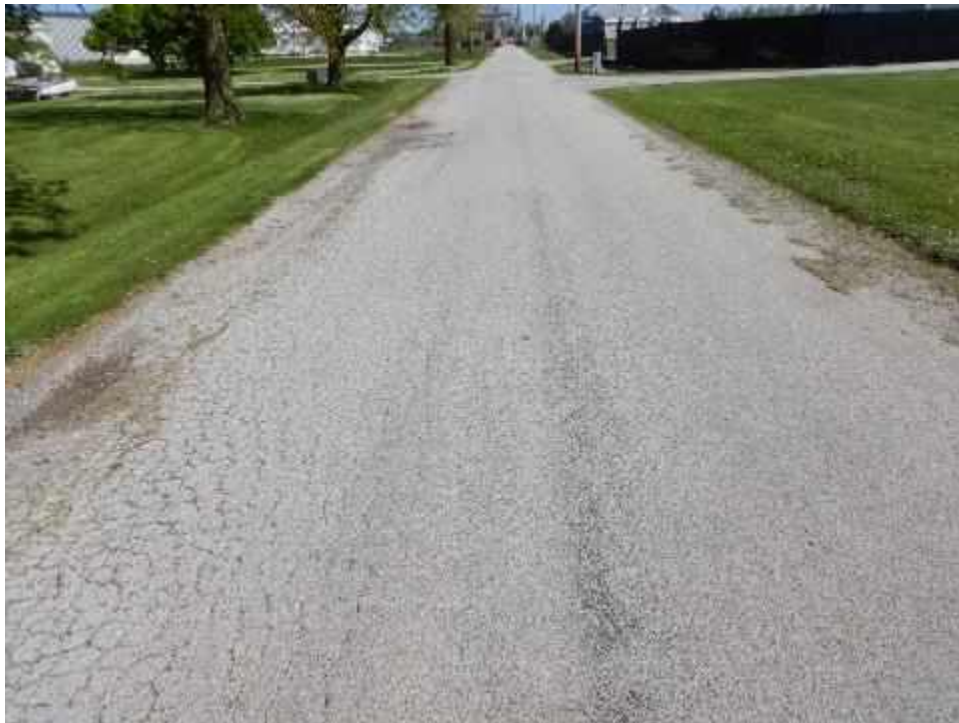
WRIGHS-S18-Alligator Cracking-(Sample Unit No. 01)

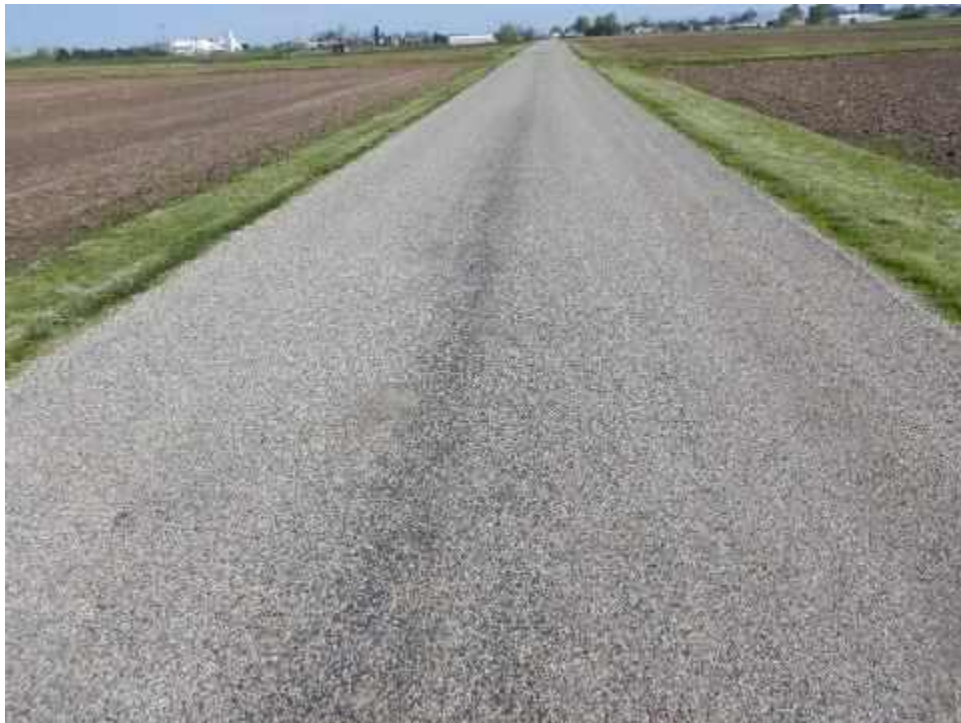
WRIGHS-S18-Weathering-(Sample Unit No. 01)
